GENERAL MOTORS LLC
Global Vehicle Safety

USG 4844
June 7, 2019

Re: Recall No. 19V375; Petition for Determination of Inconsequential Noncompliance, Federal Motor Vehicle Safety Standard No. 108 (Lamps, Reflective Devices, and Associated Equipment)

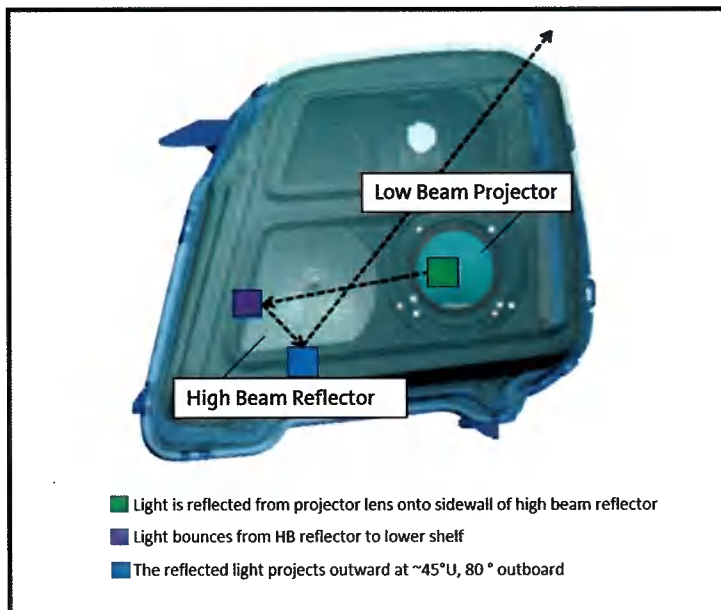
The following Figure 1 shows the path of the reflection on the left headlamp:

FIGURE 1 – PATH OF REFLECTED LIGHT

The headlamp design allows a narrow beam of light from the lower beam lamp to reflect off of the inner surface of the high beam reflector. The lamps' high beams are not affected by this condition.

GM is purging all affected service and replacement headlamps from dealer stock. Stanley has redesigned service and replacement headlamps to add graining to the inadvertent reflecting surfaces, which will prevent the reflections that are the cause of the issue. These redesigned lamps are expected to be available June 12, 2019.

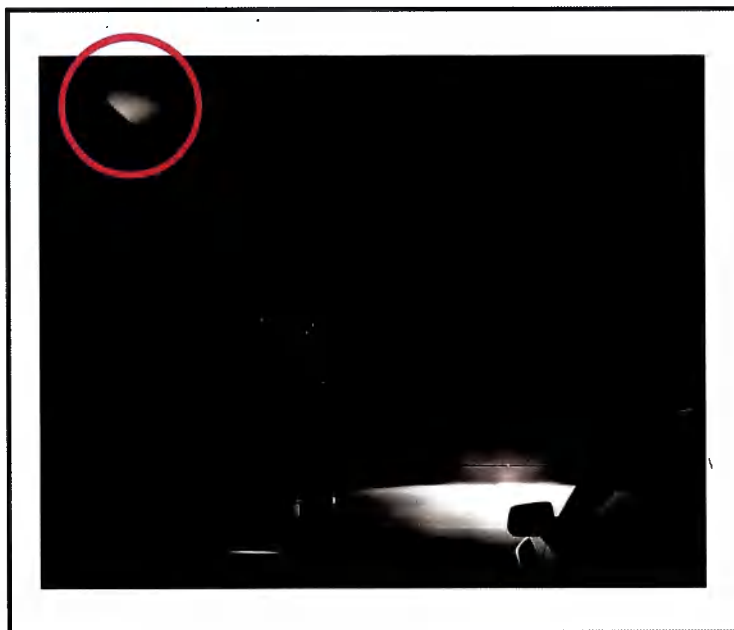
The following Figure 2 shows the location of the small area illuminated by the reflection from the left lamp on a fifteen-foot-tall ceiling. This picture was taken in a darkroom specifically used for vehicle lighting tests. While not pictured, a similar area, in a similar location, from the righthand lamp could be seen on the right side of the vehicle.

FIGURE 2 – REFLECTED LIGHT FROM LEFT HEADLAMP AS SEEN FROM REAR OF VEHICLE

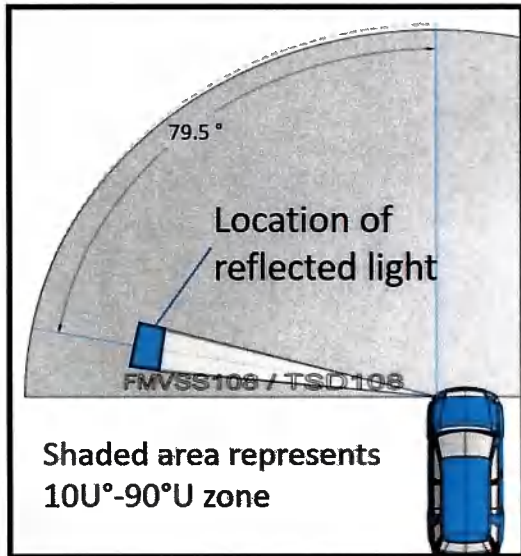
Each reflection point is near the edge of the 10°U-90°U range. The following Figures 3 through 5 show the reflection from the left headlamp in relation to the 10°U-90°U zone. The reflection from the right lamp is in a similar location on the opposite side of the vehicle. As measured, the reflection is approximately 45° up, 80° outboard; 6.6° wide by 4.9° deep; 2.2 lumens at 10 meters; and 450-470 cd.

FIGURE 3 - PLAN VIEW OF REFLECTED LIGHT OVERLAID ONTO 10°U-90°U ZONE

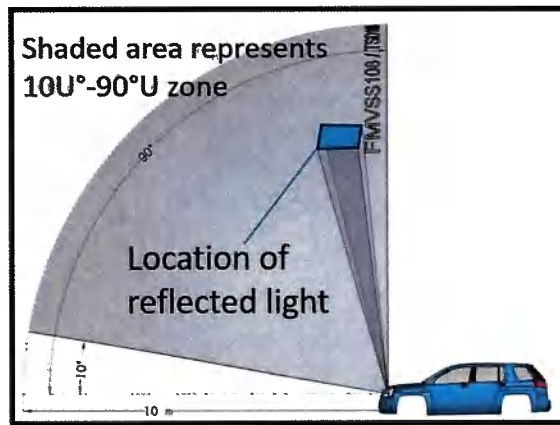
FIGURE 4 - SIDE VIEW OF REFLECTED LIGHT OVERLAID ONTO 10°U-90°U ZONE

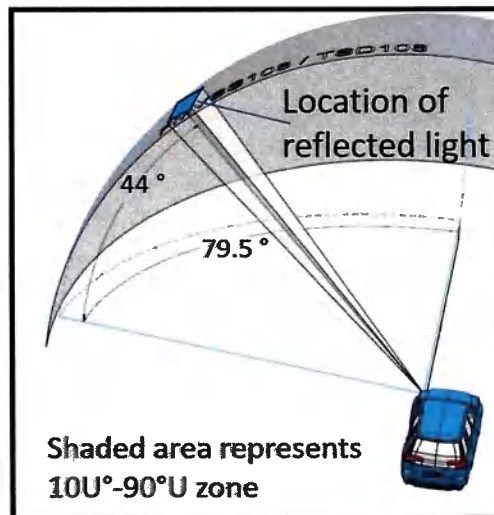
FIGURE 5 - ORTHOGONAL VIEW OF REFLECTED LIGHT OVERLAID ONTO 10°U-90°U ZONE

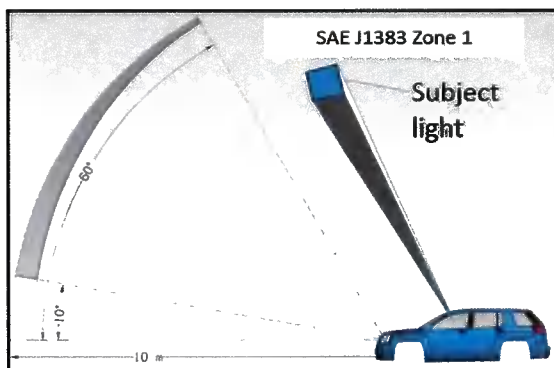
S6.1.1 of SAE International Standard J1383, *Performance Requirements for Motor Vehicle Headlamps* (May 26, 2010), sets forth certain industry-recognized intensity and size limits on headlamp photometrics. Specifically, for a zone extending 20° left to 20° right, and 10° to 60° up from the lamp optical axis, the light projected cannot exceed 550 candela and cannot occupy more than five percent of the zone’s total area. As depicted in Figures 6 and 7, the reflection from the subject lamps is well outside of this zone. Even if the reflection were within this zone, the headlamps would remain compliant, as the reflection would not exceed the maximum of five percent of the total area or the maximum of 550 candelas.

FIGURE 6 – SIDE VIEW OF REFLECTED LIGHT OVERLAID ONTO SAE ZONE 1

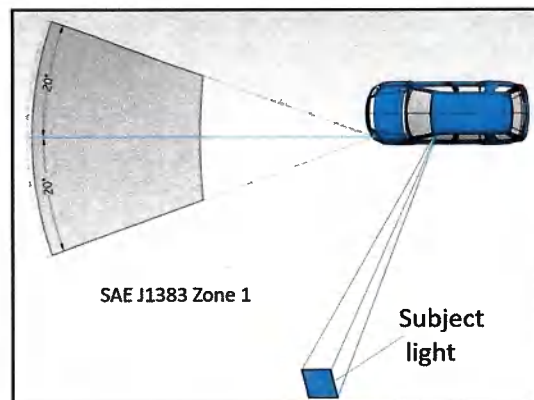
FIGURE 7 – PLAN VIEW OF REFLECTED LIGHT OVERLAID ONTO SAE ZONE 1
