Re: Petition for Exemption from Notification and Remedy Requirements Inconsequential Noncompliance with FMVSS 108 - Certain MY 2013-2019 Lexus Vehicles

Petition for Exemption from Notification and Remedy Requirements Pursuant to 49 CFR Part 556

Inconsequential Noncompliance with FMVSS No. 108 In Certain 2013-2019 Model Year Lexus Vehicles

NONCOMPLIANCE INFORMATION REPORT

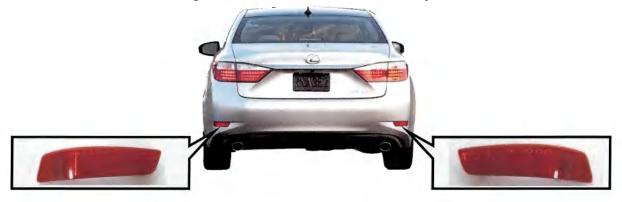
Fig. 1: Rear Reflex Reflector Assembly

The two rear reflex reflectors on the subject vehicles are designed to reflect light to make other drivers aware of the vehicles' presence under certain conditions. See the representative photograph of a 2013MY Lexus ES350 in Fig. 1 below.

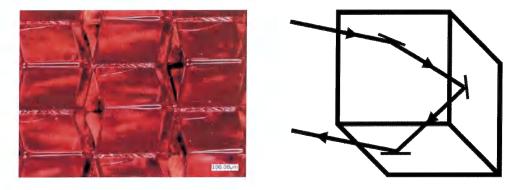
Fig. 2: Back Surface of the Lens and Image of Reflection

The rear reflex reflectors used in the vehicles are retro reflectors which are devices that reflect light back to the light source along the same light direction. The rear reflex reflector consists of the lens and housing. The lens of the rear reflex reflector is constructed of molded acrylic. The back surface of lens consists of three mutually perpendicular, intersecting flat surfaces that are lined up internally. The incident light is reflected multiple times on the three perpendicular intersecting planes, and the incident light is returned to the viewer. See Fig. 2 below. To reduce the scattering of the reflected light, all three of the reflective flat surfaces are aligned perpendicular to each other.

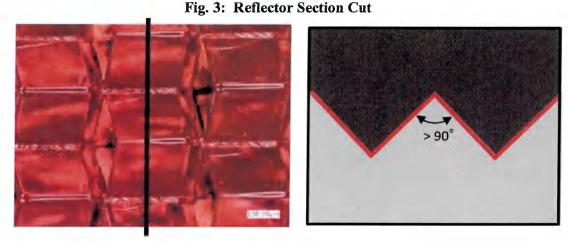
Toyota and the supplier confirmed that, since the start of the reflector production, there have not been any intended changes in the design or the manufacturing process that would affect the photometry performance. Further investigation was conducted to identify the cause of the noncompliance in the part. As explained next, the supplier found that the photometry performance of the subject reflex reflector could be degraded during the annealing process under certain specific conditions, resulting in a potential noncompliance with certain minimum photometric values.

During reflector manufacturing, the annealing operators were instructed to anneal the part for at least 30 minutes. However, it was confirmed that annealing for longer than 30 minutes could start to affect the reflective surface angle. The supplier determined that the worst-case annealing condition was at the end of a day, when the parts were annealed 30 minutes and then the oven automatically turned off, but the parts were left in the oven overnight. Some of these parts had the greatest change in angle of the reflective flat surface. The supplier found that, if the aforementioned annealing condition occurred, the reflective flat surfaces could become greater than 90 degrees, which causes the reflected light to be more scattered. See Fig. 3 below. As a result, the affected parts may not conform to the photometry requirements of FMVSS No. 108, paragraph S8.1.11.

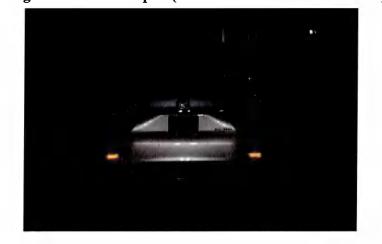
Image 1: Photo of Samples (#B-23 for LH and #B-40 for RH)

In addition, Toyota installed the same two parts that were checked in the dark tunnel (#B-23 and #B-40) on a 2018MY Lexus ES350. Using the headlamps from another vehicle that was aligned 100 feet behind the ES, Toyota members visually observed the reflectivity between the two parts at night and were unable to distinguish a difference between the two reflectors. They looked the same. See Image 1.
