RE: Petition for Determination of Inconsequential Noncompliance

2019 Model Year Nissan Armada vehicles manufactured from September 13, 2018 (start of production) to October 23, 2018 ("subject vehicles").

49 CFR §571.108 S7.4 (FMVSS No. 108): Lamps, reflective devices, and associated equipment

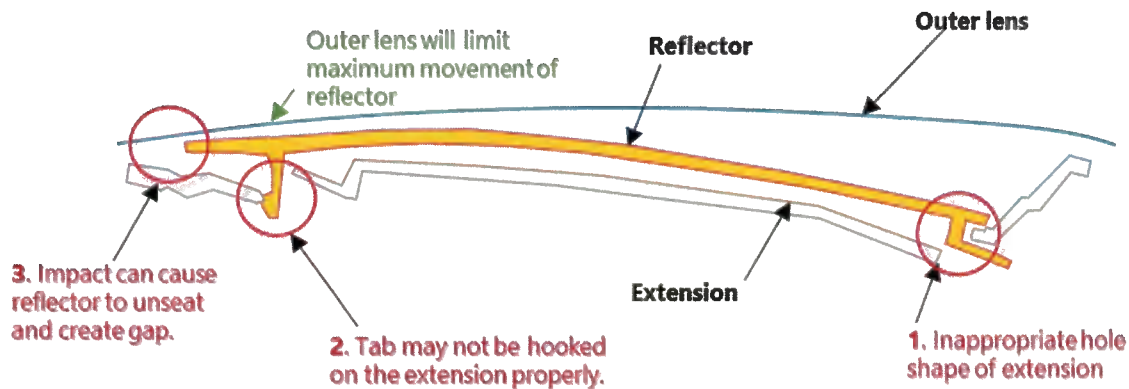
Figure 1. Diagram of headlamp in affected condition

Due to a manufacturing issue affecting only the driver's side marker lamp that has since been corrected, the reflex reflector may not be seated properly in the headlamp assembly, creating a gap between the forward edge of the reflector and the extension portion of the headlamp assembly (See Figs. 1-3 below). The reflector is restrained

from further movement by the outer lens of the headlamp and the maximum potential displacement is shown in Figure 3 below.

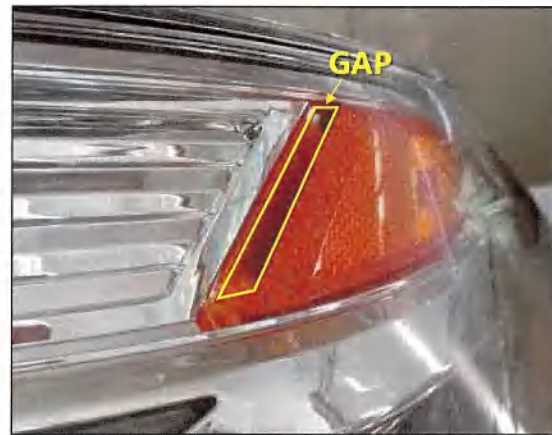
Figure 3. Photo of reflector in worst-case condition

Nissan inspected 1,790 subject vehicles, and it found and collected 14 headlamp assemblies in which the reflex reflector had moved. Nissan also collected several headlamp assemblies in which the reflex reflector had not moved. A "worst case" scenario for displacement of the reflector was also simulated in a test environment where the reflex reflector contacted the inside of the headlamp lens (Fig. 3). Nissan then conducted testing to determine any effect of the displacement on the lamp's performance.

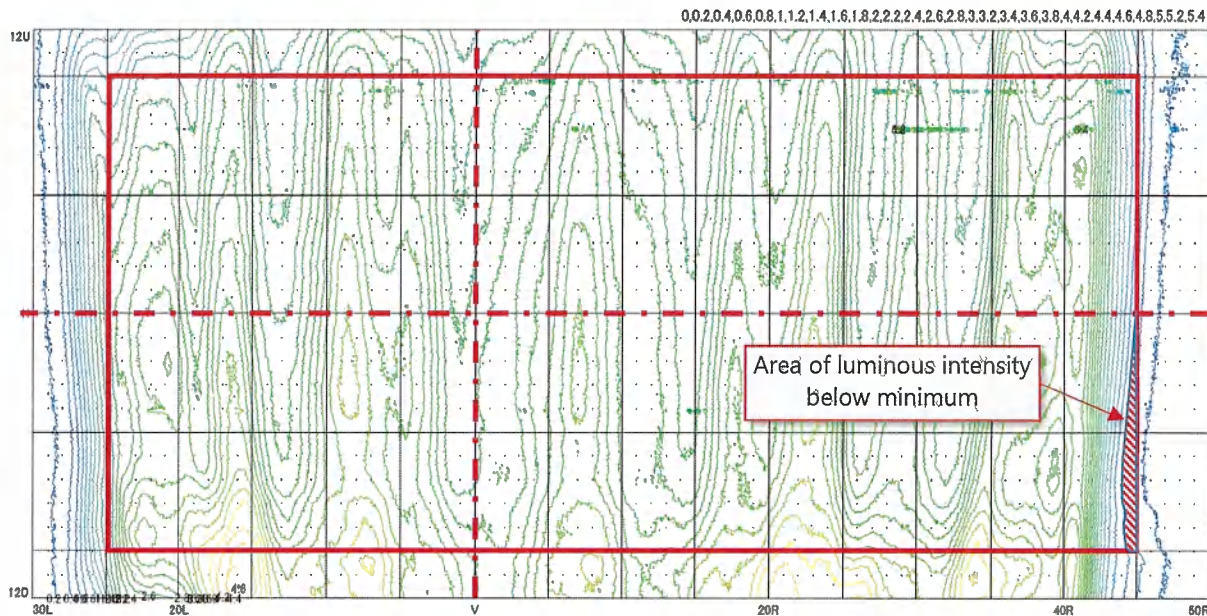
Figure 4. Photometric performance of an unseated reflex reflector at maximum displacement

The photometric intensity of the side marker lamp was confirmed to fully comply with FMVSS No. 108 for nineteen (19) of the twenty (20) tested lamp assemblies. However, in one lamp assembly with the worst-case displacement, the side marker lamp fell below the minimum photometric intensity at one test point. Specifically, S7.4.13.1 of FMVSS No. 108 requires a minimum photometric intensity (cd) of the amber side marker lamp of 0.62cd. For one of the tested lamps with the reflector out of position to the worst case of displacement, the minimum photometric intensity of the amber side marker lamp was below the specified minimum (0.53cd, or 85% of the required

intensity) in a very limited area (approximately 1% of the required area and 1 of 14 test points). The results of this test are shown in Figure 4 below. The full set of results from all 20 parts are provided as CONFIDENTIAL Attachment 2.

As seen in Figure 4 above and CONFIDENTIAL Attachment 2 (Test 1), for this lamp, the area of photometric intensity below the minimum standard is completely in the downward direction (10 degrees downward, 45 degrees to the front), and only for the last few degrees of the forward direction. At the specific test points, only one (1) of fourteen (14) tested below the standard. The rearward and upward direction are compliant throughout the required range of values for all other test results.

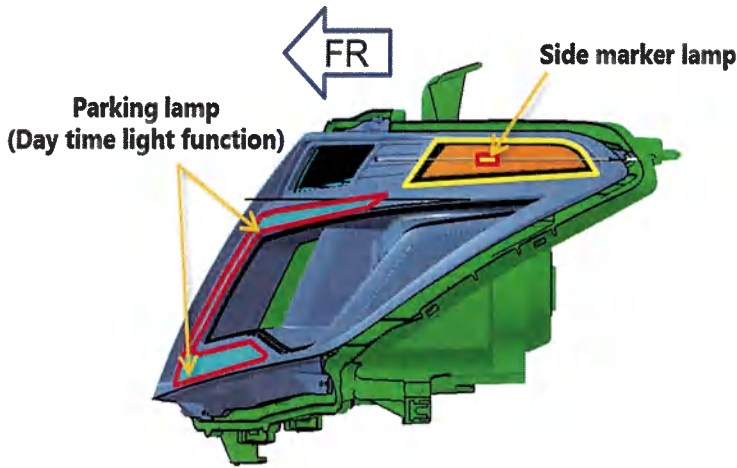
Figure 5. Location of Parking and Side Marker Lamps

Moreover, the parking lamp in the subject vehicles wraps around the corners of the headlamp assembly (Fig. 5) and adds additional illumination in the region where testing showed the photometric intensity of the side marker lamp to be slightly below standard (Fig. 6). On the affected 2019 Model Year Armada vehicles, the parking lamps are on the same circuit as the side marker lamps and therefore always illuminate in conjunction with the side marker lamps.

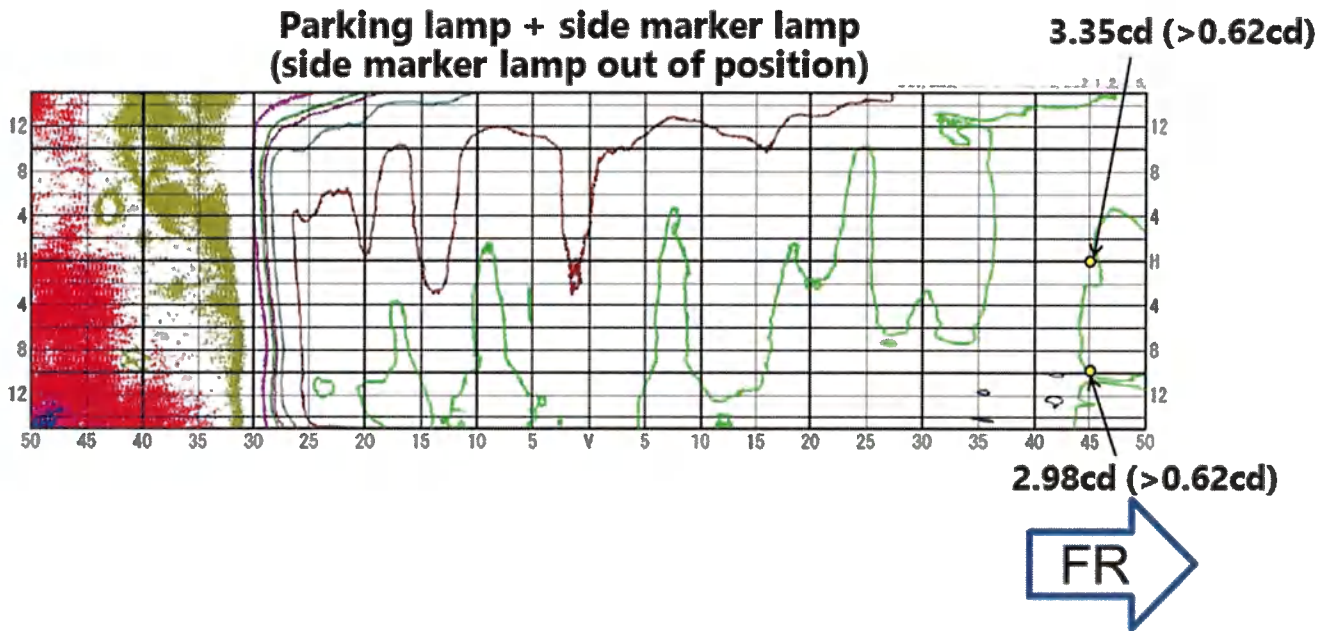
Figure 7. Photometric performance of Parking + Side Marker Lamp

When tested as a unit in real world conditions, the photometric intensity of the combined parking and side marker lamps is above the required 0.62cd for all test points and approximately 5x the test point where the side marker lamp alone was below 0.62cd, as shown in Figure 7 below.

In the event the reflector were to move out of position, the complimentary illumination from the parking lamp compensates for the slight reduction in photometric intensity of the side marker lamp over an exceedingly small range. Therefore, in actual usage conditions, the presence of an affected vehicle is conspicuous and there is no perceivable difference in visibility of the subject vehicles compared to compliant vehicles to drivers and pedestrians on the road.

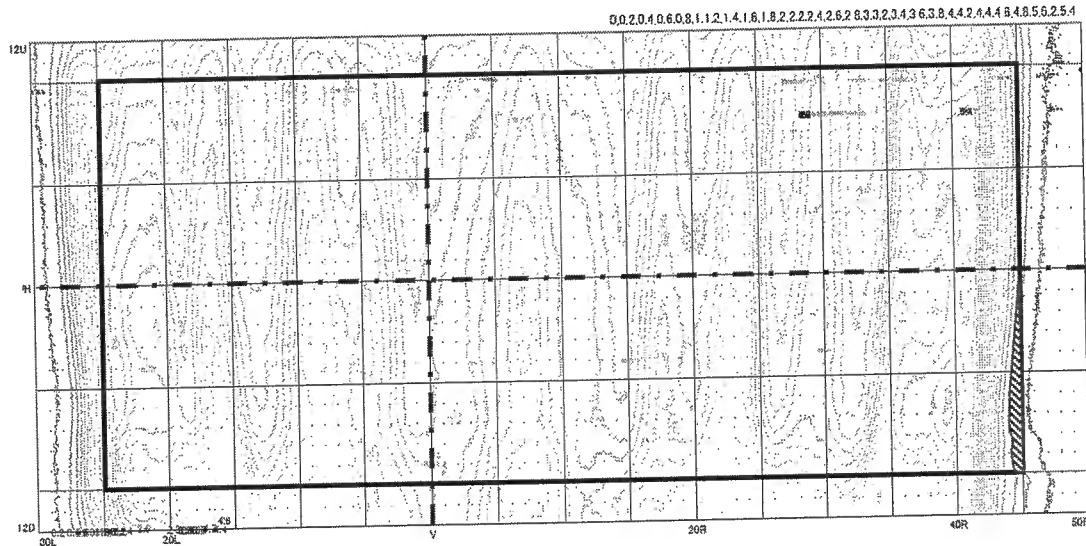
Figure 1. Area of Luminous Intensity Below Minimum

June 2019 – The testing results showed that out of twenty two (22) subject headlamps that were tested, one (1) headlight assembly failed to meet the minimum luminous intensity requirements at one test point for an amber lamp (0.62cd) specified in S7.4.13.1, Table X – Side Marker Lamp Photometry Requirements. This headlamp represented the “worst-case” condition where the reflex reflector was at its maximum displacement. Even in this scenario, the luminous intensity was below the minimum specification (0.53cd) in a very small area. This area is shown in Figure 1 below,

represented by the red cross-section on the lower right-hand side of the photometric performance test report.
