**REPORT NUMBER: NCAP305I-MGA-2018-006**

**NEW CAR ASSESSMENT PROGRAM (NCAP)  
FMVSS No. 305 Indicant Test**

**MITSUBISHI MOTORS CORPORATION  
2018 Mitsubishi Outlander PHEV SEL 5-Door SUV  
NHTSA No.: O20185600**

**MGA RESEARCH CORPORATION  
5000 Warren Road  
Burlington, WI 53105**

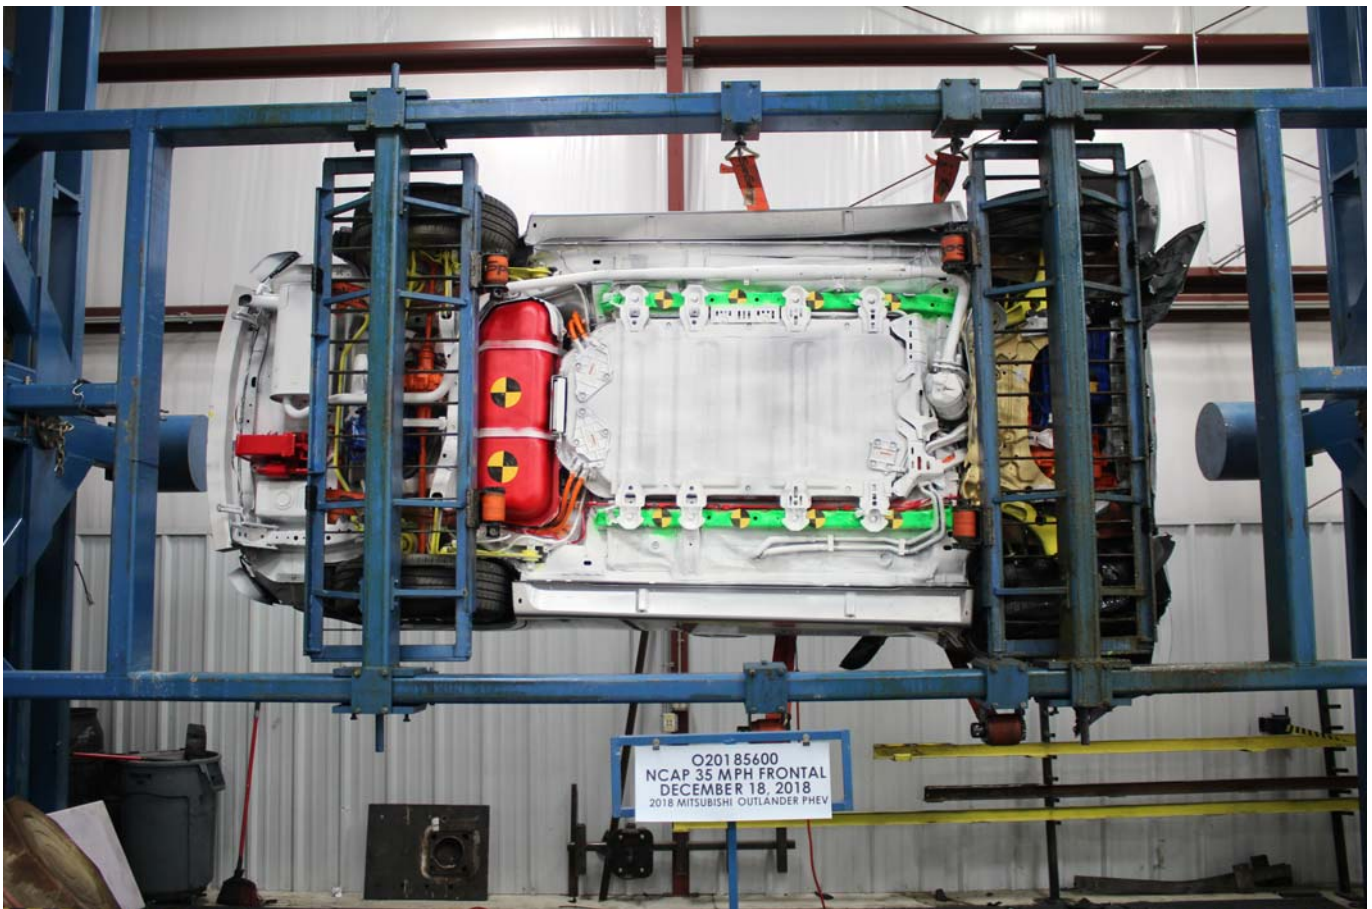
Photo No. 026 - Post-Impact View of Other Test Devices

Rollover Stage	Electric Energy Storage/Conversion Device Electrolyte Spillage (L)	Spillage Location
0° to 90°	0	Not Applicable
90° to 180°	0	Not Applicable
180° to 270°	0	Not Applicable
270° to 360°	0	Not Applicable

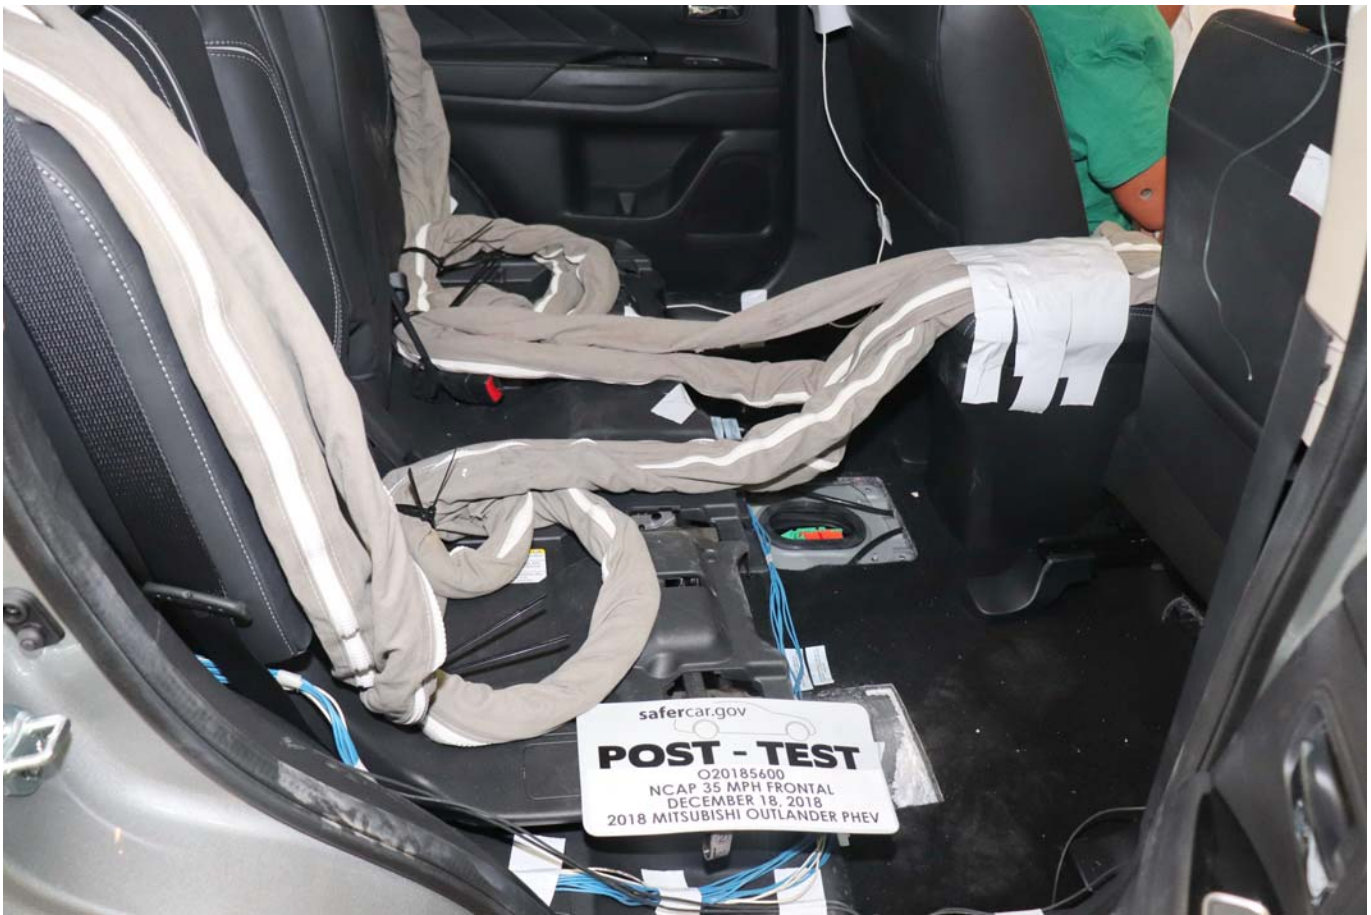
Photo No. 031 - Pre-Impact View of the Vehicle Passenger Compartment Adjacent to Propulsion Battery

Describe intrusion of an outside Electric Energy Storage/Conversion Device into the passenger compartment [Supply photographs as appropriate]:
No Intrusion
