**REPORT NUMBER: NCAP305I-MGA-2018-005**

**NEW CAR ASSESSMENT PROGRAM (NCAP)  
FMVSS No. 305 Indicant Test**

**MITSUBISHI MOTORS CORPORATION  
2018 Mitsubishi Outlander PHEV SEL 5-Door SUV  
NHTSA NUMBER: O20185602**

**FINAL REPORT**

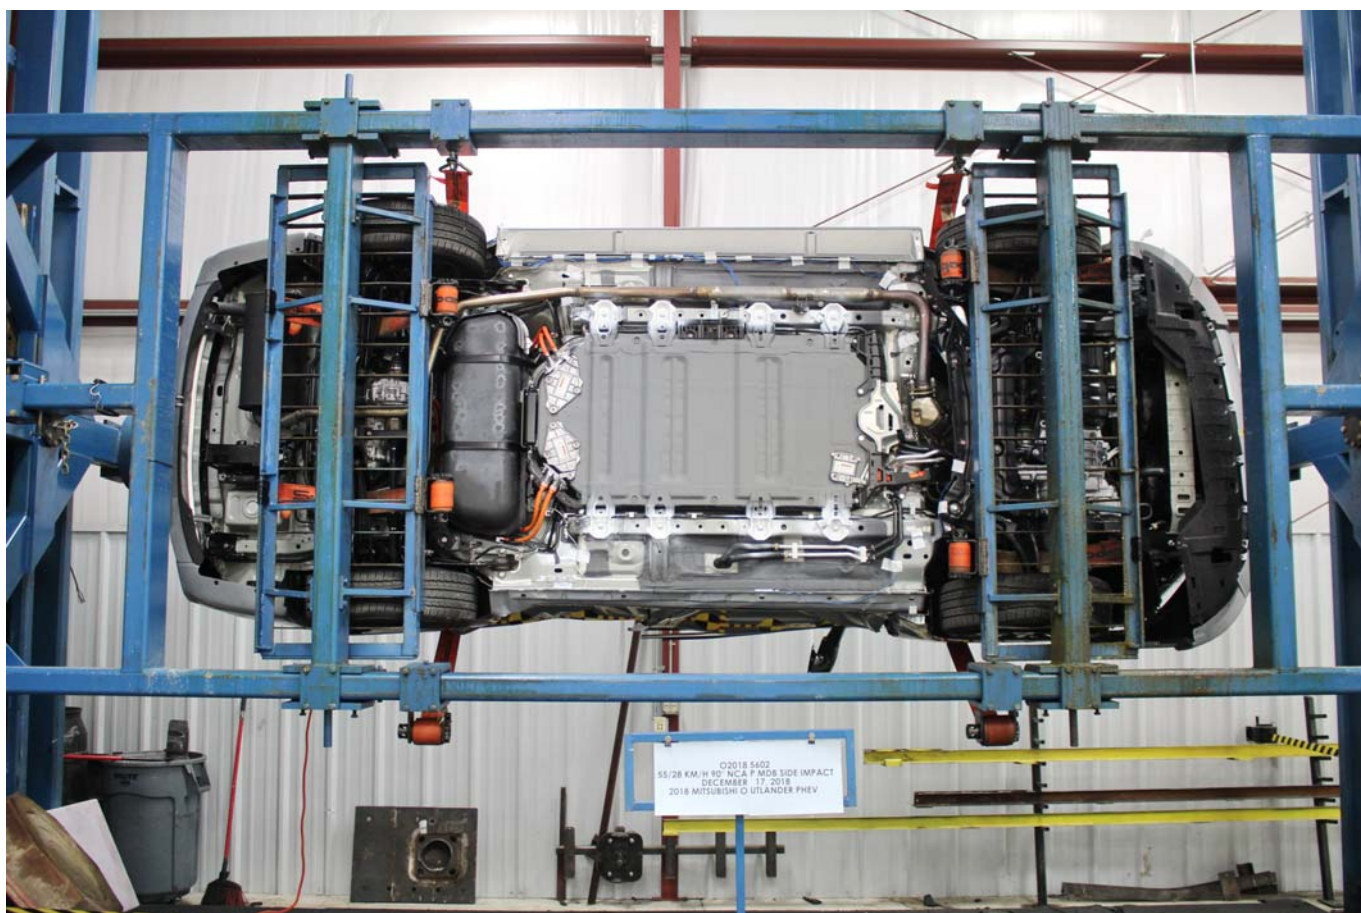
Photo No. 027 - FMVSS No. 305 Static Rollover at 90°

Rollover Stage	Electric Energy Storage/Conversion Device Electrolyte Spillage (L)	Spillage Location
0° to 90°	0	Not Applicable
90° to 180°	0	Not Applicable
180° to 270°	0	Not Applicable
270° to 360°	0	Not Applicable

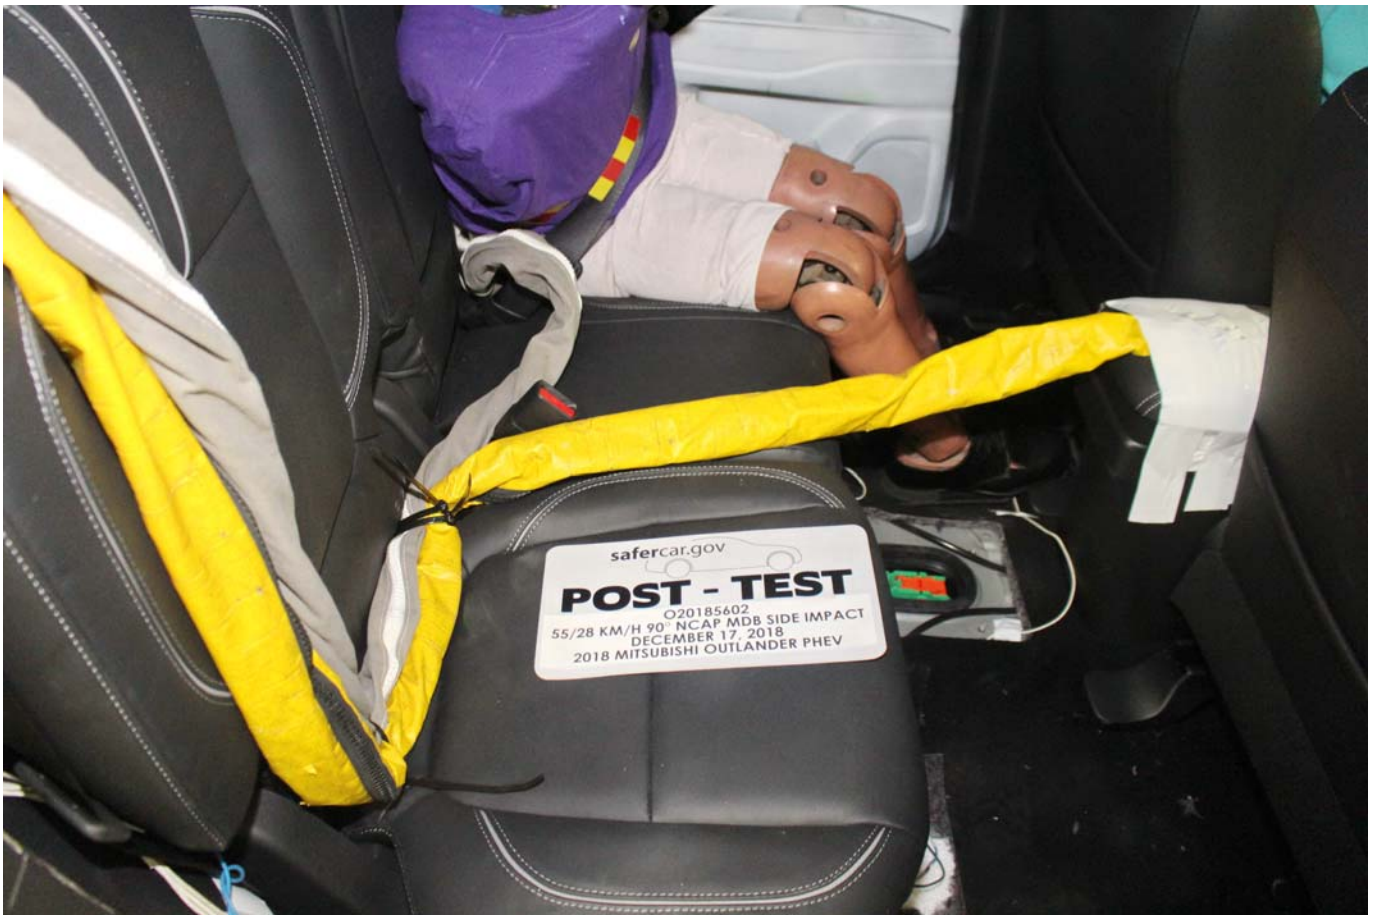
Photo No. 032 - Post-Impact View of the Vehicle Passenger Compartment Adjacent to Propulsion Battery

Describe intrusion of an outside Electric Energy Storage/Conversion Device into the passenger compartment [Supply photographs as appropriate]:
No Intrusion

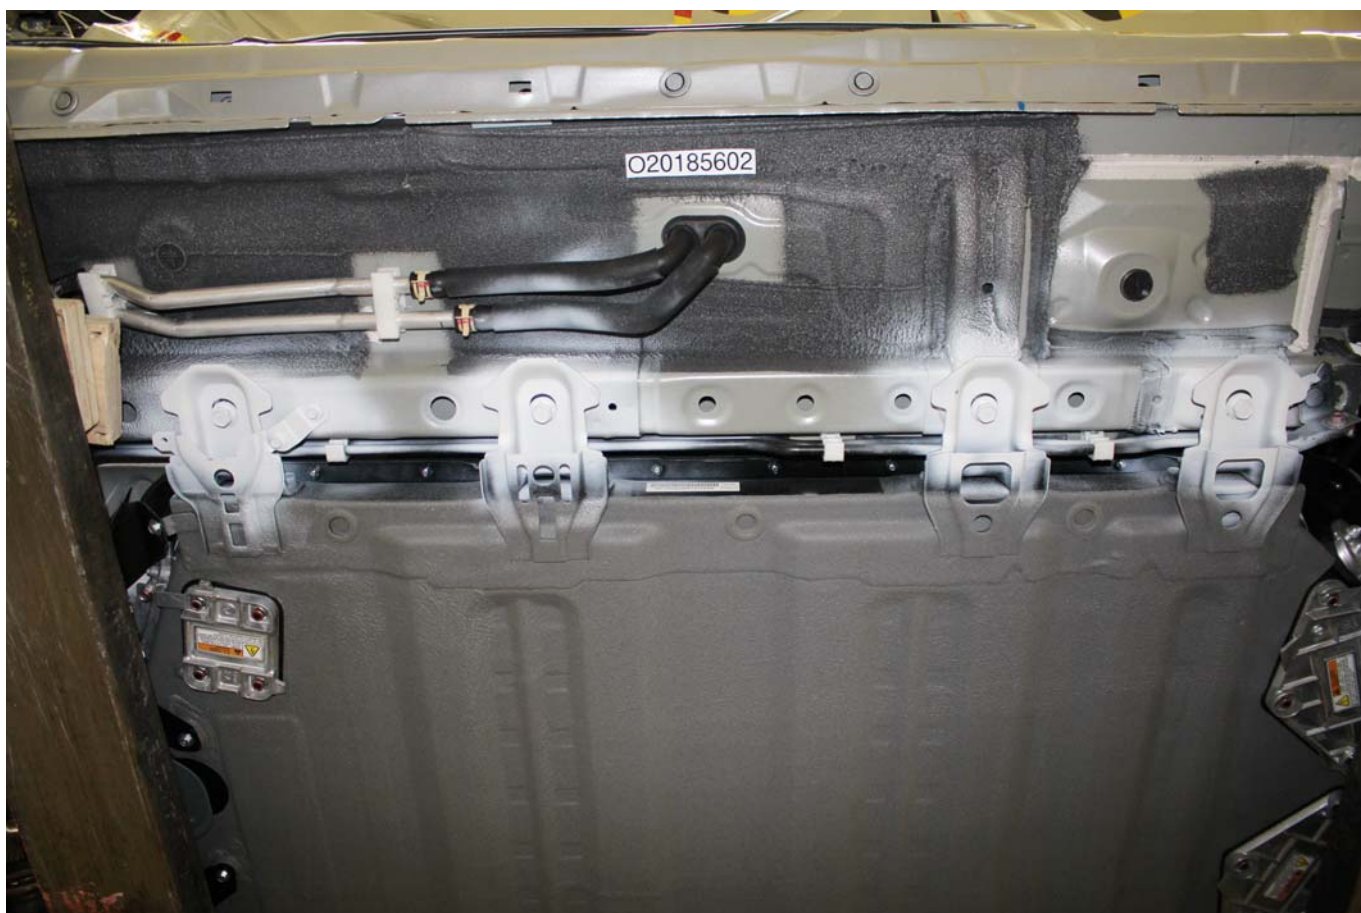
Photo No. 035 - Post-Impact View of Battery Module Movement or Retention Loss

Yes, Pass	No, Fail
All Components of Electrical Energy Storage/Conversion Device remained attached to the vehicle with at least one mounting location.	X
