REPORT NUMBER: NCAP305I-MGA-2019-001

**NEW CAR ASSESSMENT PROGRAM (NCAP)
FMVSS No. 305 Indicant Test**

**HONDA MFG. OF INDIANA, LLC
2019 Honda Insight LX 4-Door Sedan
NHTSA NUMBER: O20195304**

FINAL REPORT

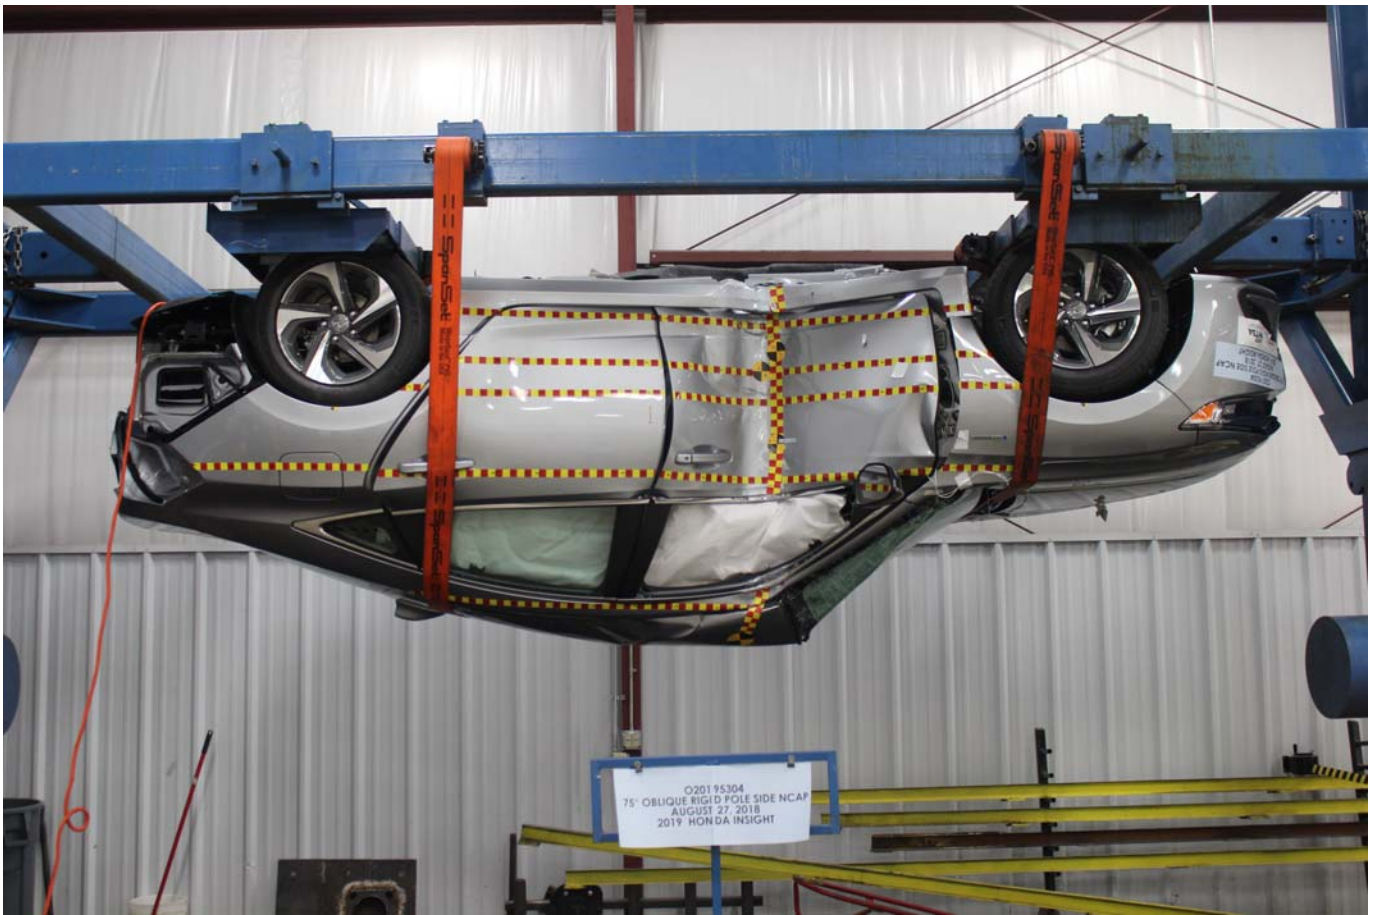
Photo No. 027 - FMVSS No. 305 Static Rollover at 90°

Rollover Stage	Electric Energy Storage/Conversion Device Electrolyte Spillage (L)	Spillage Location
0° to 90°	0	Not Applicable
90° to 180°	0	Not Applicable
180° to 270°	0	Not Applicable
270° to 360°	0	Not Applicable

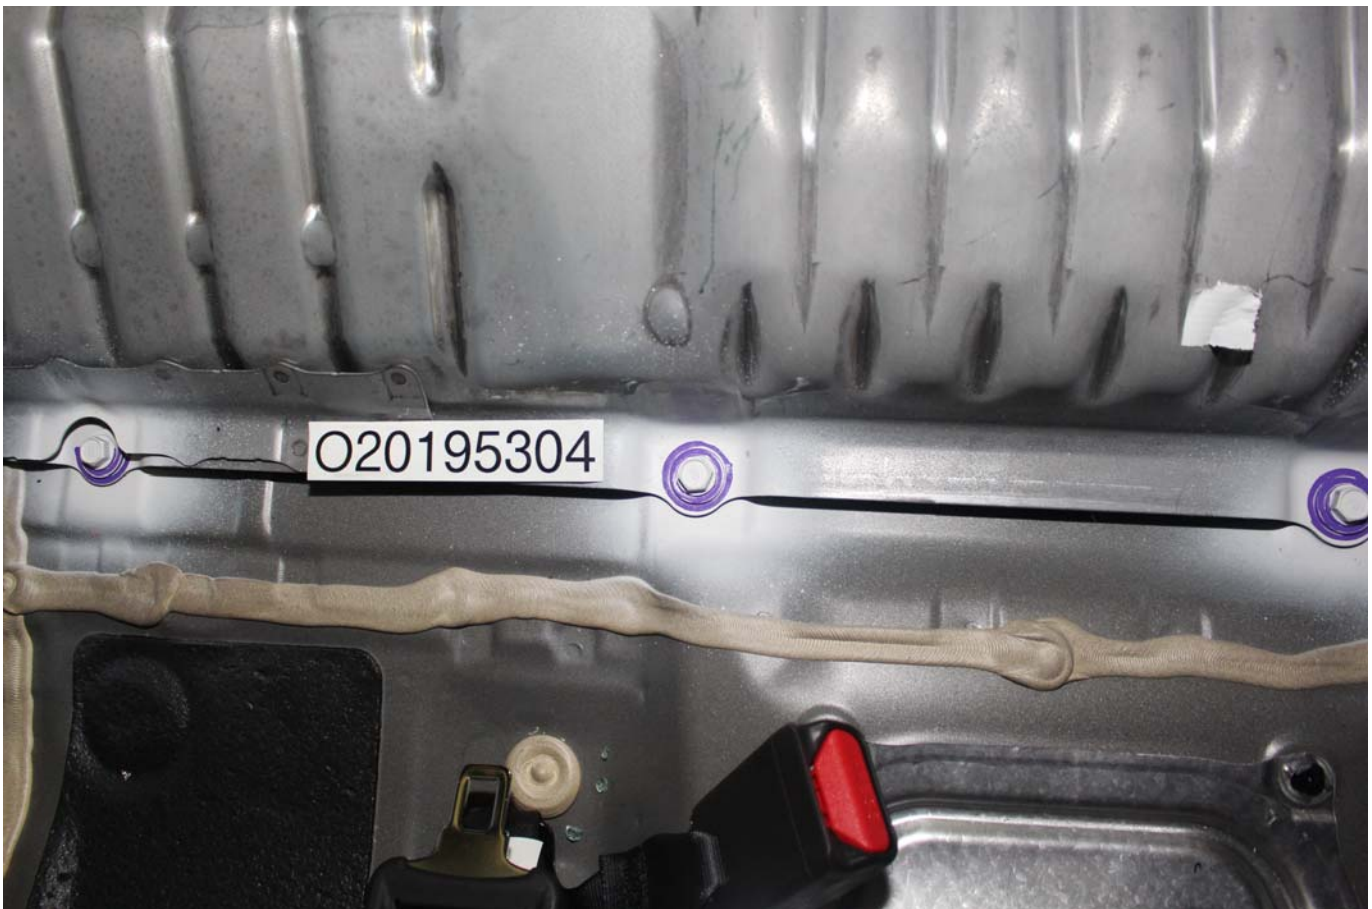
Photo No. 032 - Post-Impact View of the Vehicle Passenger Compartment Adjacent to Propulsion Battery

Describe intrusion of an outside Electric Energy Storage/Conversion Device into the passenger compartment [Supply photographs as appropriate]:
No Intrusion

Yes, Fail	No, Pass
Is Electric Energy Storage/Conversion Device electrolyte spillage visible in the passenger compartment?		X
