REPORT NUMBER: NCAP305I-MGA-2019-004

**NEW CAR ASSESSMENT PROGRAM (NCAP)
FMVSS No. 305 Indicant Test**

**TOYOTA MOTOR CORPORATION
2019 Lexus UX 250h AWD 5-Door SUV
NHTSA No.: O20195110**

**MGA RESEARCH CORPORATION
5000 Warren Road
Burlington, WI 53105**

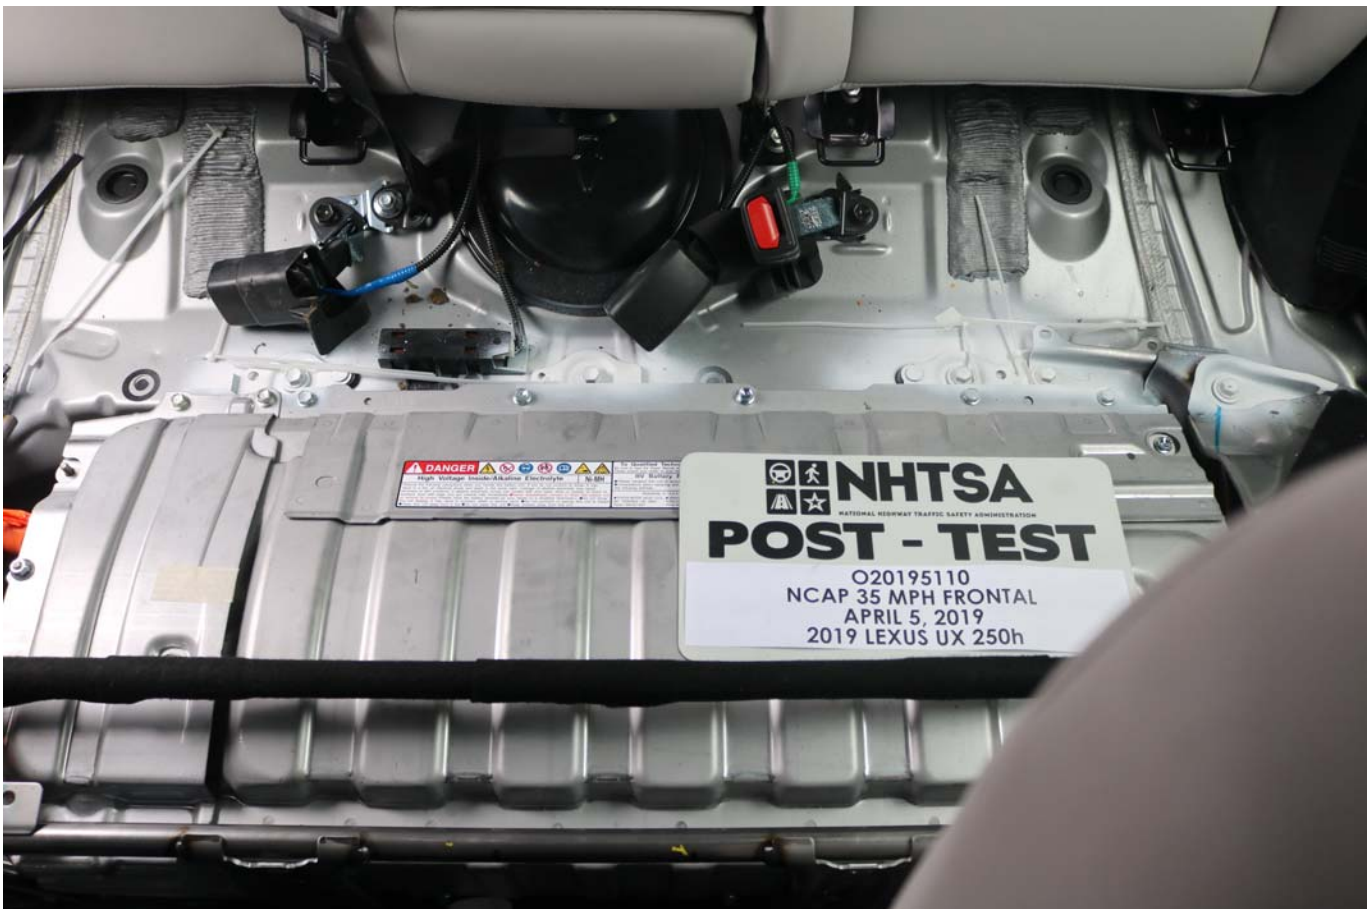
Photo No. 009 - Post-Impact Front View of Propulsion Battery

Yes, Pass	No, Fail
All Components of Electrical Energy Storage/Conversion Device remained attached to the vehicle with at least one mounting location.	X

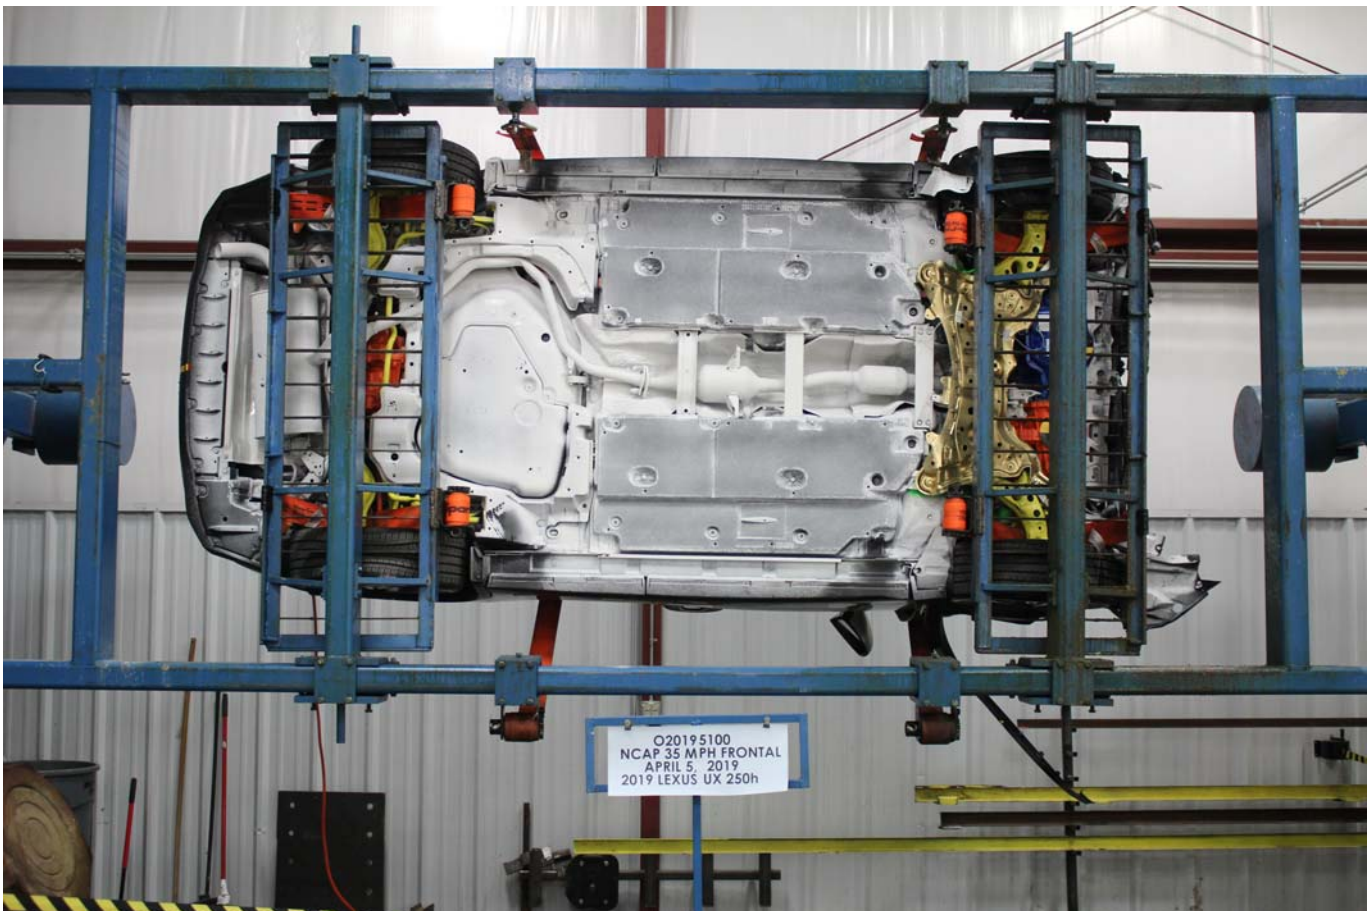
Photo No. 027 - FMVSS No. 305 Static Rollover at 90°

Rollover Stage	Electric Energy Storage/Conversion Device Electrolyte Spillage (L)	Spillage Location
0° to 90°	0	Not Applicable
90° to 180°	0	Not Applicable
180° to 270°	0	Not Applicable
270° to 360°	0	Not Applicable

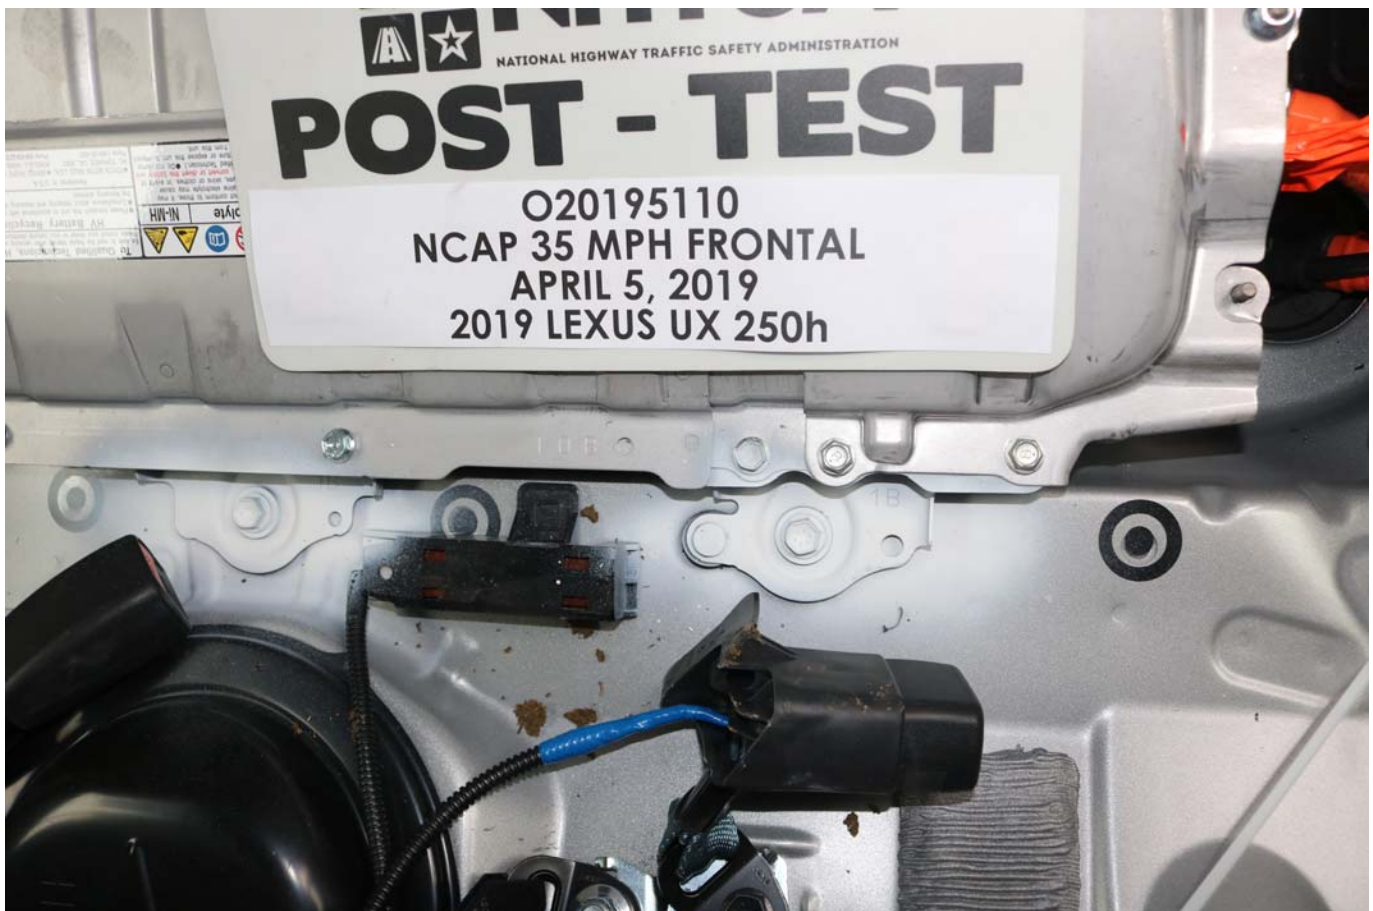
Photo No. 035 - Post-Impact View of Battery Module Movement or Retention Loss

Describe intrusion of an outside Electric Energy Storage/Conversion Device into the passenger compartment [Supply photographs as appropriate]:
No Intrusion
