REPORT NUMBER: NCAP305I-MGA-2019-002

**NEW CAR ASSESSMENT PROGRAM (NCAP)
FMVSS No. 305 Indicant Test**

**HONDA MFG. OF INDIANA, LLC
2019 Honda Insight LX 4-Door Sedan
NHTSA No.: O20195303**

FINAL REPORT

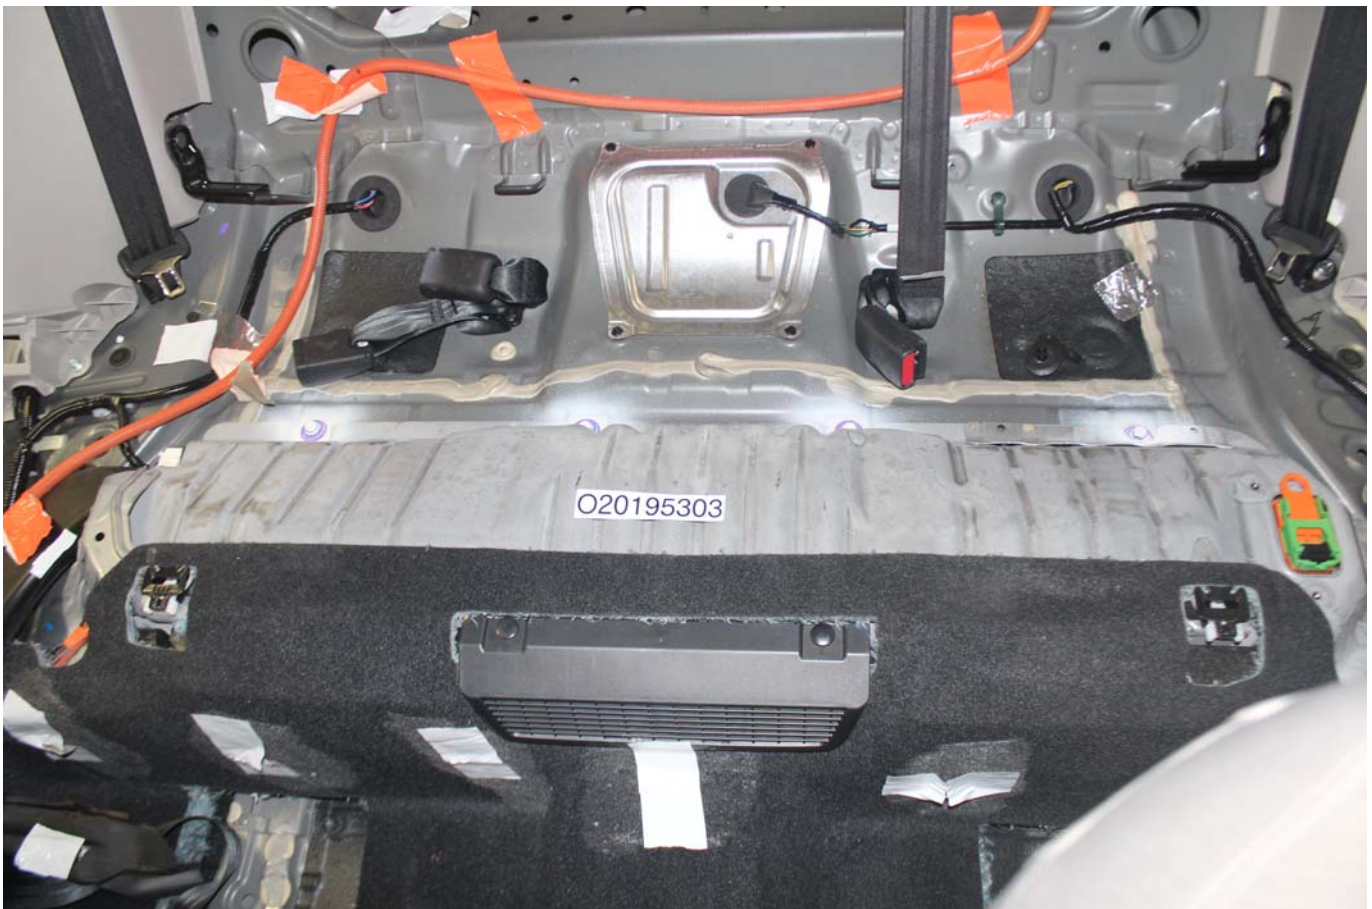
Photo No. 009 - Post-Impact Front View of Propulsion Battery

Yes, Pass	No, Fail
All Components of Electrical Energy Storage/Conversion Device remained attached to the vehicle with at least one mounting location.	X

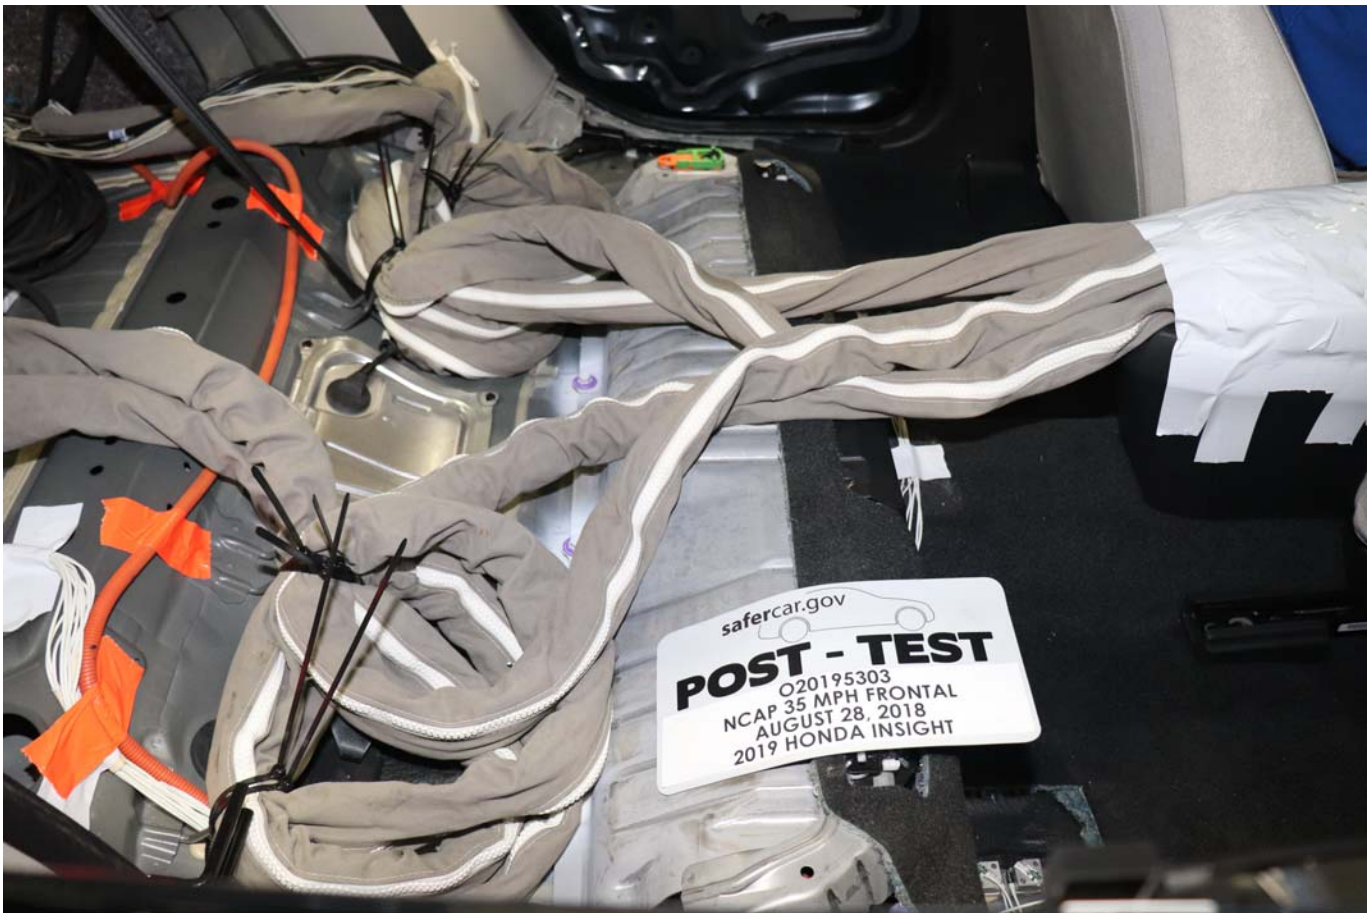
Photo No. 032 - Post-Impact View of the Vehicle Passenger Compartment Adjacent to Propulsion Battery

Describe intrusion of an outside Electric Energy Storage/Conversion Device into the passenger compartment [Supply photographs as appropriate]:
No Intrusion

Yes, Fail	No, Pass
Is Electric Energy Storage/Conversion Device electrolyte spillage visible in the passenger compartment?		X
