October 23, 2019
Ref. No.: GR19-035

Part 556 – Subaru Petition for Inconsequential Noncompliance with FMVSS No. 108, “Lamps, reflective devices, and associated equipment”

On affected 2016-2020 MY Subaru Impreza vehicles, the left front and right front halogen headlamp assemblies, containing the side reflex reflector and low beam reflector, may not fully meet requirements set forth in FMVSS No. 108, Lamps, reflective devices, and associated equipment. Additional details regarding the noncompliance are below.

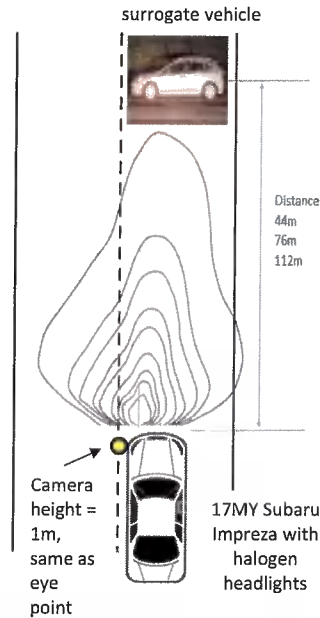
Both Failed and Pass RR are able to be detected within stopping distance.
Both RR shows real-world safety.

Headlight type	Stopping distance (m)	Fail sample (H-V 7.59) (Headlight Production date 2019.7.19)		Pass sample (H-V 19.7) (Headlight Production date 2016.4.15)	
		Visibility	Camera View ²	Visibility	Camera View ²
Vehicle (Halogen)	112	OK		OK	
	76	OK		OK	
	44	OK		OK
