**Re: Petition for a Determination of Inconsequential Noncompliance
Mercedes-Benz, FMVSS 201**

Petition for Inconsequential Noncompliance of Mercedes-Benz

19V-752

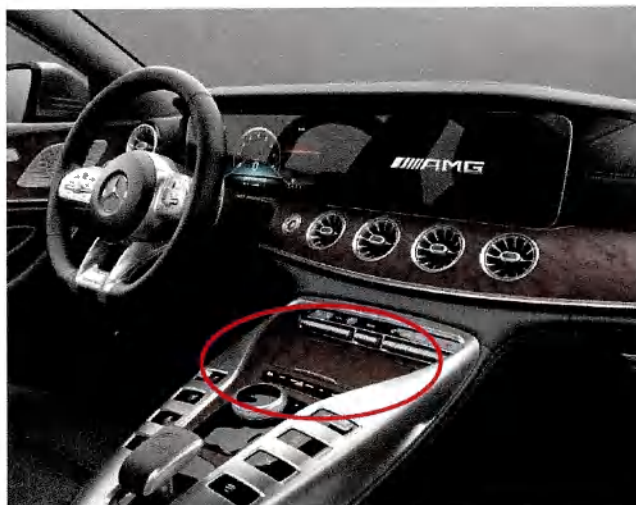
The interior compartment door at issue in this petition is a storage compartment used in vehicles with the Wireless Media Interface (WMI) package. The WMI feature allows users to wirelessly charge cell phones within the compartment and the compartment can also be used to store small objects like coins and accessories. The compartment is located within the center console between the driver and front passenger's seat and the storage portion of the compartment is approximately 15 cm/ 6 inches long and 13 cm/ 5 inches deep. (See Graphic A, below).

(Graphic A – Location of the Center Console Door in the AMG GT Vehicles)

The location, geometry and operation of the compartment door prevents it from causing or contributing to an injury in the event of a crash. The door is located in the bottom of the center console, in the area between the driver and front passenger seats. As indicated in the graphic below, the door is installed in a location where it could not strike a vehicle occupant should it open in a crash. The door, moreover, does not have any sharp edges and is not comprised of a hard, metal surface.

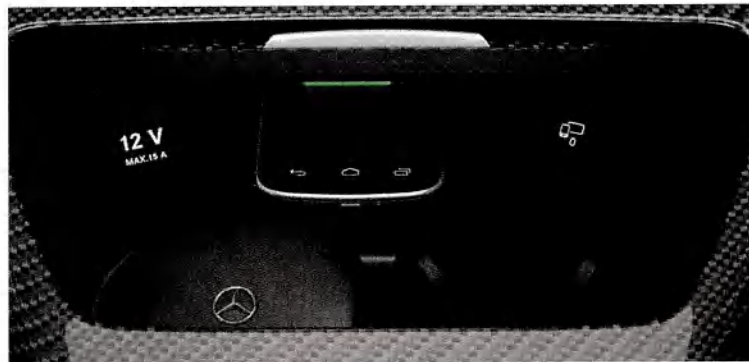
compartment itself, it does not extend outwards into the passenger compartment which is the concern that the standard is intended to address. In typical use, the operator slides the door covering away towards the front of the vehicle, away from the occupant compartment and into the center console where it becomes fully enclosed within the housing. By contrast, glove box doors and other interior compartment doors on hinges that open outwards and into the occupant compartment are the traditional types of doors that FMVSS 201 was designed to address because the door's surface could come into contact with a vehicle occupant if it opened in a crash. This same risk does not exist with the door covering in the AMG vehicles based on its geometry and design. (See Graphic B below).

(Graphic B – Image of the Console Door Fully Opened and Inside the Console Housing)

Additionally, the compartment door will automatically close after opening if it has not been snapped into place to stay open. In the event of a frontal crash force that is severe enough to cause the door to open, the door would open for an extremely short period of time -- a matter of milliseconds -- and then would automatically pull back into place and the door will close again. Because of the design and operation of the door, it remains open for a matter of milliseconds seconds after which it will retreat back into its fully closed position.
