**REPORT NUMBER: NCAP305I-KAR-19-024**

**NEW CAR ASSESSMENT PROGRAM (NCAP)  
FMVSS NO. 305 INDICANT TEST**

**KIA MOTORS CORPORATION  
2019 KIA NIRO HYBRID LX 5-DOOR MPV**

**FINAL REPORT**

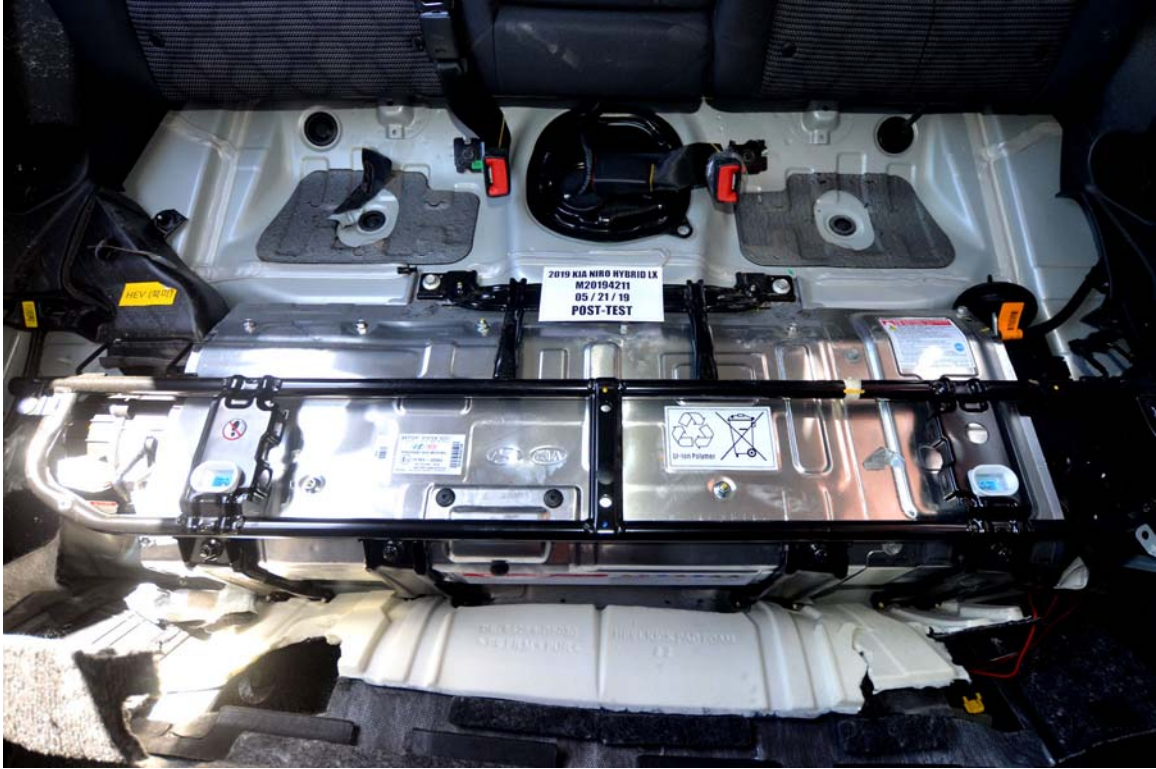
FIGURE 10. Post-Impact Front View of Propulsion Battery

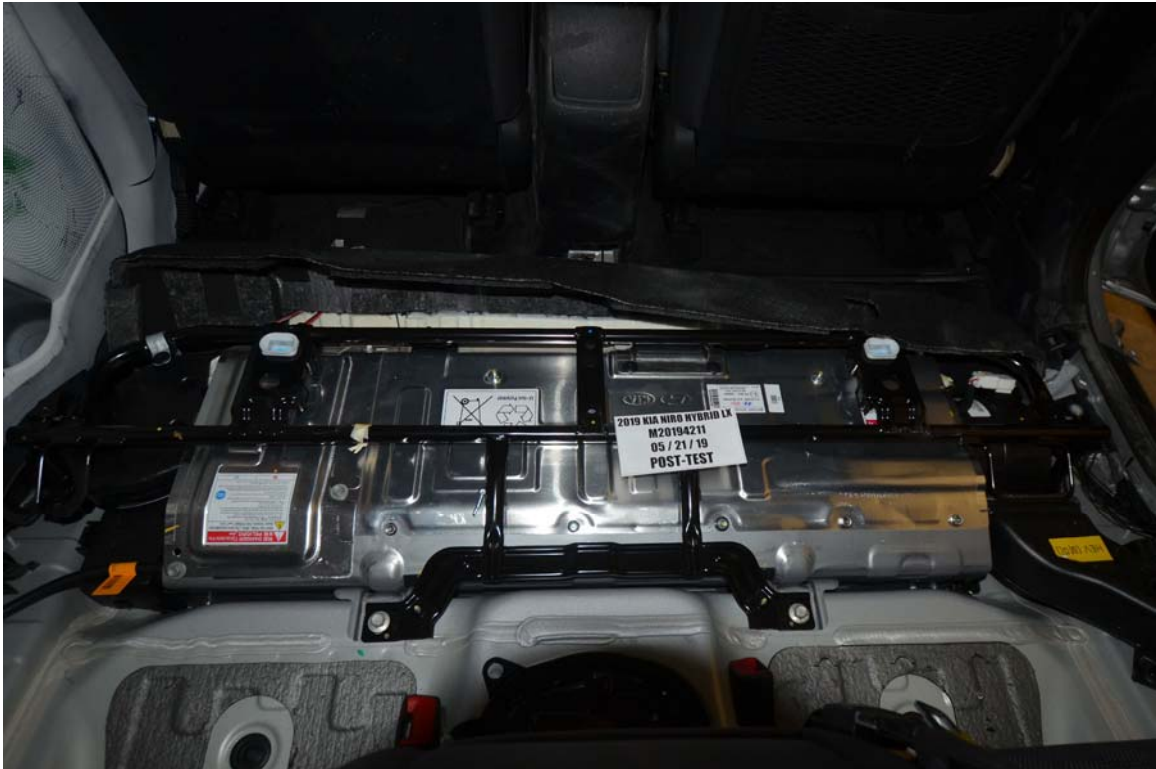
FIGURE 11. Post-Impact Rear View of Propulsion Battery

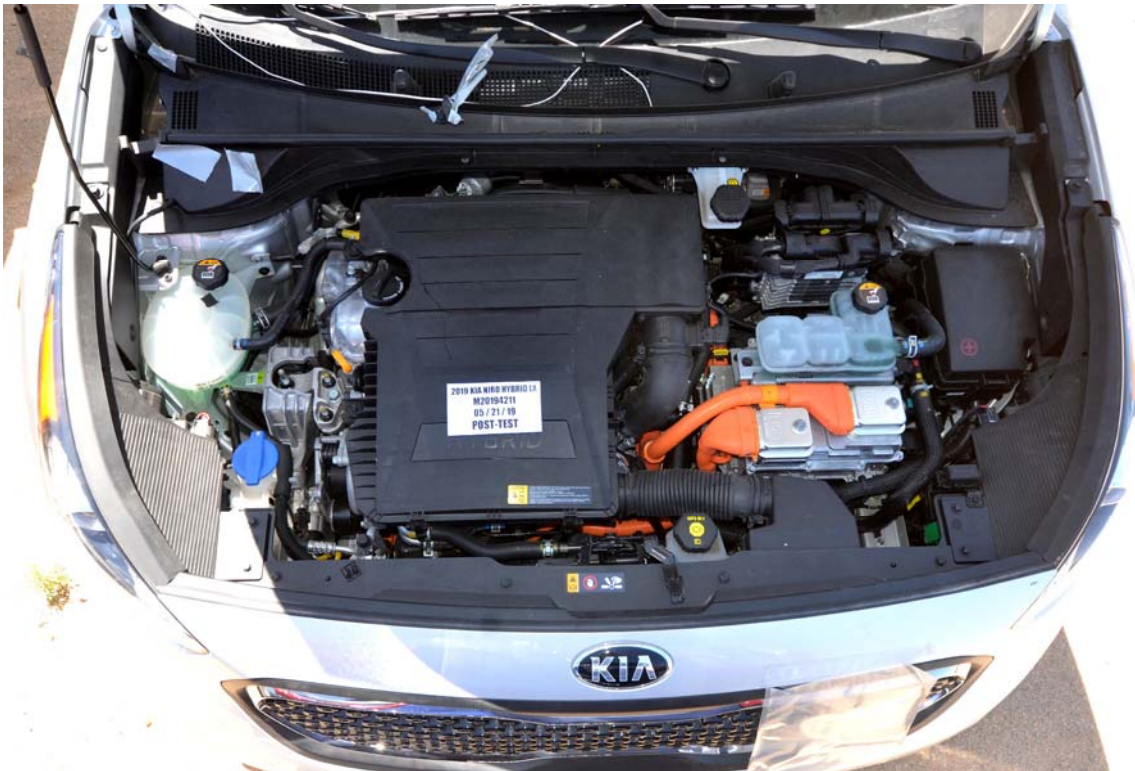
FIGURE 17. Post-Impact View of Electric Propulsion Drive

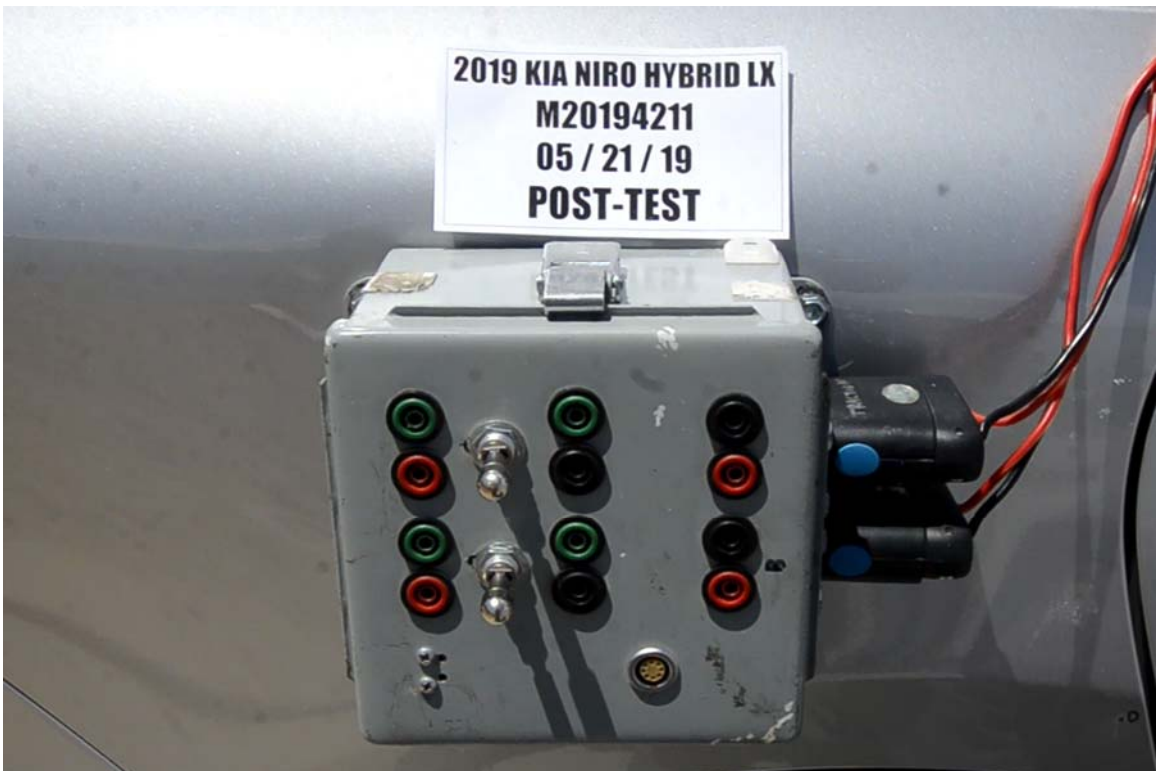
FIGURE 25. Post-Impact View of Installed Test Interface Port

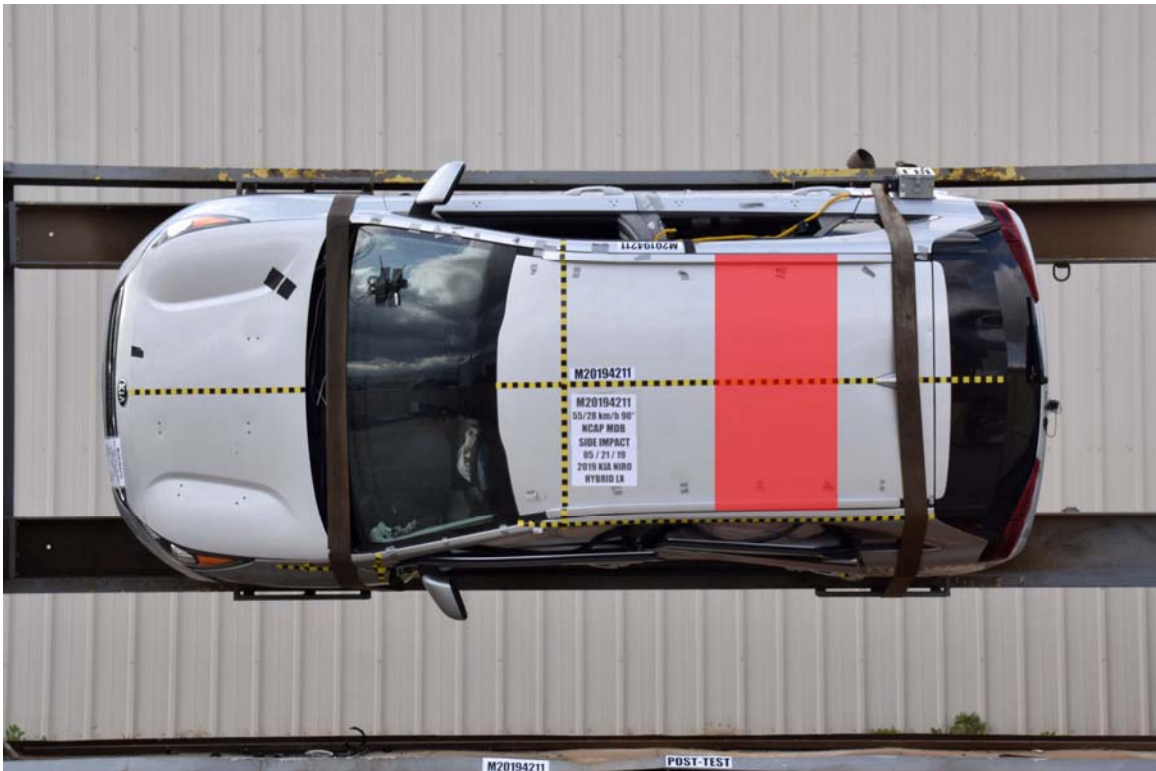
FIGURE 29. FMVSS No. 305 Static Rollover at 90°

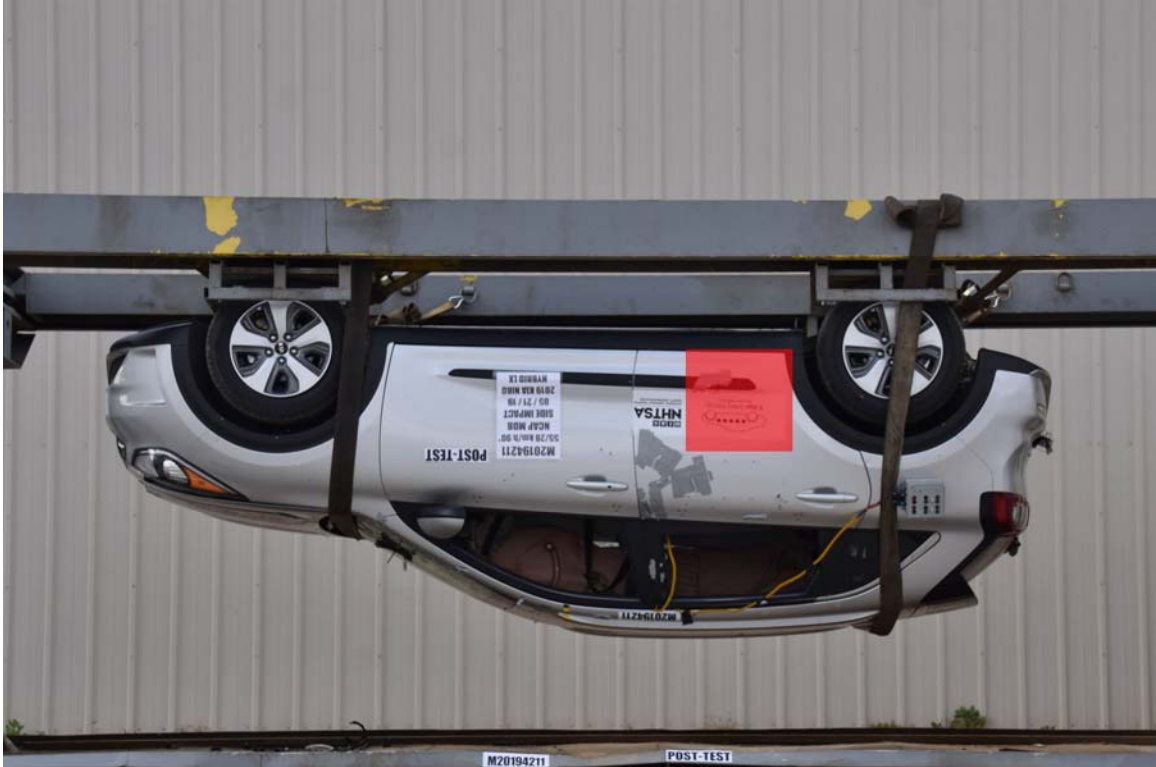
FIGURE 30. FMVSS No. 305 Static Rollover at 180°

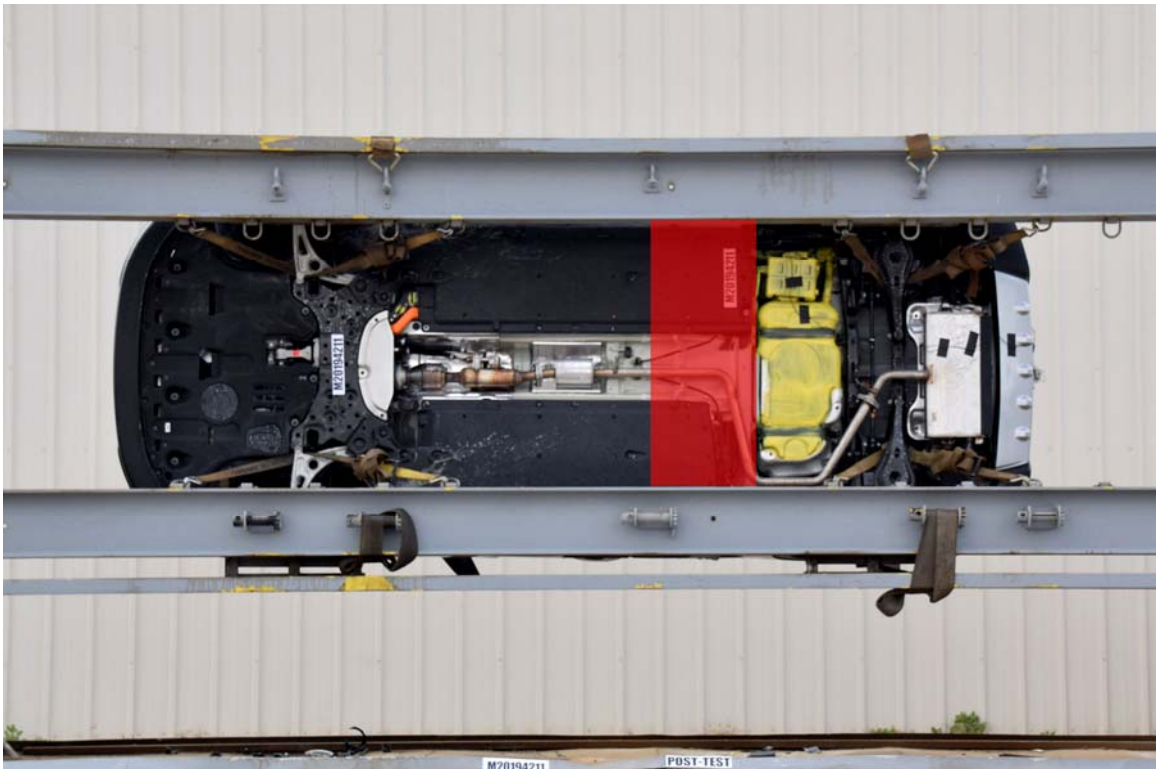
FIGURE 31. FMVSS No. 305 Static Rollover at 270°

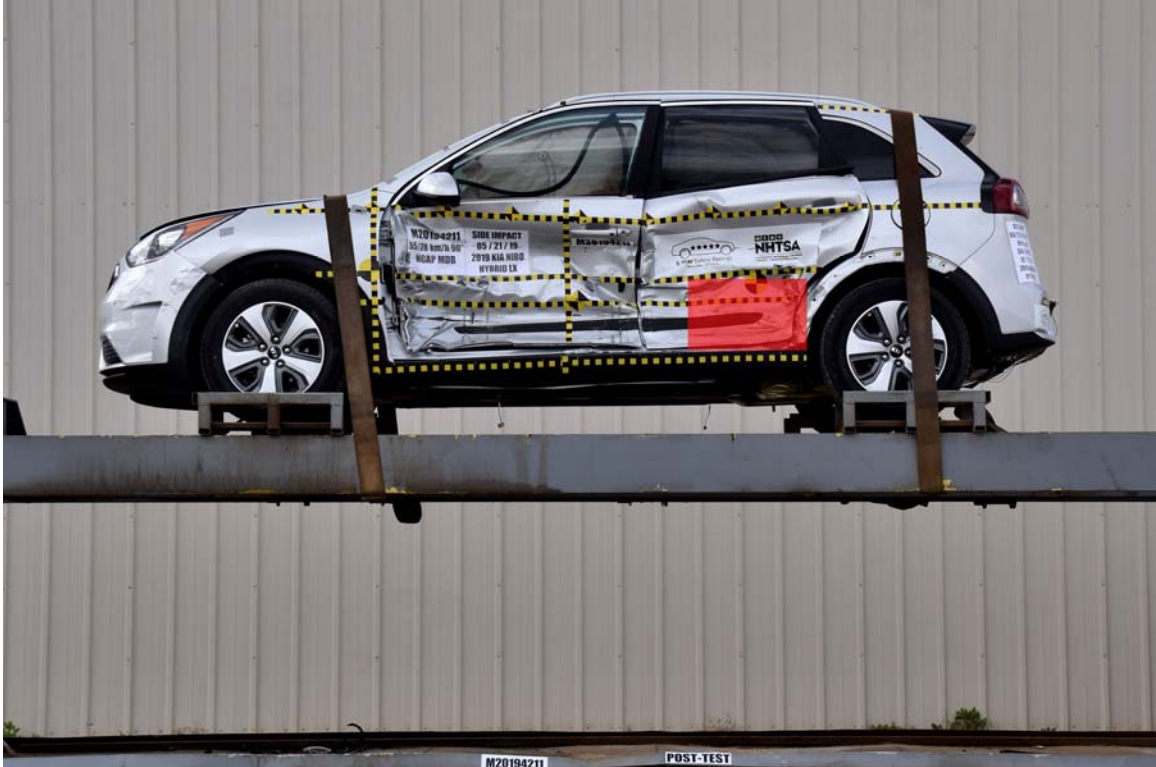
FIGURE 32. FMVSS No. 305 Static Rollover at 360°
