REPORT NUMBER: NCAP305I-KAR-19-022

**NEW CAR ASSESSMENT PROGRAM (NCAP)
FMVSS NO. 305 INDICANT TEST**

**TESLA, INC.
2019 TESLA MODEL 3 LONG RANGE AWD 4-DOOR SEDAN**

FINAL REPORT

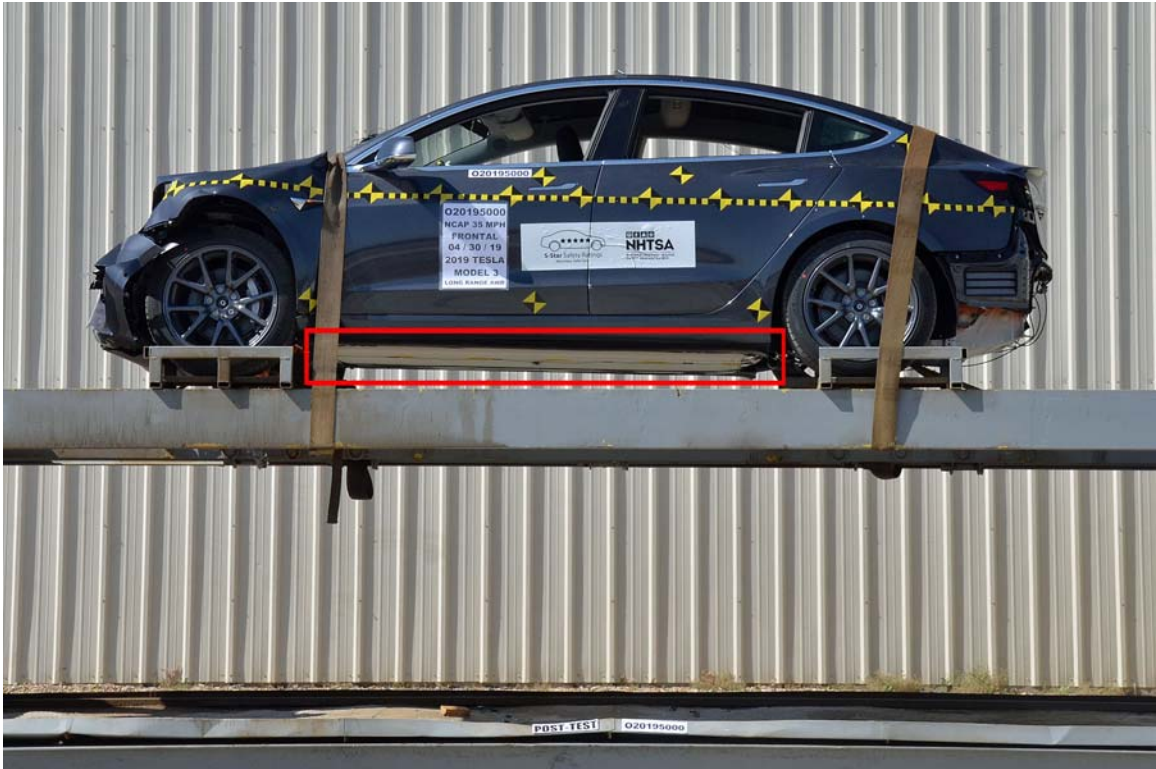
FIGURE 39. FMVSS No. 305 Static Rollover at 0°

Test Phase	Propulsion Battery Electrolyte Spillage (L)	Spillage Location
0° To 90°	0.0	N/A
90° To 180°	0.0	N/A
180° To 270°	0.0	N/A
270° To 360°	0.0	N/A

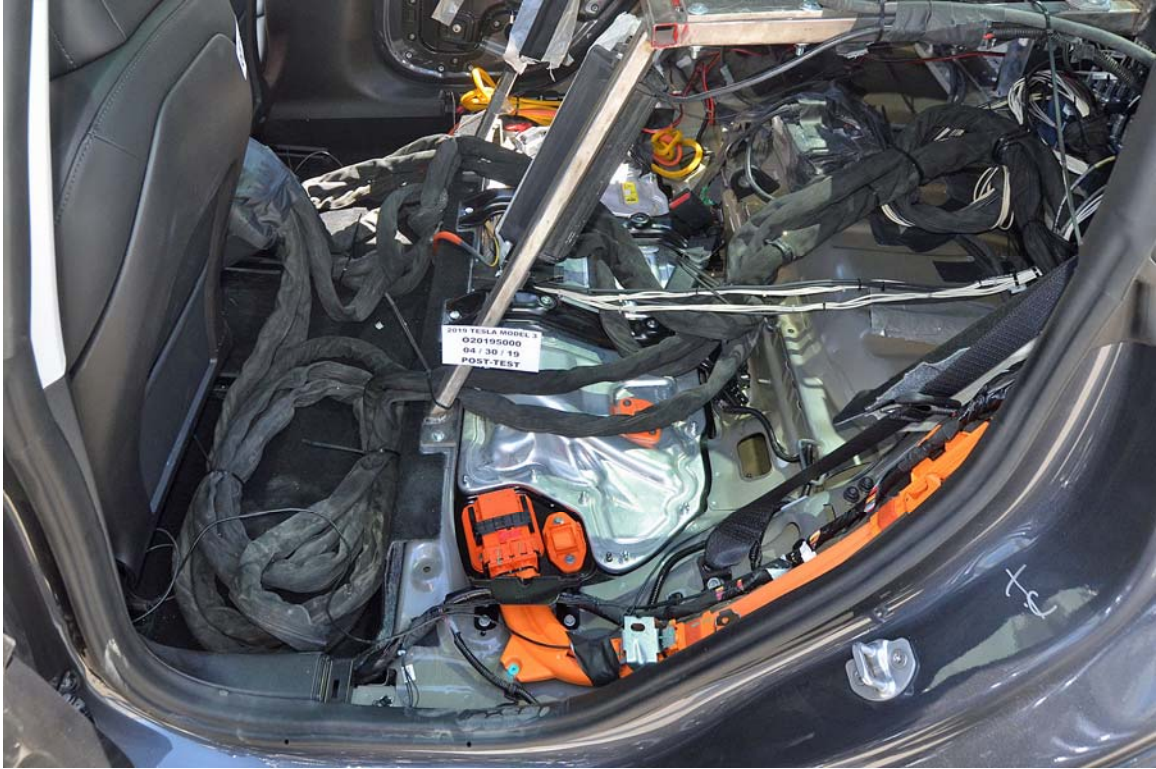
FIGURE 45. Post-Impact View of the Vehicle Passenger Compartment Adjacent to Propulsion Battery

PROPULSION BATTERY SYSTEM COMPONENTSHas the propulsion battery module moved within the passenger compartment: NoDescribe any movement: There was no movement of the propulsion battery.Has an outside propulsion battery component intruded into the passenger compartment: NoDescribe any intrusion: There was no intrusion of the propulsion battery into the occupant compartment.Is there propulsion battery electrolyte spillage visible in the passenger compartment: No
