REPORT NUMBER: NCAP305I-KAR-19-025

**NEW CAR ASSESSMENT PROGRAM (NCAP)
FMVSS NO. 305 INDICANT TEST**

**KIA MOTORS CORPORATION
2019 KIA NIRO HYBRID LX 5-DOOR MPV**

FINAL REPORT

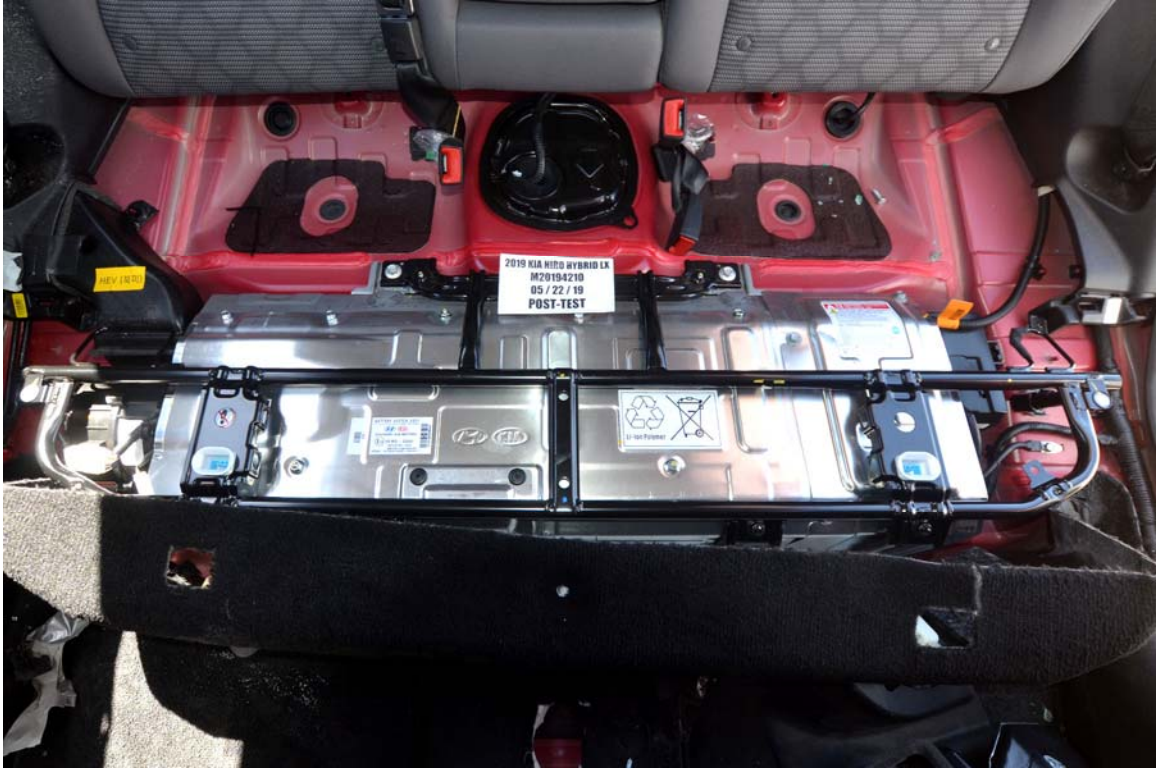
FIGURE 10. Post-Impact Front View of Propulsion Battery

Describe any movement: There was no movement of the propulsion battery.

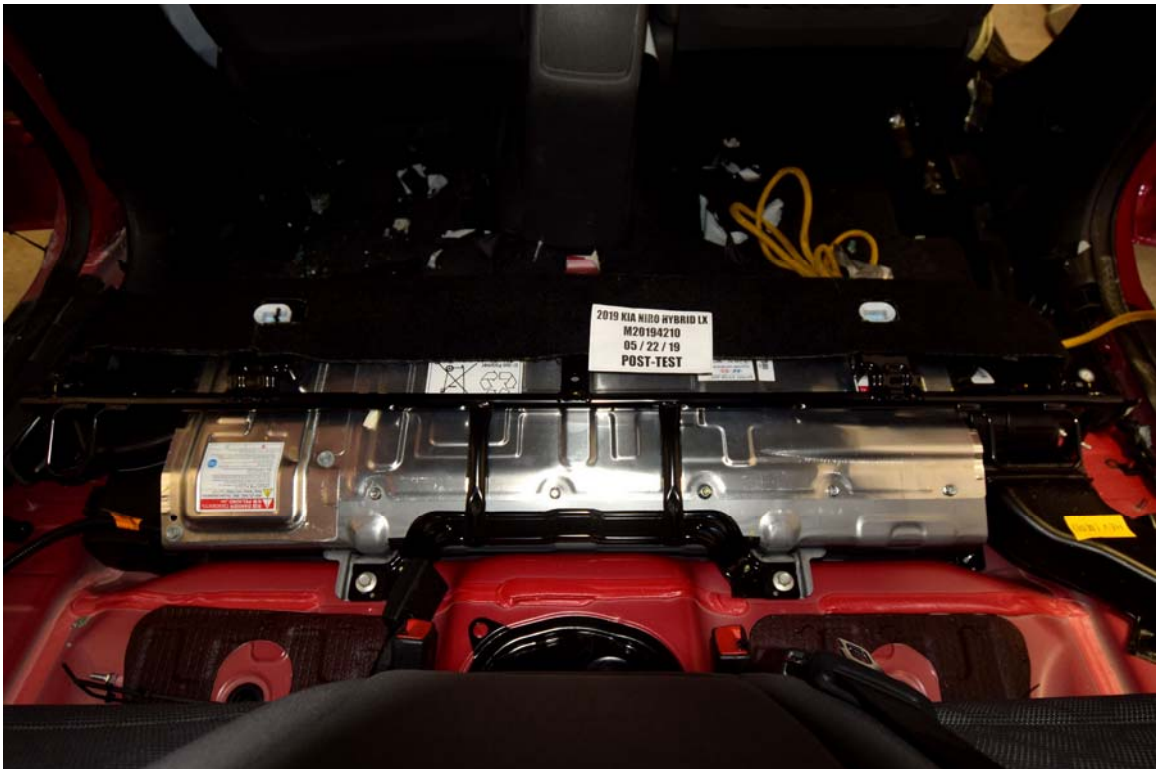
FIGURE 11. Post-Impact Rear View of Propulsion Battery

Describe any intrusion: There was no intrusion of the propulsion battery into the occupant compartment.

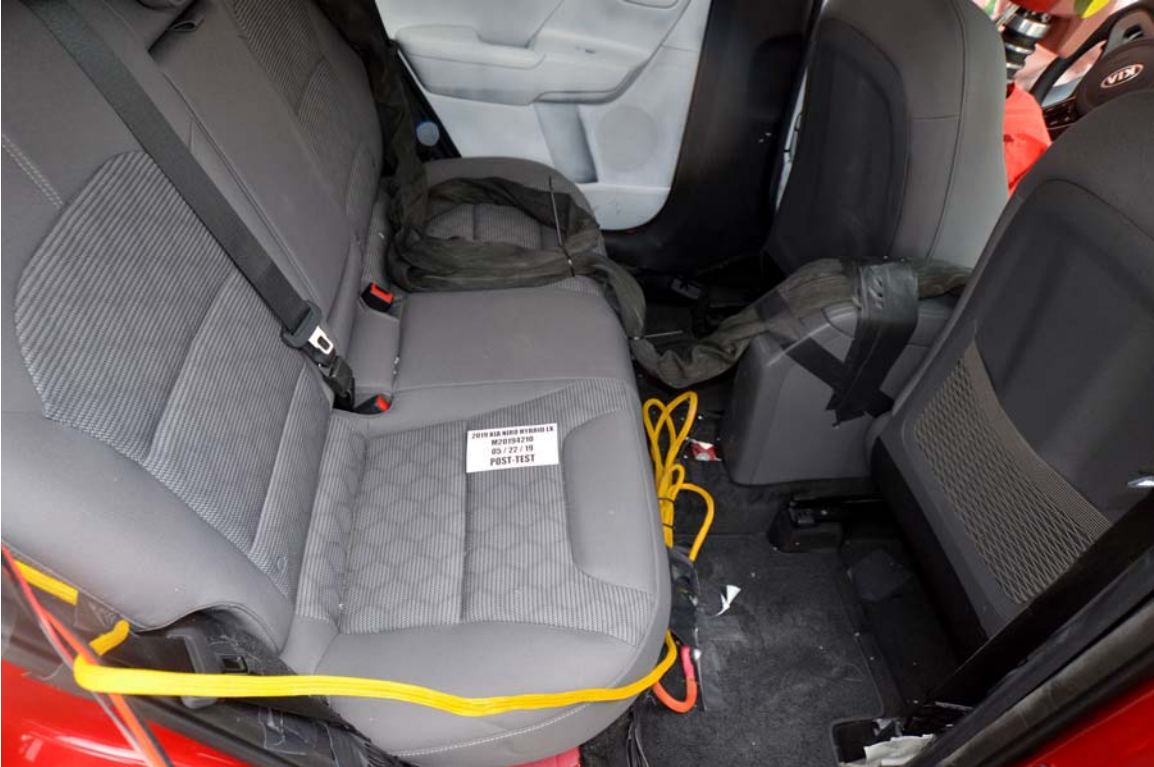
FIGURE 34. Post-Impact View of the Vehicle Passenger Compartment Adjacent to Propulsion Battery

Is there propulsion battery electrolyte spillage visible in the passenger compartment: No
