NEW CAR ASSESSMENT PROGRAM (NCAP) FMVSS No. 305 Indicant Test

AUDI AG 2019 Audi e-tron quattro 5-Door SUV NHTSA NUMBER: 020195804

FINAL REPORT

Technical Report Documentation Page		
<i>1. Report No.</i> NCAP305I-MGA-2019-006	2. Government Accession No.	3. Recipient's Catalog No.
4. Title and Subtitle Final Report of FMVSS 305 Compliance Testing of		<i>5. Report Date</i> December 30, 2019
2019 Audi e-tron quattro 5-Door SU\ NHTSA No.: O20195804	Ι,	6. Performing Organization Code MGA

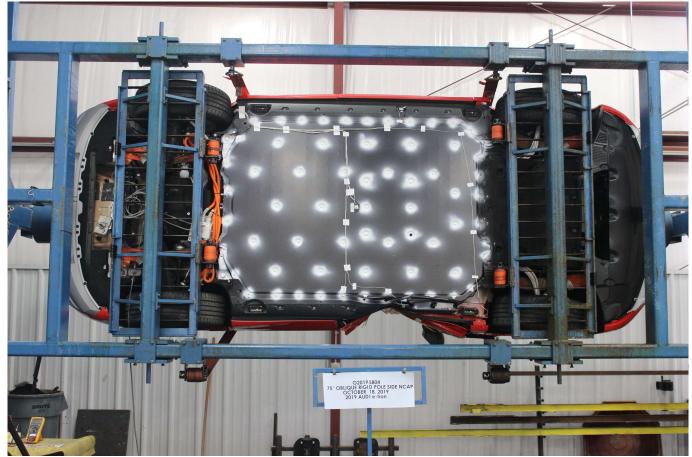
Photo No. 027 - FMVSS No. 305 Static Rollover at 90°

Rollover Stage	Electric Energy Storage/Conversion Device Electrolyte Spillage (L)	Spillage Location
0° to 90°	0	Not Applicable
90° to 180°	0	Not Applicable
180° to 270°	0	Not Applicable
270° to 360°	0	Not Applicable
