Byrne vs. Isuzu

# Exhibit F

13V547-Documentation

# ***NHSTA Defect Petition- Investigation***

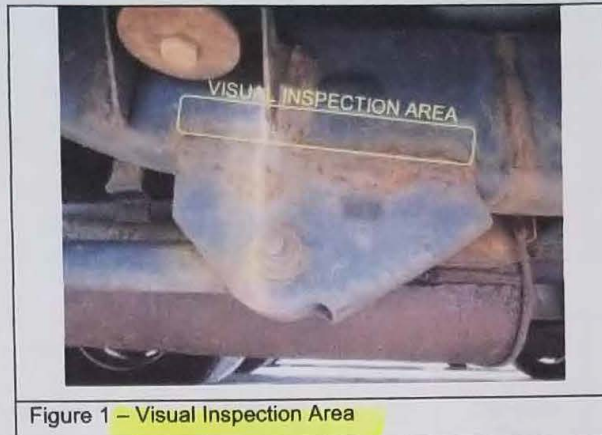
Figure 1 – Visual Inspection Area

2. Using a 3/16" flat punch and a 12-16 oz. hammer, hammer on the locations identified with an "X" in Figure 2. Swing the hammer 10 to 12 inches to be sure enough force is applied to the punch. If a hole is created go to Step 4. If no hole is created, visually inspect the Rear Lower Trailing Link Front Mounting Bracket inspection area. Use the Visual Comparison Photo (P/N 2-90SVA-003-0) or Figure 1 for reference. If most of the frame coating is still in place and very little surface rust is present, apply Noxudol 300 (Go to "Condition One: Apply Noxudol 300" in this bulletin). If most frame coating is missing and excessive rust is present go to the next step.

3. Apply Noxudol 700 and Noxudol 300 (Go to "Condition Two: Apply Noxudol 700 and Noxudol 300" in the appropriate bulletin).
4. Using a 3/16" flat punch and a 12-16 oz. hammer, hammer on the locations identified with an "X" in Figure 3.
  - a. If no hole is created, continue to Condition Three in the appropriate bulletin.
  - b. If the flat punch creates a hole in any one location, continue to Condition Four in the appropriate bulletin.

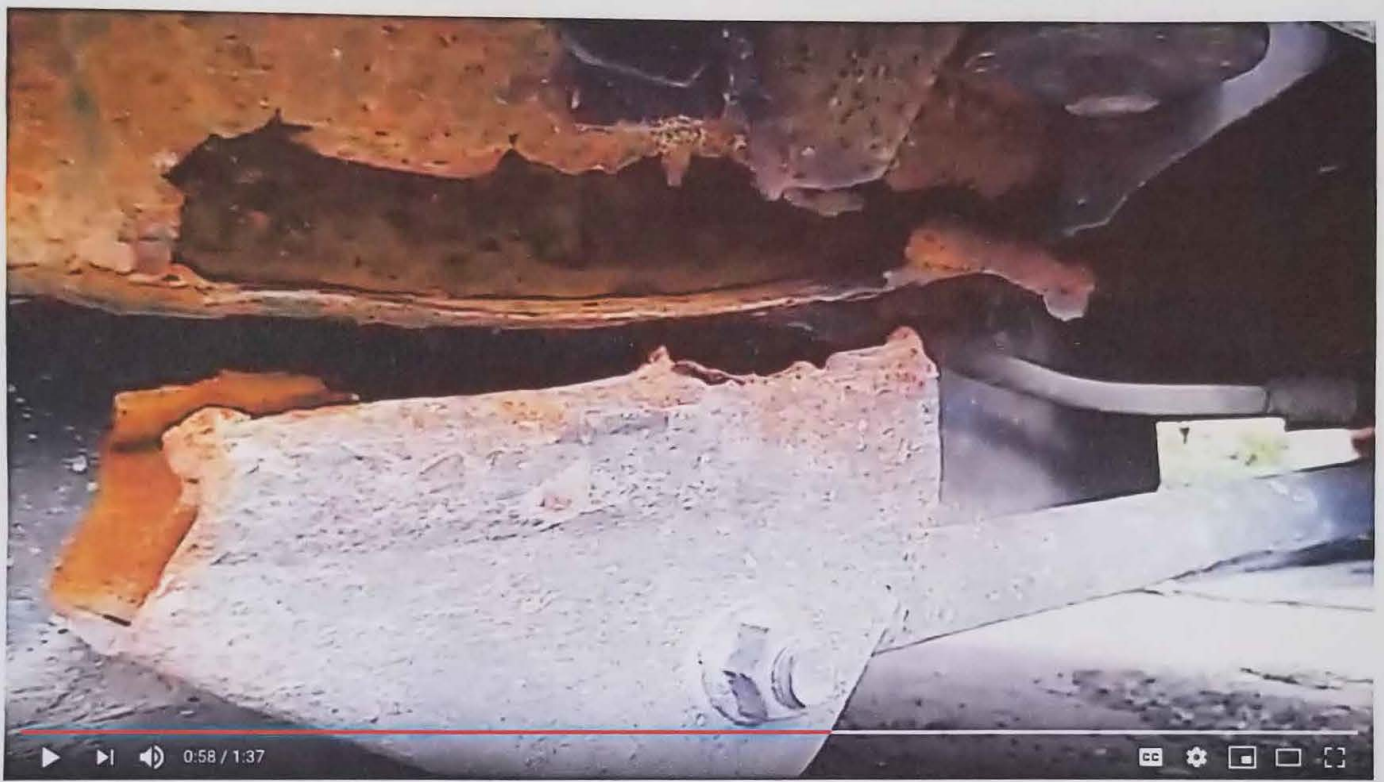
Isuzu Rodeo FRAME BROKE PT 2  
1,367 views

Video includes clear and close-up views of **corroded and detached point bracket** on 2000 Isuzu Rodeo.  
1:37

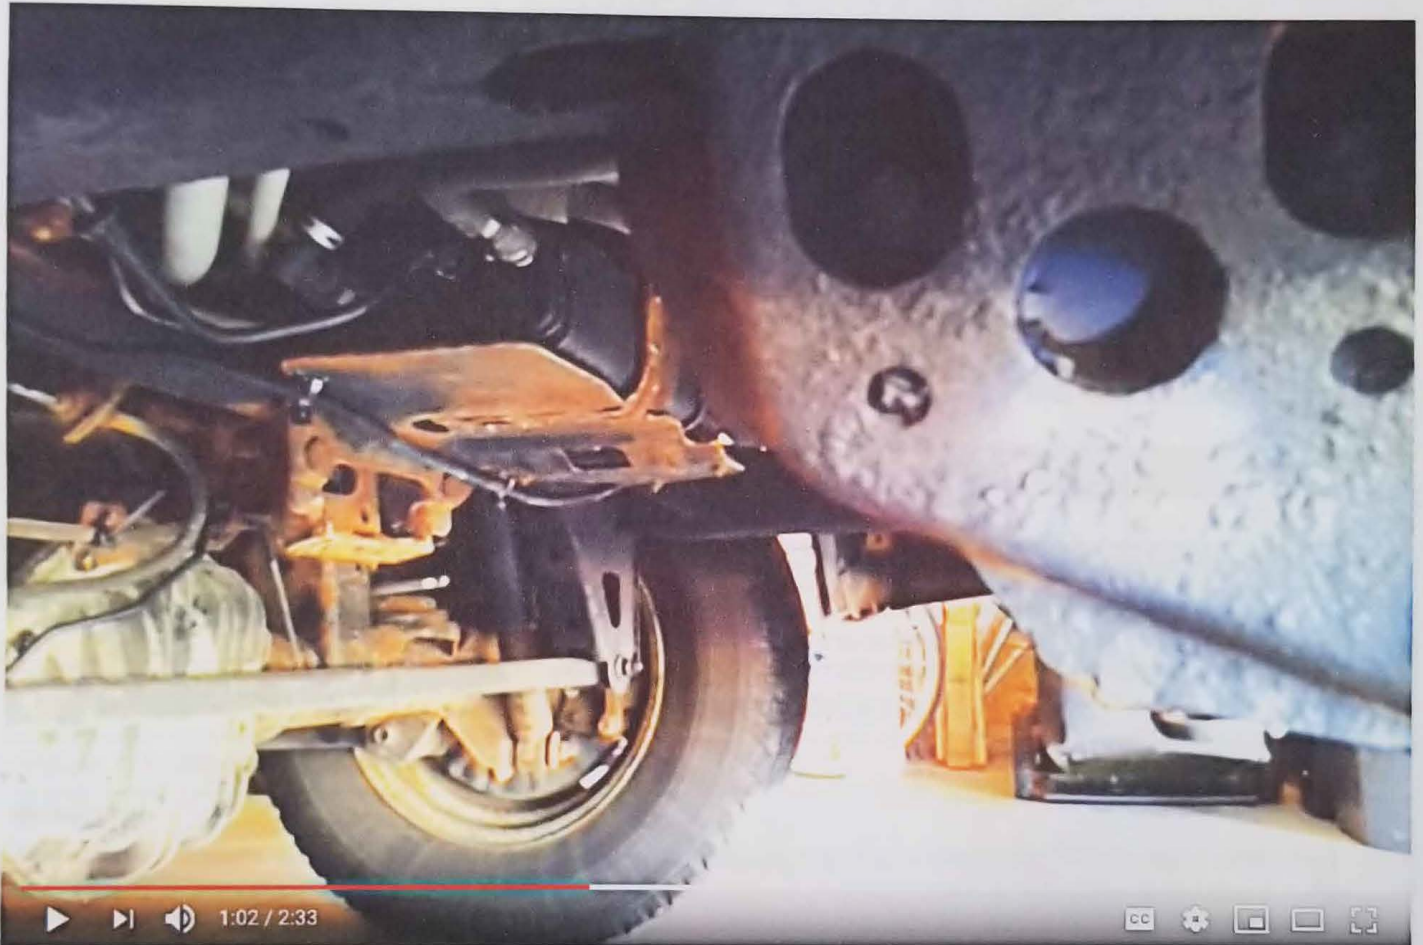
2001 Isuzu Rodeo rusted frame / frame rot AFTER recall was addressed

This is a video of the frame rot of a 2001 Isuzu Rodeo. This rust/rot is AFTER I had the recall about the suspension rotting off taken care of. Funny the technician that worked on it for the recall never mentioned this, or the **gas tank bracket being almost totally rusted off.**

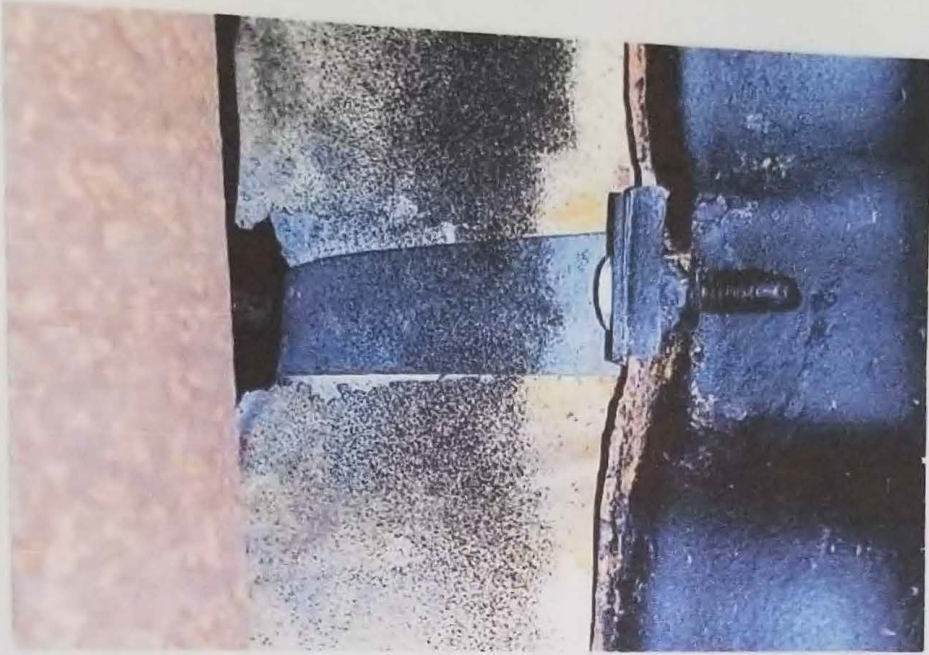
PHOTO II

\*Note that the mechanic's photos are included in order to clarify the actual locations of the current fuel tank metal jacket or saddle (photo 1) and its metal support strap with bolt (photo 2) to make all this understandable. The condition last July was the parts "rust-out" as described by the mechanic in his explanation letter but no photos of that were kept.

Part Description / Number	Qty	Sale	Ext	Labor Description	Extended
Shop Supplies					
	1.00			KEVIN BYRNE BROUGHT HIS ISUZU RODEO IN TO CHECK A GAS TANK PROBLEM [FALLING OUT DUE TO RUST THAT ANOTHER SHOP HAD POINTED OUT]. WE FOUND THE SADDLE [PHOTO 1] SEVERELY RUSTED ALONG WITH THE FRONT STRAP DETACHED [PHOTO 2]. REAR STRAP BARELY HOLDING ON. THE FRONT OF THE TANK HAD DROPPED ABOUT 5 TO 6 INCHES. THERE WERE NO NEW PARTS AVAILABLE THROUGH ISUZU OR ANY ONE ELSE. SO WE FOUND USED THROUGH LKQ [FOUND IN THE SOUTH WEST PART OF THE COUNTRY]. NOTE TANK WAS READY TO FALL COMPLETELY OUT AT ANY TIME.	0.00
