Re: Petition for Determination of Inconsequential Noncompliance – Mercedes-Benz

Petition for Inconsequential Noncompliance
NHTSA Recall 20V-106

Part 573 Safety Recall Report

20V-106

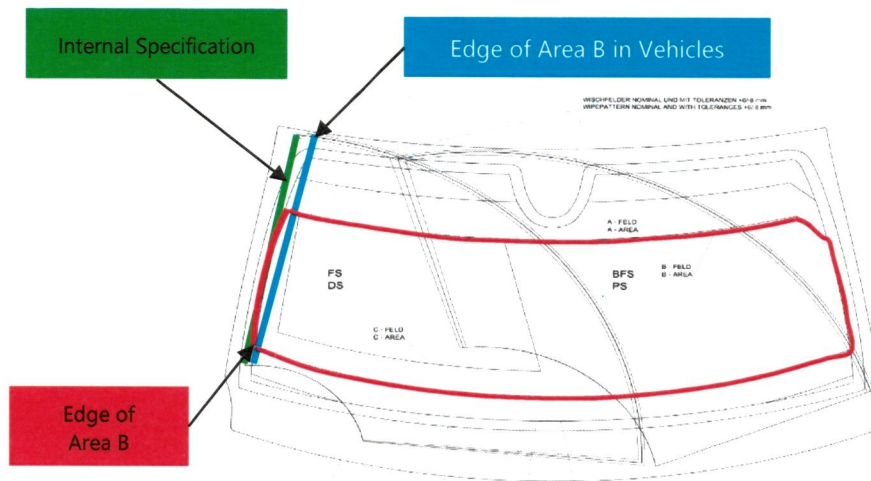
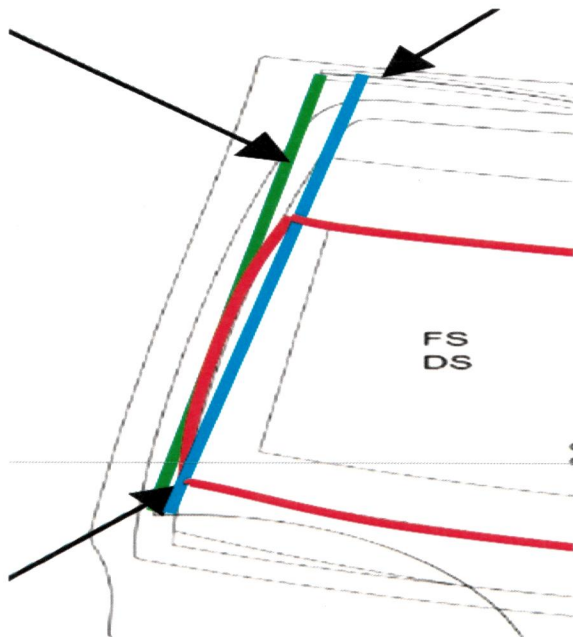
FMVSS 104 was adopted early in the development of the FMVSS and was derived from SAE industry standards. The standard is designed to ensure the windshield wiping system is able to clear specific portions of the windshield to provide the driver with a sufficient field of view. The standard divides the windshield into three different sections – Areas A, B and C – which are not fixed, but rather the size and area for each will vary depending on the angle of measurement and the width of the vehicle. The minimum wiped portion of the windshield described in S4.1.2 is calculated based on the area bounded by a perimeter line on the glazing surface 25 millimeters from the edge of the daylight opening. A minimum of 94% of Area B is to be wiped. After calculating the portion of the windshield that constitutes Area B, MBAG found that once adjusted, the windshield wiper arms fall slightly outside the minimum area. In the worst case, 93.8% of Area B is wiped.

In the subject vehicles, the portion of the windshield that just falls below the minimum wiped area is located at the outer edge of the windshield. As shown in the illustrations below, this area falls between the red and blue lines. In the worst case scenario, only 93.8%, instead of the minimum 94%, of the Area B portion of the windshield remains unwiped. The affected portion of Area B is located at the outer edge of the passenger's side of the windshield and not in the area located directly in front of the driver's field of view.
