Re: Petition for Determination of Inconsequential Noncompliance – Mercedes-Benz

Petition for Inconsequential Noncompliance
NHTSA Recall 20V-265

NHTSA ID: 20V265 Transaction ID: 20-00855-24511-11 (Amendment 1)

Part 573 Safety Recall Report

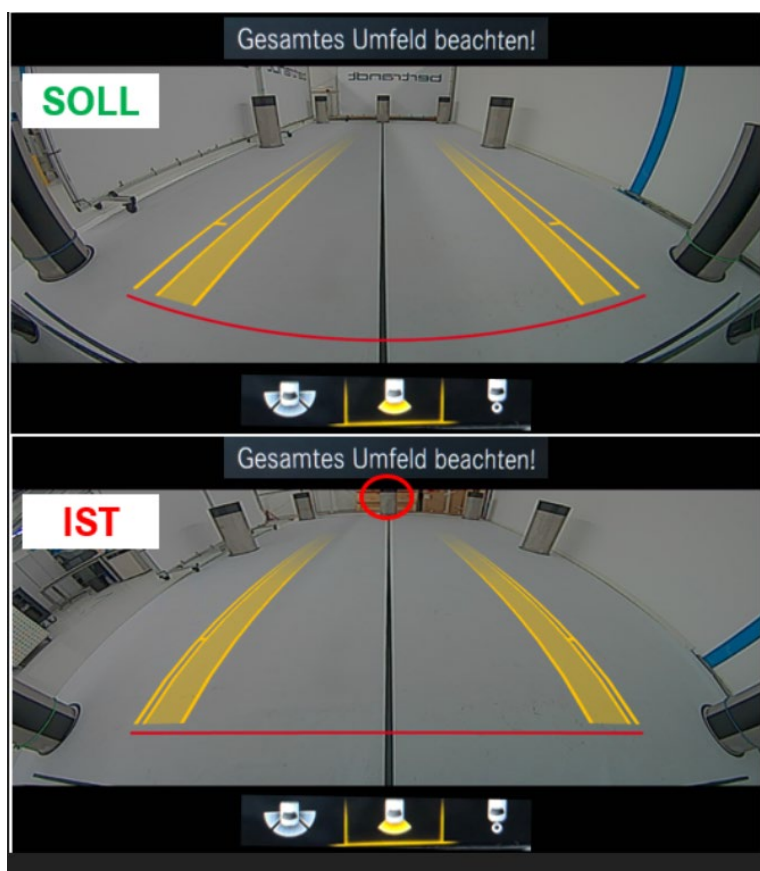
Given the background regarding the very specific type of concern related to the use of overlays, the subject vehicles do not create an increased safety risk. The portion of Test Object B that is affected by the software issue is limited to the extreme top edge of the test object, as provided in the photo below.¹ The border of the text box covers approximately 10% of the top edge of Test Object B. The full height of the test object when displayed on the screen is 800 mm. The uppermost portion of the test object (indicated by the black band at the top of the test object) is 150 mm. When the alert message appears on the in-vehicle display, the border obscures approximately half of the 150 mm strip of the text object, or 75 mm.

¹ The photo below provides an example of the in-vehicle display for a vehicle sold in the German market. The display image, text size and measurements used in a vehicle for the U.S. market are the same with the exception that the warning language is provided in English text. MBAG will provide an updated photo once available.
