MOTORS LLC  
Global Vehicle Safety

USG 4947  
June 19, 2020

Subject: Petition for Determination of Inconsequential Noncompliance;  
FMVSS 302 Flammability of Interior Materials  
NHTSA Recall No. 20V318

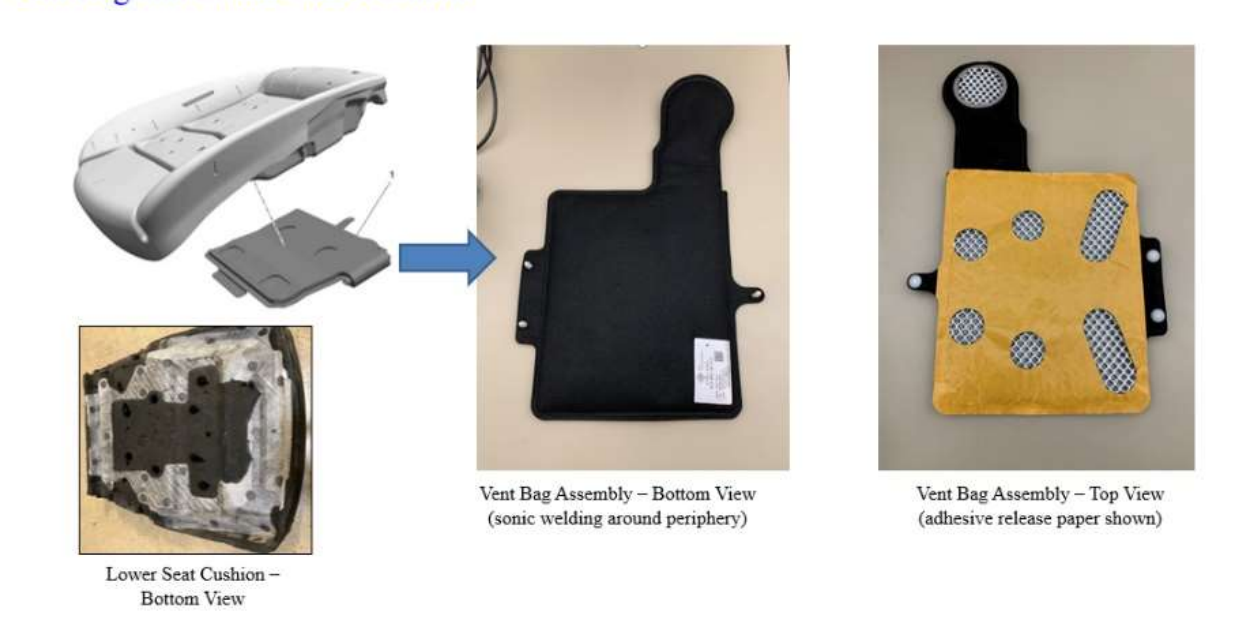
FIGURE 1 – Seat Vent Bag and Lower Seat Cushion

The vent bags assembly (or “vent bags”) in the subject vehicles is shown below in Figure 1. The vent bags are designed to pull air into and through the seat to cool the occupant.

The vent bag is positioned below the seat cushion and attaches via a very thin adhesive strip to the lower seat cushion shown on the bottom left of Figure 1.

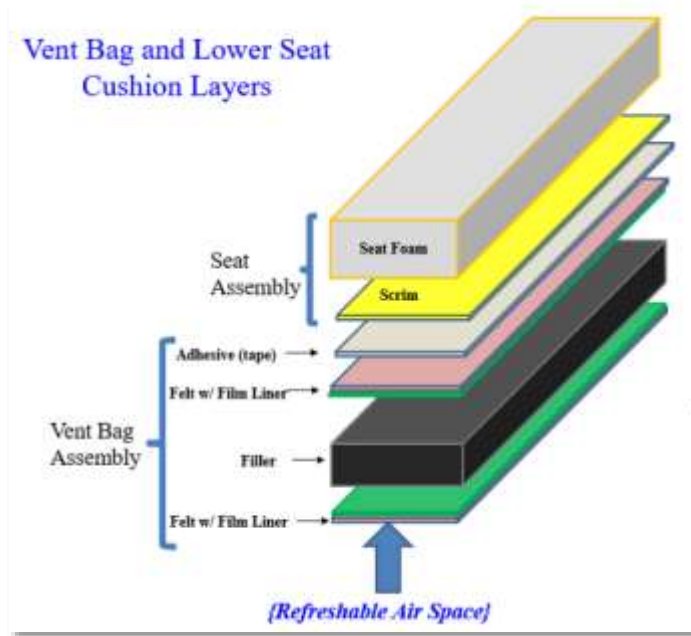
FIGURE 2 – Vent Bag and Lower Seat Cushion Material Layers

The vent bags are comprised of multiple layers of materials as shown below in Figure 2.

The scrim layer shown in yellow in Figure 2 above does not extend uniformly in a layer as illustrated above. It is localized around the seat foam. The scrim can be seen in the lower picture in Figure 3 below—it is the white material that surrounds the black seat foam. That picture is a bottom-side view of the underside of the seat cushion.

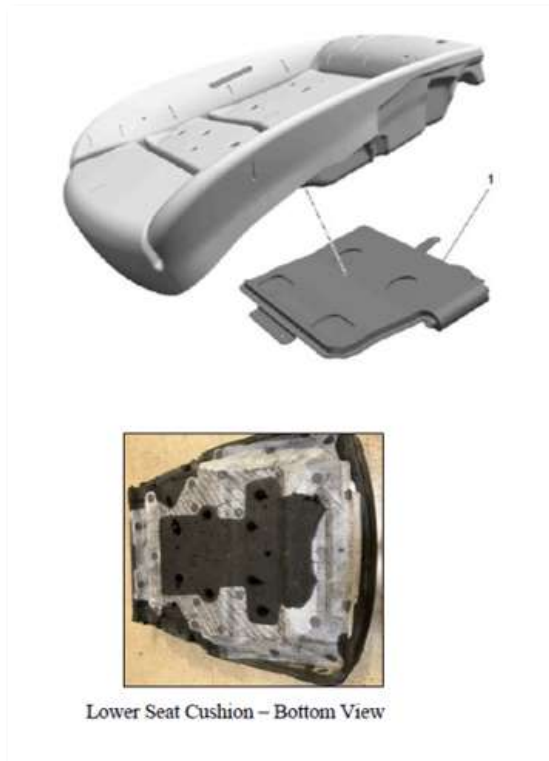
FIGURE 3 – Lower Seat Cushion

Depending on the location of the sample cut for FMVSS 302 testing, the sample may not have any scrim if cut in the center, or it may have scrim if cut closer to the edges of the seat.

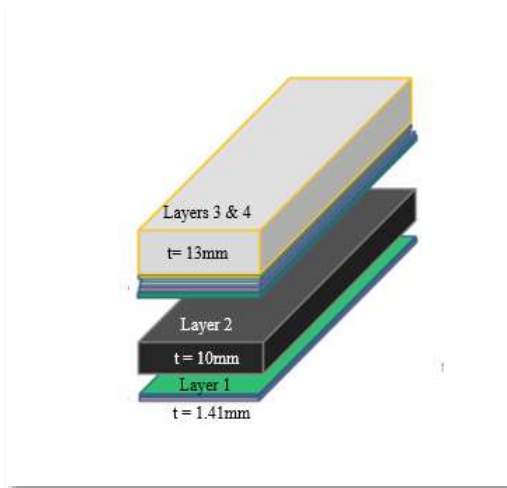
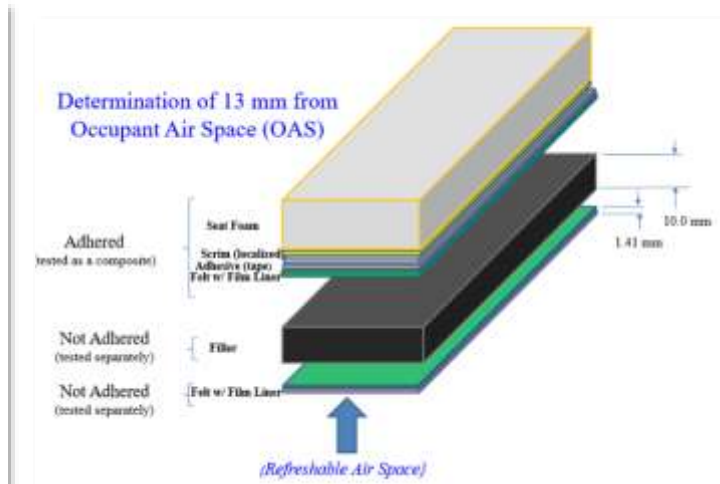
Figures 4A and 4B below, illustrate the 4 layers of the vent bag assembly that must be tested separately for FMVSS 302. Figure 4A identifies the 4 layers and their thicknesses and Figure 4B describes the material(s) that make up the testable layers.

For orientation purposes, Layer 1 is adjacent to the occupant airspace under the seat. Layers 3 and 4 are closest to the seated occupant but furthest from the airspace under the seat.

- Layer 1: Bottom Felt (Purple) + Film (Green)
- Layer 2: Filler (Black)
- Layer 3: Film (Green)+ Top Felt (Purple) + PSA tape + Cushion Scrim + Cushion Foam (Gray)
- Layer 4: Film (Green)+ Top Felt (Purple) + PSA tape + Cushion Foam (Gray)

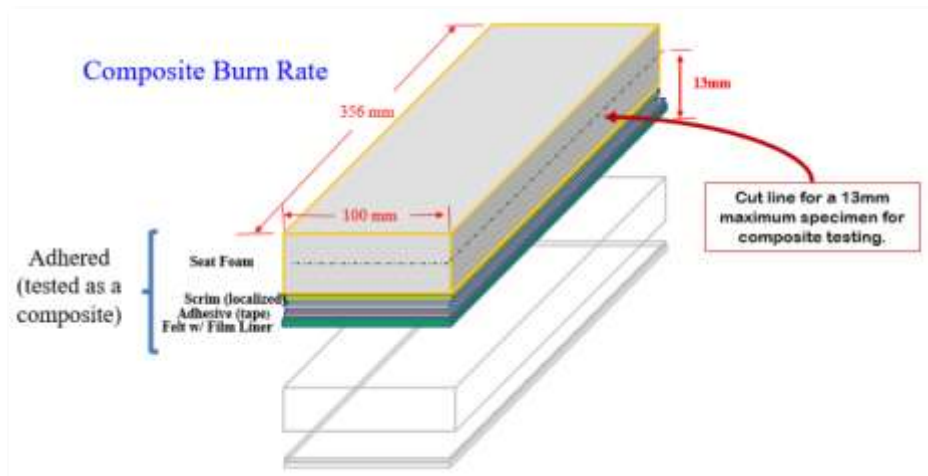
FIGURE 5 – Illustration of Layers 3 and 4 Composite Test Sample

Layers 3 and 4 are adhered at all points and are tested as a composite as shown in Figure 5. The seat foam is cut to comply with S4.2.2, which requires a maximum composite thickness of 13mm. The cut line is illustrated in Figure 5.

The difference between layer 3 and layer 4 is the presence of scrim. Two samples (layers 3 and 4) were taken of the composite material at different locations of the seat to ensure one captured the scrim. Layer 3 was cut to capture scrim and layer 4 was cut closer to the

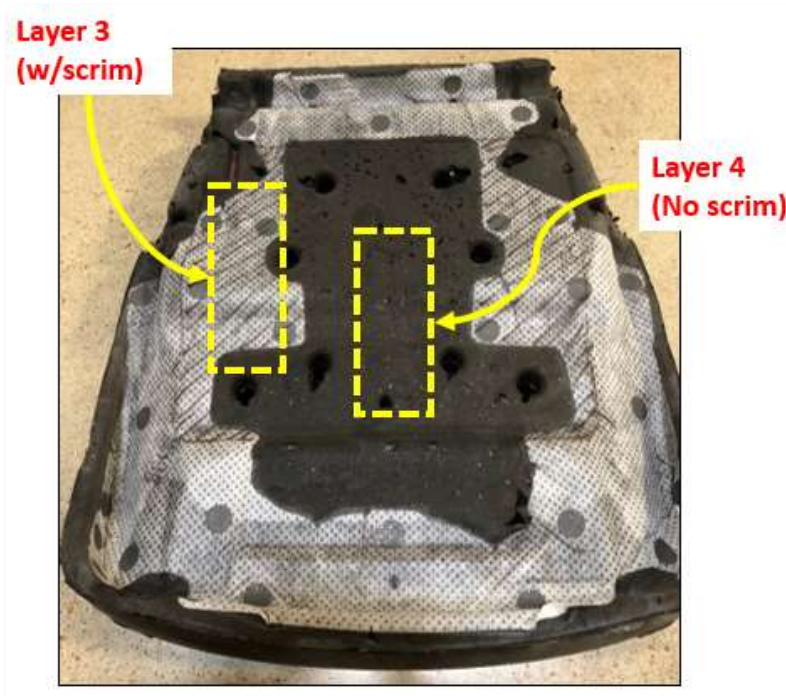
FIGURE 6 – Cut Locations of Layers 3 and 4

center of the seat and does not capture any scrim. Figure 6 below shows the cut locations of layers 3 and 4.

The only layer that did not meet FMVSS 302 is layer 3. All other layers meet the burn rate requirements.

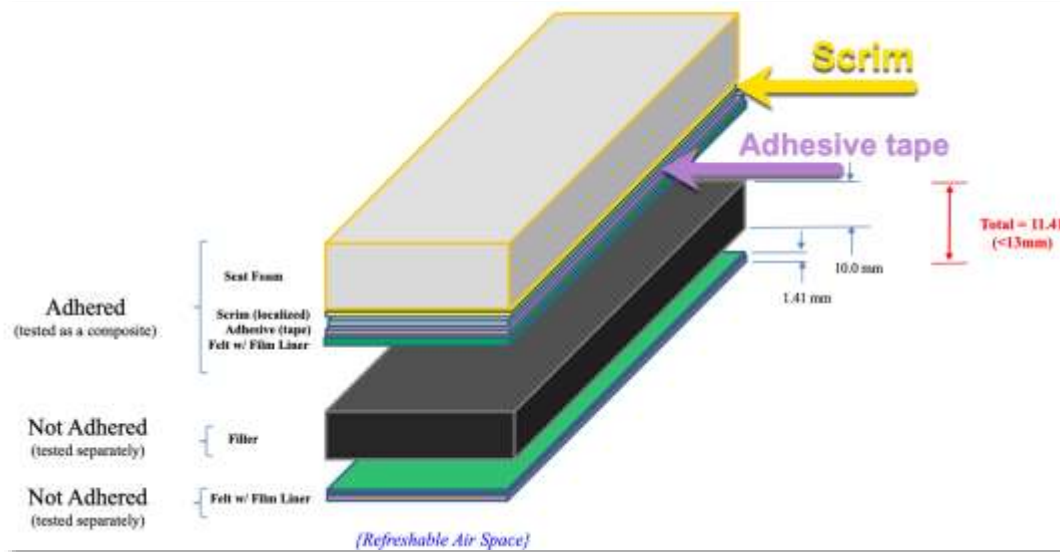
FIGURE 8 – Scrim Material Location

In the real world, however, the adhesive tape and scrim would never be exposed to an open flame because they are well encased from the airspaces below (and above) the seat by layers of self-extinguishing or flammability compliant materials. Specifically, as shown in Figure 8, below, the scrim is encased by at least 11.41 mm of materials from the air space below.

Encasing the scrim from the airspace below are two layers of the felt w/film liner, the filler, and the adhesive tape. The felt w/film liner has a burn rate of 42 mm/min and the filler is self-extinguishing. Moreover, the as-installed seat has more than 13 mm of self-extinguishing seat foam above the adhesive tape and scrim, and the scrim is localized and only exists in certain areas as shown above in Figure 6. Taken as a whole, the adhesive tape and scrim have a negligible effect on the overall burn rate. Layer 4, which is a closer representation of the relative percentage of component materials, has a burn rate of only 12 mm/min to 24 mm/min.

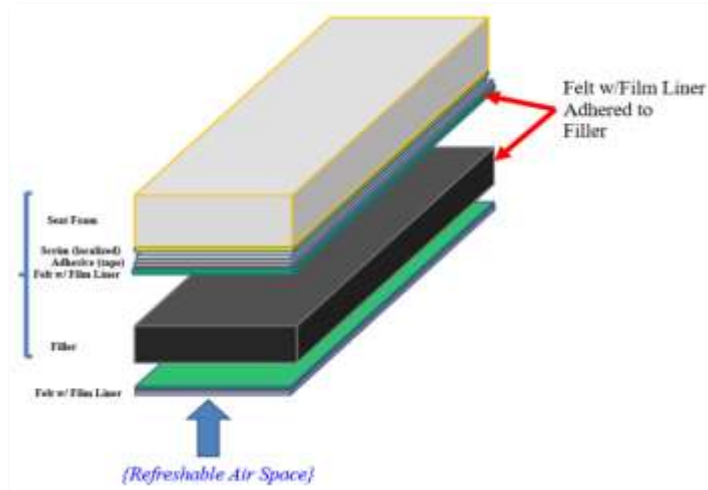
FIGURE 9 – Compliant Vent Bag from Supplier's China Plant

The exact same seats with the exact same materials meet FMVSS 302 when heat is used during the assembly process, which results in the filler layer (layer 2) adhering to the upper felt with film material of layers 3 and 4. The vent bags in the subject seats are assembled using a "radio frequency" welding process to adhere the filler to the upper felt with film liner, and that process does not create sufficient adhesion for FMVSS 302 purposes. However, when these same seats are assembled at the supplier's plant in China, where they use a "heated surface" molding during assembly, the filler and "upper" felt with film liner are sufficiently adhered for purposes of FMVSS 302 – i.e., they are adhered "at every point of contact" – and are therefore considered a "composite" under FMVSS 302, S4.2.2. The relevant adhesive surface is shown in Figure 9, below.

The only difference between the compliant vent bags assembled in China and those used in the subject vehicles is the level of adhesion between the filler and felt illustrated above. The vent bag and seat material, the material thickness, and the stack up of materials from the occupant air space is identical.

To address this technical noncompliance, GM's suppliers will use the "heated surface" molding process explained above, which results in the filler and felt-with-film liner to be adhered at all points. This process will be used to correct the non-compliant vehicles in production and parts in service inventory. Through testing, GM confirmed that the vent bags assembled with this process comply with S4.3(a) for FMVSS 302.

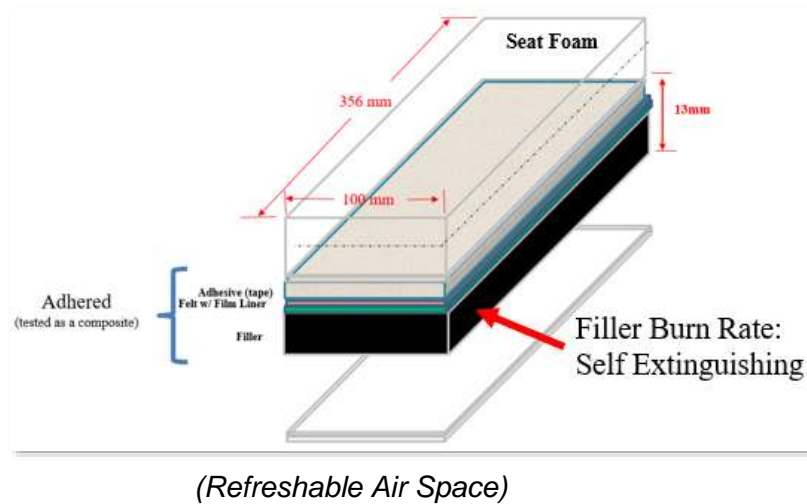
FIGURE 10 – Alternate Construction Process Composite Test Sample

Since the upper felt w/film liner adheres to the filler, the filler is included in the composite stack as shown in Figure 10. The applied flame must travel through the filler (thickness: 10mm, burn rate: SE) layer prior to contacting the adhesive tape, in the upper composite material. The new composite burn rate is SE to 53 mm/min.
