Re: Request for Inconsequential Noncompliance, Daimler Coaches North America, LLC
Recall No.: 20V-411

Part 573 Safety Recall Report**20V-411****Manufacturer Name :** Daimler Coaches North America**Submission Date :** JUL 16, 2020**NHTSA Recall No. :** 20V-411**Manufacturer Recall No. :** N/A

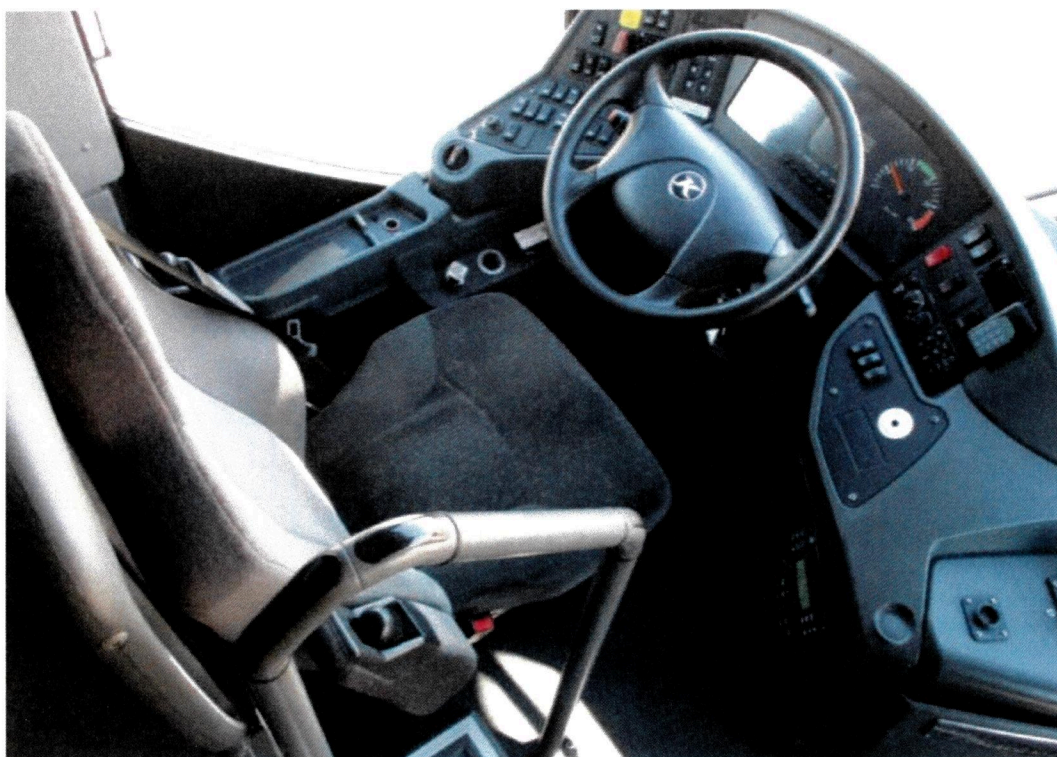
The hazard warning lamp is controlled by a large red plastic toggle switch that is 19 mm across by 40 mm high. See photograph below:

The switch is activated by pressing the bottom half of the switch downward with one finger until a clicking noise occurs. When the hazard warning lamp is activated, even without illumination the operation of the hazard function is confirmed because the hazard lamp itself will flash on and off and both the right and left turn signal indicators in the instrument cluster will flash on and off and in unison with the hazard warning lamps on the exterior of the vehicle. Thus, there is no question that the driver would not be able to confirm that the hazard warning lamp is operational.

The vehicle operator can readily identify and locate the hazard warning lamp switch under nighttime conditions, even without illumination of the hazard warning lamp symbol on the switch. The hazard warning lamp control is located at the immediate right of the driver. The switch is located at the driver's eye level and remains in plain view of the driver when the driver is belted. The hazard warning lamp switch is bright red and is the only switch or control on the immediate right side of the driver that is not black or grey and thus easily contrasts with the remainder of the interior and background of the driver's compartment area. The characteristics and placement of the hazard warning lamp switch make it readily apparent under all operating conditions.

The switch for the Hazard Warning Lamp on affected vehicles is not illuminated and is not adjustable for brightness. According to FMVSS 101, Table 1, S.5.3.1 and S5.3.2 the switch for the Hazard Warning Lamp must be illuminated and adjustable for brightness.

EvoBus and DCNA have corrected this issue in production by including a mechanism to adjust the brightness of the vehicle's defrost/defog control and to illuminate the hazard warning lamp control. DCNA is not aware of any complaints or reports related to the condition described in

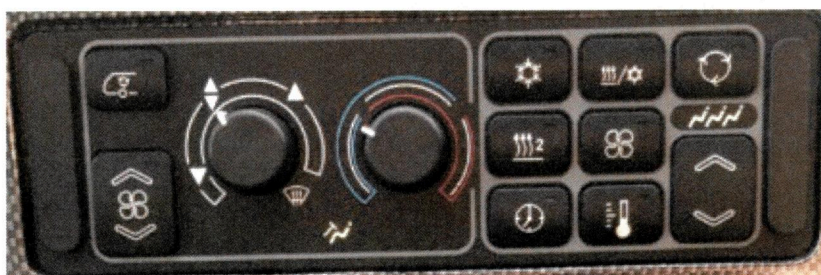
The windshield defrost/defog symbol is located adjacent to the control knob as depicted in the photo below:

The turn style control knob that activates the windshield defrost/defog function and the adjacent symbol are automatically illuminated when the vehicle's headlamps are activated, but cannot be dimmed in accordance with S5.3.2.1. However, each of the functions surrounding the windshield defrost/defog symbol, many of which are not regulated by FMVSS 101 Table 1, are illuminated. There is a master switch for adjusting the brightness of the area surrounding the driver. Dimming is controlled within the meter assembly menu for the dashboard lights and is adjustable to more than two different levels of brightness. Further, the windshield defog/defrost control is located within a group of controls that are responsible for the heating, cooling and

temperature operations of the driver's compartment of the vehicle. Thus, the driver would be well aware of the location of the defrost/defog control because it is located within a cluster of controls that operate similar functions. Thus, there is little to no risk that the driver's vision would otherwise be impaired if the display was too bright or too dim.

Description of the Noncompliance : The symbol on the switch for defogging/defrosting the windshield on affected vehicles is illuminated but not adjustable for brightness. According to FMVSS 101, Table 1, as of August 17, 2005 the symbol of the switch for defogging/defrosting the windshield must be illuminated and with adjustable brightness.
