August 4, 2020

Re: Request for Inconsequential Noncompliance, Daimler Coaches North America, LLC  
Recall No.: 20V-411

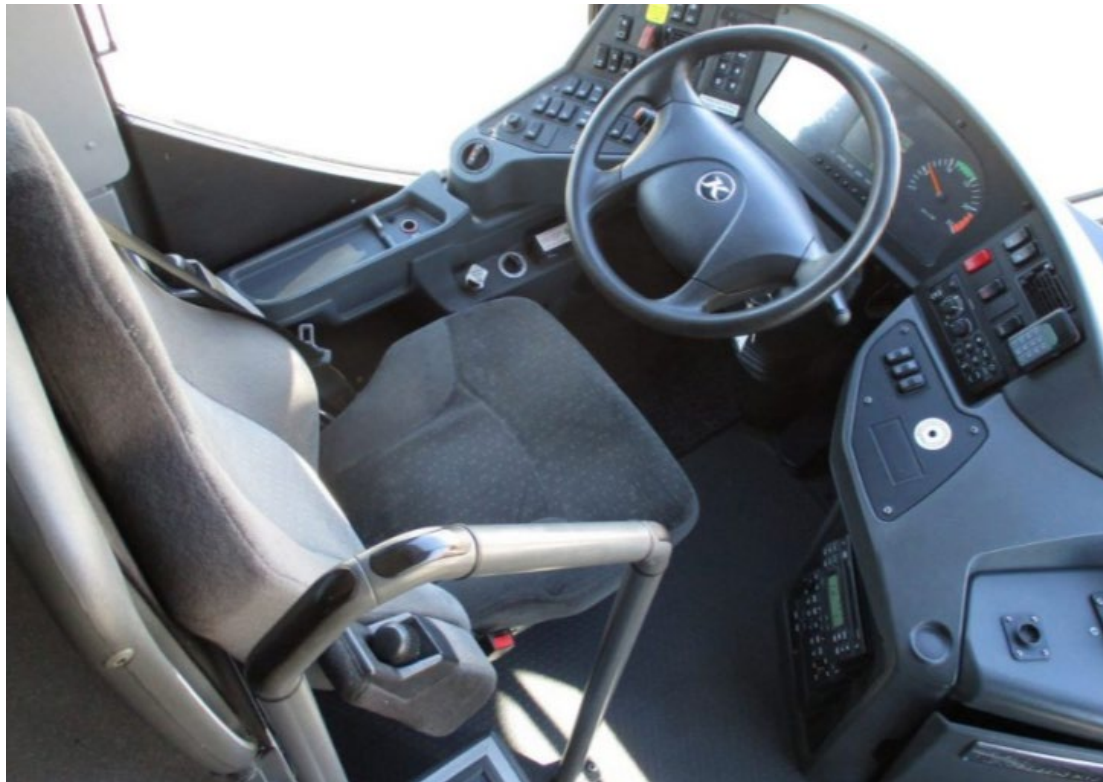
The hazard warning lamp is controlled by a large red plastic toggle switch that is 19 mm across by 40 mm high. See photograph below:

The switch is activated by pressing the bottom half of the switch downward with one finger until a clicking noise occurs. When the hazard warning lamp is activated, even without illumination the operation of the hazard function is confirmed because the hazard lamp itself will flash on and off and both the right and left turn signal indicators in the instrument cluster will flash on and off and in unison with the hazard warning lamps on the exterior of the vehicle. Thus, there is no question that the driver would not be able to confirm that the hazard warning lamp is operational.

The vehicle operator can readily identify and locate the hazard warning lamp switch under nighttime conditions, even without illumination of the hazard warning lamp symbol on the switch. The hazard warning lamp control is located at the immediate right of the driver. The switch is located at the driver's eye level and remains in plain view of the driver when the driver is belted. The hazard warning lamp switch is bright red and is the only switch or control on the immediate right side of the driver that is not black or grey and thus easily contrasts with the remainder of the interior and background of the driver's compartment area. The characteristics and placement of the hazard warning lamp switch make it readily apparent under all operating conditions.

An exemplar photo is provided below:

EvoBus and DCNA have corrected this issue in production by including a mechanism to adjust the brightness of the vehicle's defrost/defog control and to illuminate the hazard warning lamp control. DCNA is not aware of any complaints or reports related to the condition described in

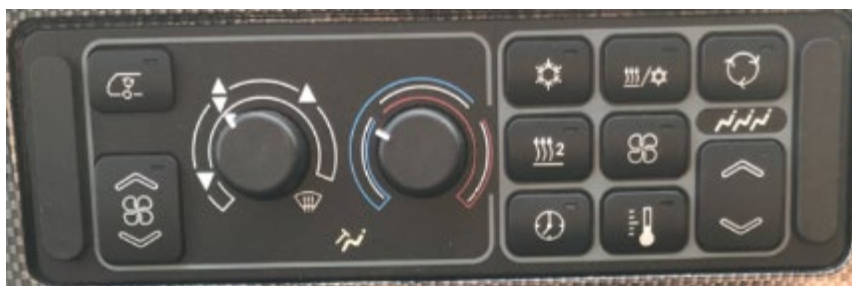
The windshield defrost/defog symbol is located adjacent to the control knob as depicted in the photo below:

The turn style control knob that activates the windshield defrost/defog function and the adjacent symbol are automatically illuminated when the vehicle's headlamps are activated, but cannot be dimmed in accordance with S5.3.2.1. However, each of the functions surrounding the windshield defrost/defog symbol, many of which are not regulated by FMVSS 101 Table 1, are illuminated. There is a master switch for adjusting the brightness of the area surrounding the driver. Dimming is controlled within the meter assembly menu for the dashboard lights and is adjustable to more than two different levels of brightness. Further, the windshield defog/defrost control is located within a group of controls that are responsible for the heating, cooling and

temperature operations of the driver's compartment of the vehicle. Thus, the driver would be well aware of the location of the defrost/defog control because it is located within a cluster of controls that operate similar functions. Thus, there is little to no risk that the driver's vision would otherwise be impaired if the display was too bright or too dim.
