# The More You Know About The 10R80... The Better Off You Are!

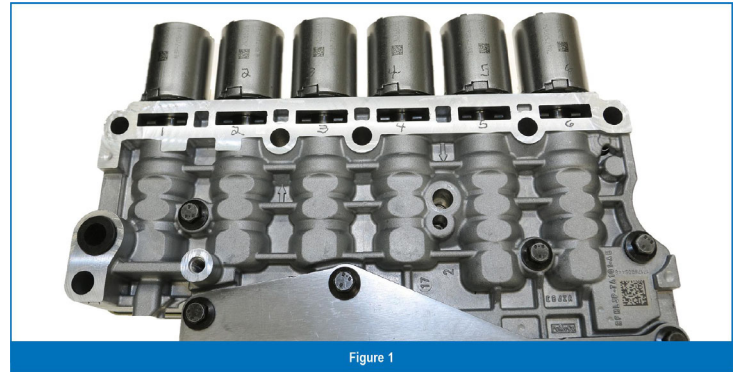
The 10R80 utilizes six shift solenoids that are listed by the factory as A-F and are linear force solenoids (Figure 1). You can scribe numbers on them from 1-6 if you choose for a

If the power circuit to the transmission solenoids fails open, then all solenoids are failed electrically off. None of the clutch packs can engage, and there is no fail-safe operation.

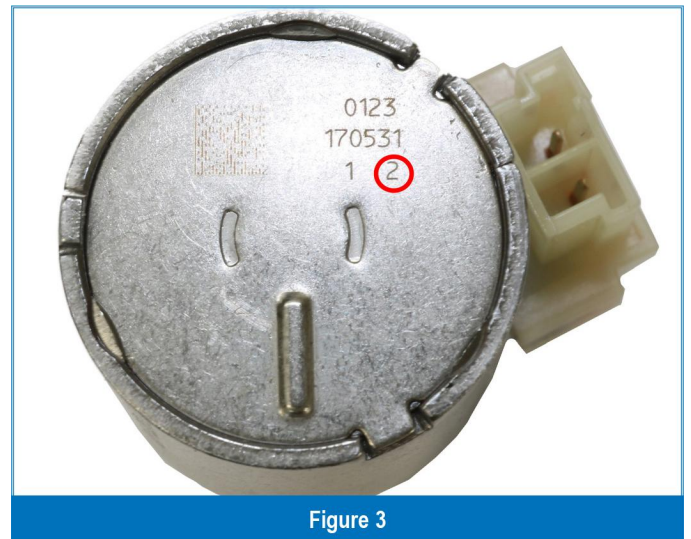
Figure 3

The replacement solenoid band number must match the band number of the solenoid being replaced. The band number is printed on the solenoids in the location shown and will be a 1, 2, 3, 4, or 5 (Figure 3).

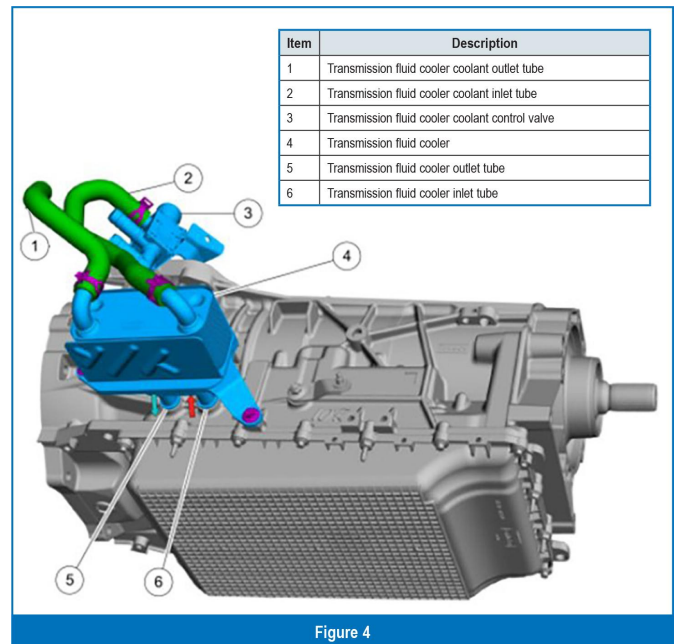
Figure 4

In 2018 and later models with the transmission warmer mounted to the transmission, there can be a concern with coolant leaking under the vehicle. The complaint is usually associated with the vehicle sitting for a while (after it has been running at operating temperature).

Inspect the warmer for damage and related lines for leaks (Figure 4). Note, all models will have a warmer. The location of the warmer and the routing of the hoses can vary widely. Most of the larger displacement applications will have an auxiliary oil-to-air cooler in the system as well. If the warmer is not mounted to the transmission, refer to factory information to locate it.

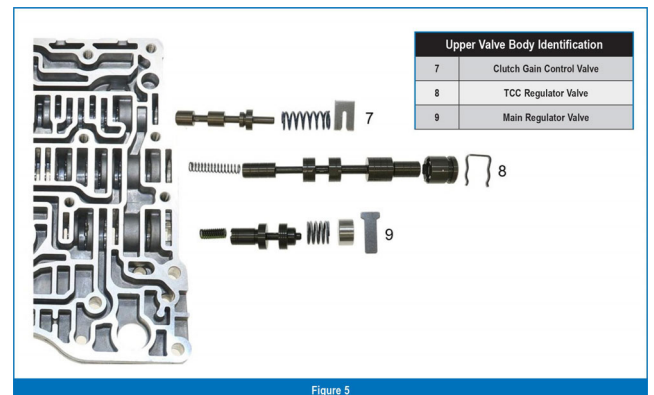
While working on a 2017-2018 Ford F150/Raptor, 2018 Expedition, Mustang, and Lincoln Navigator equipped with a 10R80 transmission, you may experience erratic TCC operation, or a TCC shudder concern. Codes P0741 or P1744 may or may not set in the PCM or TCM (depending on application).

These concerns may be caused by a sticking TCC Regulator Valve (Figure 5). You might run into a lack of valve body repair options. If that's the case, the valve body will have to be replaced to correct these concerns. If the transmission fluid is discolored or has evidence of debris in the fluid, it would be recommended to replace the torque converter and flush the system to complete this repair.

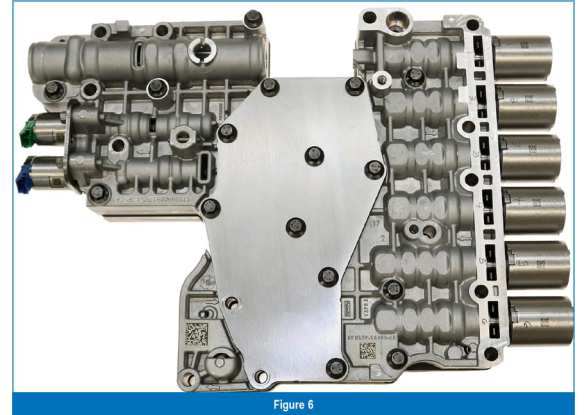
Complaints of erratic shifting, poor shift quality, missed shifts, and other shifting and TCC control complaints are becoming more common with these units. As these units accumulate more mileage, these concerns may become more frequent. There may or may not be codes associated with these complaints. The complaints may be difficult to duplicate.

If concerns are still present, it may be necessary to service or replace the valve body assembly (Figure 6). Sticking valves and sticking CIDAS solenoids are becoming more common concerns with these units.

First, check for updated programming for the TCM strategy. *About 80% of issues are cured by updating the programming.* After programming, perform the Adaptive Learning Drive Cycle and reevaluate the vehicle.

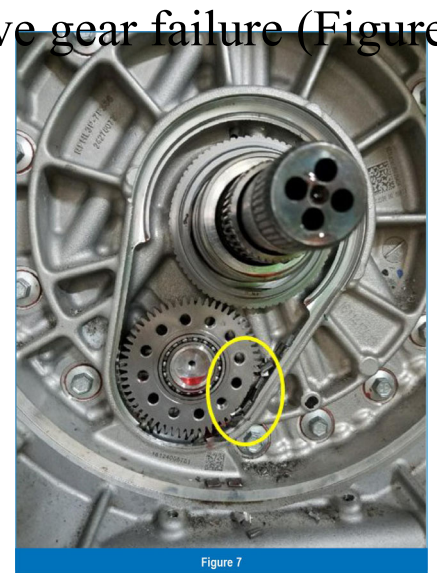
A more recent issue with these units is pump drive gear failure (Figure 7). For now, the bulk of reported cases are related to diesel vehicles.

Note, some customers may complain of a converter type whine noise coming from the transmission. Ford considers this to be a normal condition! Since these are straight cut gears, they will tend to be somewhat noisy.

Always inspect the sump for possible evidence of debris that could indicate the pump drive gears could be failing.
