**REPORT NUMBER: SideNCAPPole-KAR-21-014**  
**NEW CAR ASSESSMENT PROGRAM (NCAP)**  
**SIDE IMPACT POLE TEST**

**VOLKSWAGEN GROUP OF AMERICA**  
**2021 VOLKSWAGEN ID.4 5-DOOR SUV**

**NHTSA No: M20215801**

**FINAL REPORT**

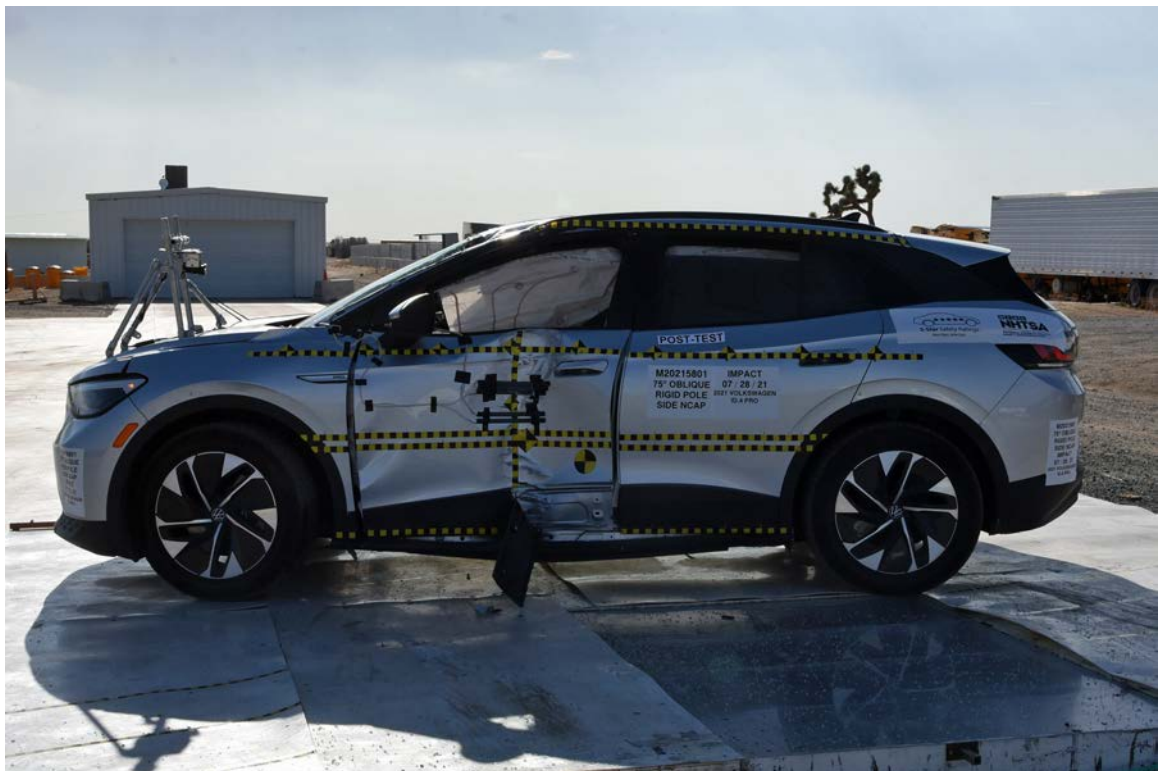
FIGURE 8. Post-Test Left Side View of Test Vehicle

The struck side door at the front of the vehicle was jammed shut. There was no separation at the hinges or latches. The remaining doors remained closed and latched. There were no ATD values that exceeded limits.
