Re: Petition for Determination of Inconsequential Noncompliance:

Sumitomo Rubber Industries, Ltd. and Sumitomo Rubber North America Inc.
Petition for Determination of Inconsequential Noncompliance
NHTSA No. 20T020

-- The Deformation in the Subject Tires Does Not Affect Structural Integrity

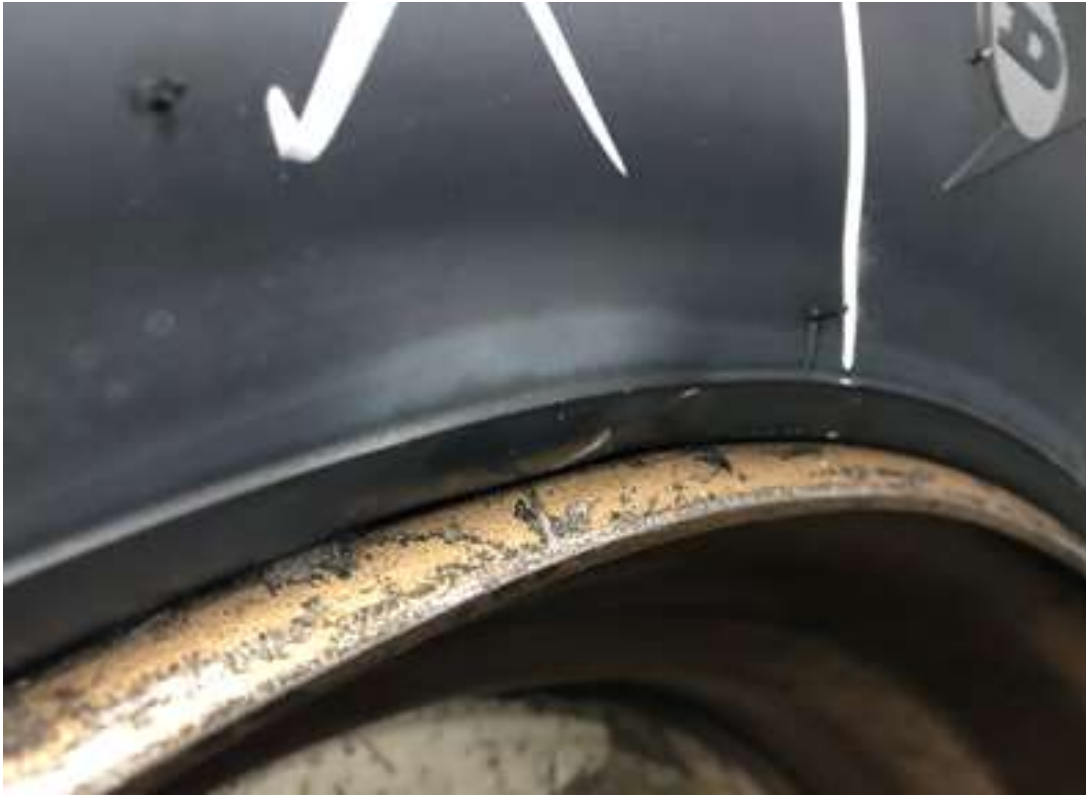
Due to misplacement of the joint tape and a change in the tape’s composition, the subject tires may develop a visible deformation in the bead area near the edge of the rim flange. The following is a photograph of a test tire built with the misplaced joint tape following the FMVSS 119 Endurance test:

The deformation is to the left of the white line marked on the tire in the photograph. As the photograph shows, this small deformation appears on the surface of the tire near the rim.

The deformation forms due to a lack of adhesion between the joint tape and components in the bead area, which can increase the percentage of butyl rubber content in this area. The increased butyl rubber content makes the material more susceptible to heat expansion and, combined with the lack of adhesion in the joint tape, the small area becomes susceptible to separations. Because the joint tape terminates in the bead area, the deformation will only occur there. The steel filler cords next to this area contain the deformation and prevent it from propagating beyond the area shown in the photographs. SRI's testing demonstrates that this deformation does not indicate, and will not subsequently cause, a structural weakness that could lead to a tire failure or rapid air loss.

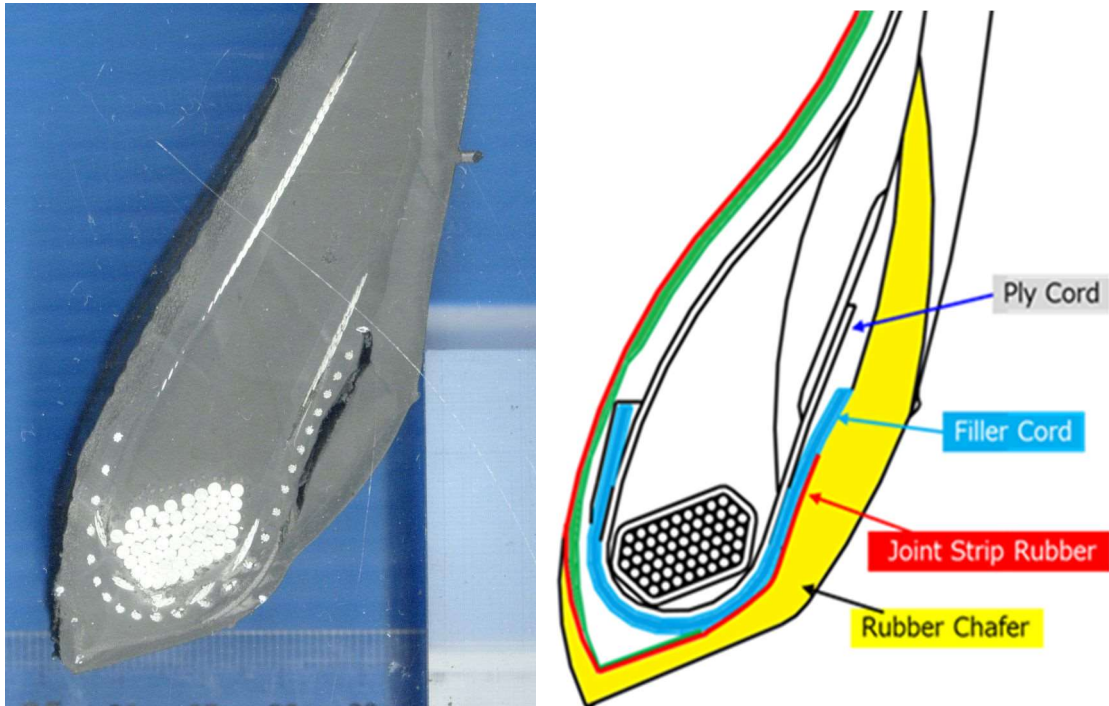
The following photograph shows the same tire, but with a cross-section through the deformation, followed by a diagram to highlight the components:

In this image, the tire's sidewall is on the right-hand side. The tire's bead core (made of several layers of steel cord bundled closely together) is enveloped by a separate layer of steel cords that is depicted by the J-shape of small white dots (also known as the filler cord). The deformation is the separation between the joint strip rubber and the rubber chafer (which serves as the outer layer of the tire). As the photograph demonstrates, the deformation occurs outside the structural components of the tire (*i.e.*, it forms to the right of the filler cord).

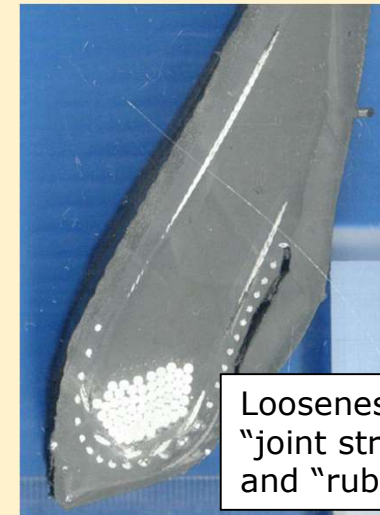
Exhibiting 40mm length of bulge on bead area(Non DOT side)

*2 tires are same result

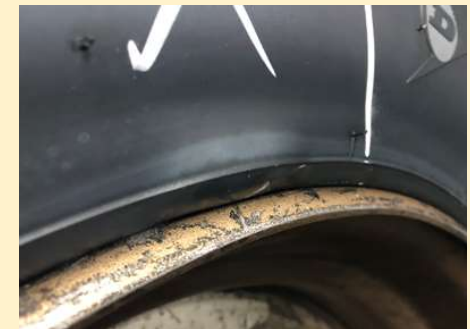
Appearance after endurance test

Looseness between
"joint strip rubber"
and "rubber chafer"

- ◆ Completed full distance but exhibiting separation between 2 rubbers.
- ◆ Air leakage did not occur until test end.

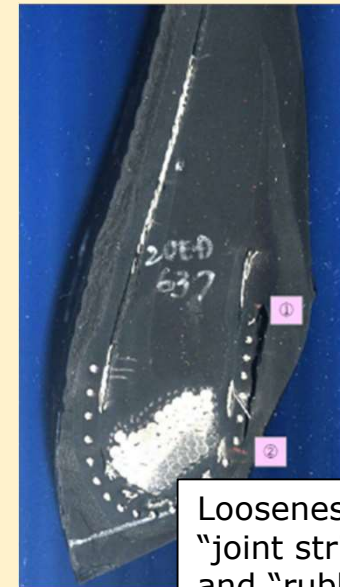
Exhibiting 50mm length of bulge on bead area(Non DOT side)

*2 tires are same result

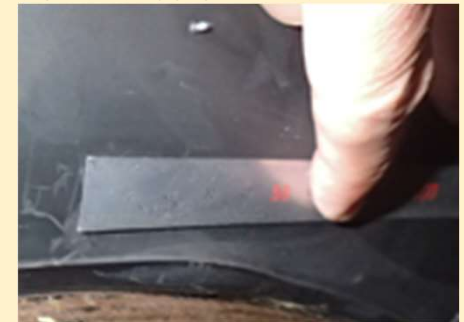
Appearance after endurance test

Looseness between
"joint strip rubber"
and "rubber chafer"

- ◆ Completed full distance but exhibiting separation between 2 rubbers.
- ◆ Air leakage did not occur until test end.

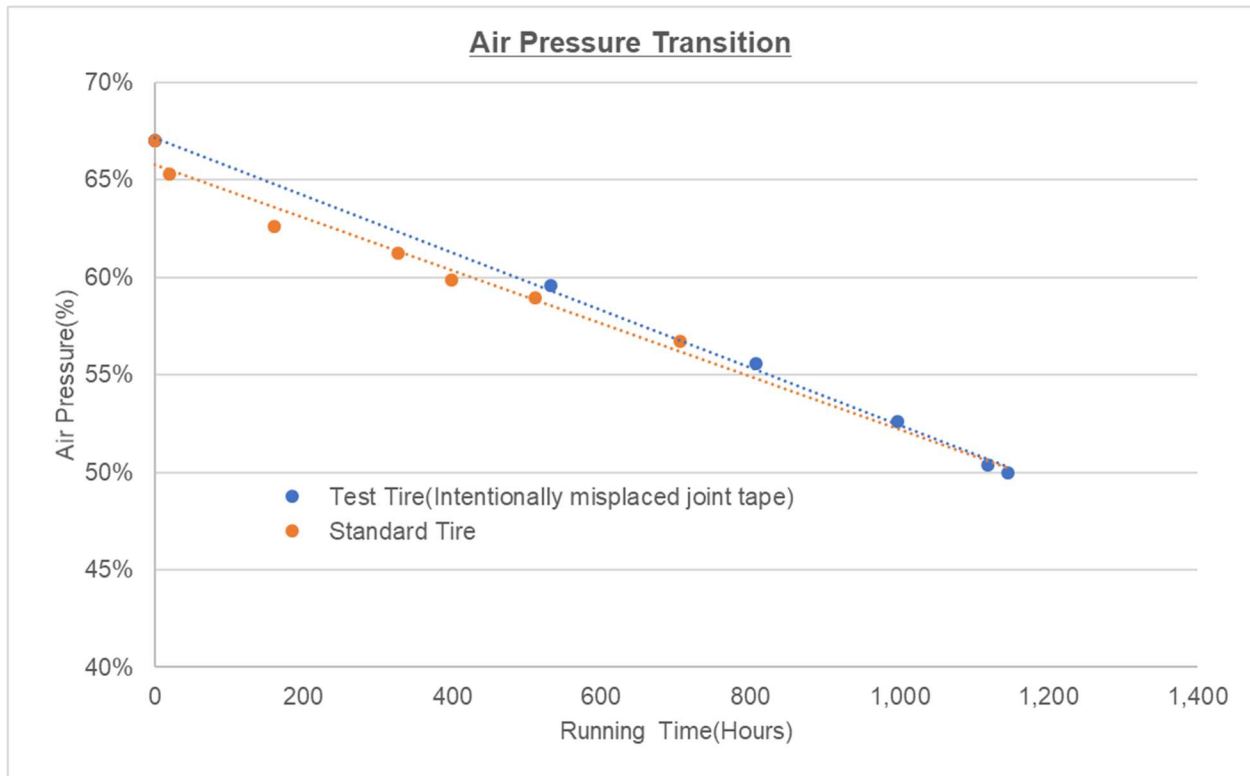
The following graph represents the loss of inflation pressure in the standard tire with *correctly* placed joint tape compared with the same tire size with *intentionally* misplaced joint tape.

Each tire lost air pressure at similar rates over the phases of the test. These results corroborate SRI's conclusions that the loss of inflation pressure was not the result of misplaced joint tape or bead separation in the tire.
