REPORT NUMBER: SideNCAPPole-MGA-22-012

**NEW CAR ASSESSMENT PROGRAM (NCAP)
Side Impact Pole Test**

**MAZDA MOTOR CORPORATION
2022 Mazda MX-30 5-Door Hatchback
NHTSA No.: O20225401**

**MGA RESEARCH CORPORATION
5000 Warren Road
Burlington, WI 53105**

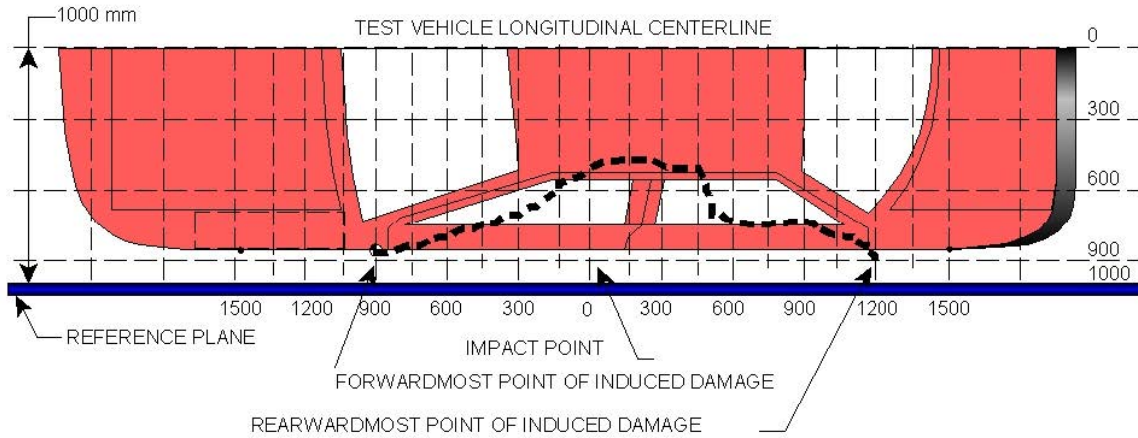
DATA SHEET NO. 10 (CONTINUED)
TEST VEHICLE EXTERIOR CRUSH MEASUREMENTS

DPD	Distance from Impact Point (mm)	Level	Pre-Test (mm)	Post-Test (mm)	Max. Static Crush (mm)
1	475	3	214	270	56
2	252	3	208	328	120
3	29	3	203	486	283
4	-194	3	202	378	176
5	-417	3	202	266	64
6	-640	3	201	194	-7

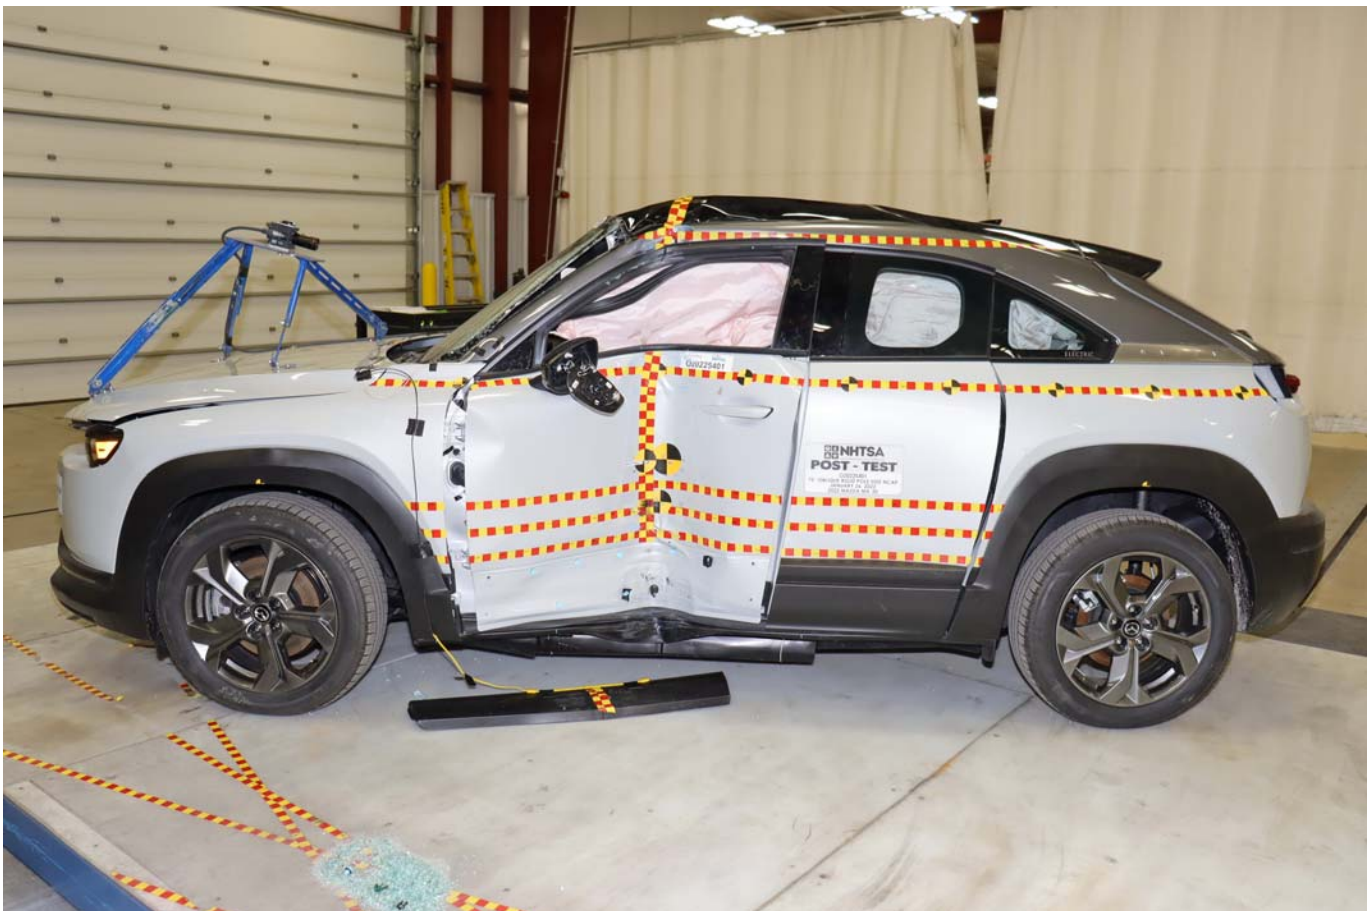
Photo No. 008 - Post-Test Left Side View of Test Vehicle

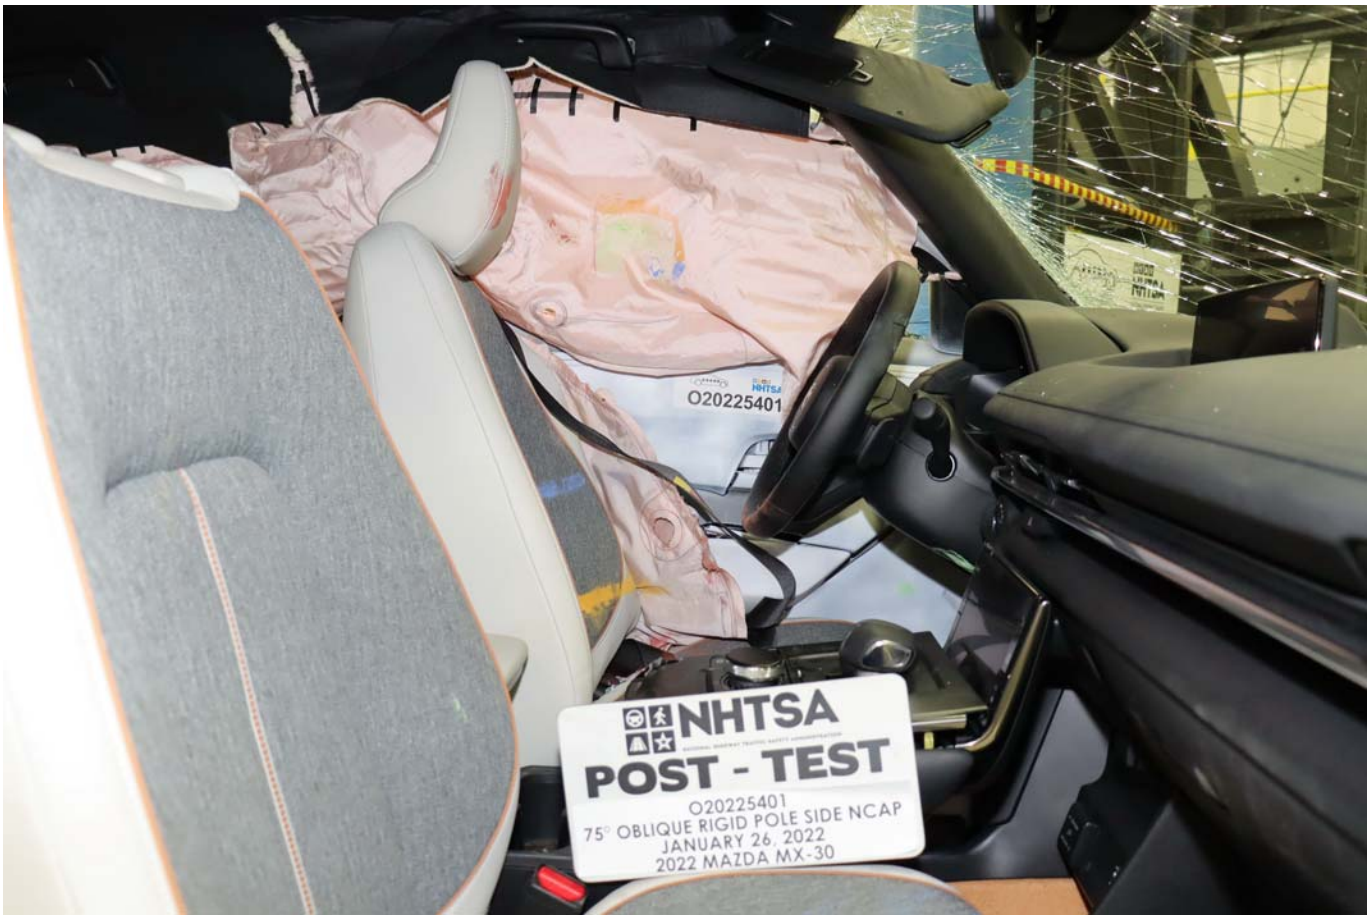
Photo No. 045 - Post-Test Inner Door Panel View Showing Dummy Contact Location

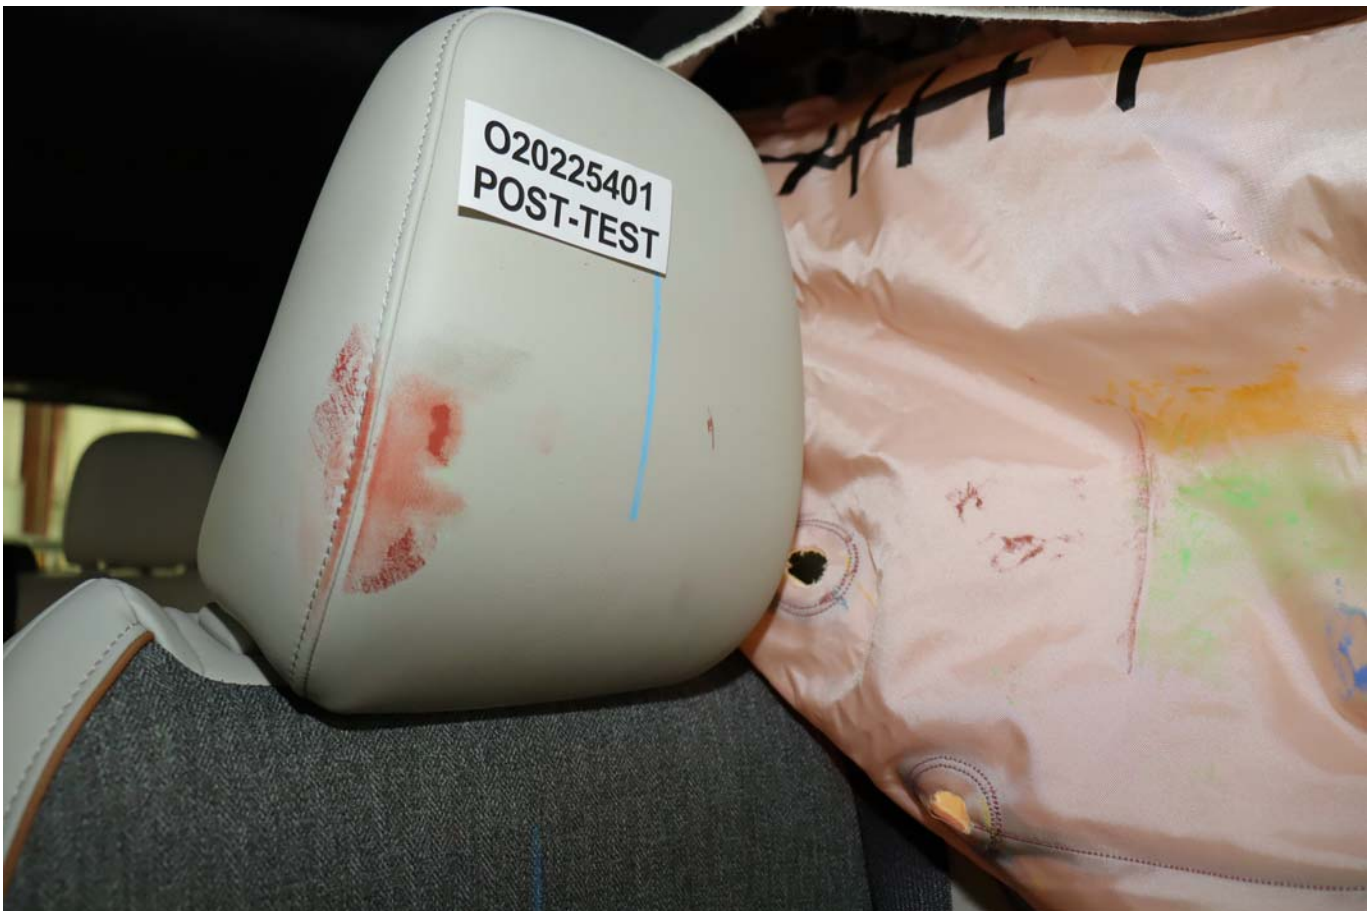
Photo No. 046 - Post-Test Dummy Close-Up Head Contact with Vehicle Interior View

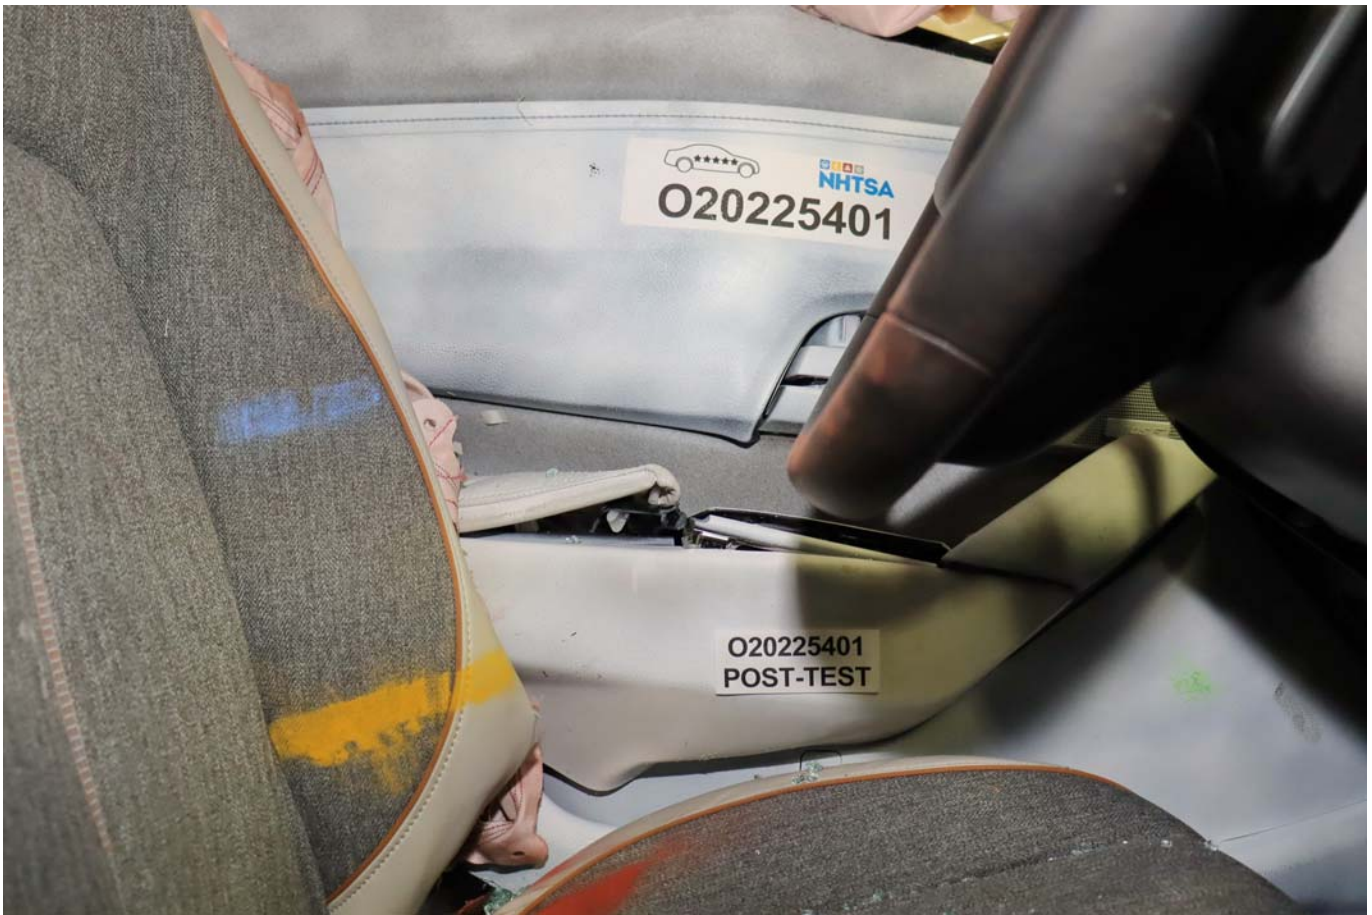
Photo No. 073 - Post-Test View of Shattered Vehicle Inner Door Panel
