Re: Petition for Inconsequential Treatment, Ricon Corp., 21E-069

Ricon Corporation – Petition for Inconsequential Noncompliance

NHTSA Recall 21E-069

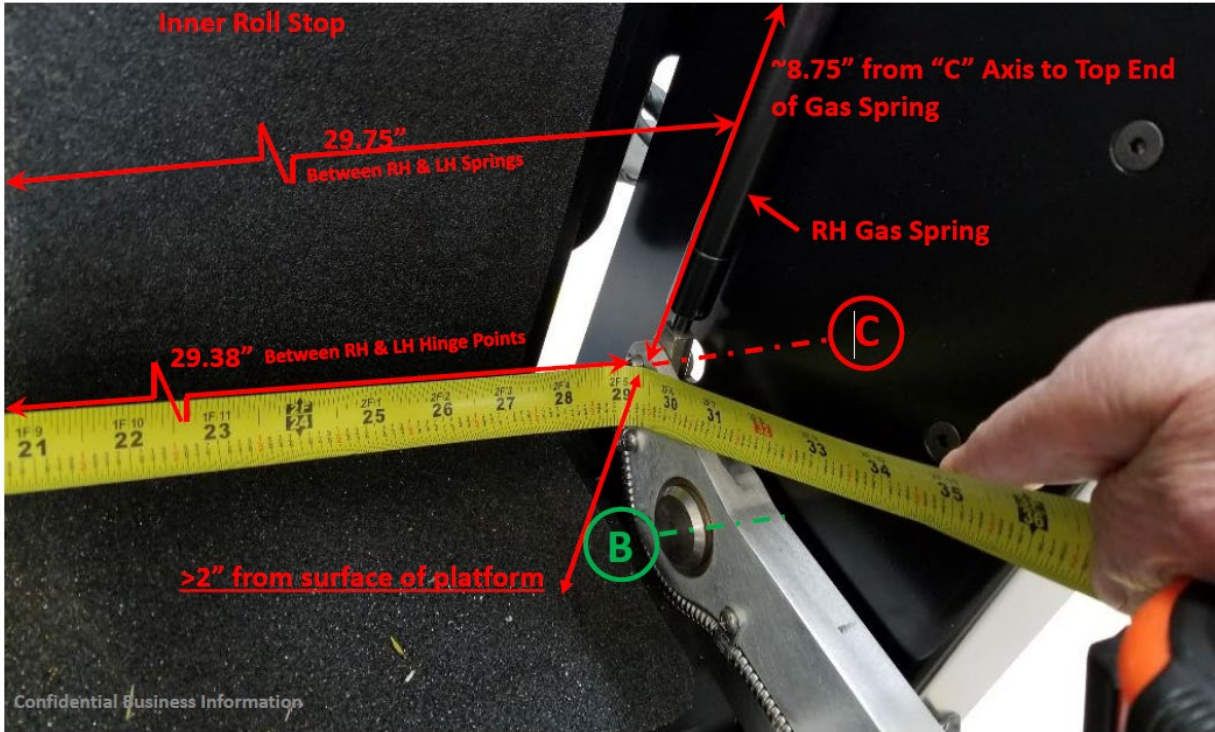
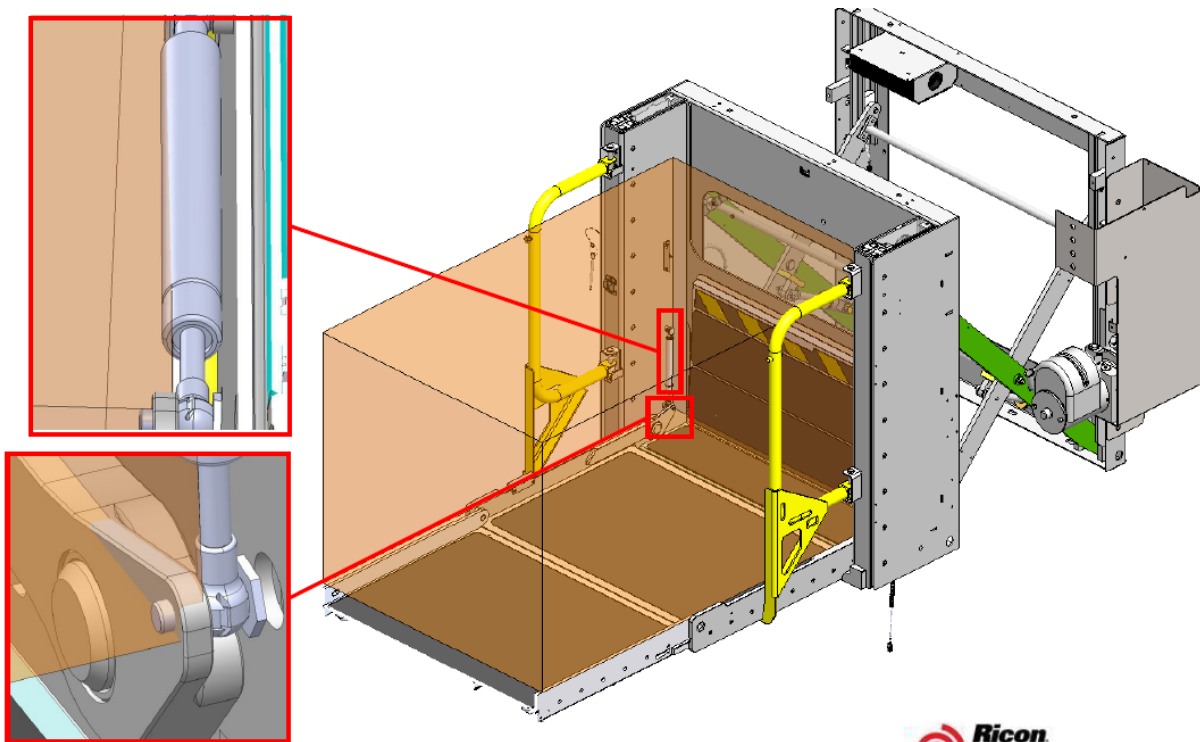
Exhibit A

The Baylift platform does not meet the unobstructed platform minimum operating volume at one particular location on the platform. FMVSS 403, S6.4.2.1, requires, in part, a minimum operating volume of 30 inches width at 2 inches above the platform surface. At one specific location, the upper part of the Baylift measures 29.38 inches wide (as compared to the required 30 inches) – a difference of approximately 0.62 inches. The platform operating volume is slightly impeded by the gas spring mounting hardware on the sides of the platform. The platform occupancy volume is restricted only at the specific location of the side barriers where the gas springs and mounting hardware are located, which is at the extreme inner edges of the platform. See Exhibit A, Baylift Platform Operating Volume Diagram. The platform meets the volume requirements in all other locations.

While the slight protrusion of the side barriers, gas springs and mounting hardware on the Baylift platform makes the overall volume slightly shy of the unobstructed platform minimum operating volume at one particular location, it does not pose a safety risk or deny access for mobility users. The FMVSS 403 rulemaking describes that the rationale for the unobstructed operating volume provision is to create a consistent platform size to ensure most users with mobility devices are able to access the platform and the vehicle. *See* 67 Fed. Reg. 79416, 424 (December 27, 2002). In the case of the Baylifts, even with the current condition, they are still able to meet the objective of this provision and the Baylifts continue to allow access for the vast majority of users. Further, the Baylifts are only installed in specialized over the road buses such as motorcoaches that are used for tour operations. The Baylifts are not designed for and are not used in public transit buses or other vehicles that are more commonly used to transport the mobility impaired on a day-to-day basis. Because of the limited and specialized environment in which the Baylifts are used, there is no risk that even with the current design of the platform, a user would be precluded from accessing the vehicle and being unable to carry out their essential daily activities.

How Remedy Component Differs from Recalled Component : (1) On new production lifts, Ricon plans to incorporate a redesigned outer platform hinge and pin geometry that will comply with the minimum unobstructed lower platform width of 725 mm (28.5 inches) from 50 mm (2 inches) to 760 mm (30 inches) above the platform surface.

Furthermore, the inner and outer platforms on new production lifts will be lengthened to achieve a width of 30" above 50 mm (2 inches) from the surface of the platform within the required 1219.2 mm (48 inches) length of the usable platform surface. Ricon's intent for new production lifts was discussed with NHTSA and Ricon is awaiting any feedback from NHTSA to the contrary.

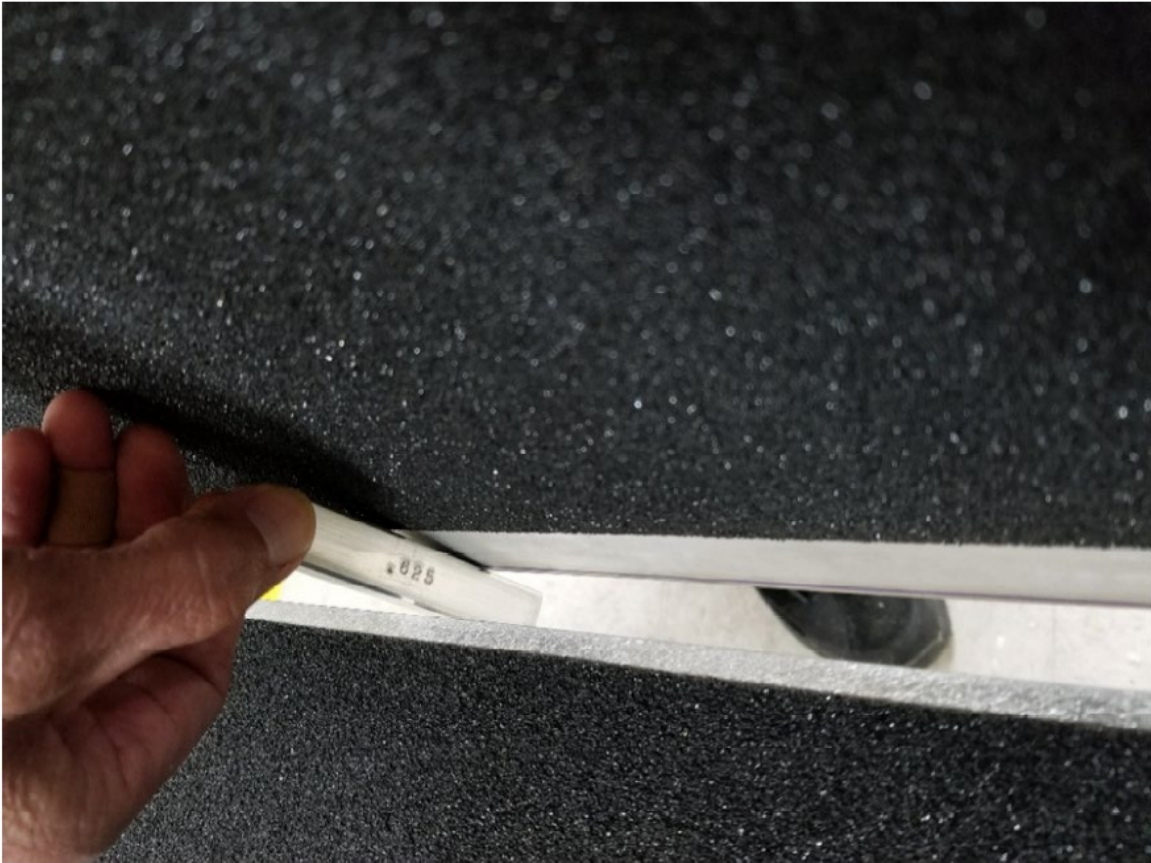
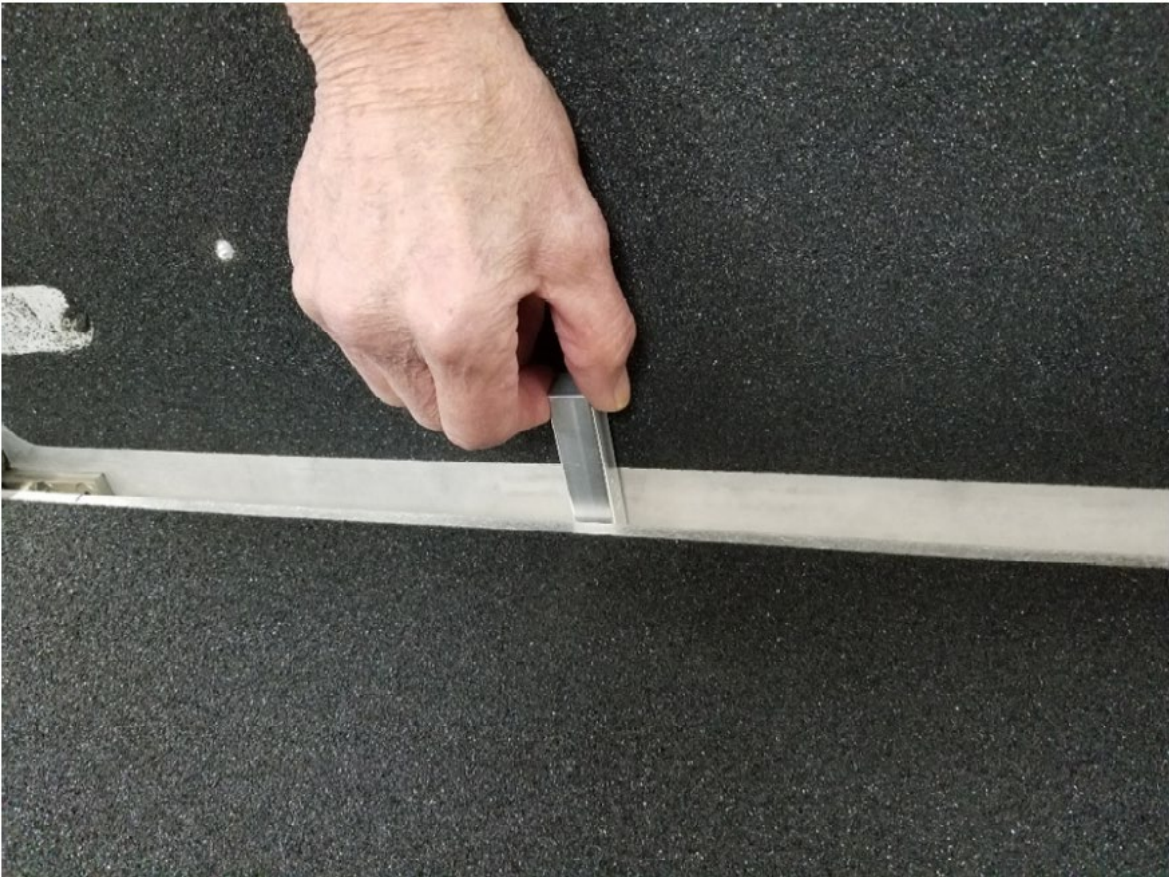
Exhibit B

The Baylift has a gap between the edge of the outer platform and the fully deployed outer barrier that marginally exceeds the allowable width permitted by FMVSS 403. The test procedure outlined in S6.4.4.3 requires that the clearance test block specified in S.7.1.3 must not pass through any gap between the outer barrier and lift platform when the long axis is held perpendicular to the platform reference plane. On the Baylift, the gap between the edge of the outer platform and the fully deployed outer barrier is approximately 2.38 mm (or 0.094 inches) greater than the clearance test block. See Exhibit B, Outer Platform Edge and Outer Barrier Clearance Photo.

The marginal exceedance of the allowable gap between the edge of the outer platform and the fully deployed outer barrier of approximately 2.38 mm (0.094 inches)) does not present a safety risk. Images of the gap when measured against the testing block are attached. As depicted in the images, the gap allows the testing block to bend slightly within the space, however, the size of the gap with the exceedance is so small that it does not create an open space or a void between the testing block and the metal edge of the gap.

The gap between the edge of the outer platform and the fully deployed outer barrier is marginally larger (approximately 2.38 mm (0.094 inches)) than the clearance test block specified in S7.1.3 and may allow the test block to pass through the gap when the long axis is held perpendicular to the platform reference plane as required in S6.4.4.3.

(2) New production lifts will incorporate a slightly extended outer platform to reduce the gap between the edge of the platform and the deployed outer barrier within the maximum allowable limit of 15.9 mm (0.625 inches).

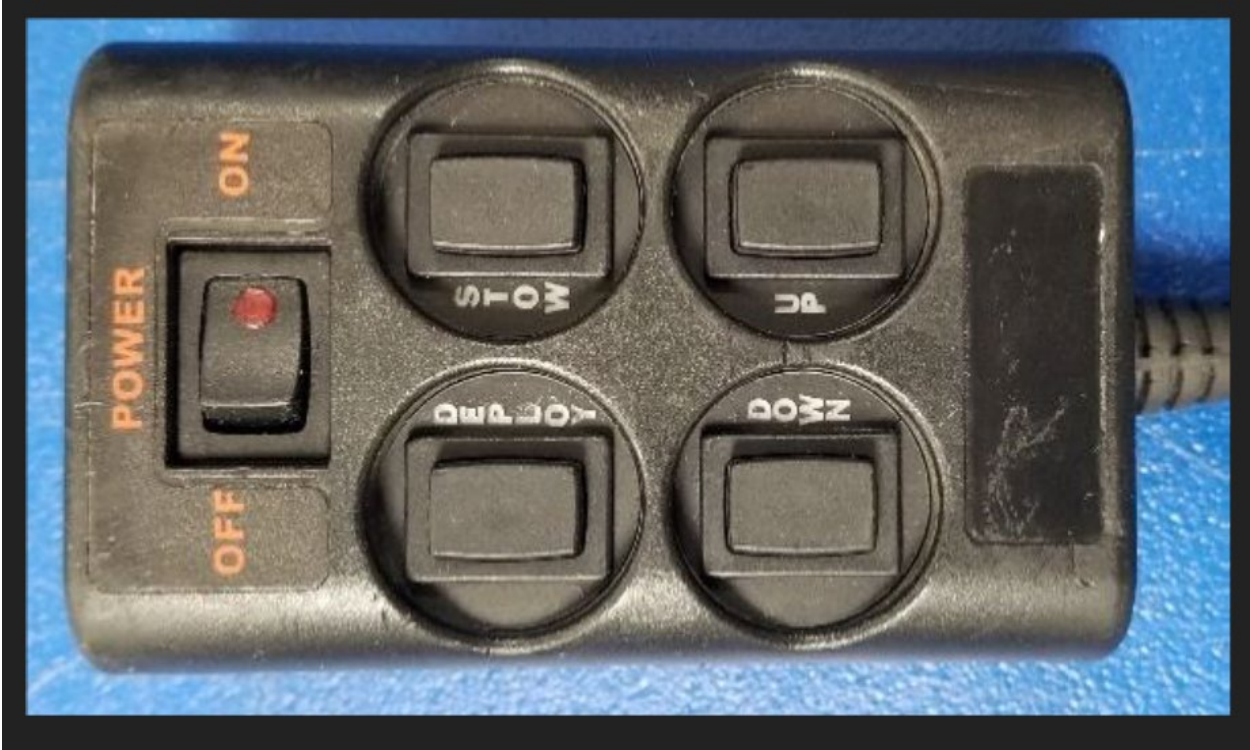
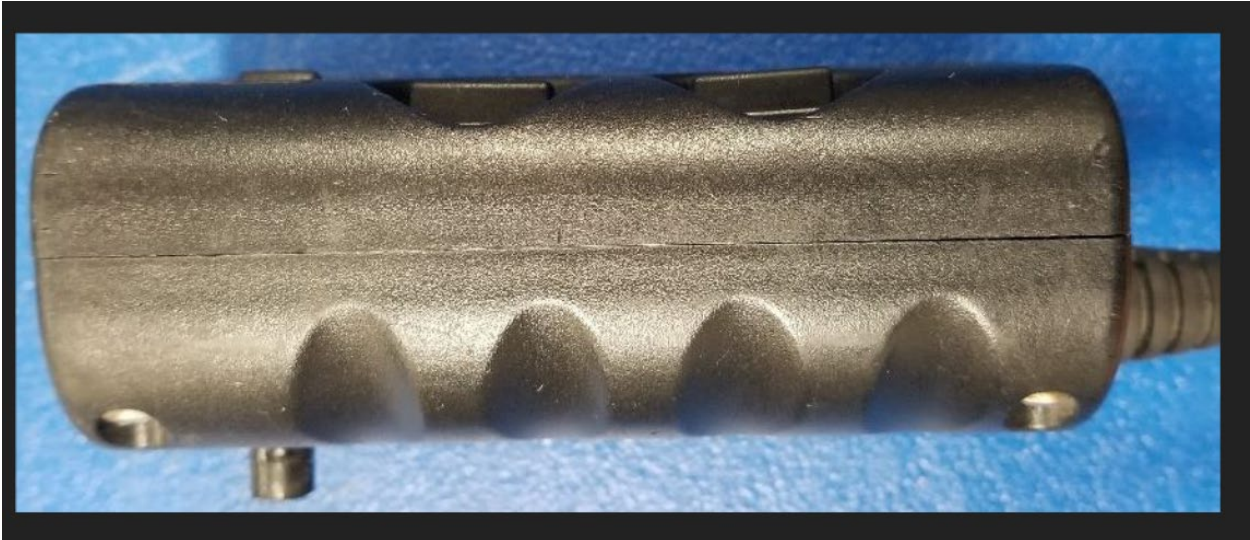
Exhibit C

The Baylifts use an external control pendant to operate the lifts. The control pendant uses an on/off switch to energize and power the lift. To move and change the direction of the lift, the control pendant contains four individual buttons to operate the functions for stow, deploy, down and up positions. These four buttons are momentary switches, meaning that continuous pressure must be applied to the button in order to continue the movement or direction of the lift. Once the button is released, movement of the lift immediately stops. Photographs of the exemplar control pendant is provided in Exhibit C.

Ricon has found that under two specific conditions, the control pendant used on the Baylifts permits the simultaneous activation of functions because it does not allow the initial function to continue in the initial direction or stop as directed in S6.7.4. In the first condition, the lift platform is located at vehicle floor level and is moving downwards to ground level by pressing the “DOWN” button on the control pendant. If the “UP” button is activated at the same time as the “DOWN” button, the lift platform will stop its downward motion and instead, initiate a normal upward motion. In the second condition, the unoccupied lift is already in a stowed position and is commanded to deploy by pressing the “DEPLOY” button on the control pendant. If the “STOW” button is pressed at the same time, the lift will stop the deploy process and instead revert to a normal stow motion. The Baylifts perform consistent with the requirements of S6.7.4 under all other conditions when the activation buttons are pushed simultaneously. As described in detail below, the potential for any simultaneous activation of functions would be highly unlikely and extremely difficult when holding the pendant with one hand and there are

The potential for simultaneous activation of the “UP”/”DOWN” or “STOW”/”DEPLOY” buttons is extremely unlikely as due to the geometry of the pendant and buttons. The pendant device measures approximately 2.8 inches wide / 4.5 inches long / 1.7 inches thick and is composed of hard plastic which does not yield to force. The buttons are spaced out approximately 1.25 inches between centers across the top surface of the pendant device. An image of the control pendant is provided as an attachment at Exhibit B. This geometry would make it difficult for the operator to wrap their hand around the back of the pendant or contort their hand across the top of the pendant to activate multiple buttons at once. Because of the difficulty the operator would have in reaching the pendant buttons with one hand given the geometry and dimensions of the pendant and button spacing, there is essentially no risk of an operator accidentally activating more than one command at the same time.

(4) New production lift controllers will incorporate an updated version of software that will prevent simultaneous performance of more than one function during the lift's "DOWN" and "DEPLOY" functional states.
