Subject: 49 CFR Part 556 – Petition for Inconsequential Non-Compliance
Model Year 2009 to 2023 Volvo 9700
FMVSS 108 (Lamps, Reflective Devices, and Associated Equipment)

Volvo Bus Corporation (“VBC”) is submitting this 49 CFR Part 556 Petition for Inconsequential Non-Compliance on behalf of Volvo Group Mexico.

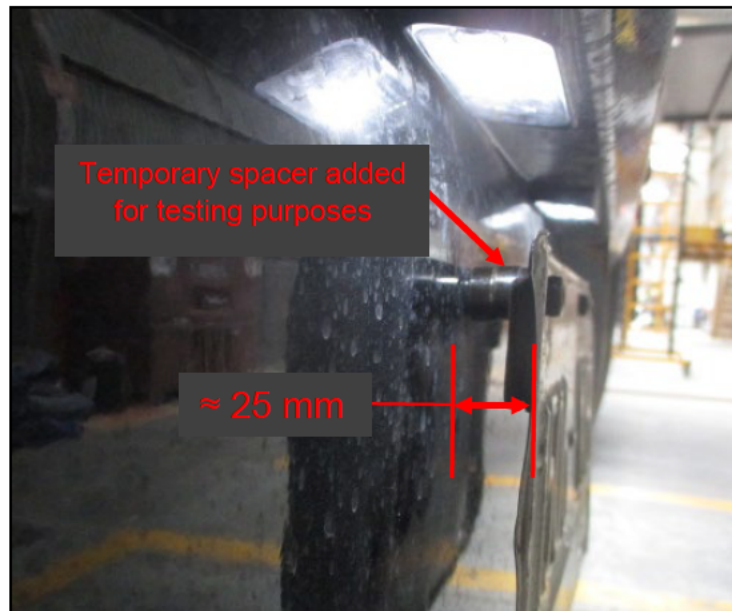
Figure 1: Overall view of the license plate when placed approximately 25 mm ahead of its normal position (test position with added spacers between license plate and rear bumper).

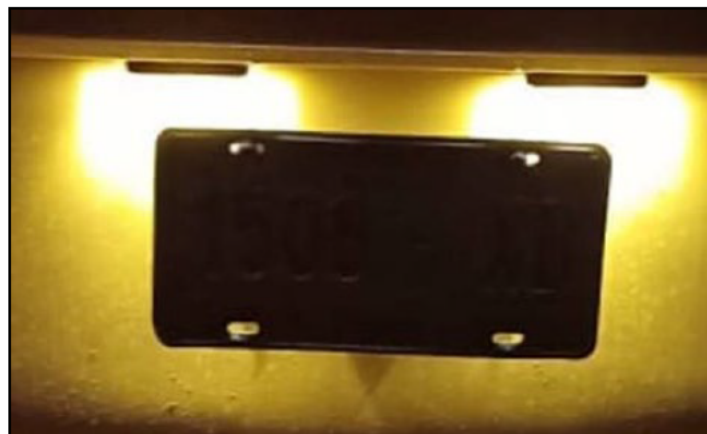
Paragraph S7.7.15.3 of FMVSS 108 indicates that the light rays of the license plate lamps must reach all portions of an imaginary plate of the same size at least 25 mm ahead of the actual plate measured perpendicular to the plane of the plate. Internal Volvo testing revealed that the license plate lamps do not comply with paragraph S7.7.15.3 as the light rays do not reach all portions of the license plate when it is placed 25 mm ahead of its normal position (see figures #1 and #2). However, it is to be noted that the license plate is fully illuminated by the lamps when installed in its normal position (see figures #3 and #4) and Attachment 2 “VBC Engineering Report ER-684684”.

Figure 2: Overall view of the license plate when placed approximately 25 mm ahead of its normal position (test position), showing that it is not fully illuminated.

The non-compliance was corrected in production on October 13, 2022, when an internal campaign was launched to reposition the license plate lamps on the rear bumper towards the rear of the vehicle. Vehicle production is currently in compliance with FMVSS 108 Section 7.7.13.3.

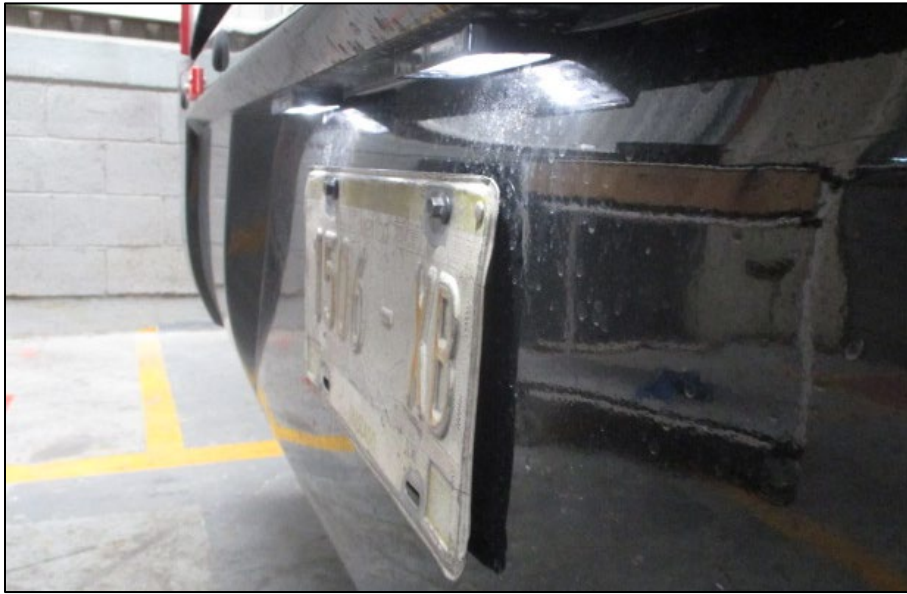
Figure 3: Overall view of the license plate in its normal position, showing that it is fully illuminated.

- A license plate installed in its normal position is fully illuminated by the lamps. Consequently, the license plate lamps fulfill its main purpose, as identified by prior NHTSA findings, to ensure that law enforcement personal and the general public can uniquely identify vehicles by assuring the legibility of the license plate in low lighting conditions.

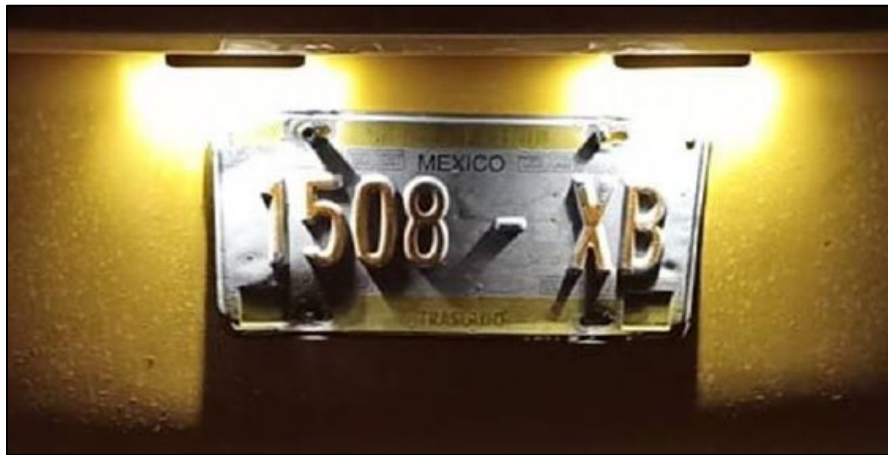
Figure 4: Overall view of the license plate in its normal position, showing that it is fully illuminated.
