### National Highway Traffic Safety Administration

### Denial of Motor Vehicle Defect Petition, DP13–001

**ACTION:** Denial of petition for a defect investigation.

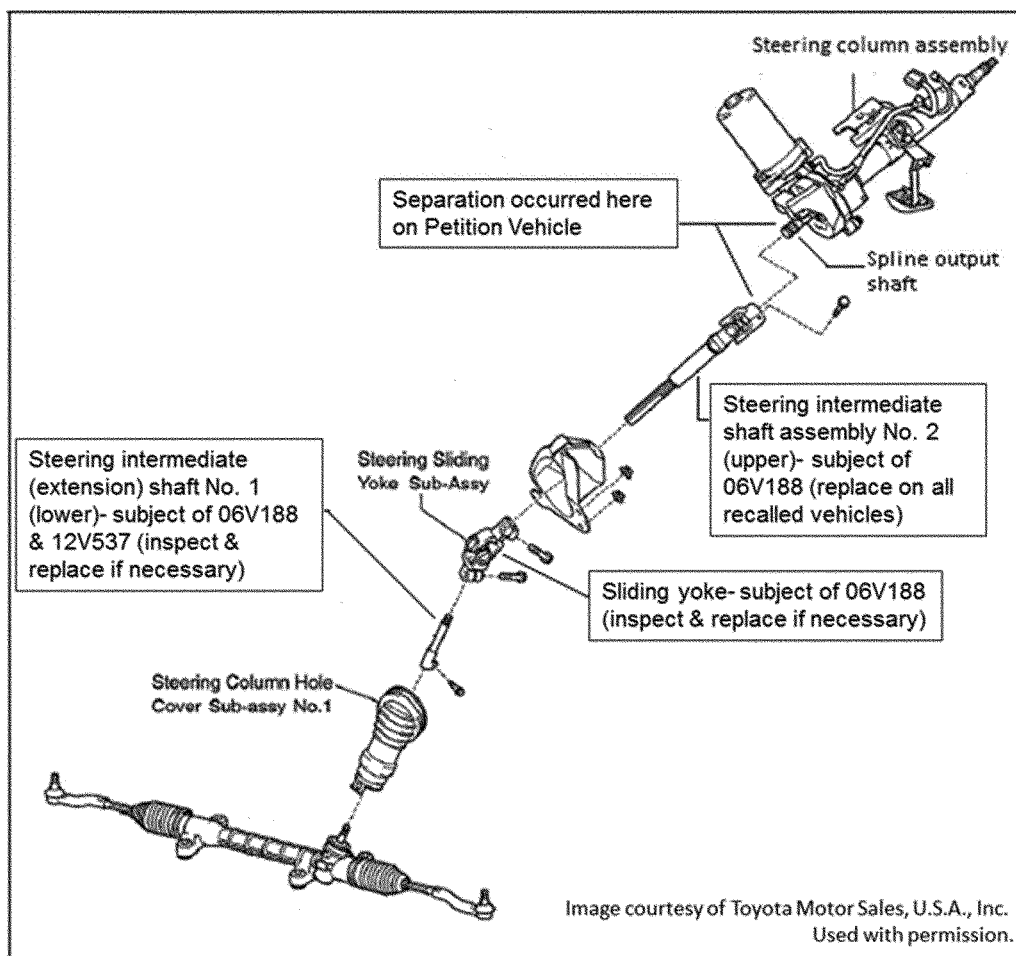
The subject power steering system is assisted by an electric motor linked to the steering column assembly. Steering torque is transmitted to a manual steering rack via a pair of intermediate shafts and a sliding yoke assembly. Image 1 below illustrates the Toyota Prius steering system and the components subjected to the two recalls.
