**OCAS-DRI-CIB-19-03  
NEW CAR ASSESSMENT PROGRAM  
CRASH IMMINENT BRAKE SYSTEM CONFIRMATION TEST**

**2019 Lincoln Continental**

**DYNAMIC RESEARCH, INC.**  
355 Van Ness Avenue, STE 200  
Torrance, California 90501

**Final Report**

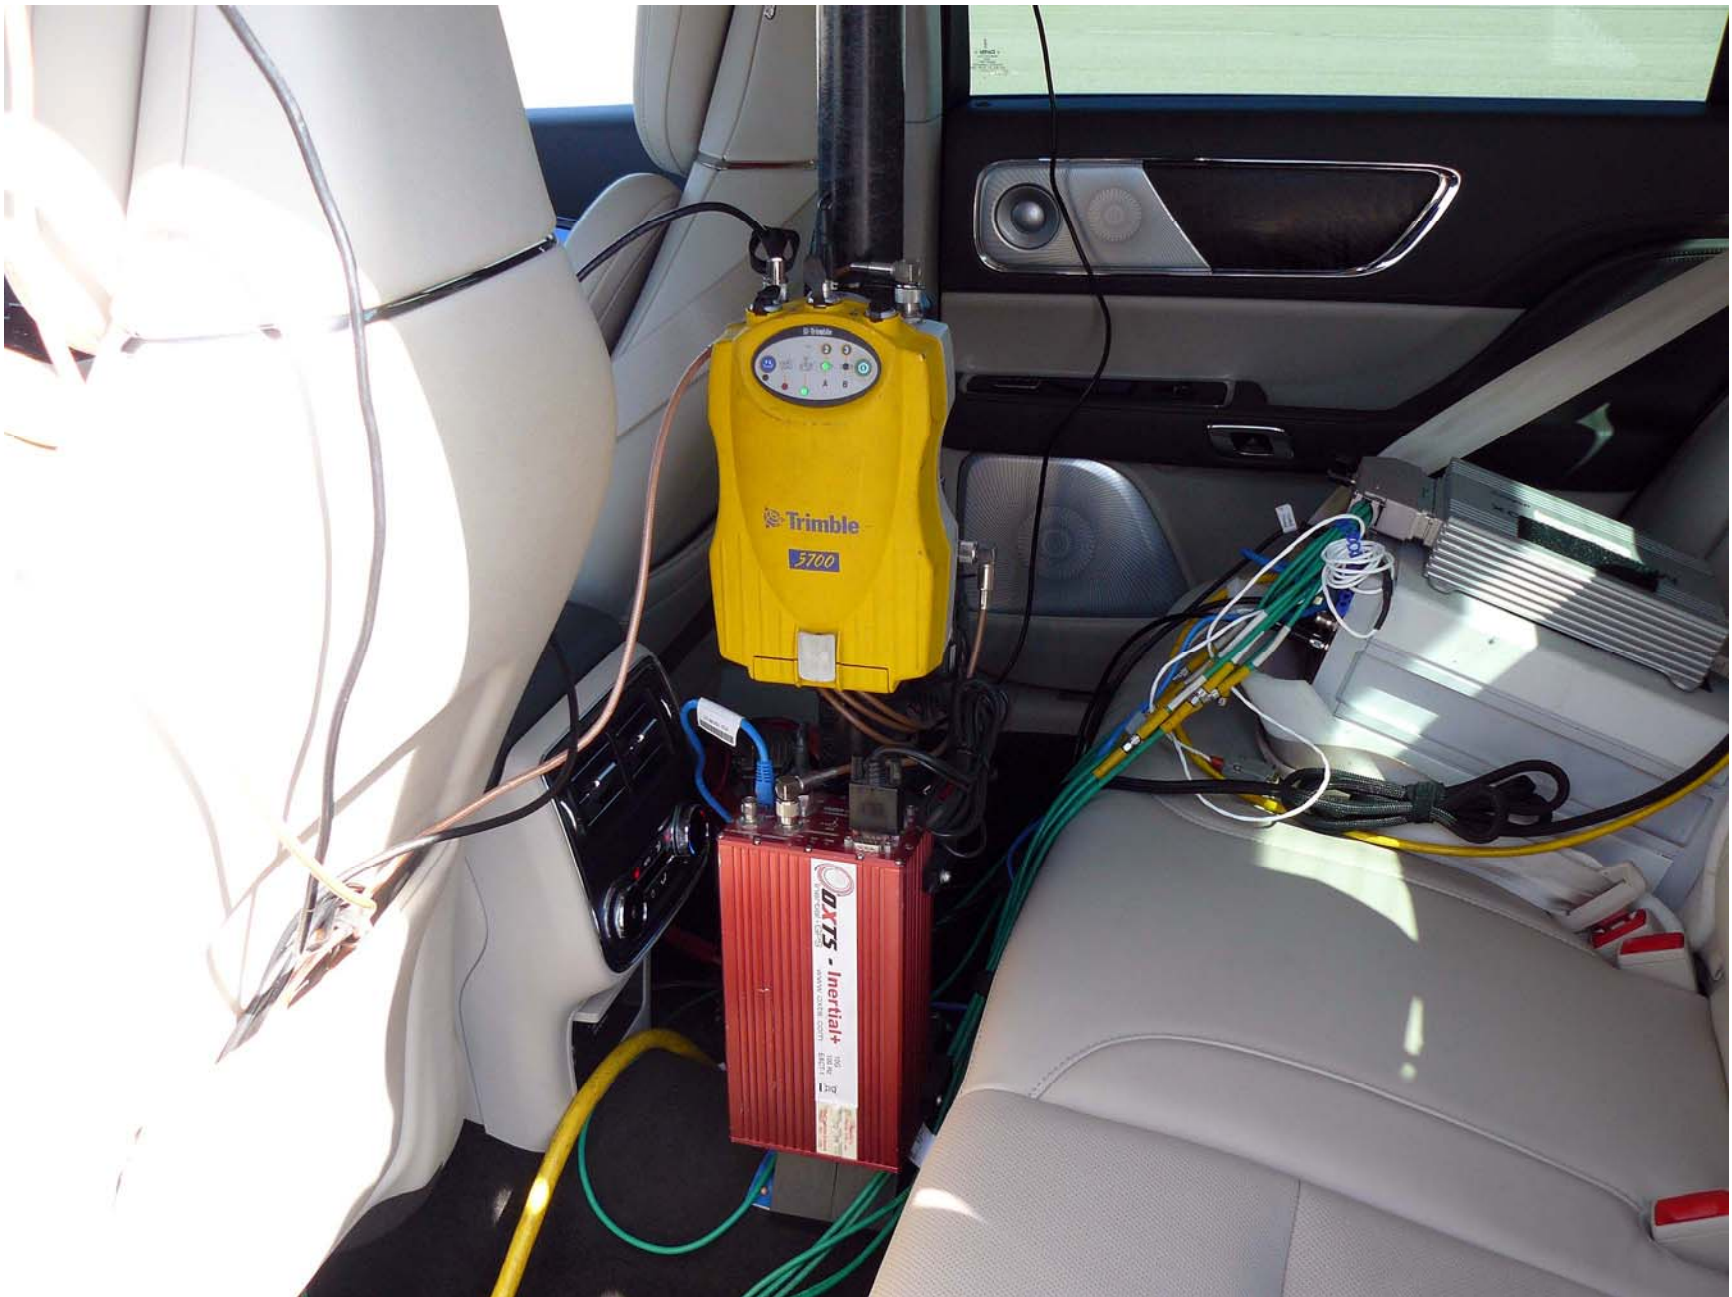
Figure A10. DGPS, Inertial Measurement Unit and MicroAutoBox Installed in Subject Vehicle

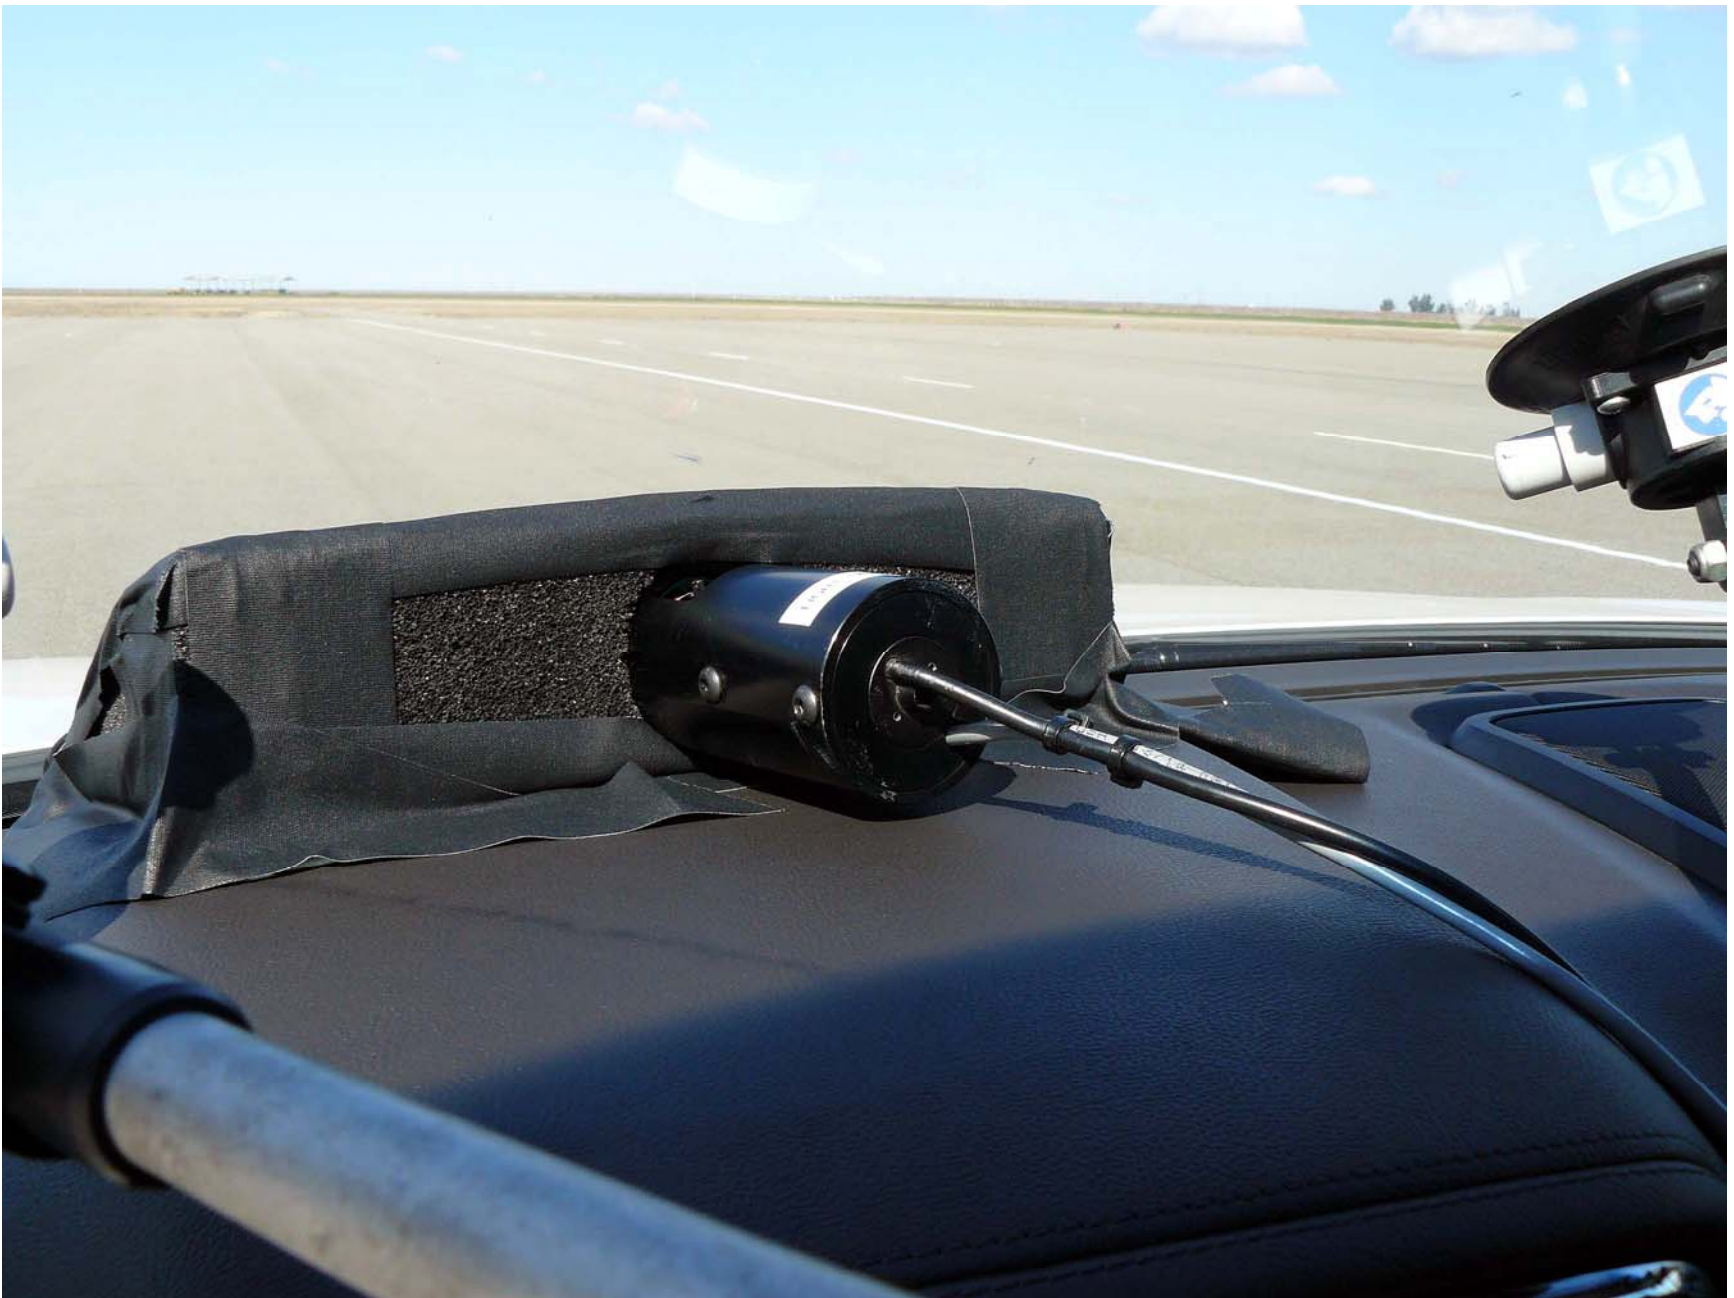
Figure A11. Sensor for Detecting Visual Alert

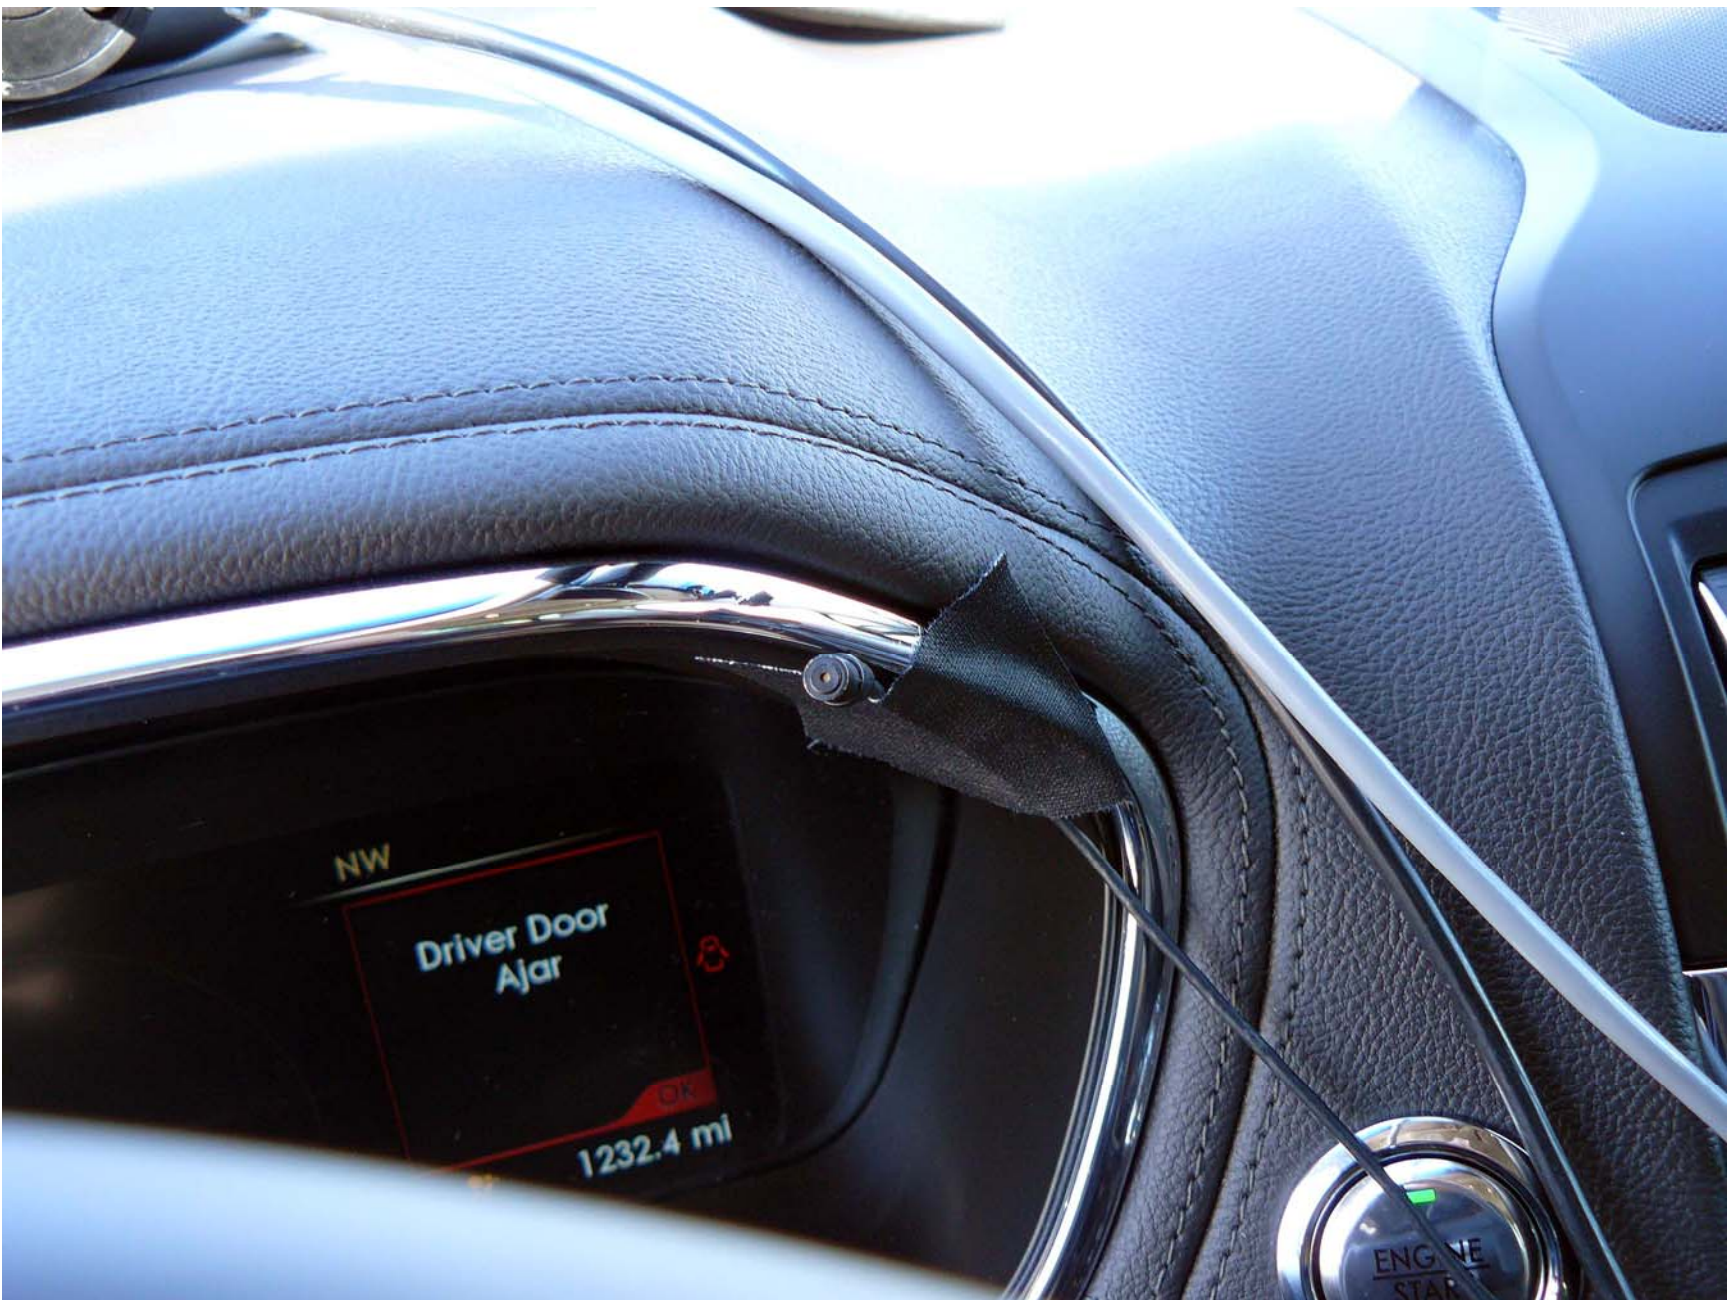
Figure A12. Sensor for Auditory Visual Alert

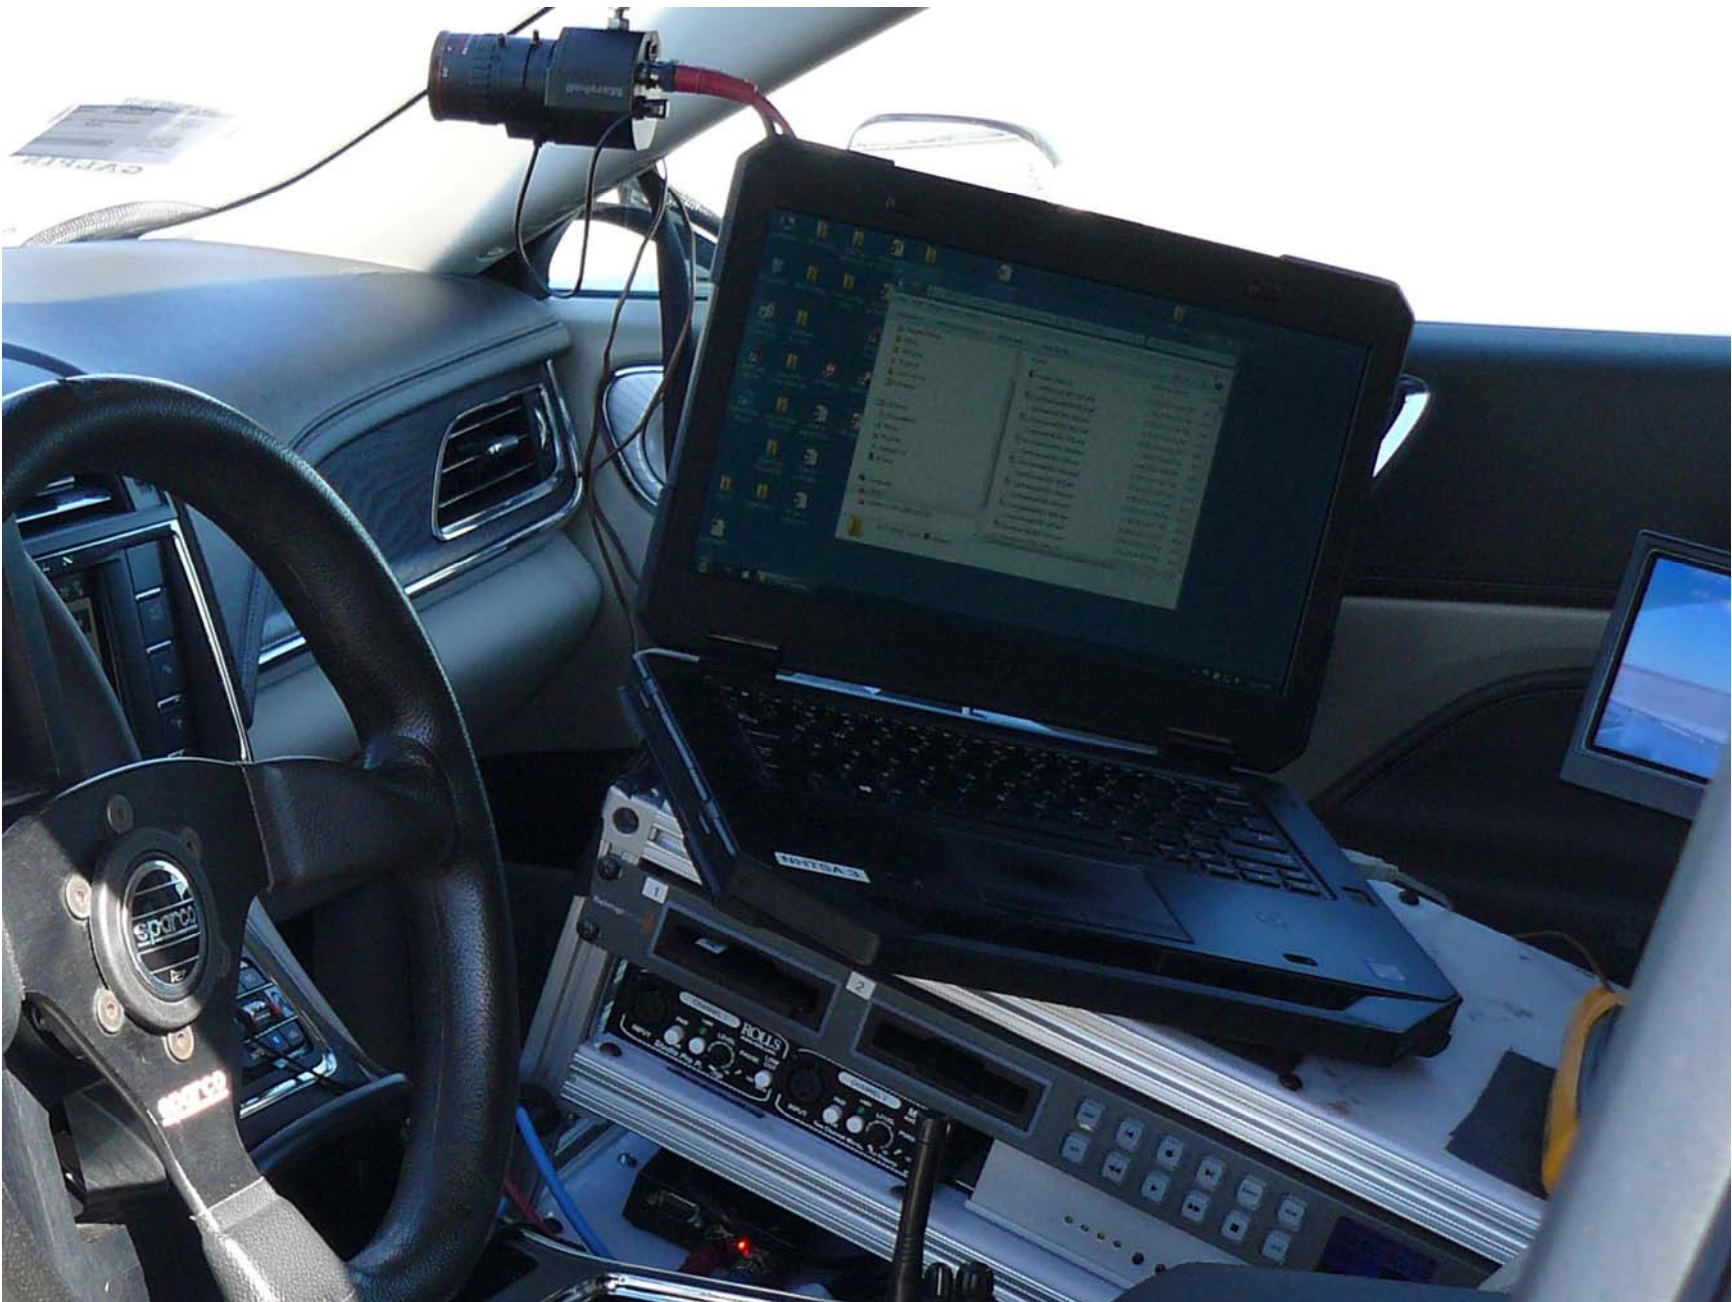
Figure A13. Computer Installed in Subject Vehicle

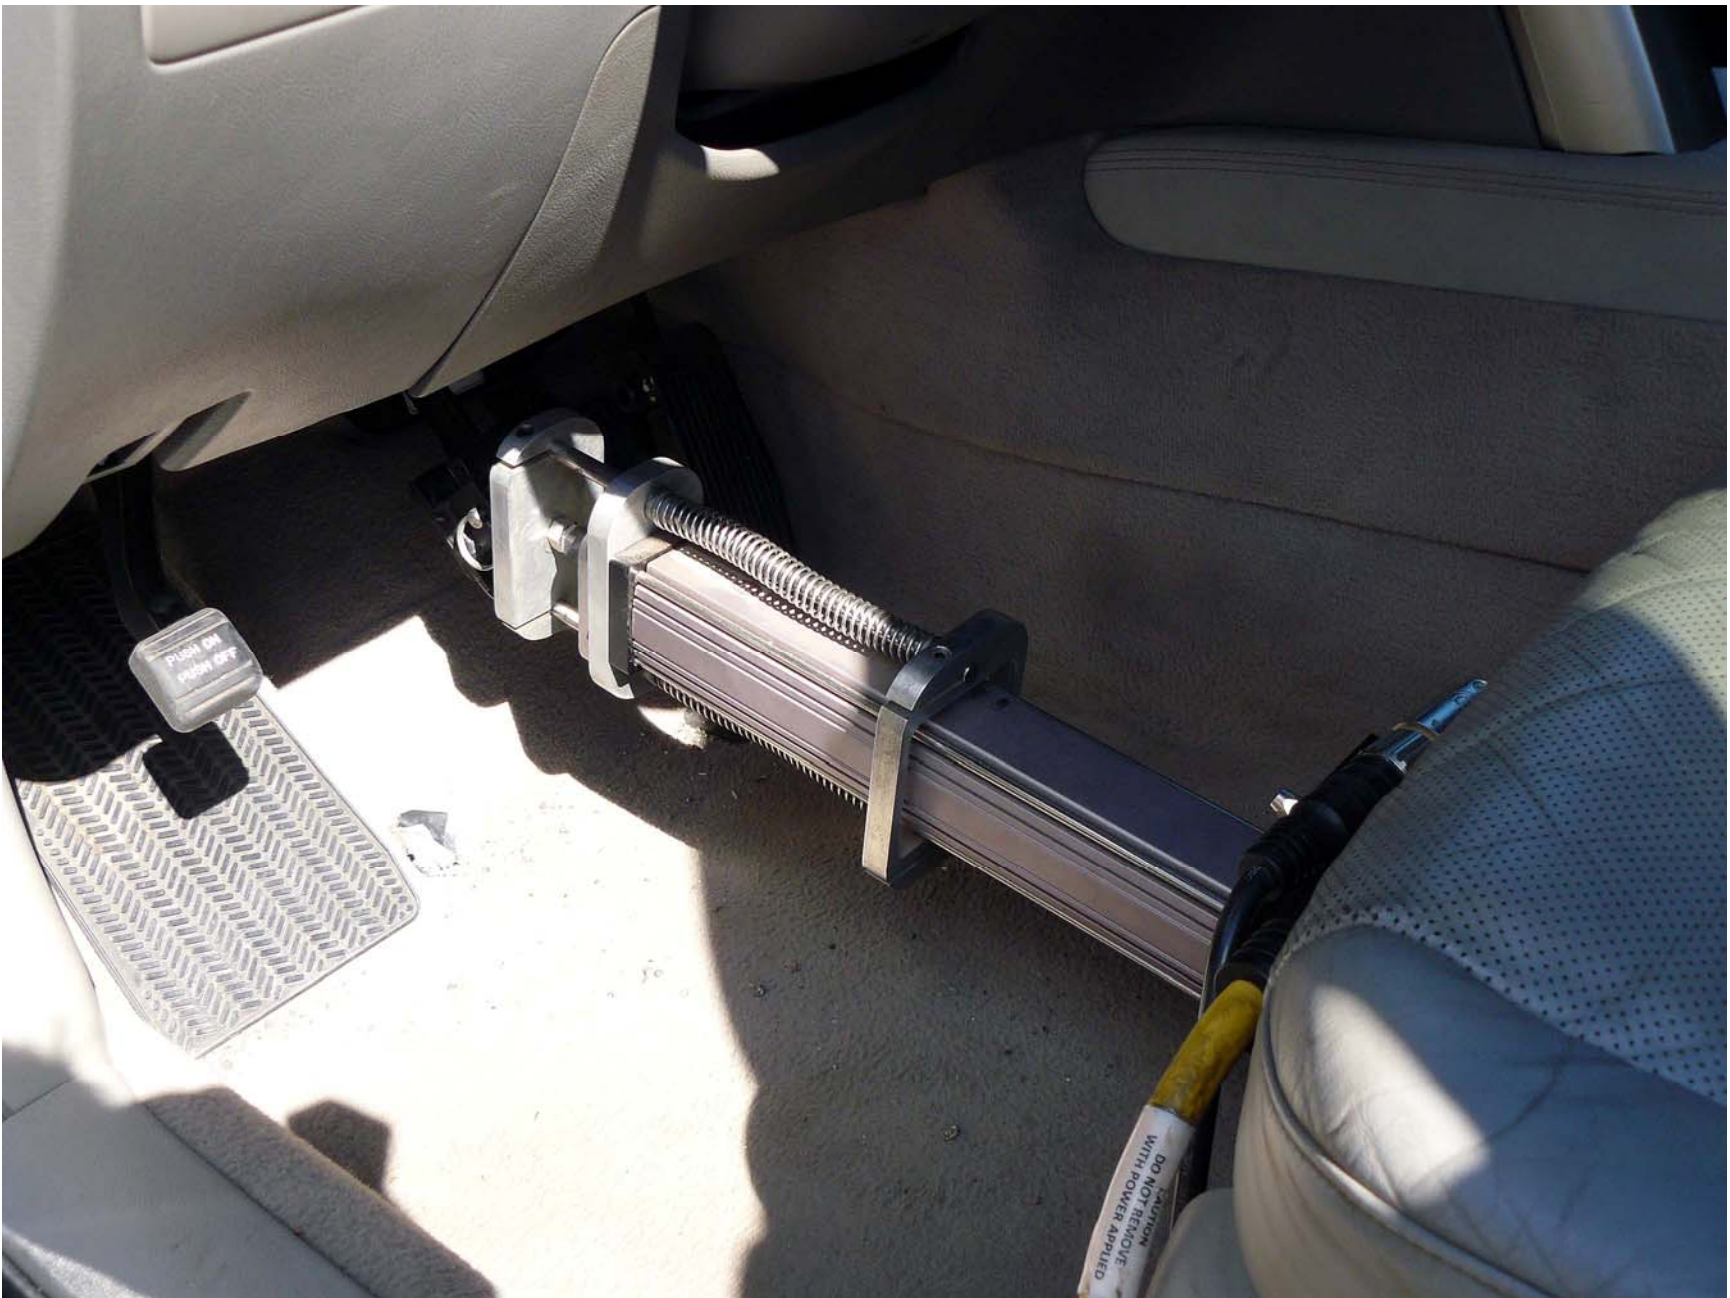
Figure A14. Brake Actuator Installed in POV System

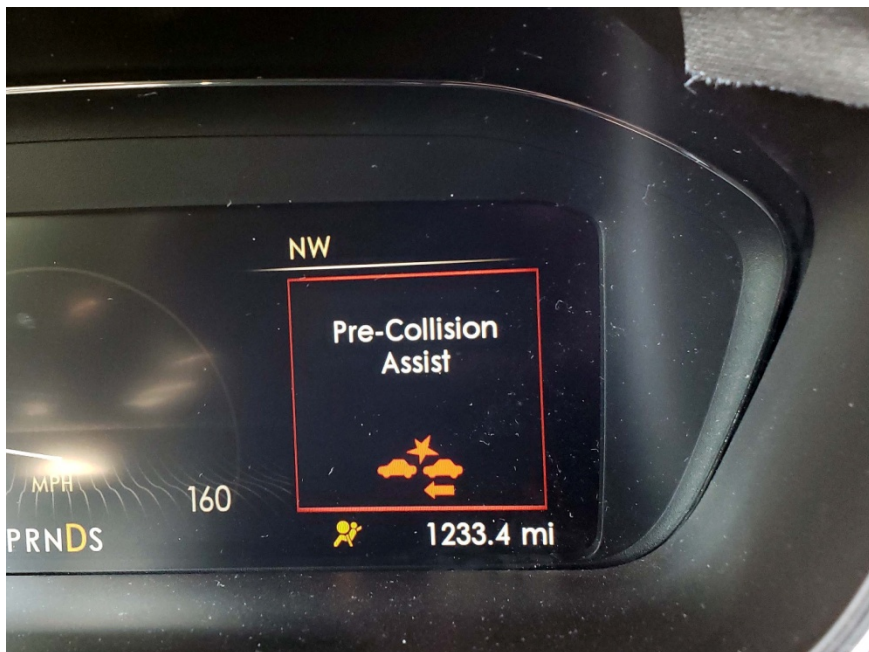
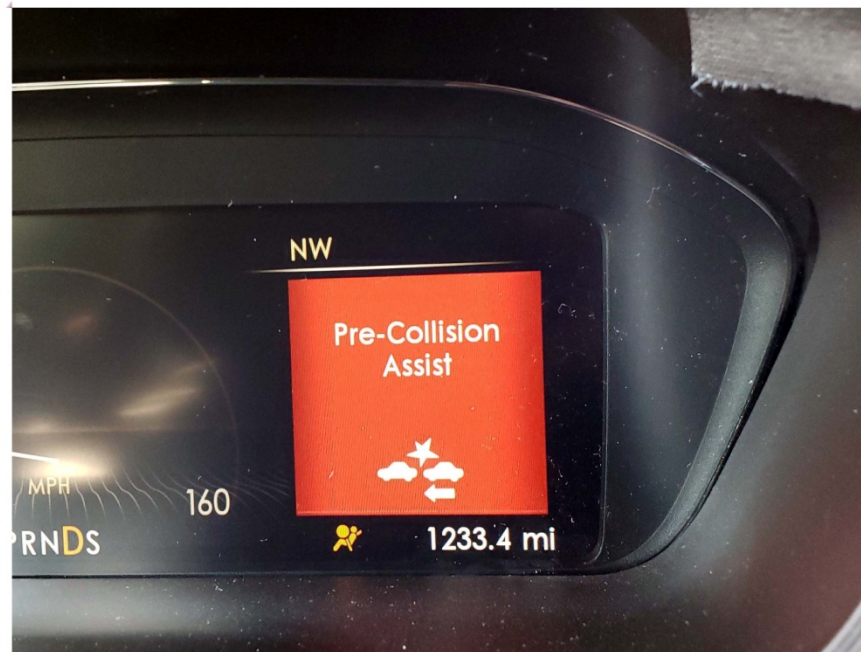
Figure A16. Instrument Panel AEB Visual Alert

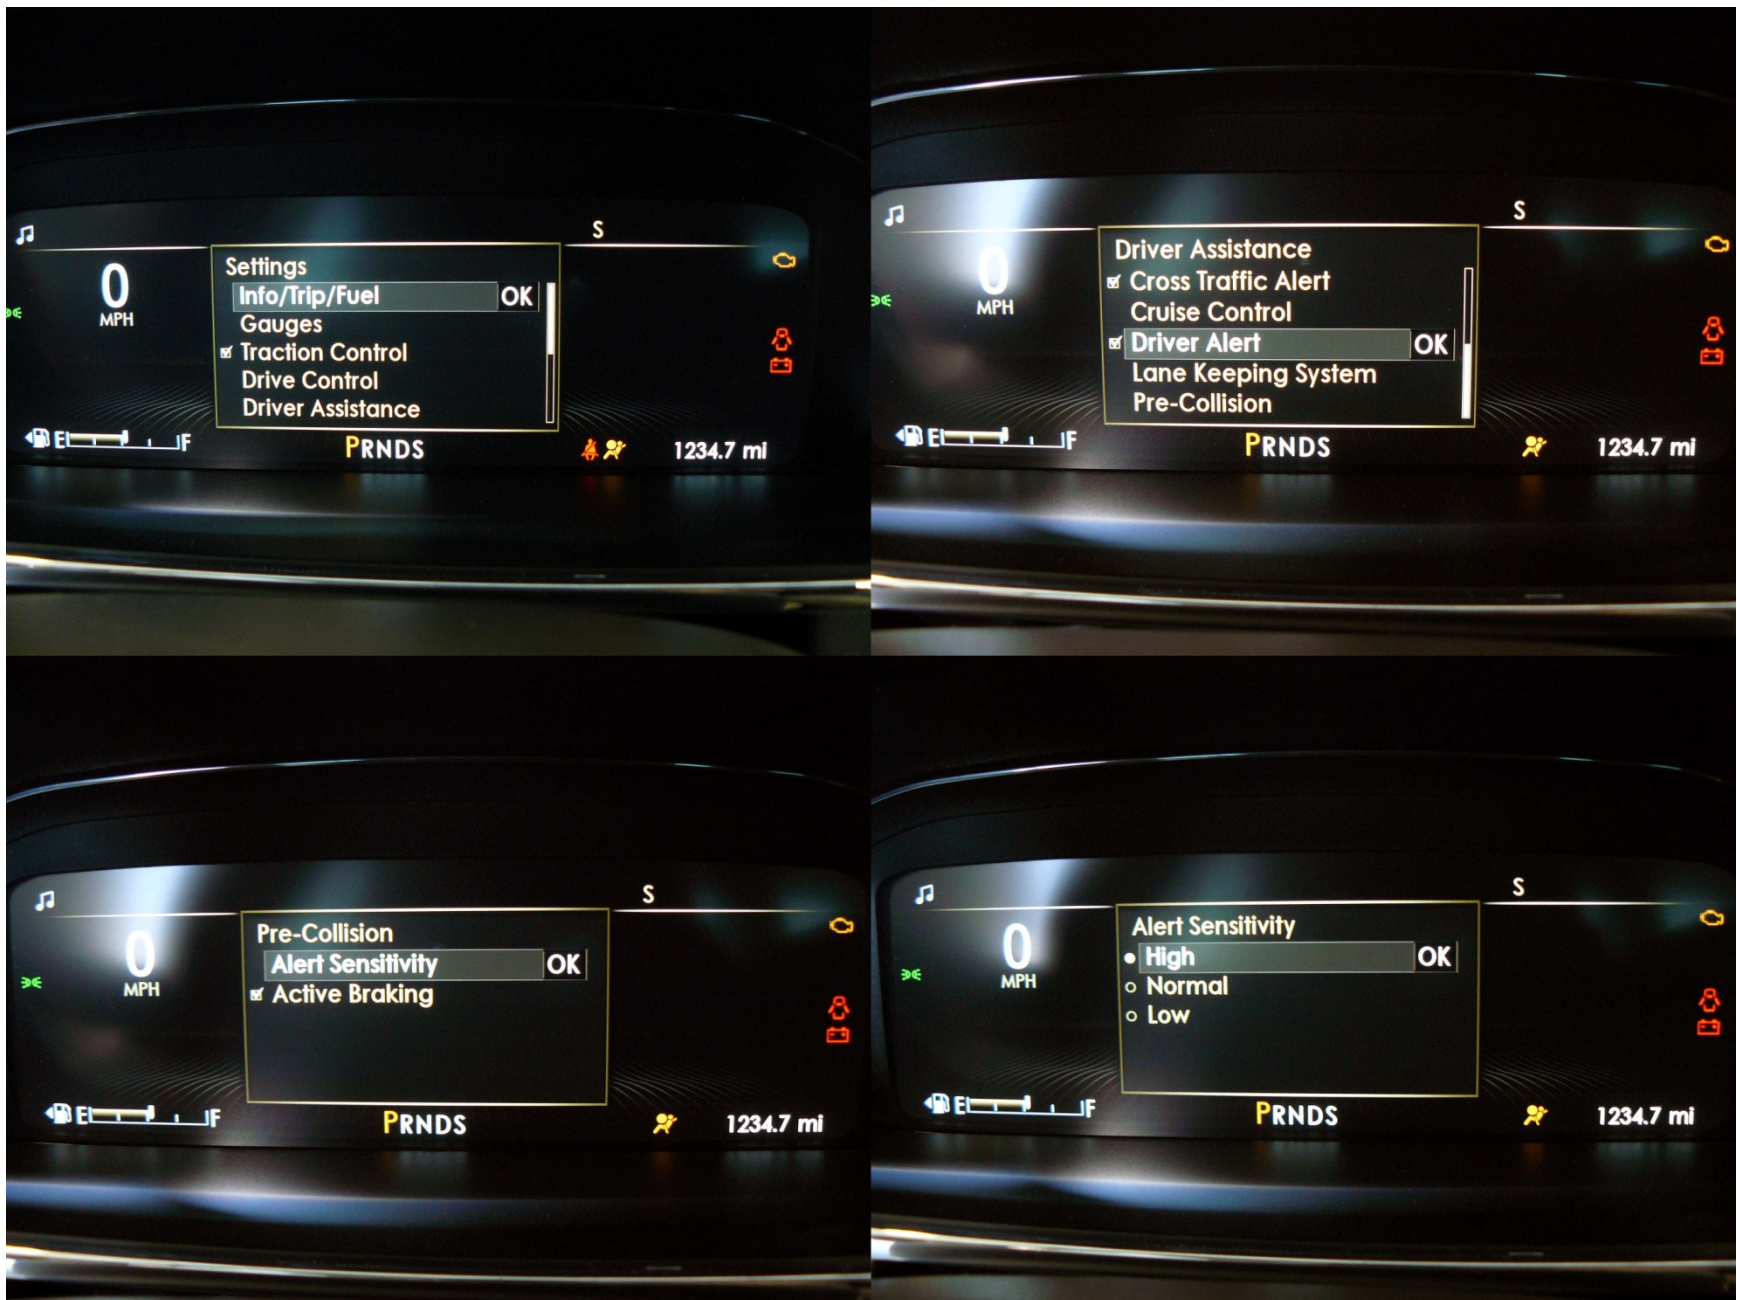
Figure A17. AEB Setup Menus

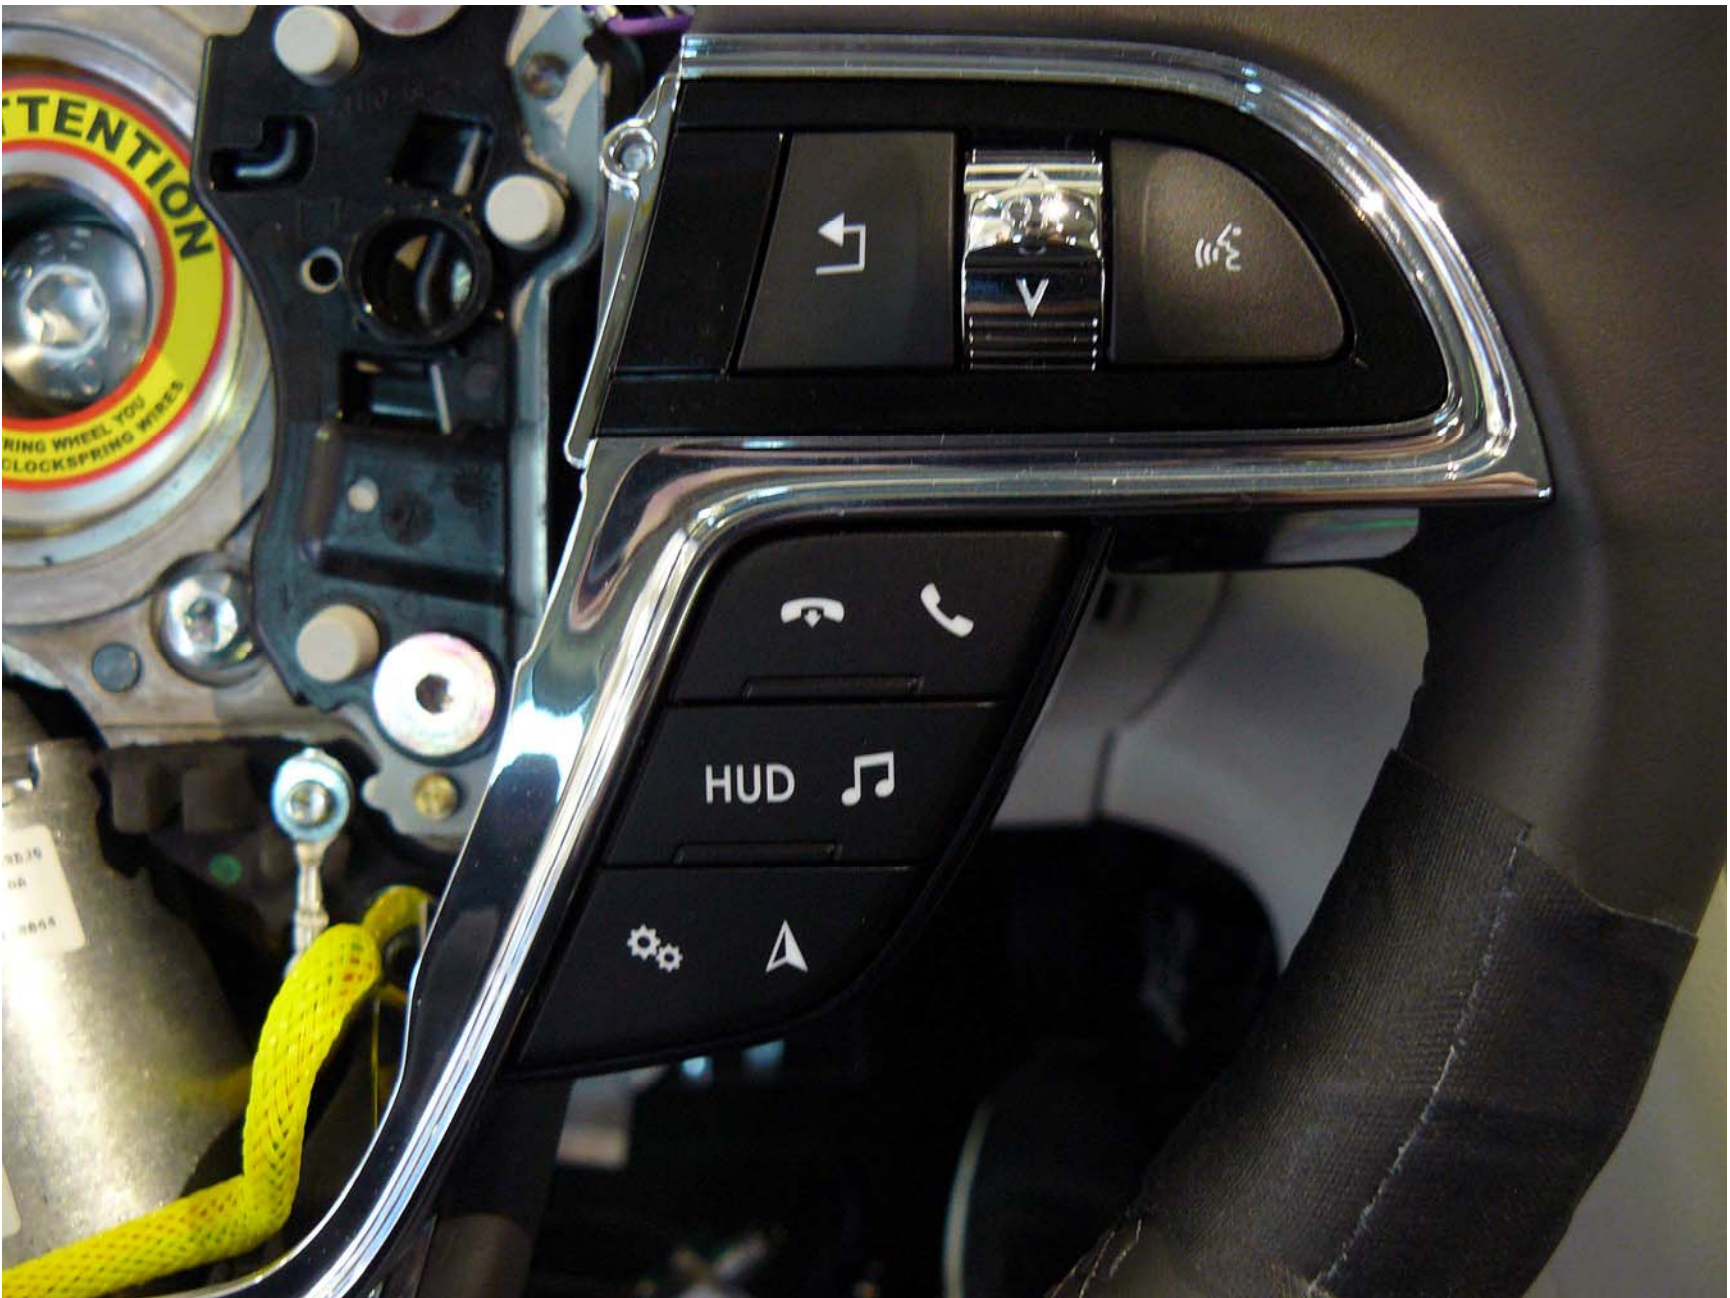
Figure A18. Steering Wheel Mounted Controls for Changing Parameters
