**REPORT NUMBER: NCAP-MGA-2019-018**

**NEW CAR ASSESSMENT PROGRAM (NCAP)  
Frontal Barrier Impact Test**

**TOYOTA MOTOR CORPORATION  
2019 Toyota Corolla Hatchback SE 5-Door Hatchback  
NHTSA No.: O20195100**

**FINAL REPORT**

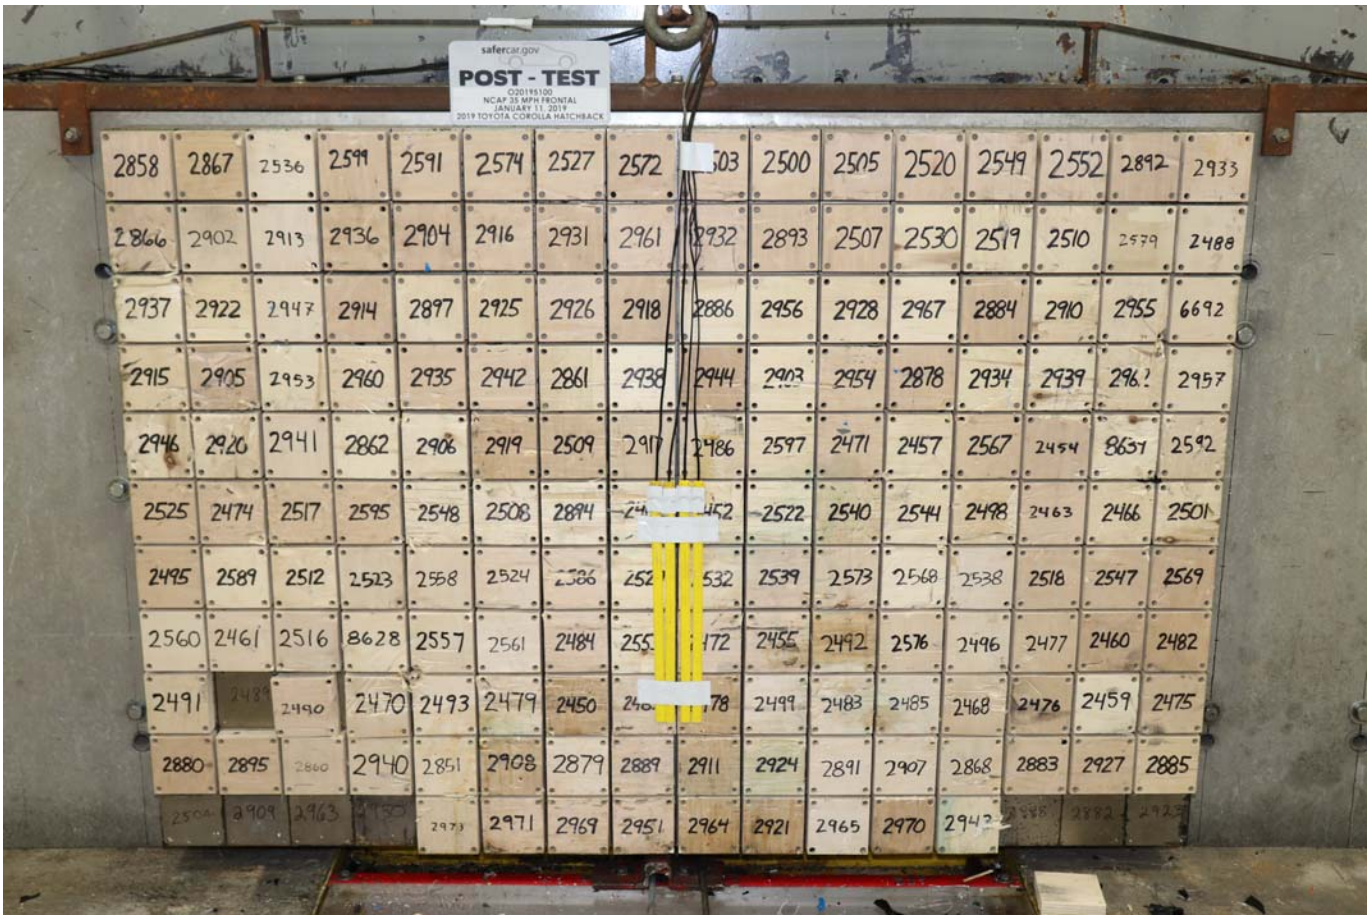
Photo No. 003 - Post-Test Load Cell Wall

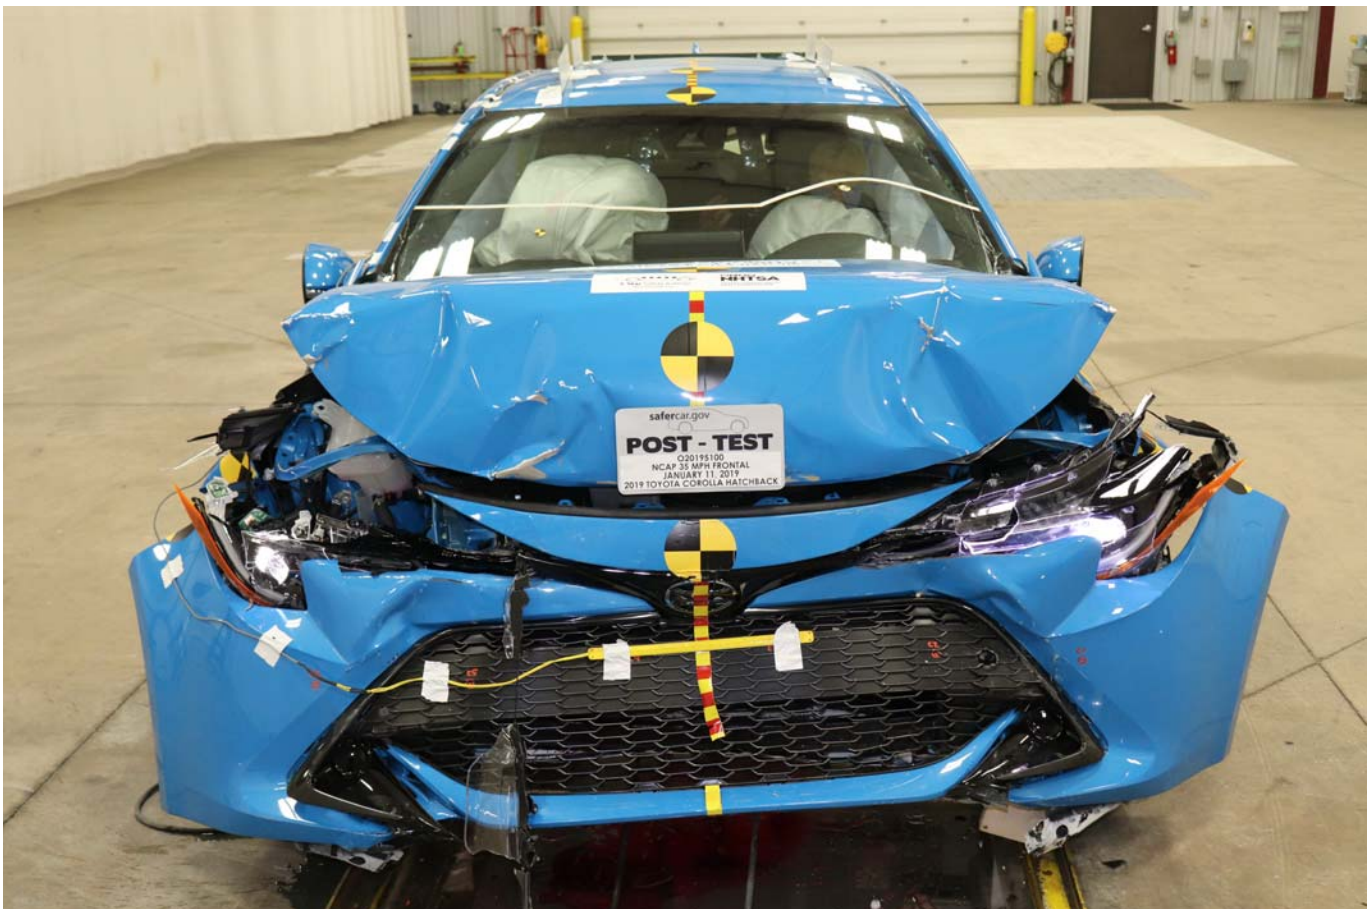
Photo No. 009 - Post-Test Front View of Test Vehicle

The maximum static crush of the vehicle was 506 mm located at the vehicle centerline and both the driver and passenger side doors remained closed during the impact event and were operable after the impact.

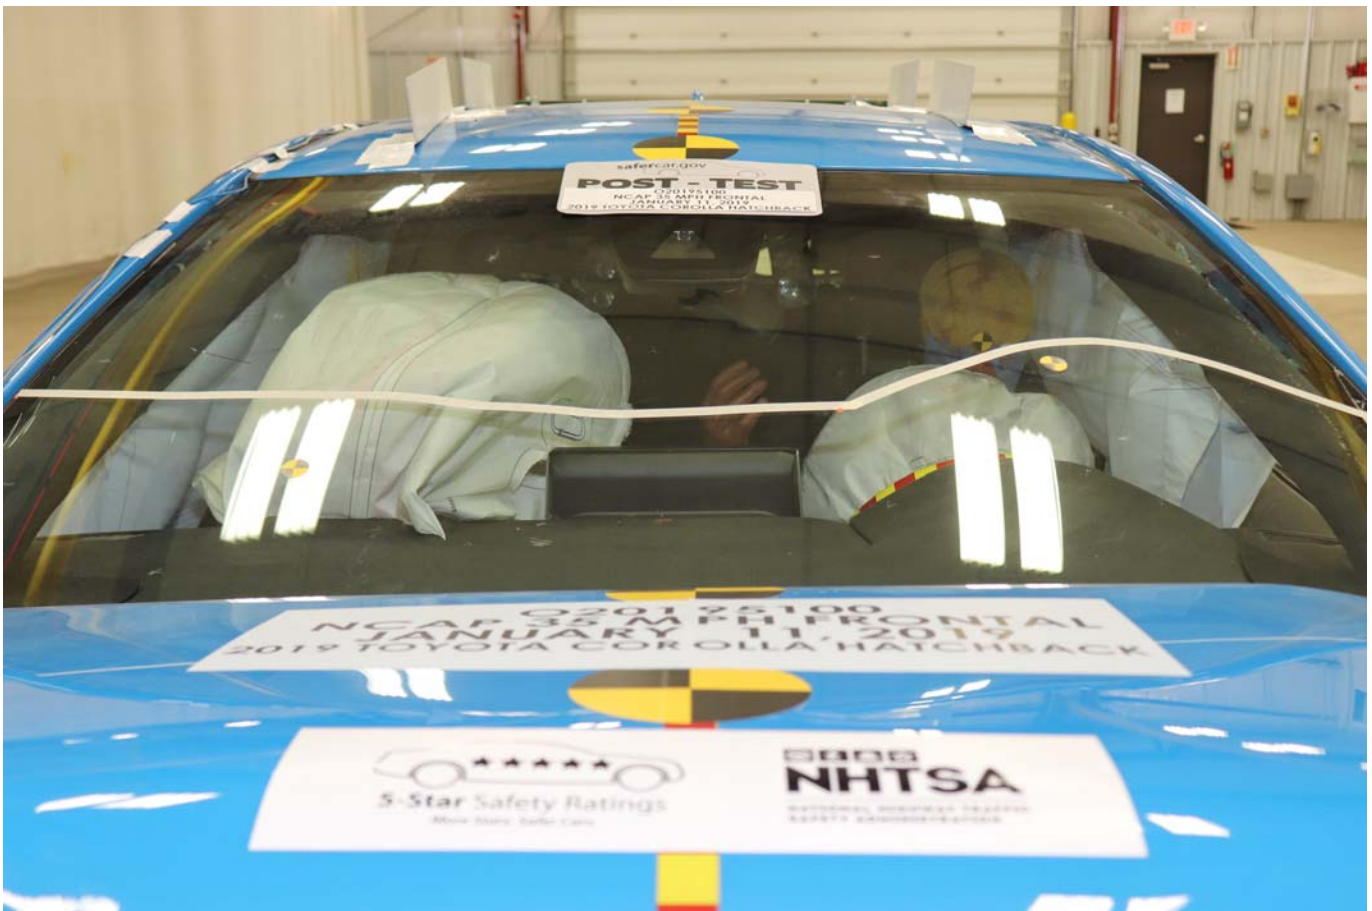
Photo No. 019 - Post-Test Windshield View

Critical Areas of Performance	Observations and Conclusions
Windshield Damage	Lower left windshield cracked by hood corner
Window Damage	None
Other Notable Effects	None

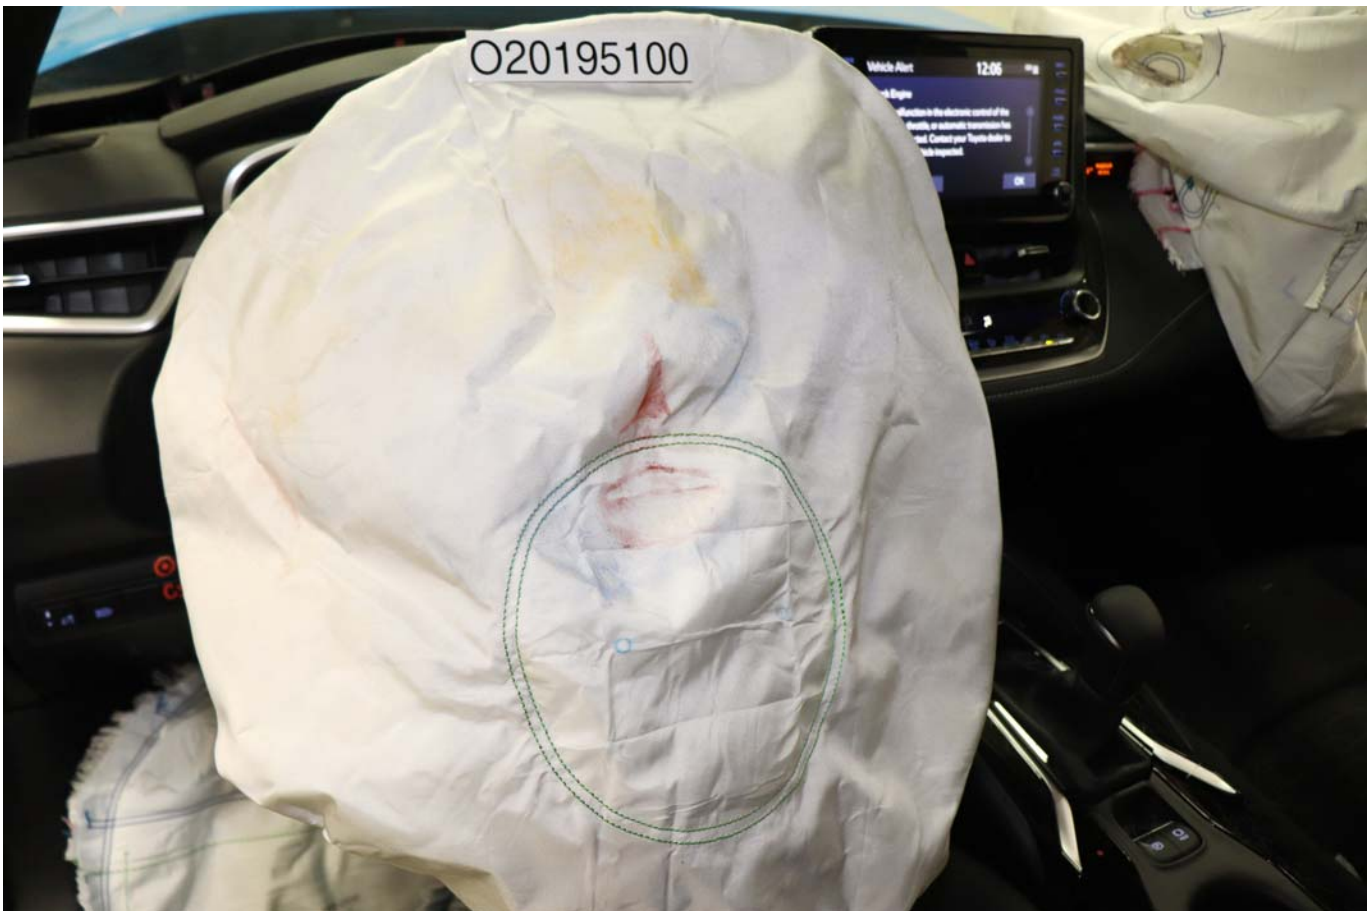
Photo No. 047 - Post-Test Driver Dummy Contact with Airbag

The driver's visible contact points were as follows: The driver's head contacted the airbag. The driver's head also contacted the headrest. The driver's knees contacted the knee airbag. The passenger's visible contact points were as follows: The passenger's head contacted the airbag. The passenger's head also contacted the headrest. The passenger's knees contacted the glove box.

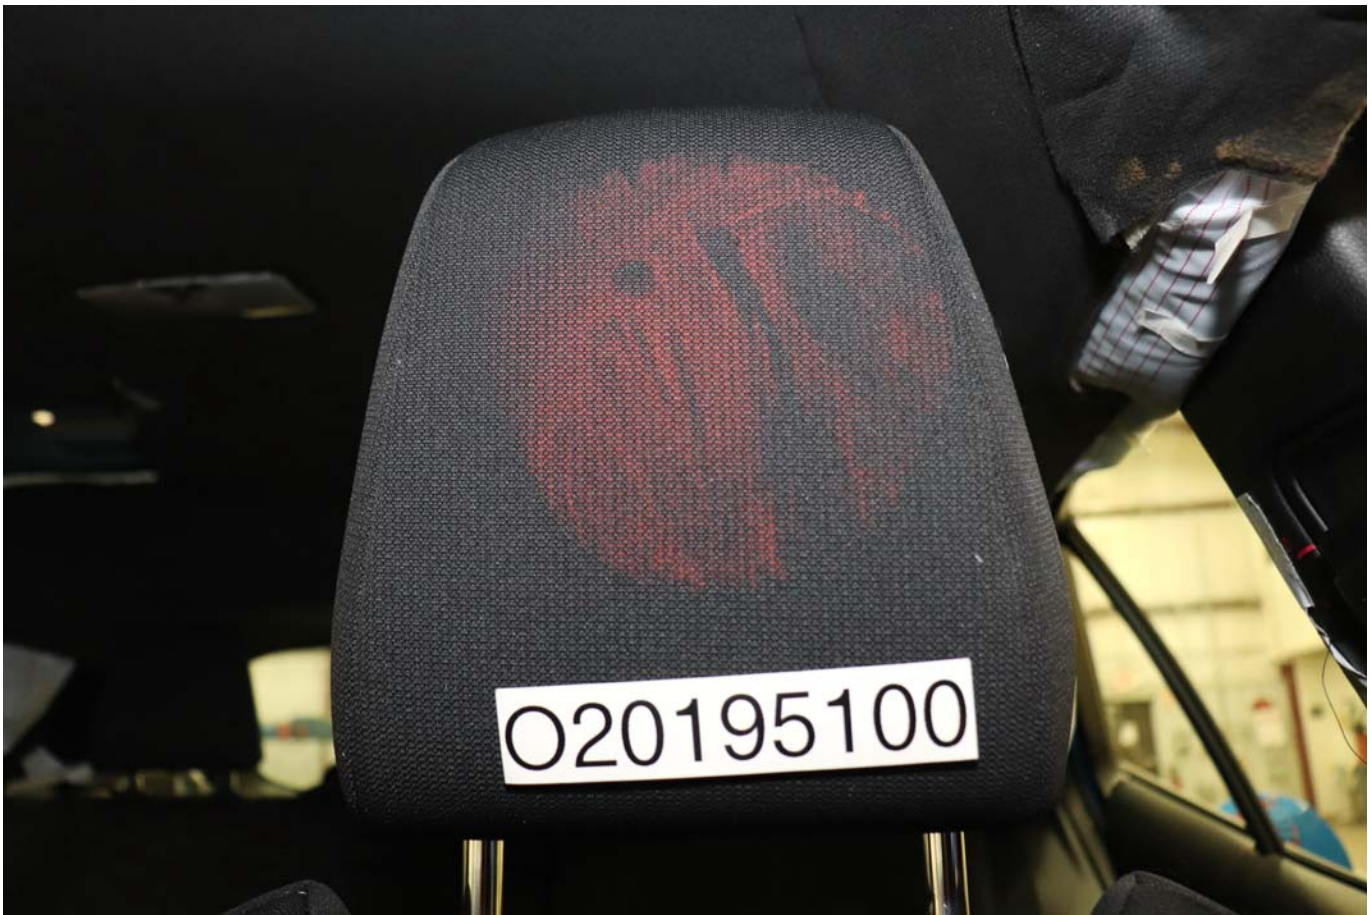
Photo No. 048 - Post-Test Driver Dummy Contact with Headrest

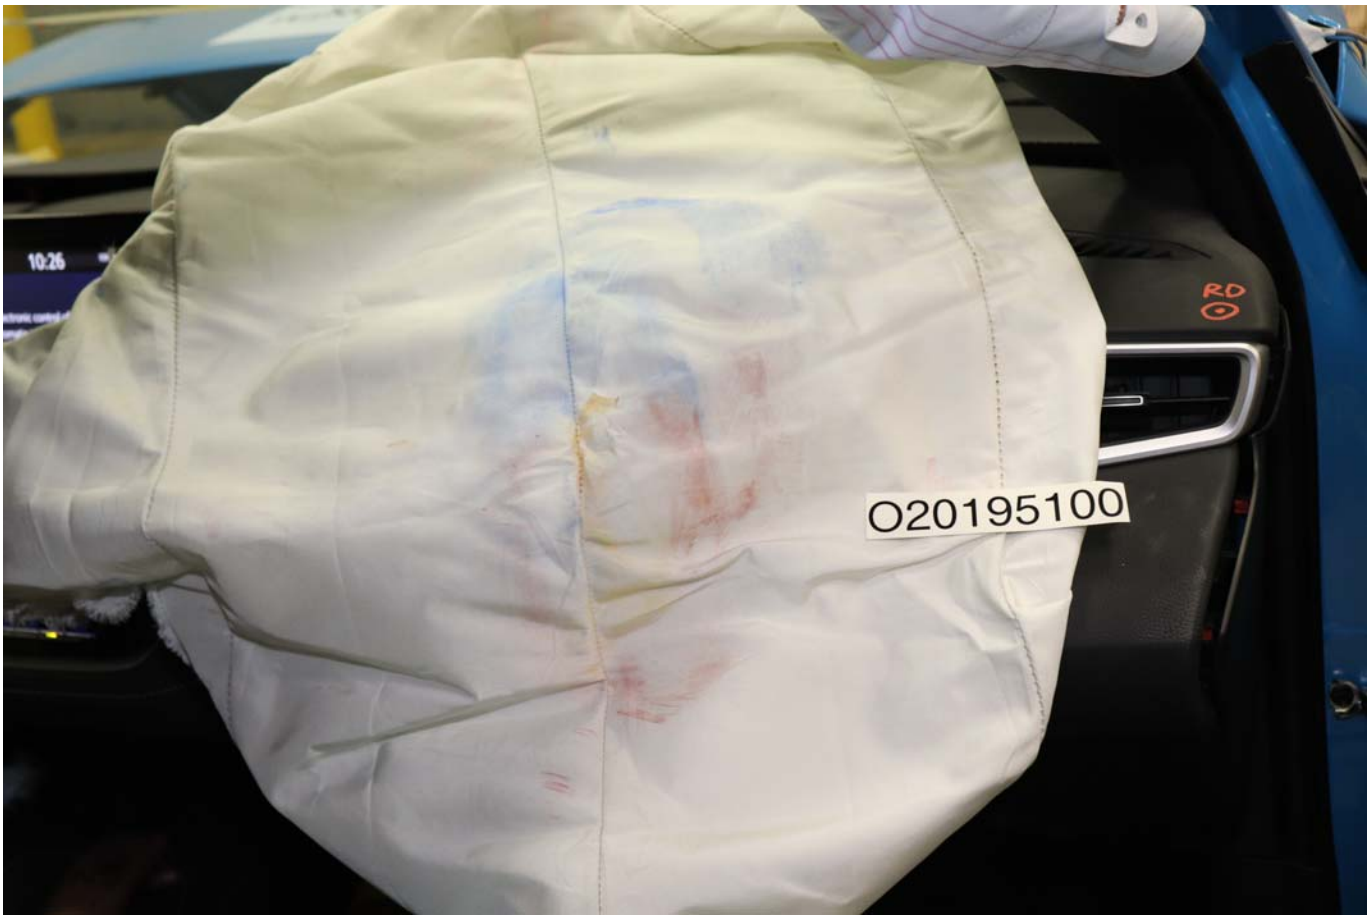
Photo No. 068 - Post-Test Passenger Dummy Contact with Airbag

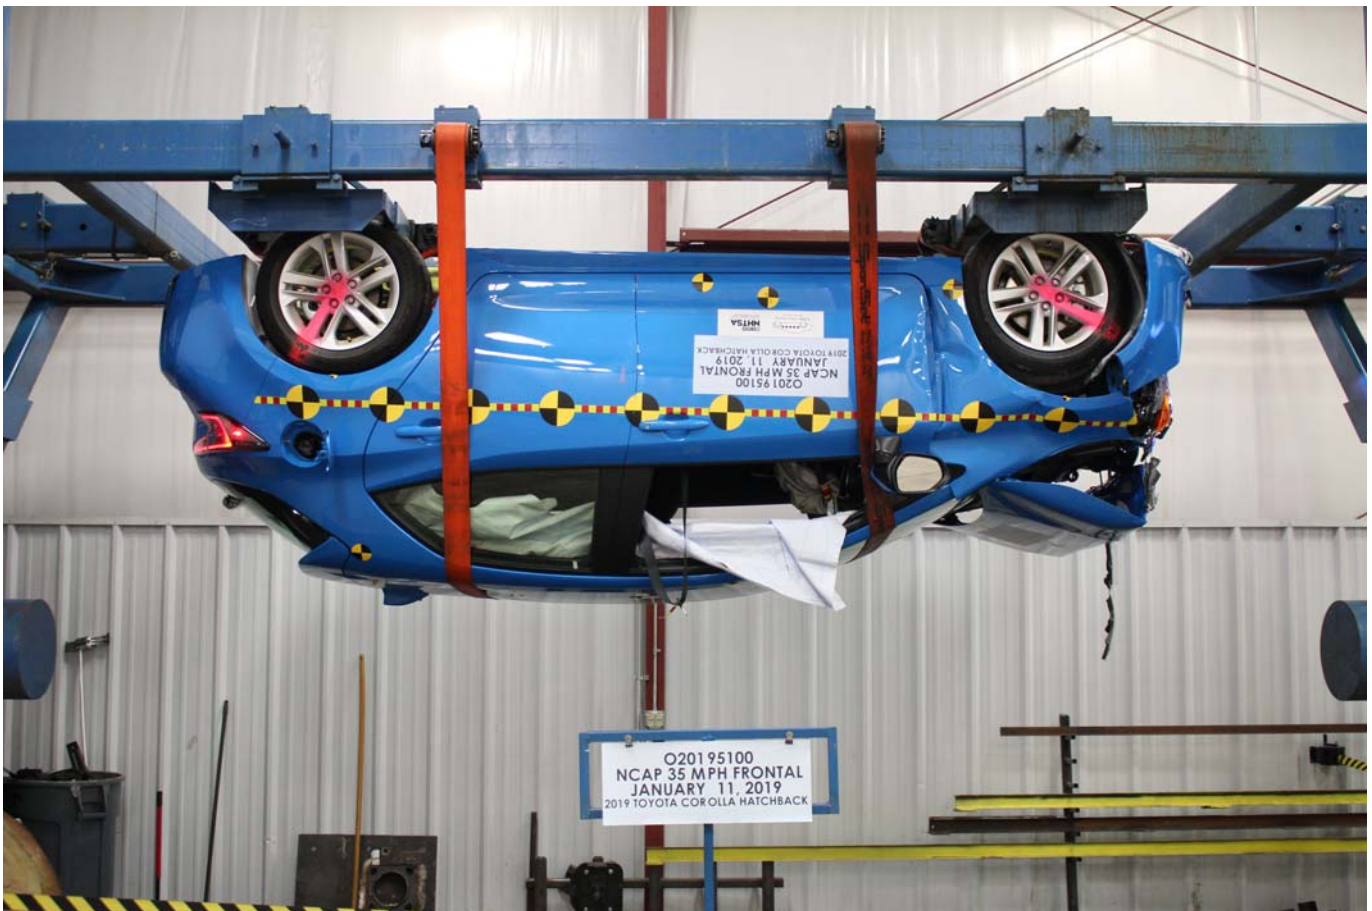
Photo No. 075 - Vehicle at 180 Degrees on Static Rollover Device

There was 100 percent windshield retention and no intrusion into the protected zone of the windshield during the event. There was no Stoddard Solvent leakage after the event or during any phase of the static rollover.

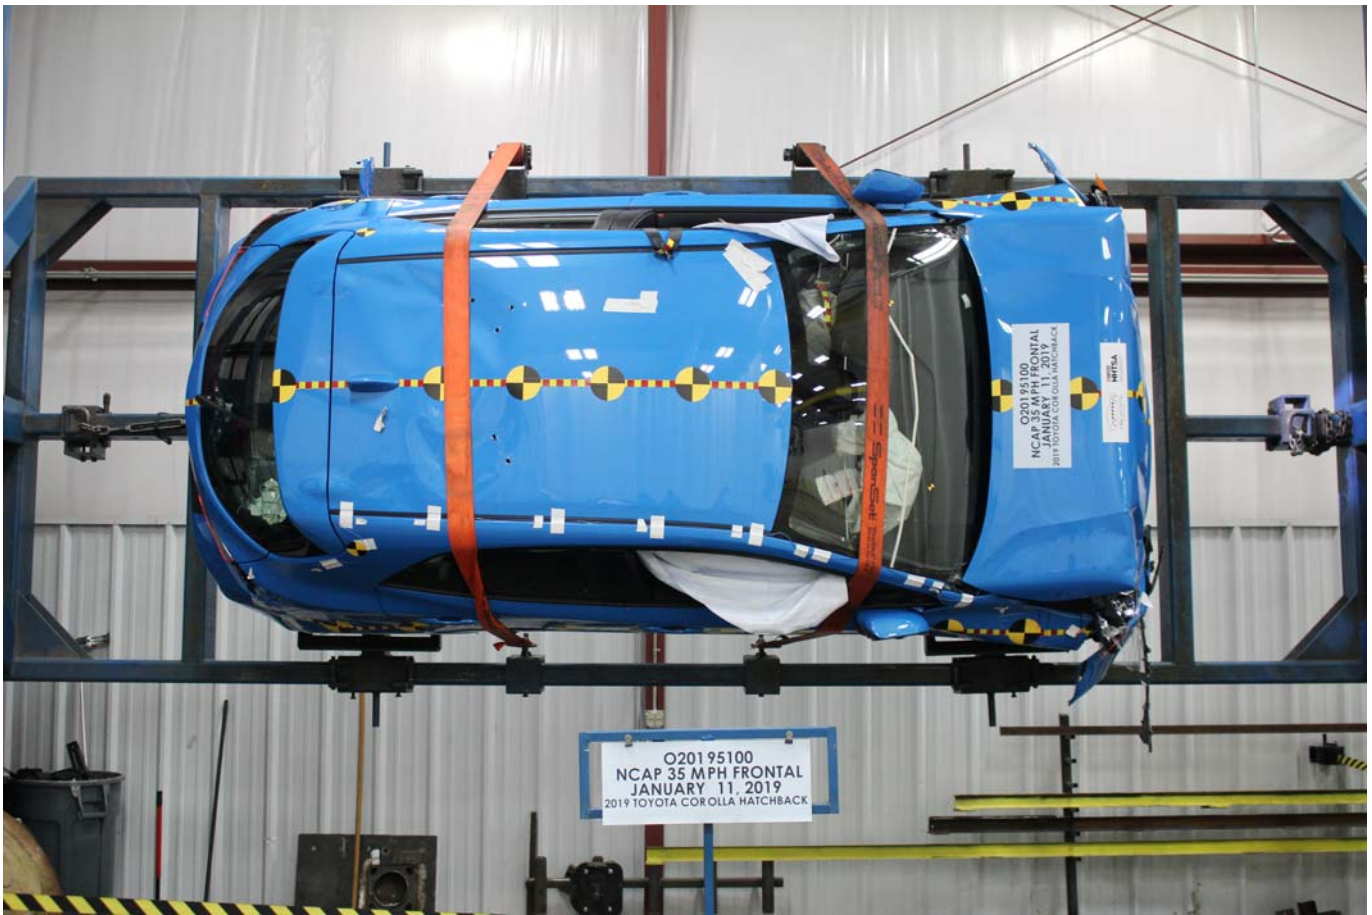
Photo No. 076 - Vehicle at 270 Degrees on Static Rollover Device

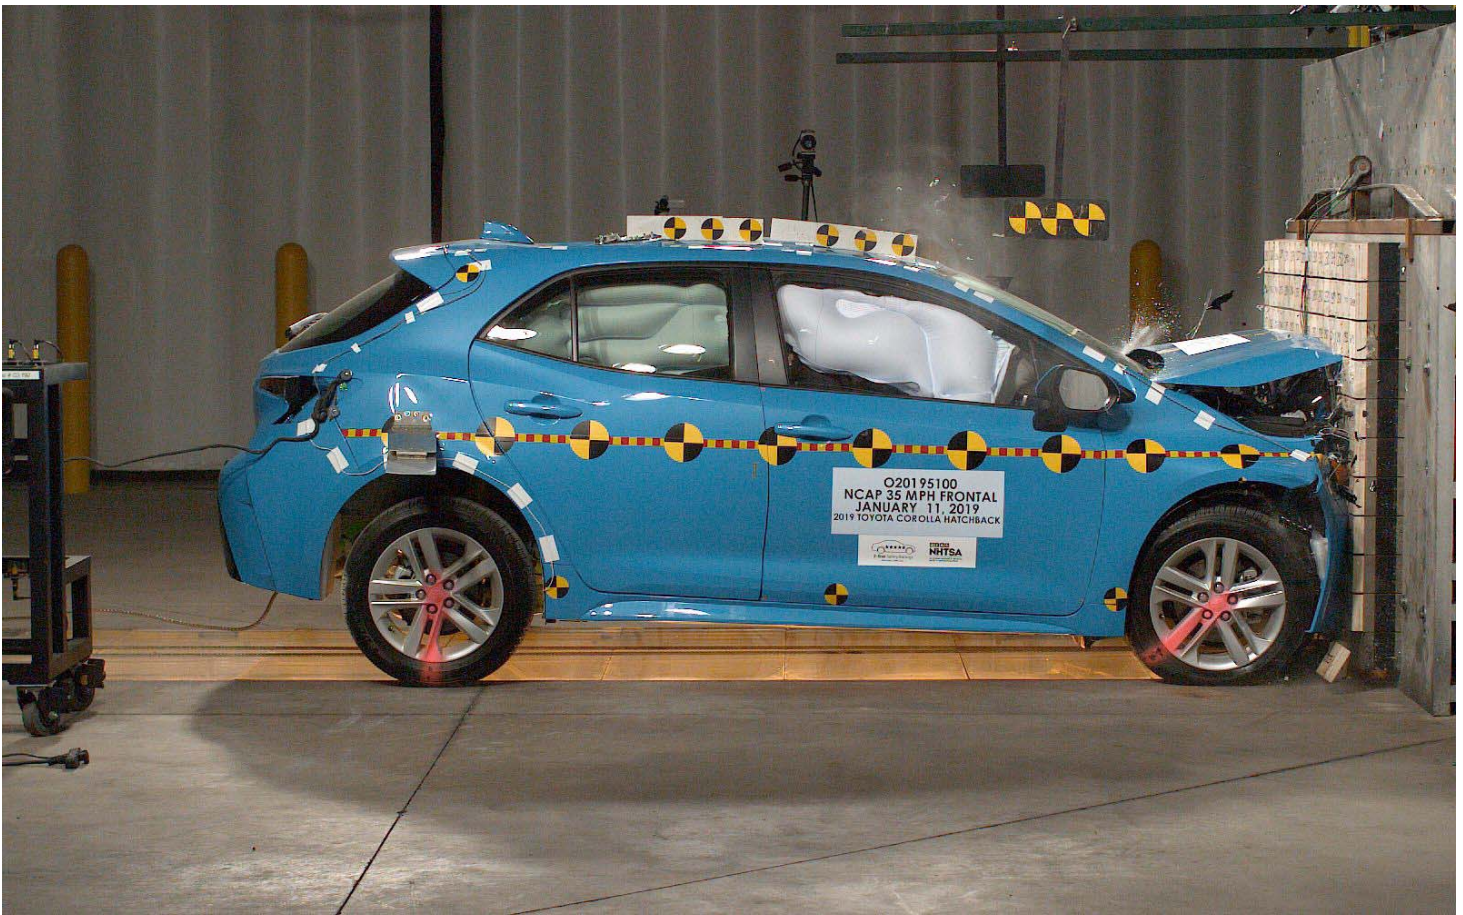
Photo No. 078 - 2019 Toyota Corolla Hatchback SE 5-Door Hatchback Frontal Impact Event
