REPORT NUMBER: SPNCAP-CAL-19-002

**NEW CAR ASSESSMENT PROGRAM (NCAP)
SIDE IMPACT POLE TEST**

**Volkswagen de Mexico S.A. de C.V
2019 Volkswagen Jetta
Four Door Sedan**

FINAL REPORT

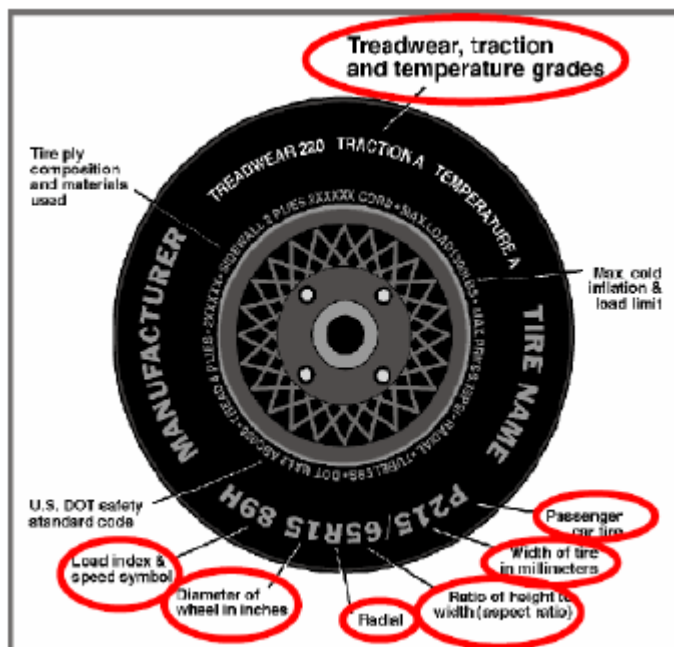
Collected for year, make, model, & VIN, all items circled in red, tire manufacturer and tire name.

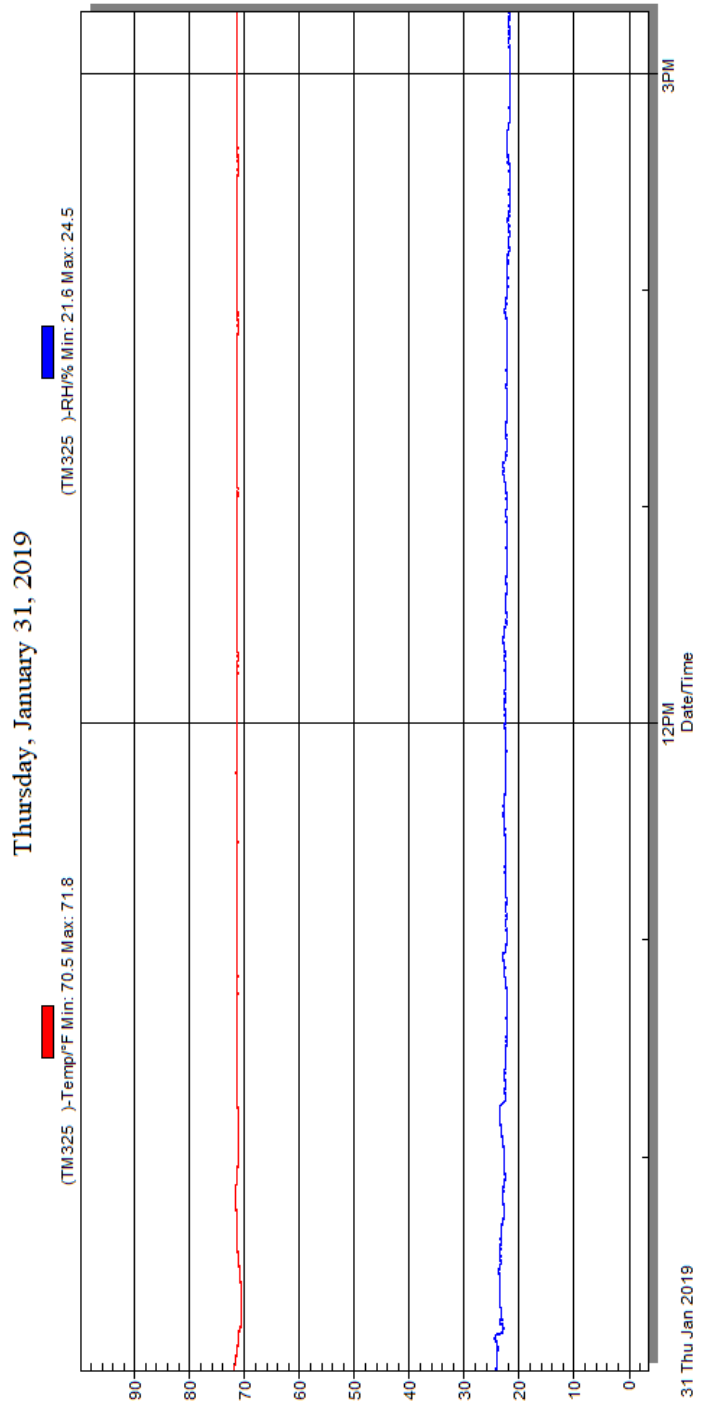
Temperature and Humidity Stabilization Chart / Data for Dummies and Test Vehicle

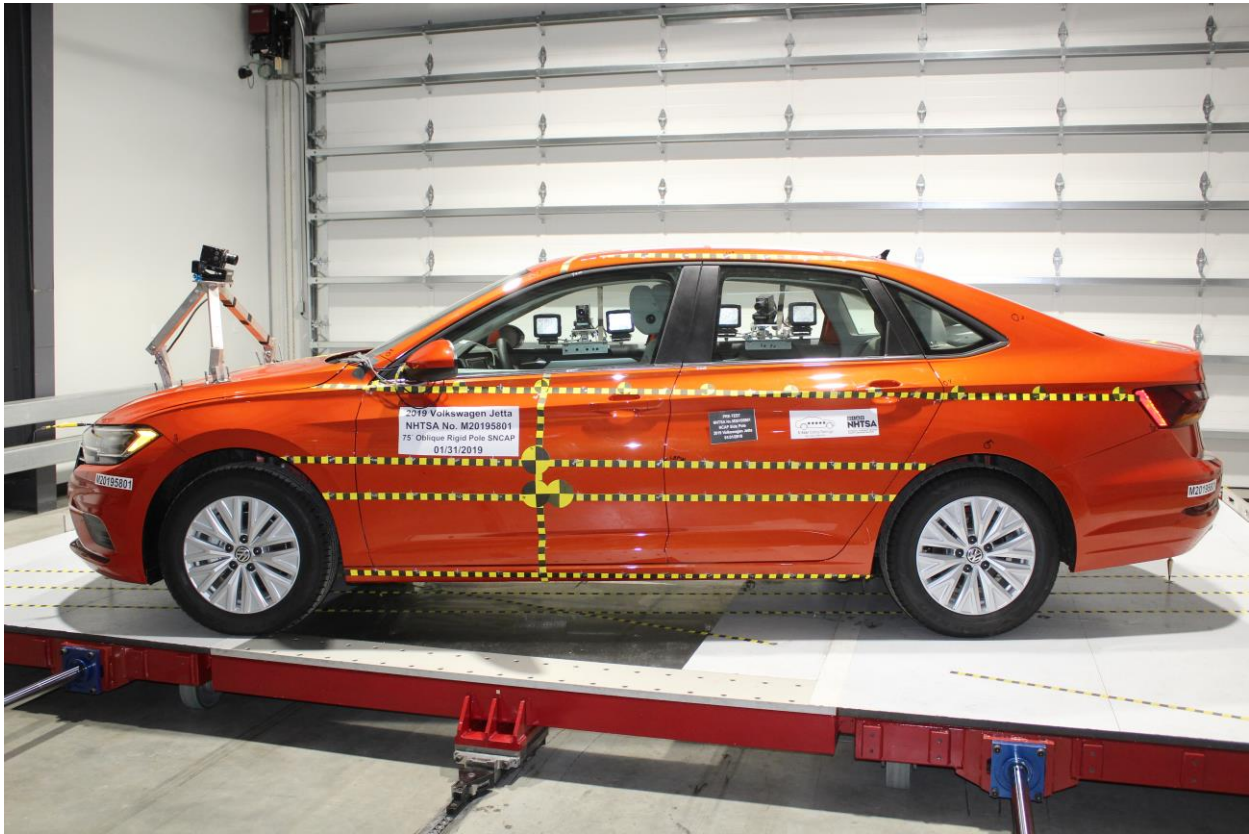
Figure A-6: Post-Test Left Front $\frac{3}{4}$ View of Test Vehicle

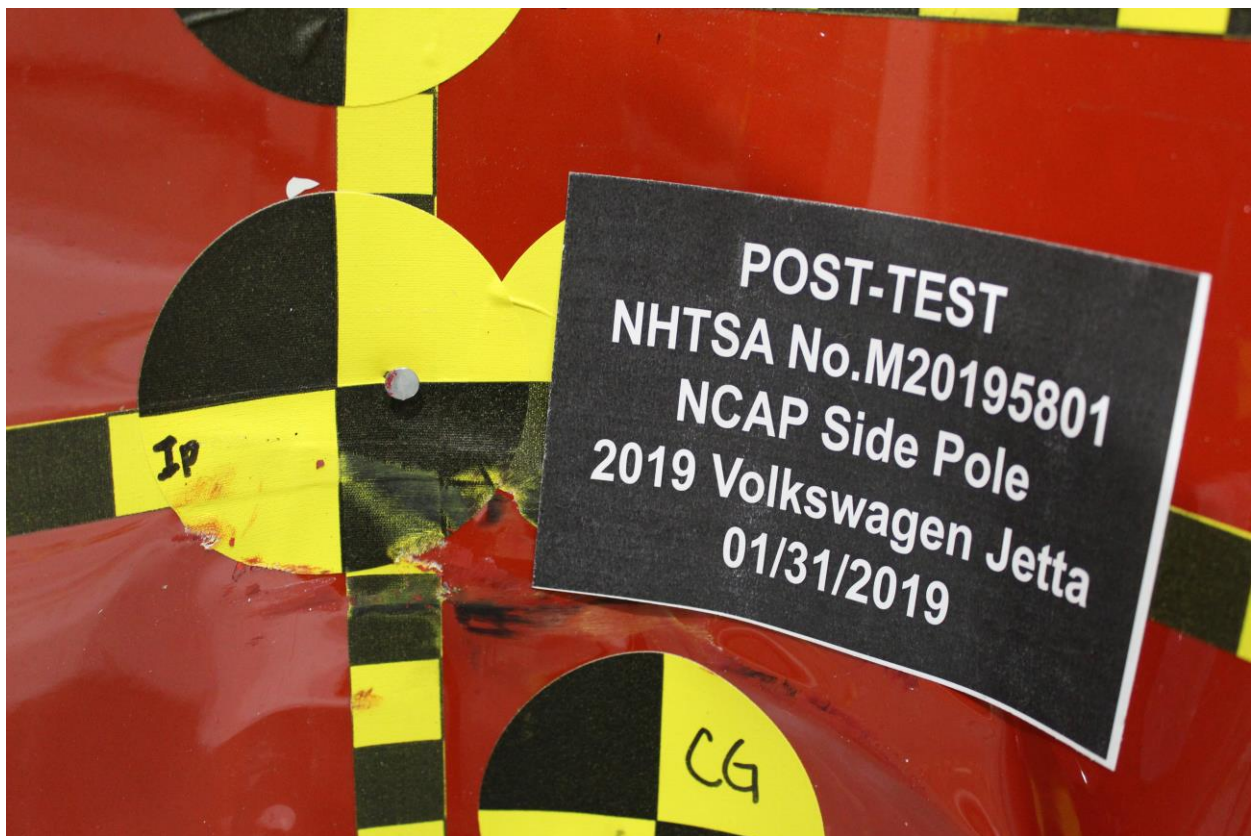
Figure A-20: Post-Test Close-Up View of Impact Point Target Showing Impact Location

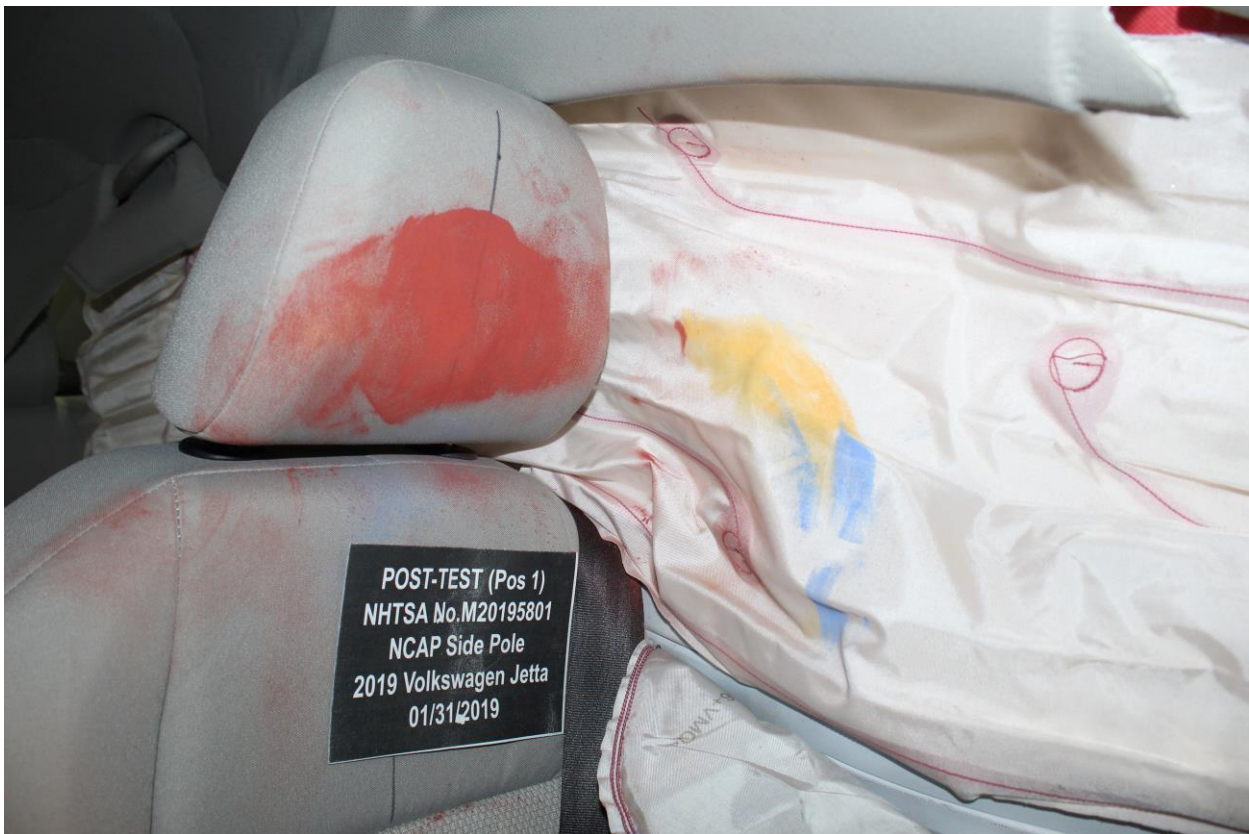
Figure A-46: Post-Test Dummy Close-Up Head Contact with Vehicle Interior View
