**REPORT NUMBER: NCAP-MGA-2019-031**

**NEW CAR ASSESSMENT PROGRAM (NCAP)  
Frontal Barrier Impact Test**

**GENERAL MOTORS LLC  
2019 Chevrolet Suburban 4WD LS 5-Door SUV  
NHTSA No.: O20190102**

**FINAL REPORT**

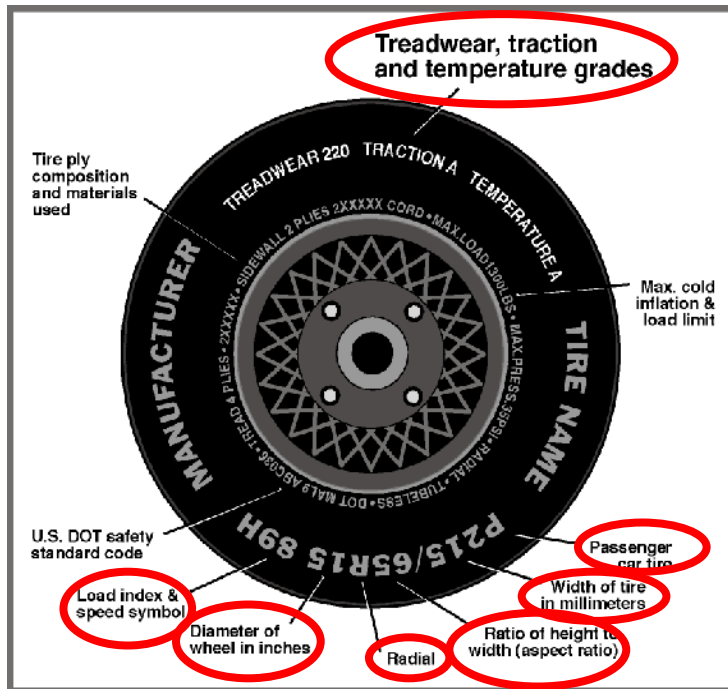
**VEHICLE TIRE INFORMATION**

Measured Parameter	Front	Rear
Max. Tire Pressure (kPa)	300	300
Cold Pressure (kPa)	240	240
Recommended Tire Size	265/65R18	265/65R18
Tire Size on Vehicle	265/65R18	265/65R18
Tire Manufacturer	Michelin	Michelin
Tire Model	EnergySaver A/S	EnergySaver A/S
Treadwear	480	480
Traction	A	A
Temperature Grade	B	B
Tire Plies Sidewall	2 Polyester	2 Polyester
Tire Plies Body	2 Polyester, 2 Steel, 1 Polyamide	2 Polyester, 2 Steel, 1 Polyamide
Load Index/Speed Symbol	112T	112T
Tire Material	Rubber	Rubber
DOT Safety Code Left	M3K4 007X 2718	M3K4 007X 2718
DOT Safety Code Right	M3K4 007X 2718	M3K4 007X 2718

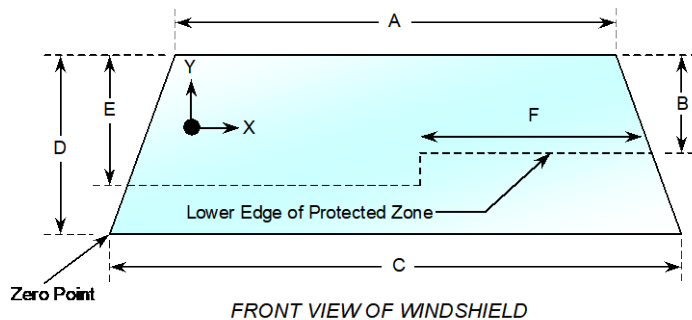
**WINDSHIELD PERIPHERY MEASUREMENTS**

Measurement	Pre-Test (mm)	Post-Test (mm)	% of Retention
Left Side	2312	2091	90.4
Right Side	2312	1982	85.7
Total	4624	4073	88.1

Item	Units	Value
A	mm	1370
B	mm	465
C	mm	1634
D	mm	810
E	mm	477
F	mm	554

There was 88 percent windshield retention and no intrusion into the protected zone of the windshield during the event. There was no Stoddard Solvent leakage after the event or during any phase of the static rollover.

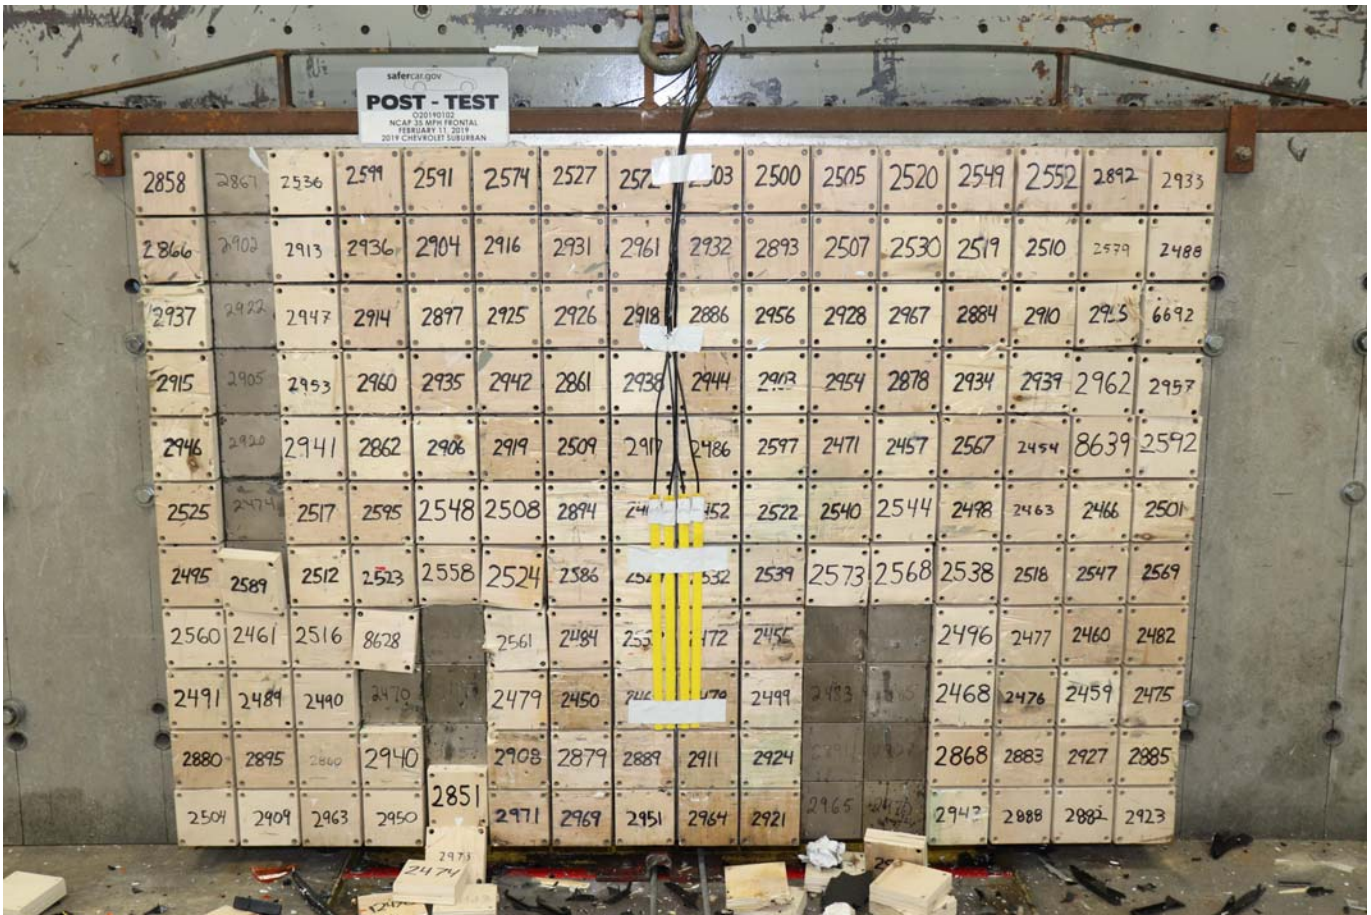
Photo No. 003 - Post-Test Load Cell Wall

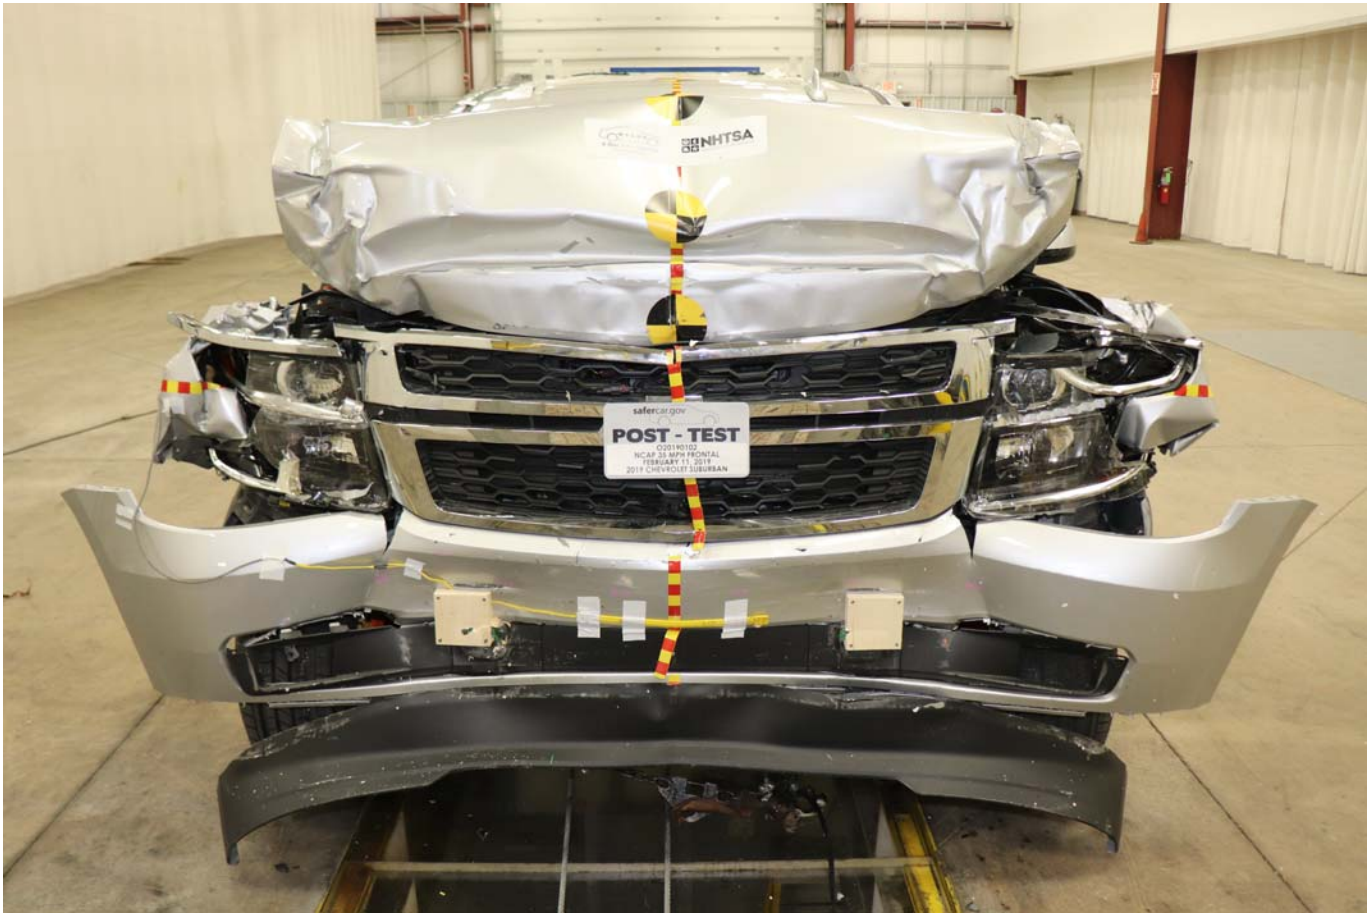
Photo No. 009 - Post-Test Front View of Test Vehicle

The maximum static crush of the vehicle was 666 mm located at the vehicle centerline and both the driver and passenger side doors remained closed during the impact event and were operable after the impact.

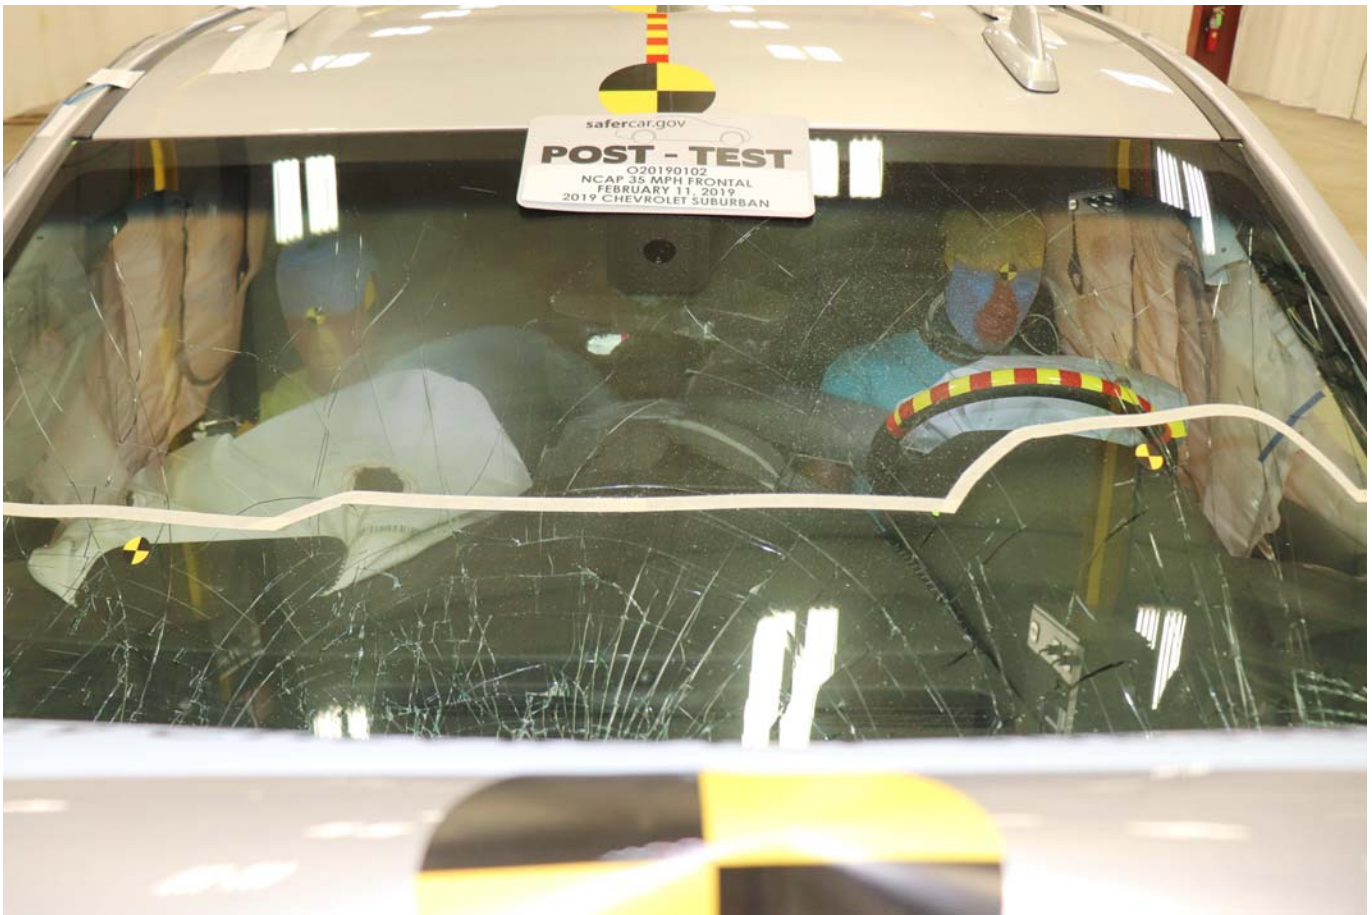
Photo No. 019 - Post-Test Windshield View

Critical Areas of Performance	Observations and Conclusions
Windshield Damage	Cracked
Window Damage	None
Other Notable Effects	None

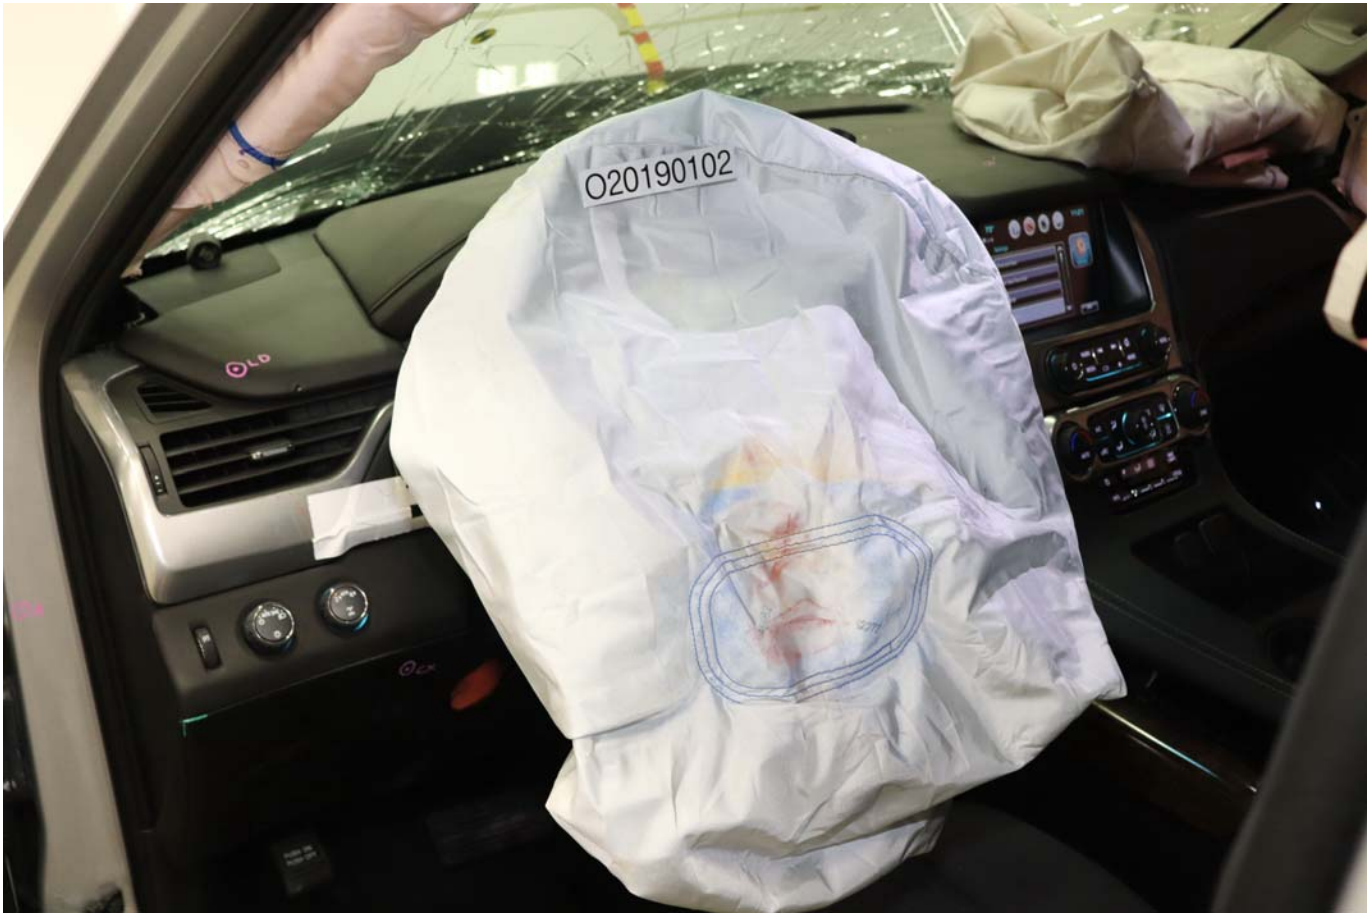
Photo No. 047 - Post-Test Driver Dummy Contact with Airbag

The driver's visible contact points were as follows: The driver's head contacted the airbag. The driver's head also contacted the headrest. The driver's knees contacted the knee bolster. The passenger's visible contact points were as follows: The passenger's head contacted the airbag. The passenger's head also contacted the headrest. The passenger's knees contacted the glove box.

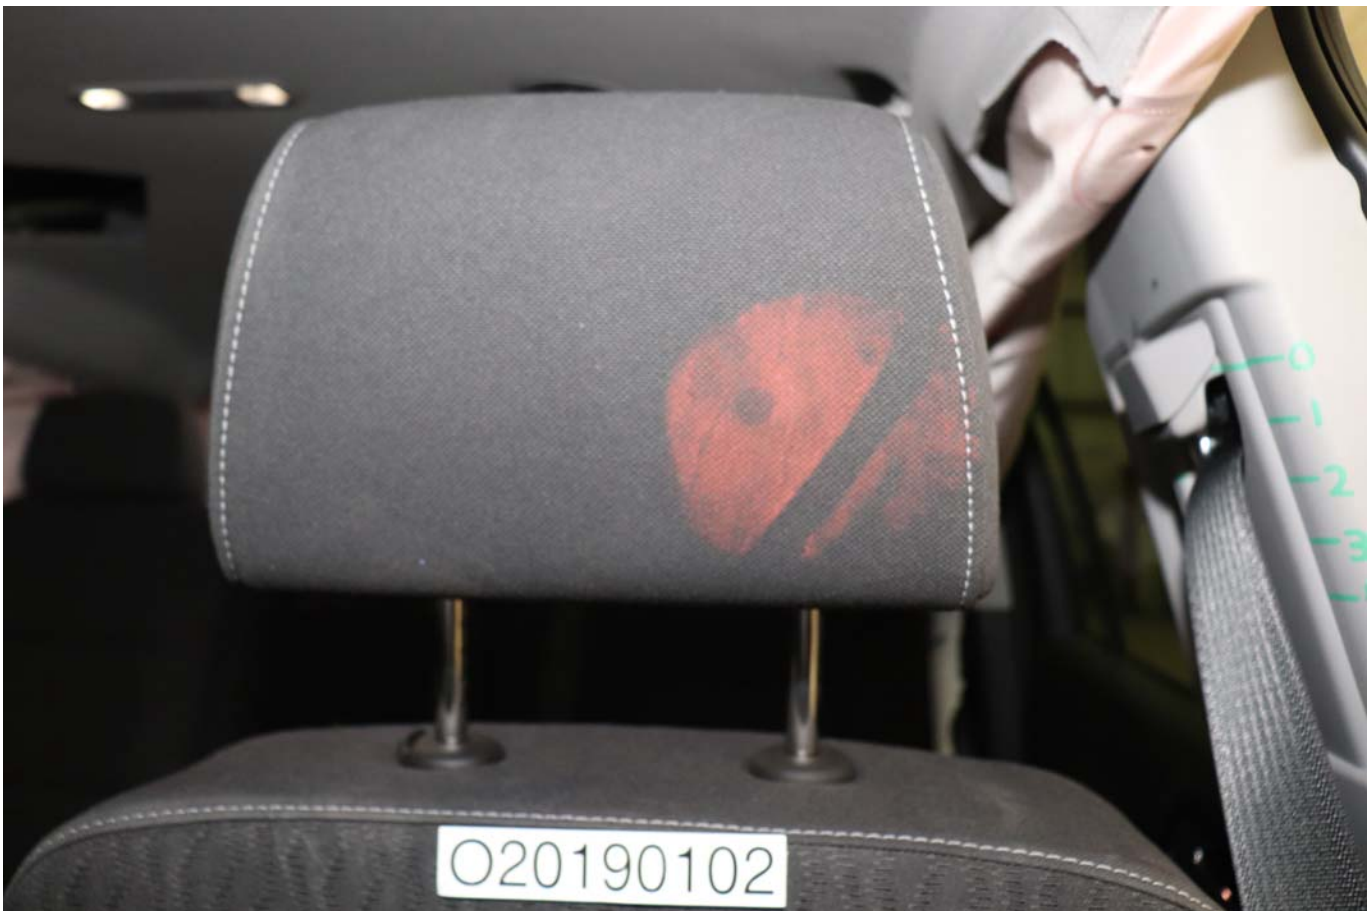
Photo No. 048 - Post-Test Driver Dummy Contact with Headrest

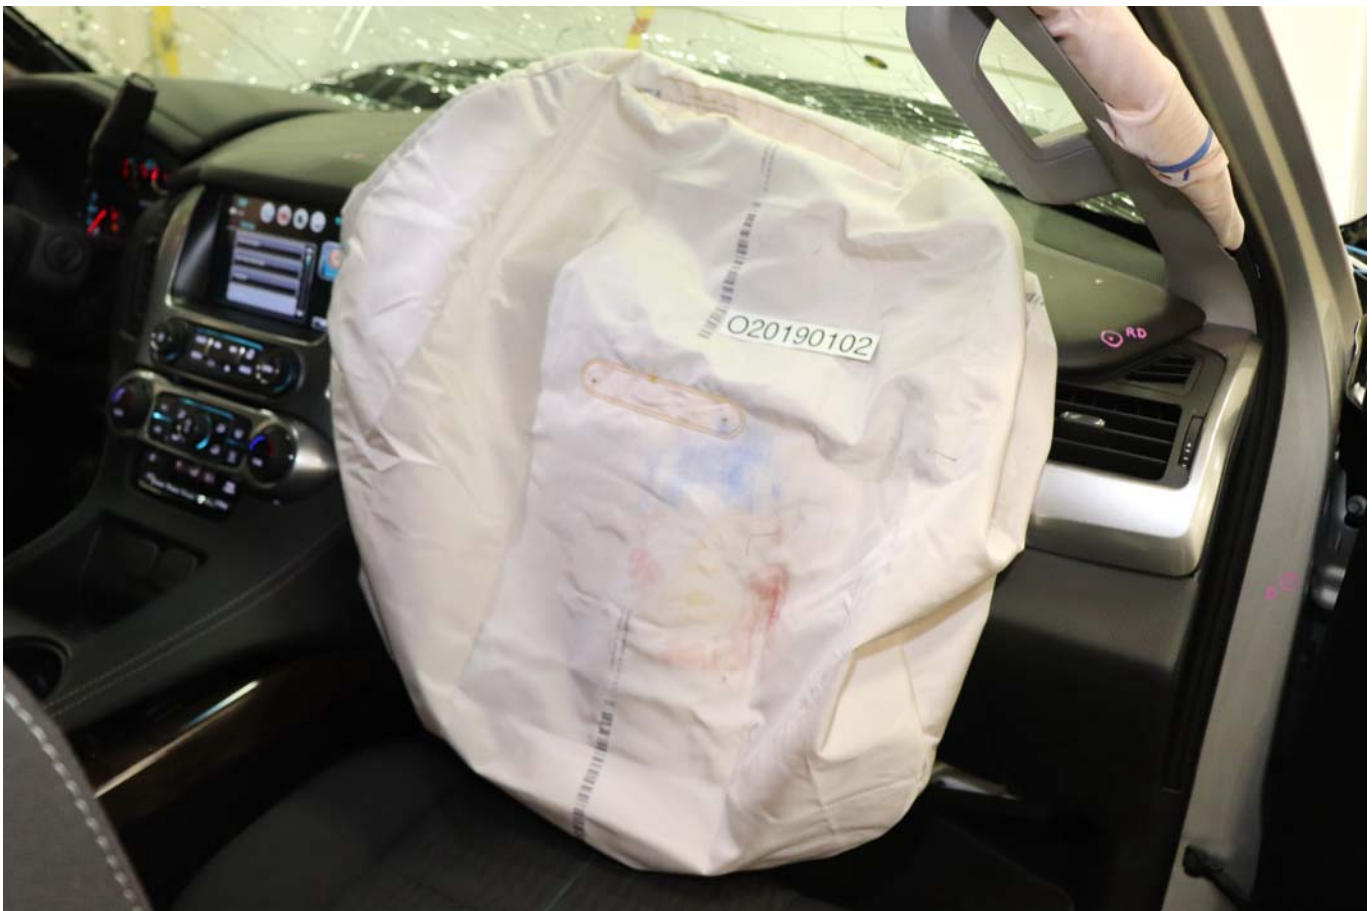
Photo No. 068 - Post-Test Passenger Dummy Contact with Airbag

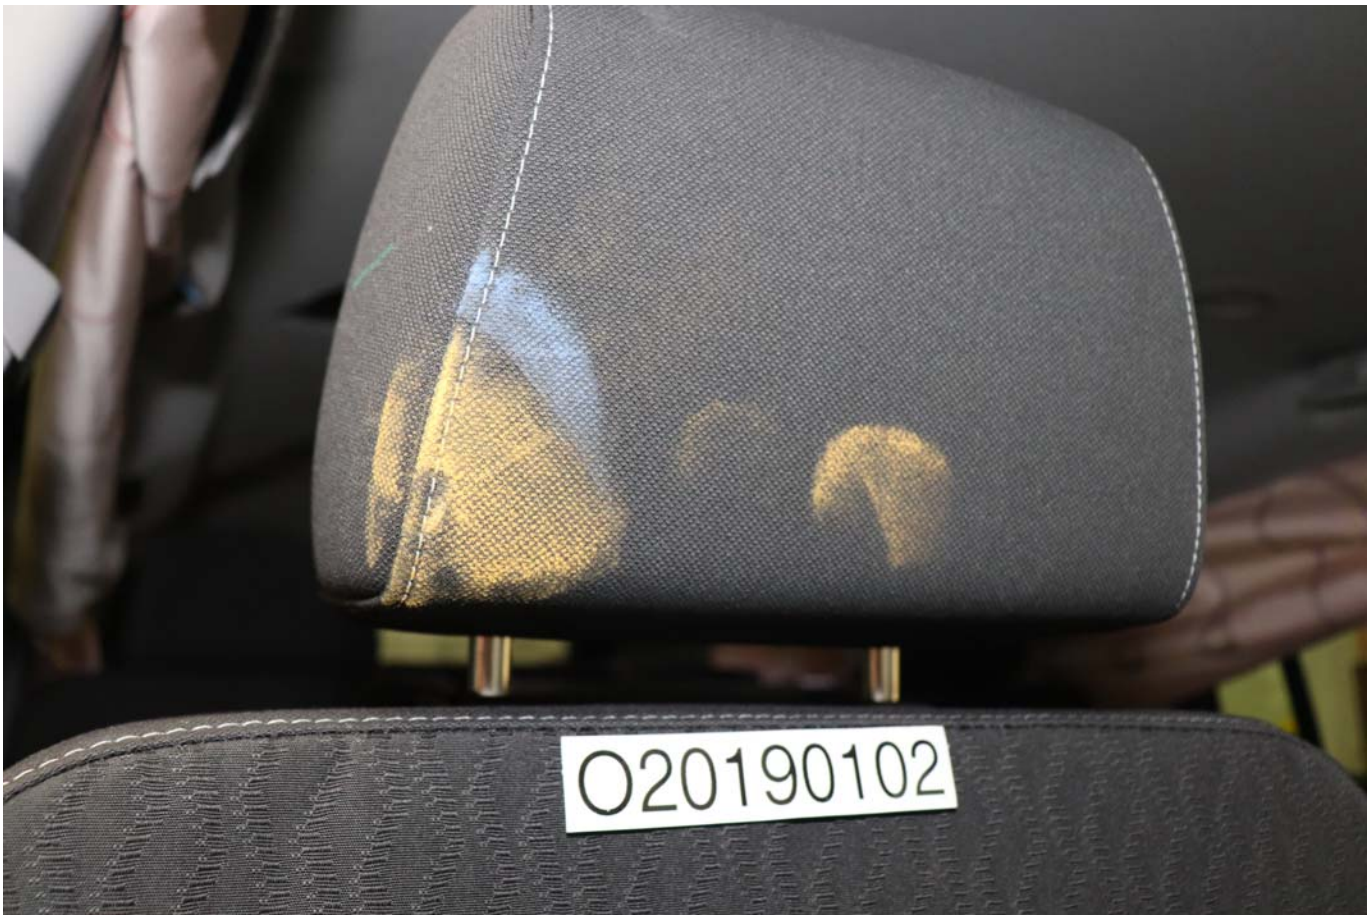
Photo No. 069 - Post-Test Passenger Dummy Contact with Headrest
