**REPORT NUMBER: SINCAP-KAR-19-014**

**NEW CAR ASSESSMENT PROGRAM (NCAP)  
MOVING DEFORMABLE BARRIER SIDE IMPACT TEST**

**HYUNDAI MOTOR COMPANY  
2019 HYUNDAI KONA SE 5-DOOR MPV**

**NHTSA No: M20194202**

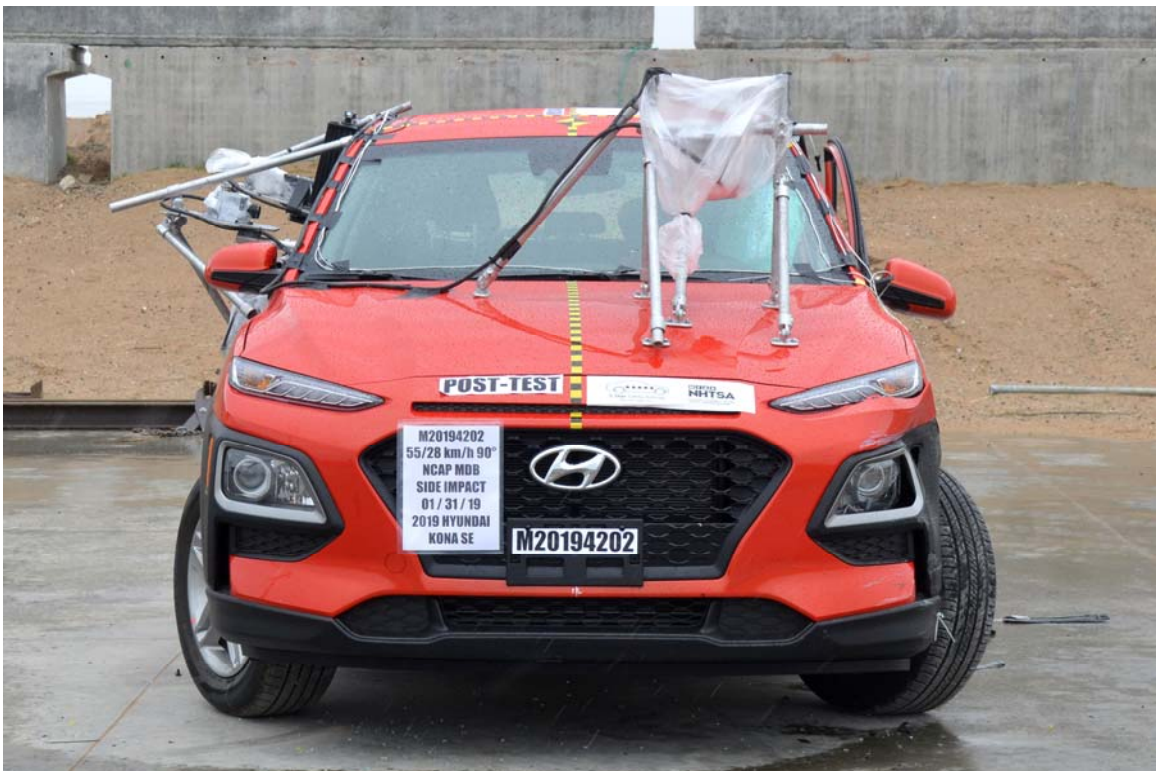
FIGURE 4. Post-Test Frontal View of Test Vehicle

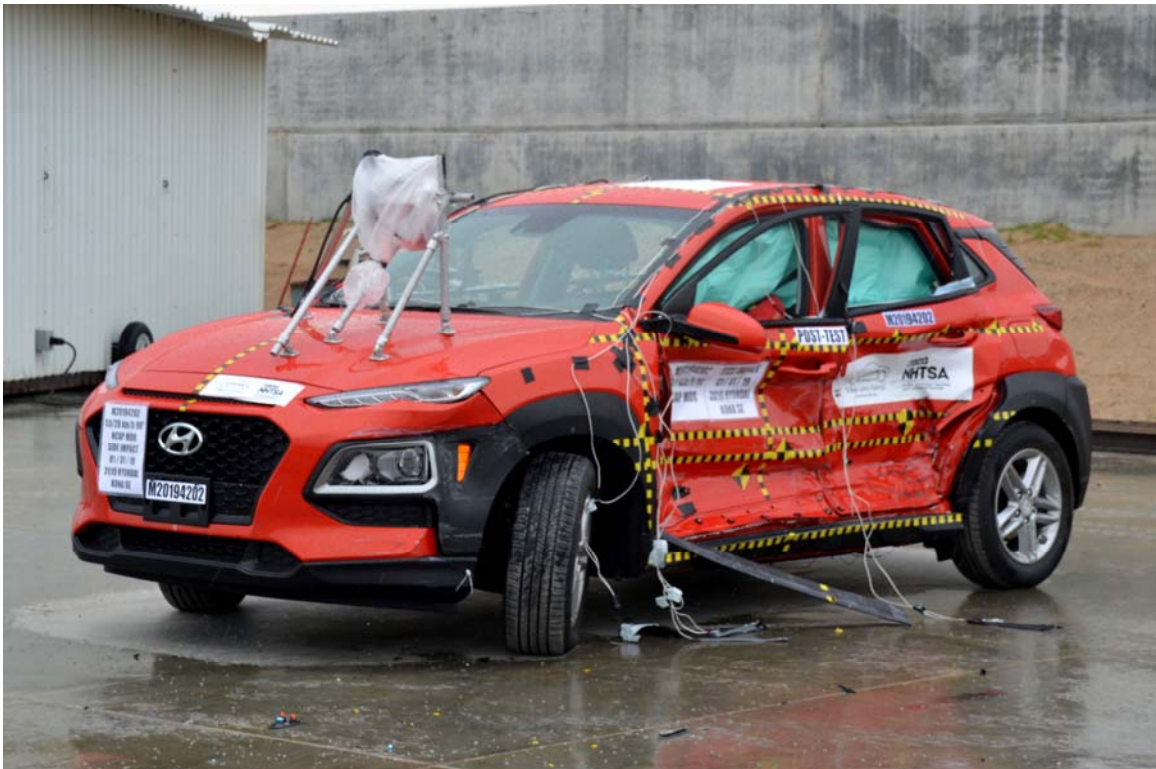
FIGURE 6. Post-Test Left Front  $\frac{3}{4}$  View of Test Vehicle

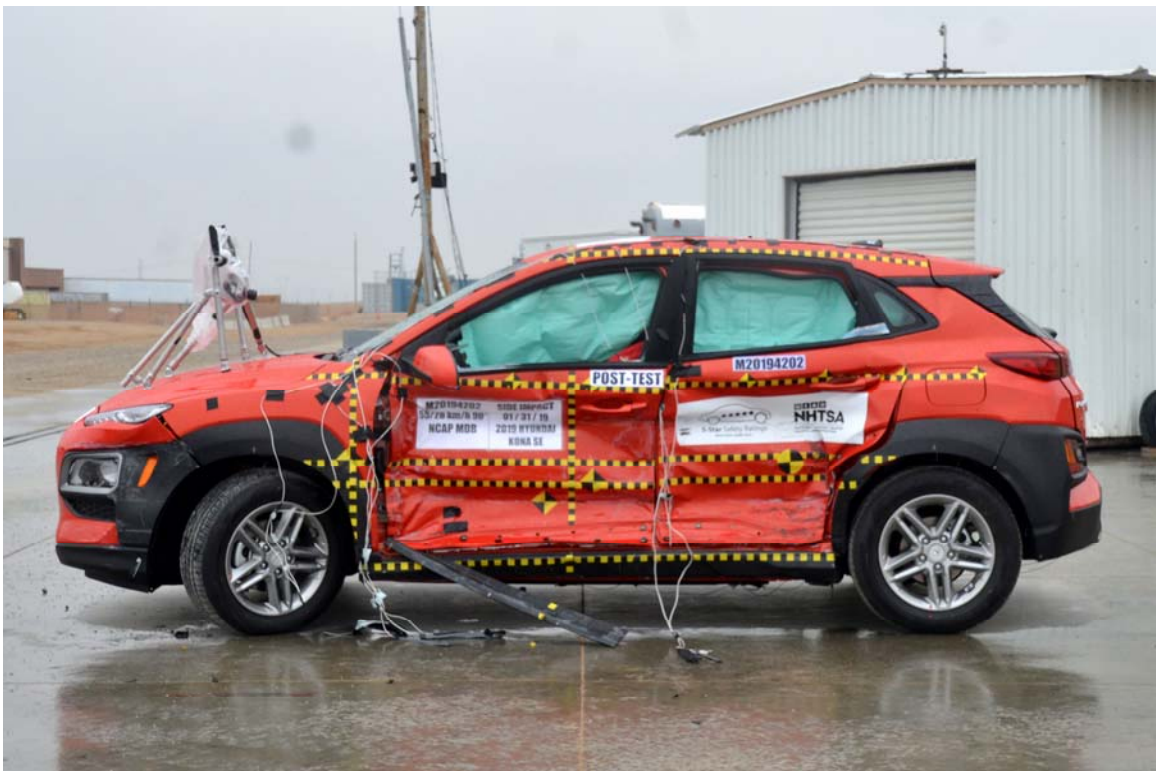
FIGURE 8. Post-Test Left Side View of Test Vehicle

Both the left front driver and left rear passenger doors were jammed shut. The doors on the struck side of the vehicle did not separate from the body at the hinges or latches. The opposite side doors did not open during the side impact event.

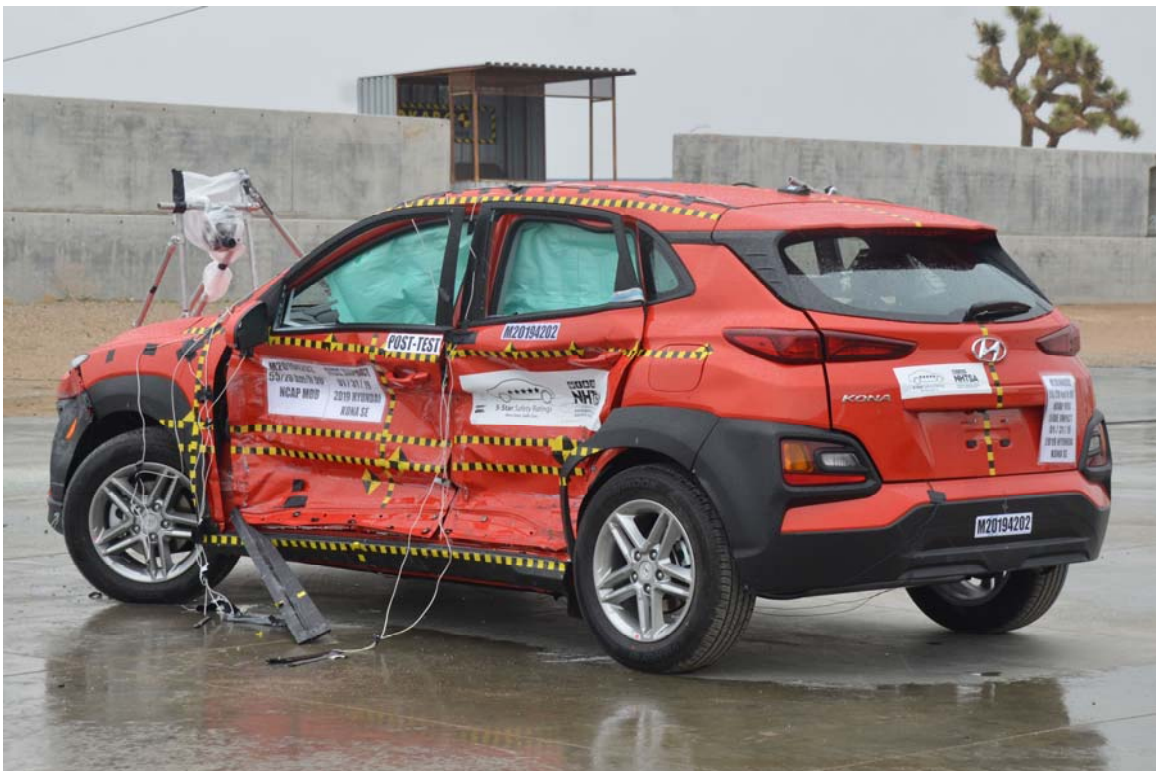
FIGURE 10. Post-Test Left Rear  $\frac{3}{4}$  View of Test Vehicle

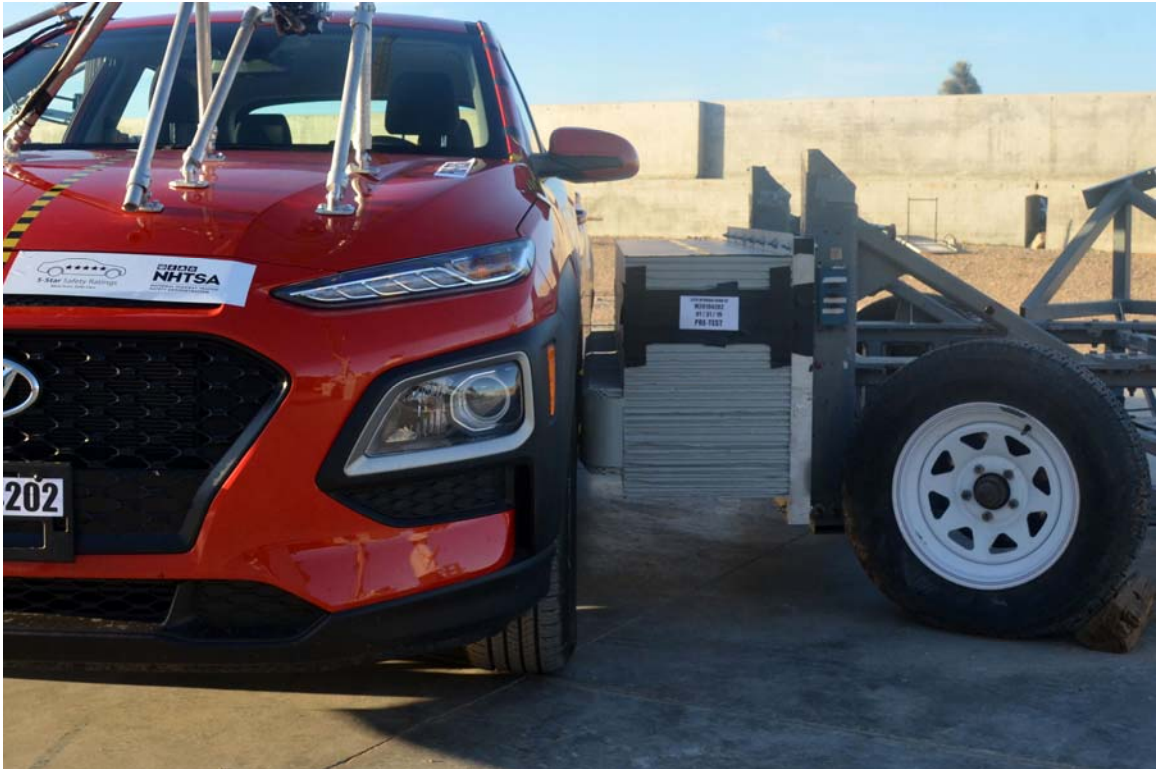
FIGURE 17. Pre-Test Left Side View of MDB Positioned  
Against Side of Test Vehicle

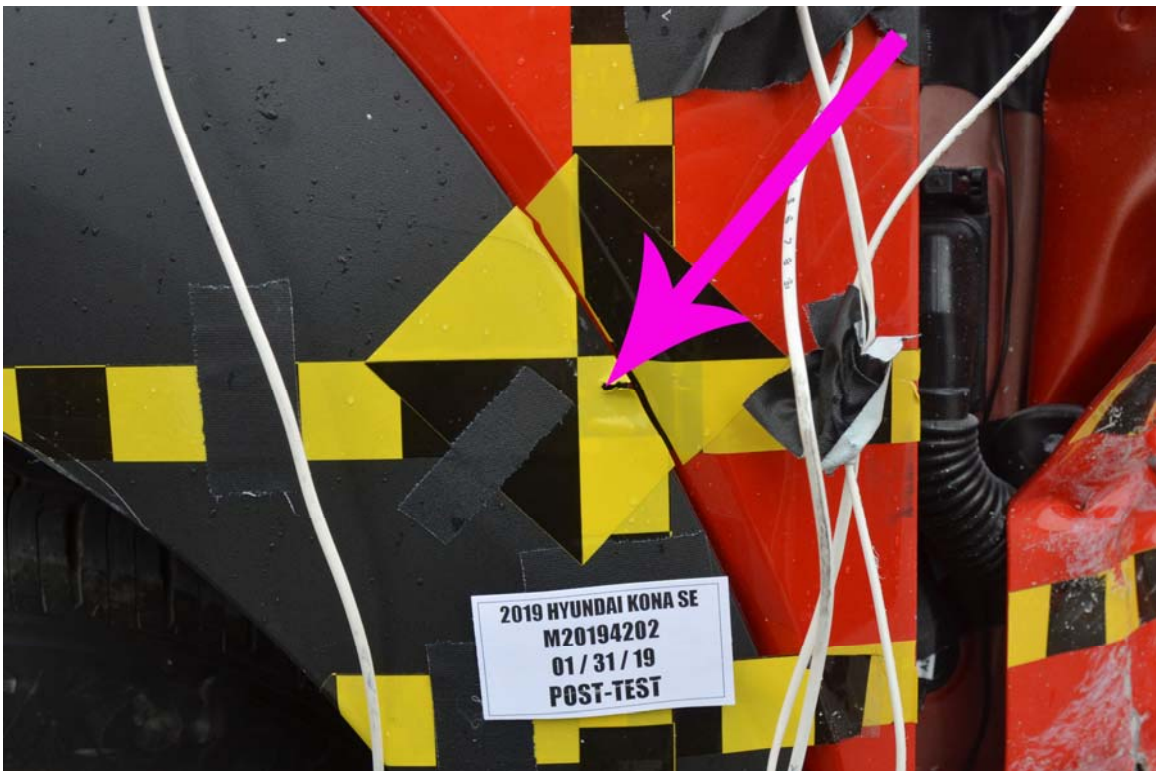
FIGURE 20. Post-Test Close-Up View of Impact Point Target

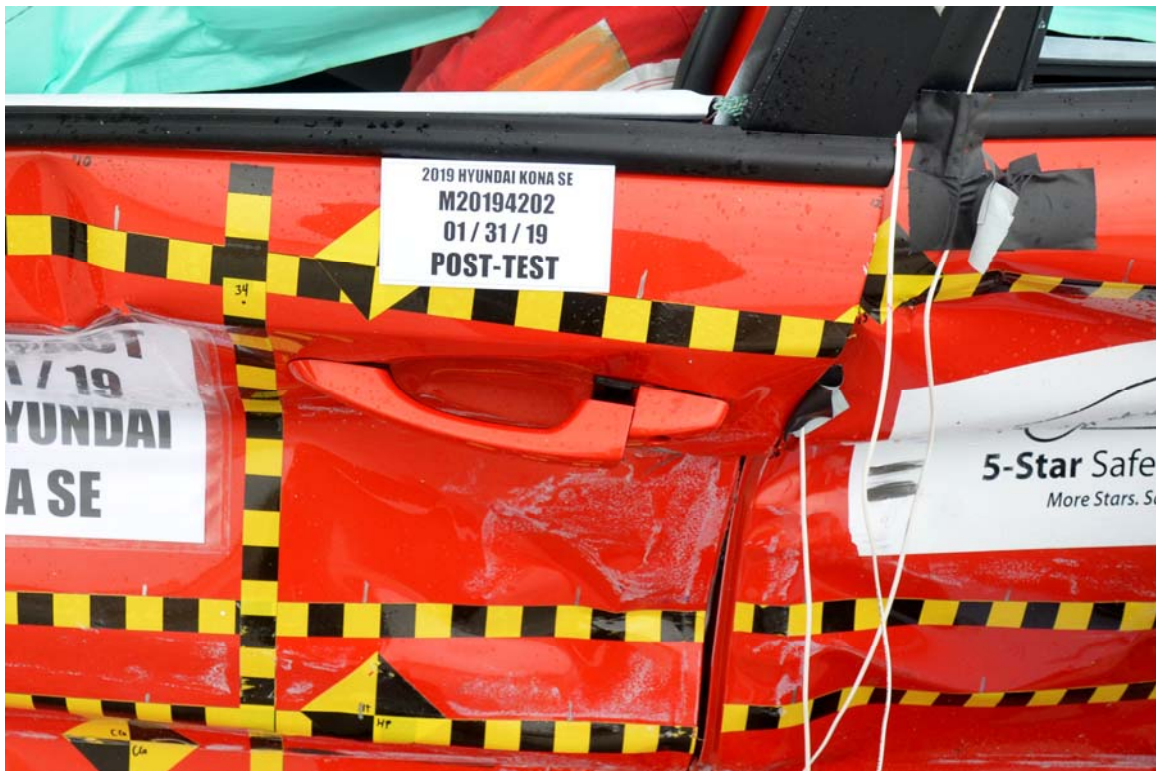
FIGURE 22. Post-Test Left Front Door Latch Close-Up

The doors on the struck side of the vehicle remained closed and latched. There was no separation at the hinges or latches. The doors on the non-struck side remained closed and latched. There was no ATD value that exceeded its limit. The Left Rear Sill Y channel failed at 35.9 ms and the Left Lower A-Post Y channel did not collect data.

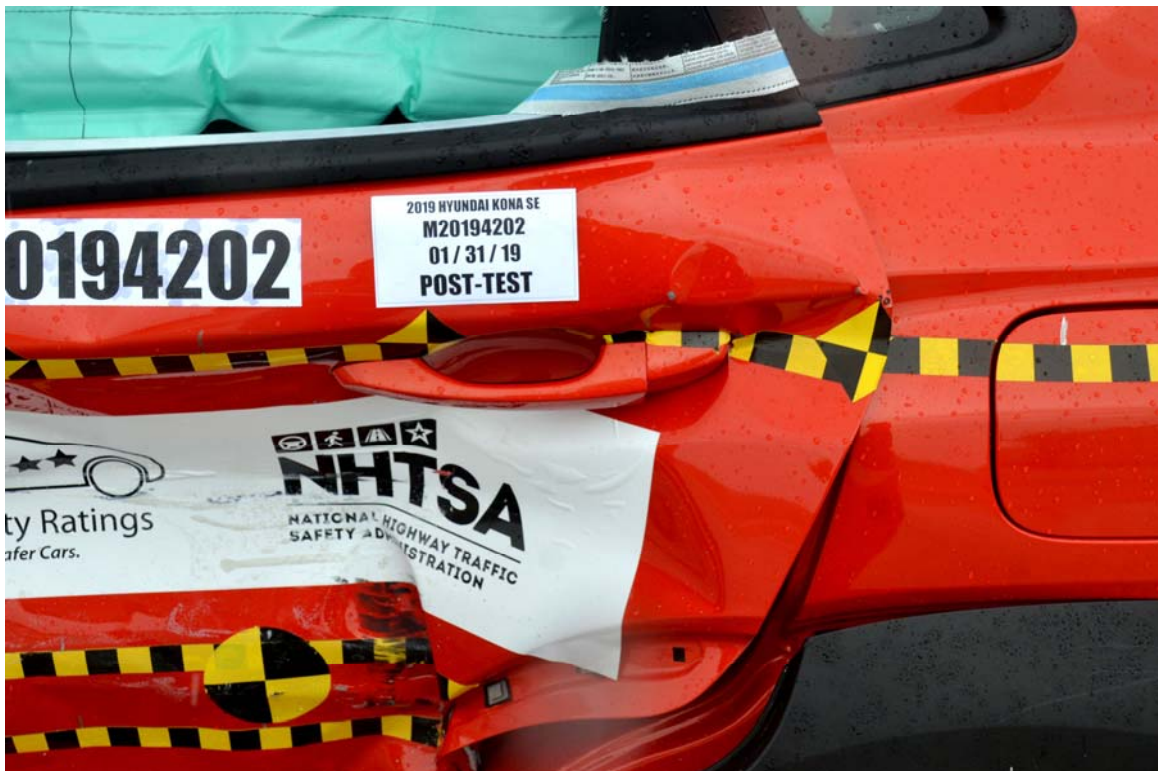
FIGURE 24. Post-Test Left Rear Door Latch Close-Up

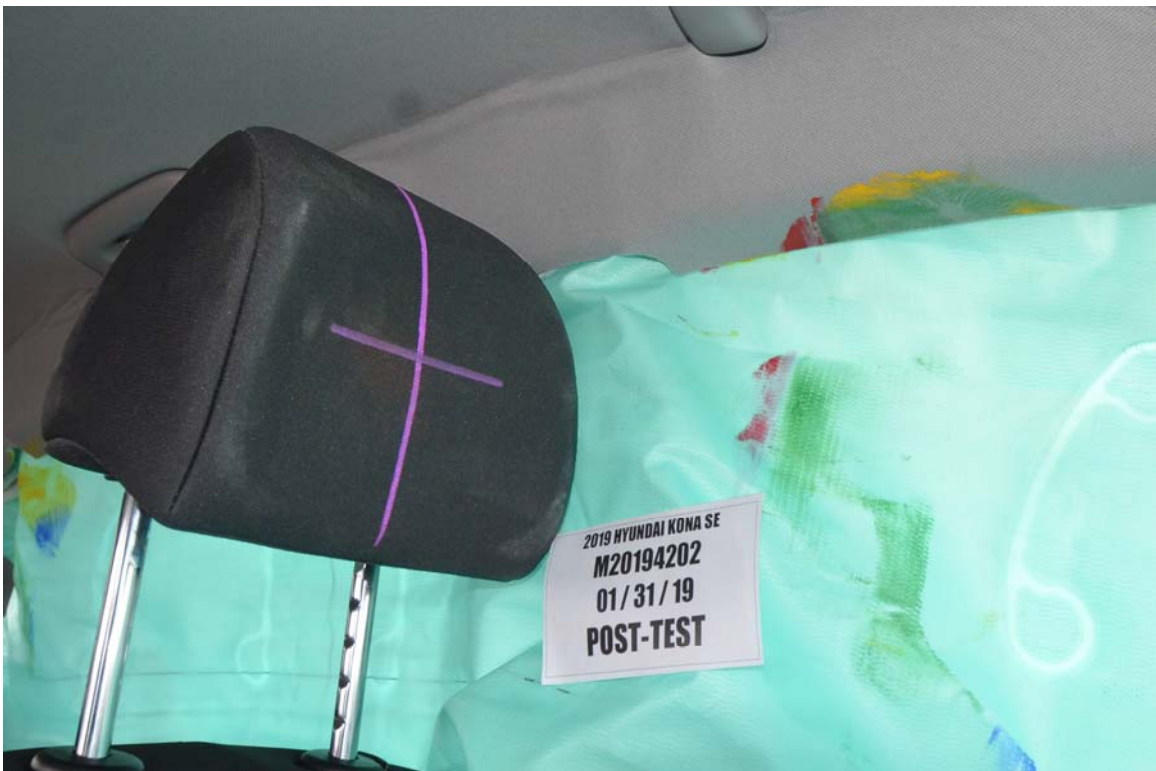
FIGURE 48. Post-Test Driver Dummy Close-Up Head Contact  
with Vehicle Interior View

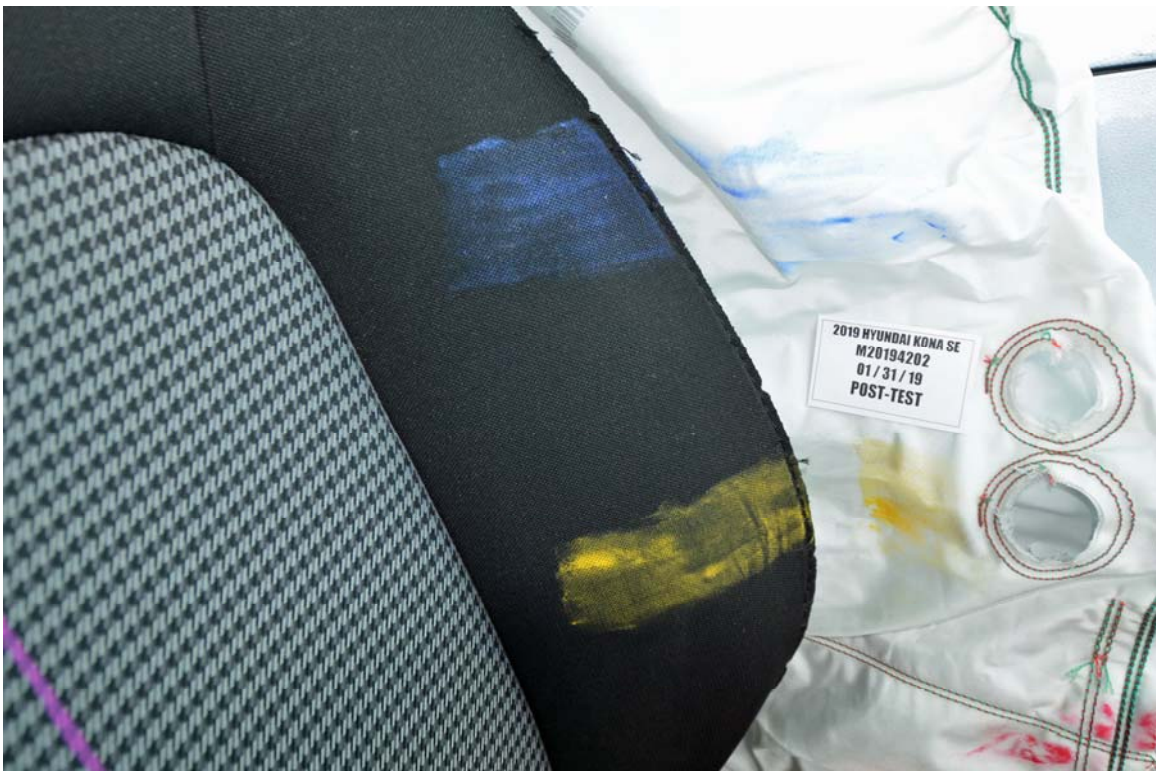
FIGURE 50. Post-Test Driver Dummy Close-Up Torso Contact with Vehicle Interior View

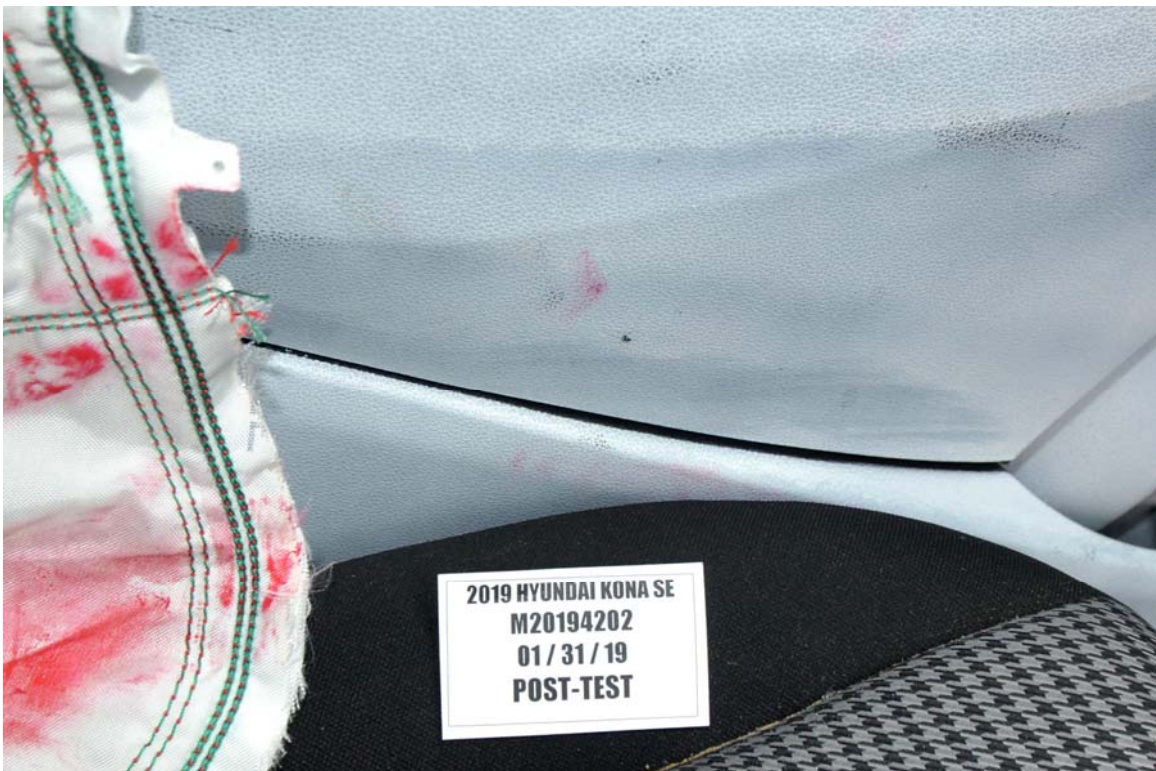
FIGURE 52. Post-Test Driver Dummy Close-Up Pelvis Contact  
with Vehicle Interior View

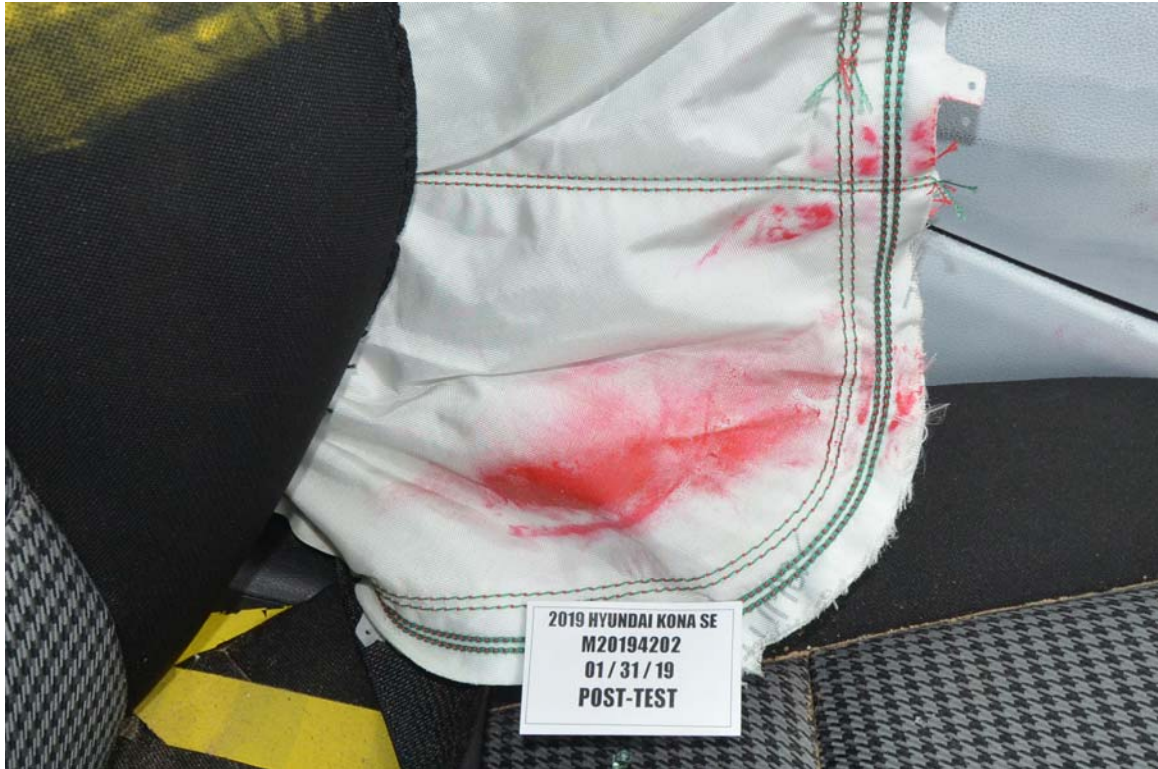
FIGURE 53. Post-Test Driver Dummy Close-Up Pelvis Contact with Side Airbag View

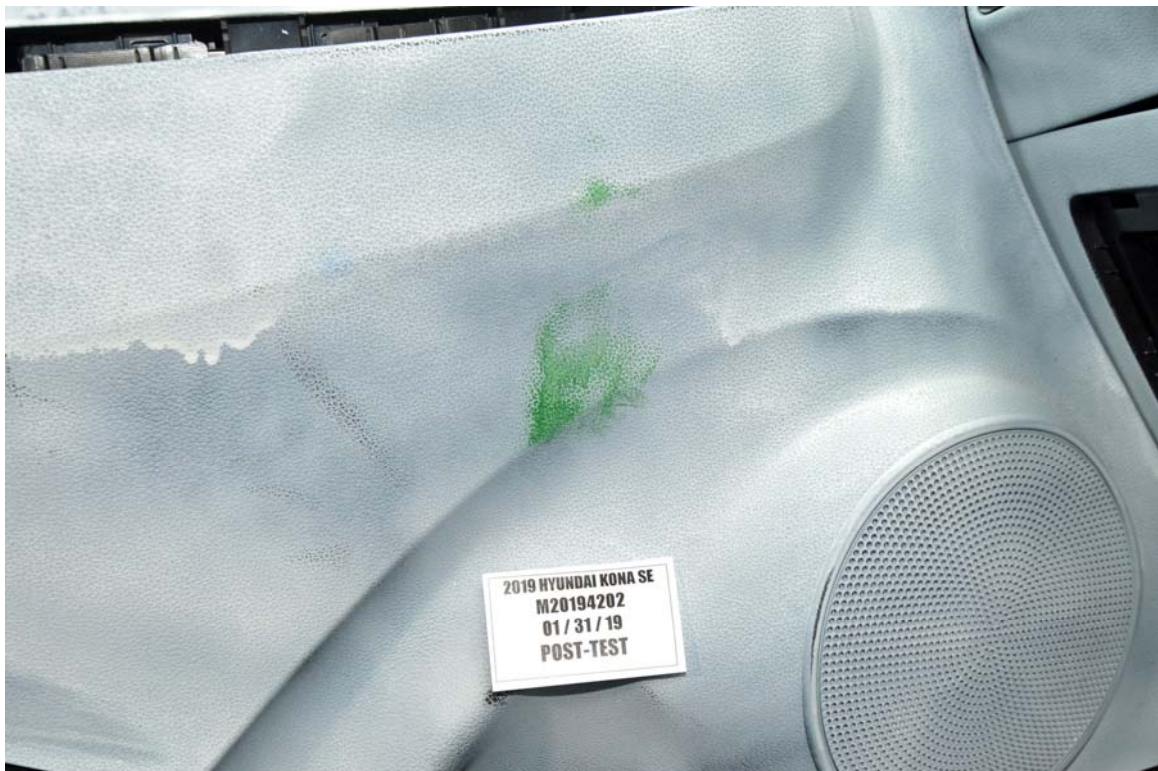
FIGURE 54. Post-Test Driver Dummy Close-Up Knee Contact View

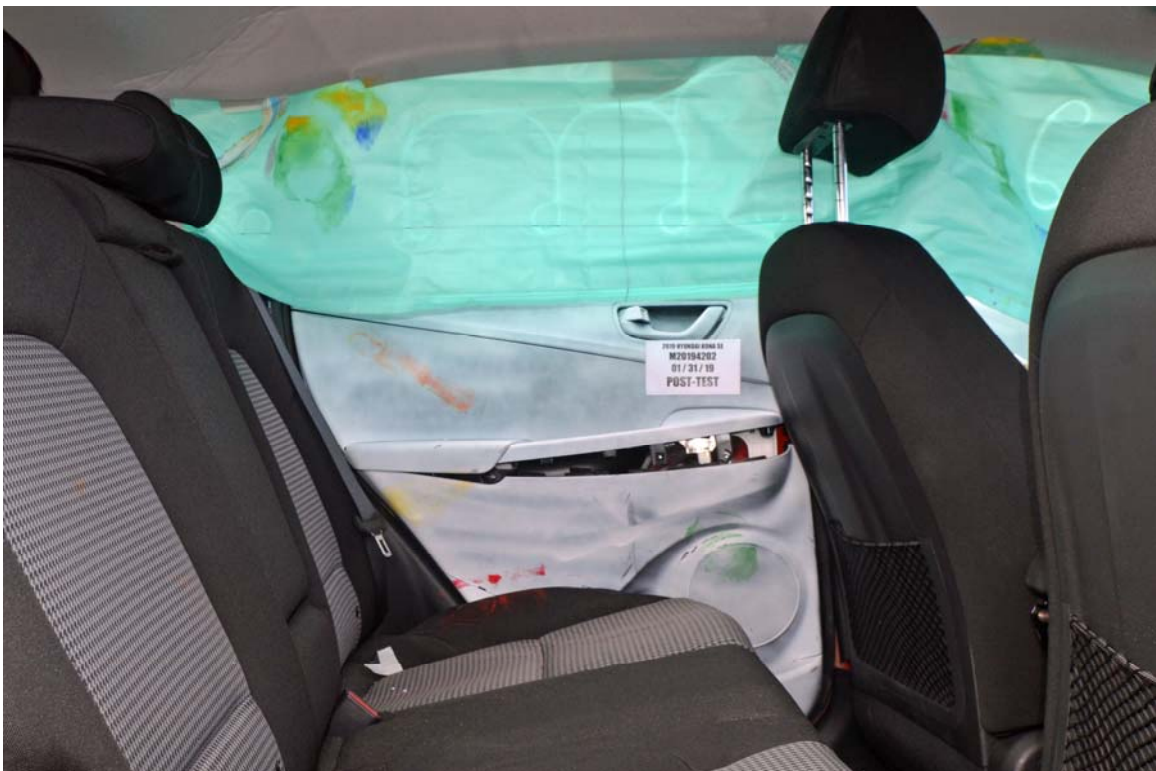
FIGURE 74. Post-Test Rear Passenger Inner Door Panel View  
Showing Rear Passenger Dummy Contact Locations

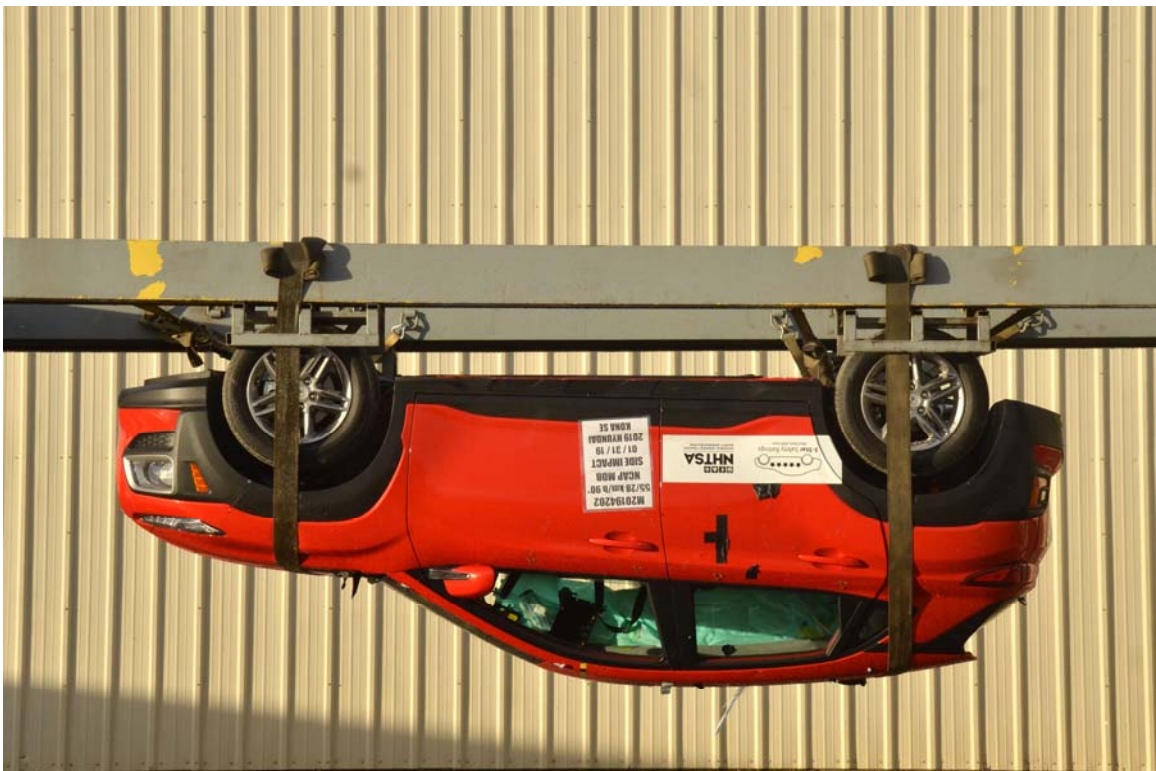
FIGURE 98. FMVSS No. 301 Static Rollover 180 Degrees
