REPORT NUMBER: SPNCAP-CAL-19-003

**NEW CAR ASSESSMENT PROGRAM (NCAP)
SIDE IMPACT POLE TEST**

**KIA Motors Mexico S.A. de C.V.
2019 KIA Forte
Four Door Sedan**

NHTSA No: M20194207

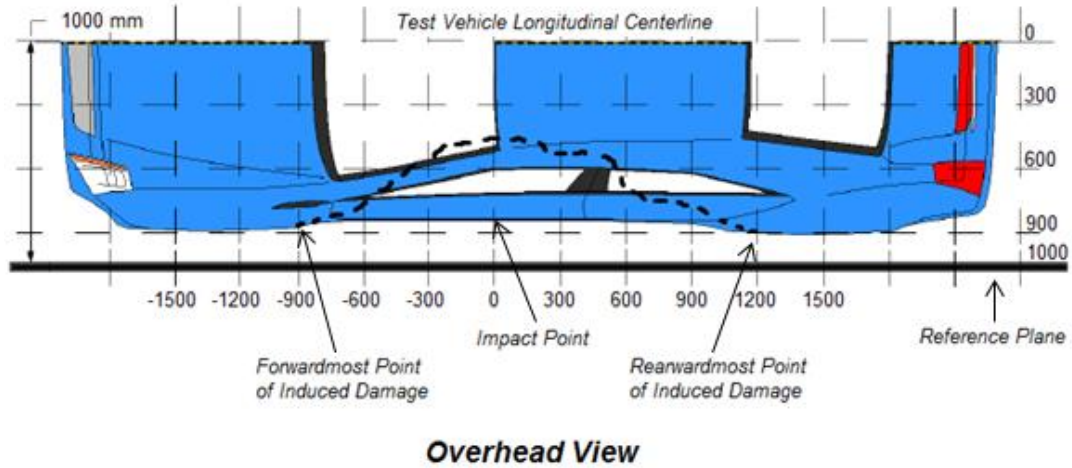
DATA SHEET NO. 11
VEHICLE DAMAGE PROFILE DISTANCES

For guidance regarding damage profile distance measurements, please refer to the latest version of the *NHTSA Test Reference Guide, Volume 1: Vehicle Tests*.

DPD	Distance From Impact Point (mm)	Level	Post-Test (mm)	Pre-Test (mm)	Crush (mm)
1	-900	3	81	108	-27
2	-450	3	184	111	73
3	0	3	409	110	299
4	450	3	196	118	78
5	900	3	160	128	32
6	1350	3	114	108	6

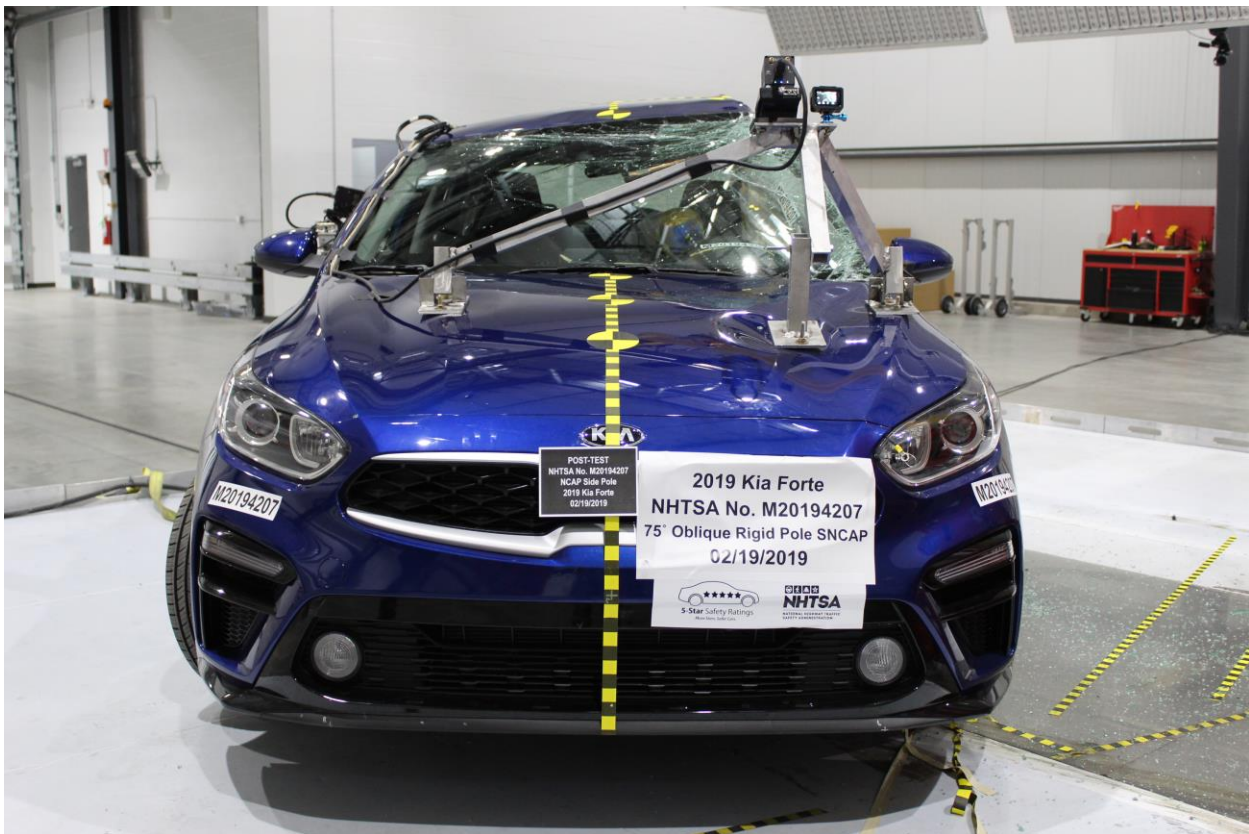
Figure A-4: Post-Test Frontal View of Test Vehicle

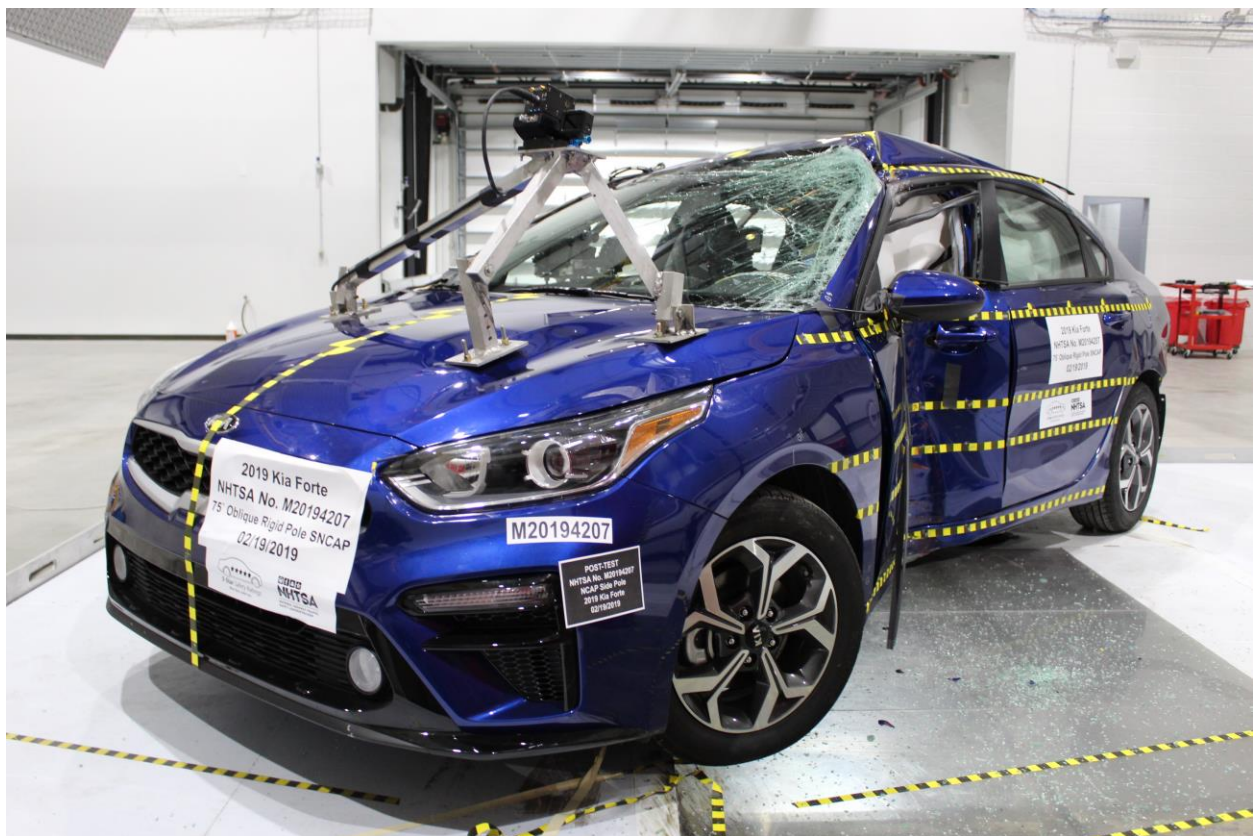
Figure A-6: Post-Test Left Front ¾ View of Test Vehicle

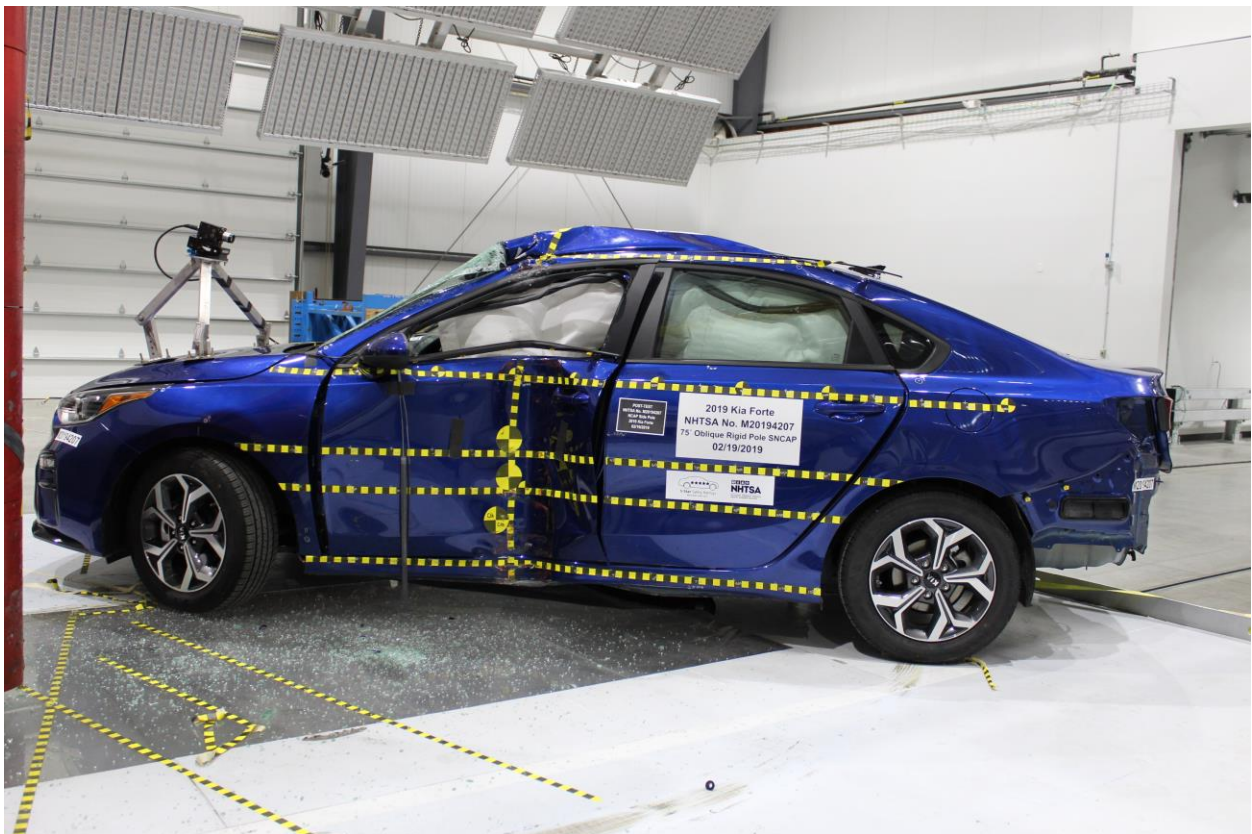
Figure A-8: Post-Test Left Side View of Test Vehicle

Critical Areas of Performance	Observations and Conclusions
Pillar Performance	A-Pillar buckled
Sill Separation	None
Windshield Damage	Cracks throughout and separation along driver A-Pillar
Side Window Damage	Driver's window shattered during impact
Other Notable Effects	None

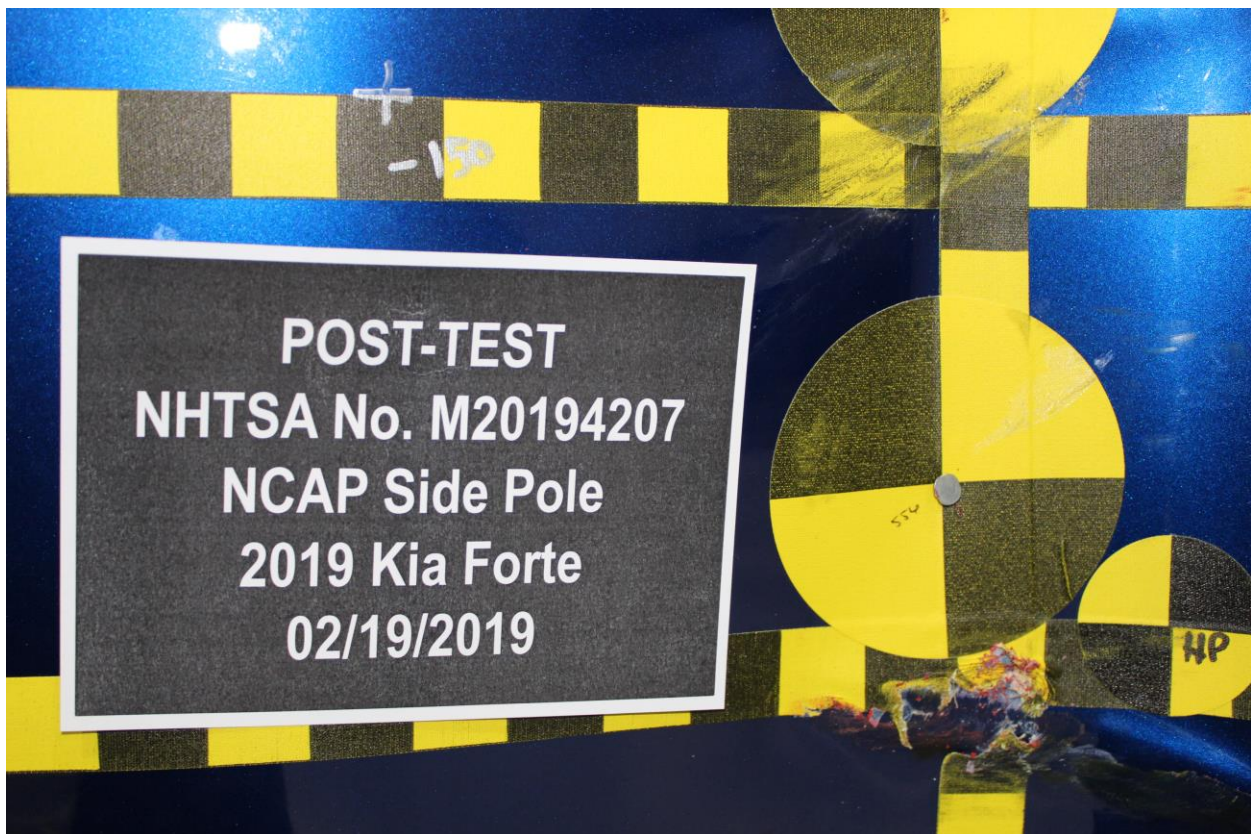
Figure A-20: Post-Test Close-Up View of Impact Point Target Showing Impact Location

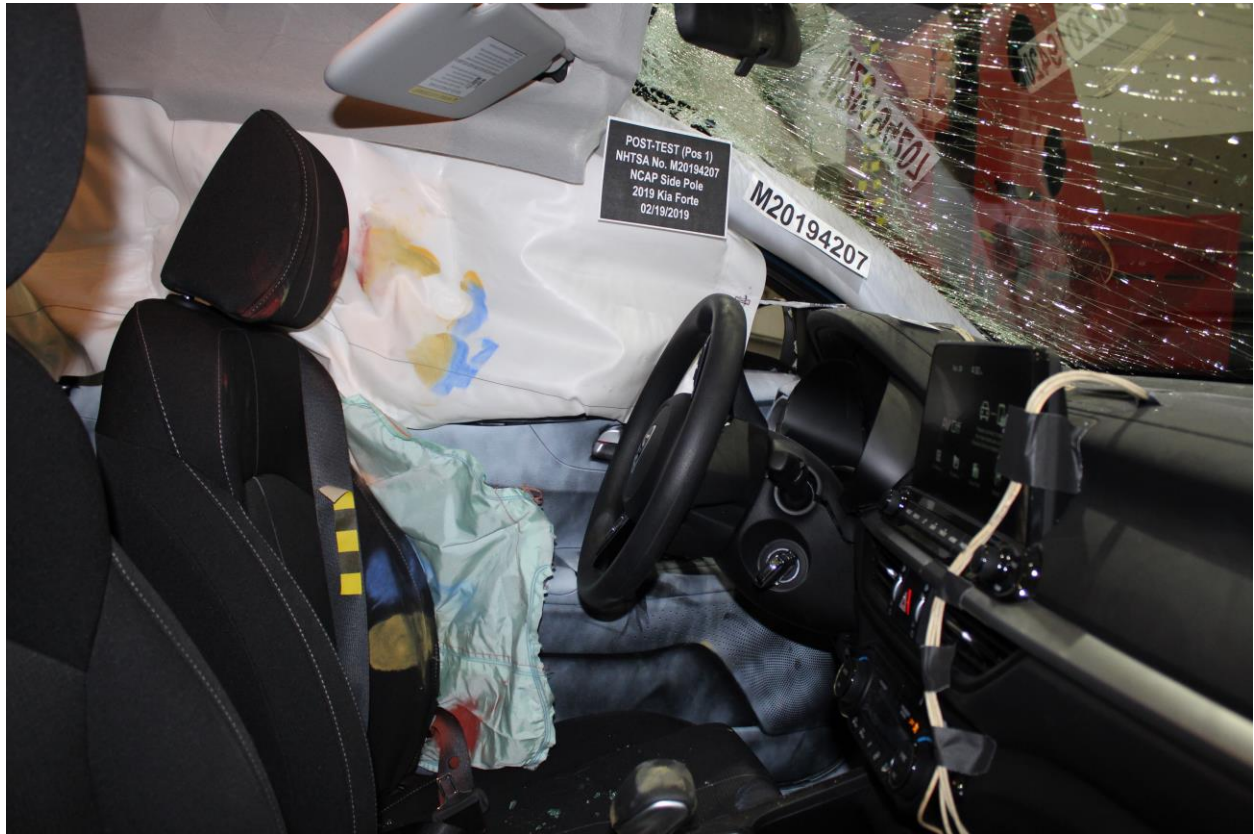
Figure A-45: Post-Test Inner Door Panel View Showing Dummy Contact Location

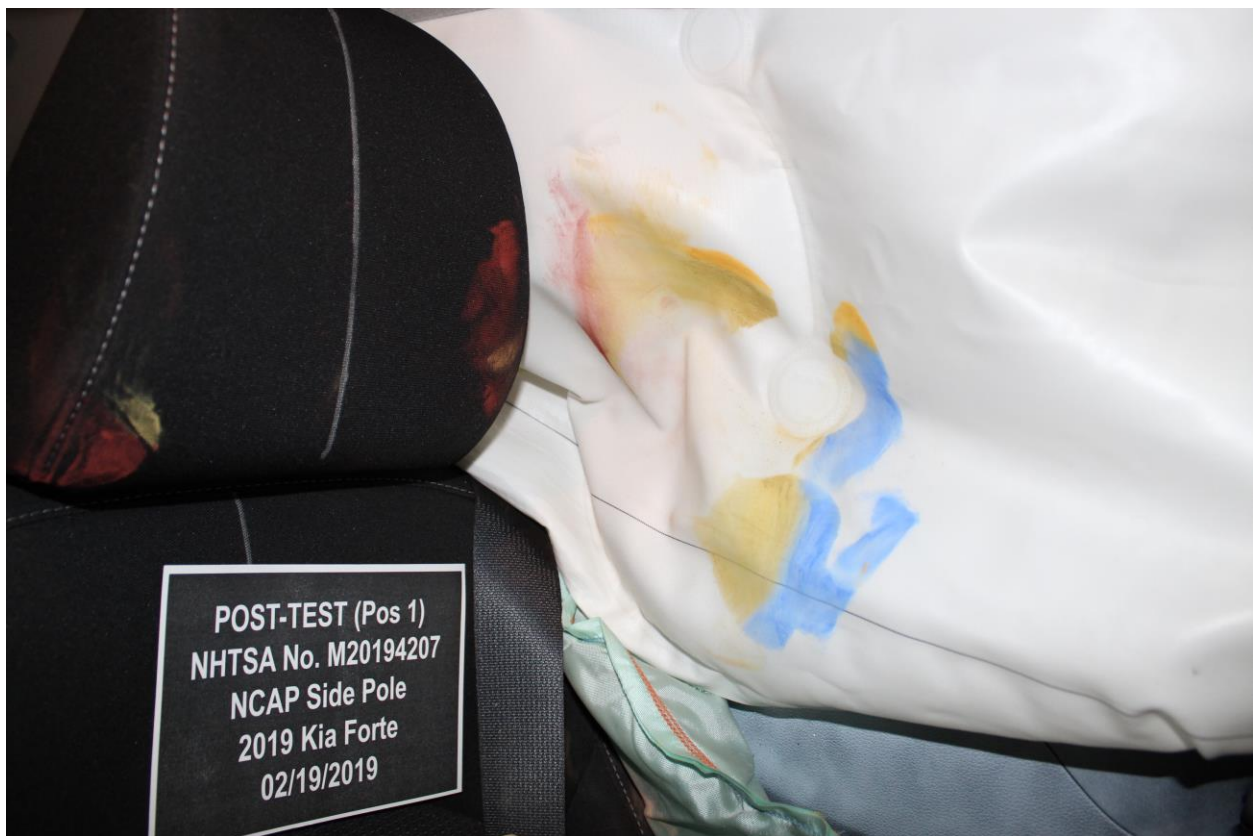
Figure A-46: Post-Test Dummy Close-Up Head Contact with Vehicle Interior View

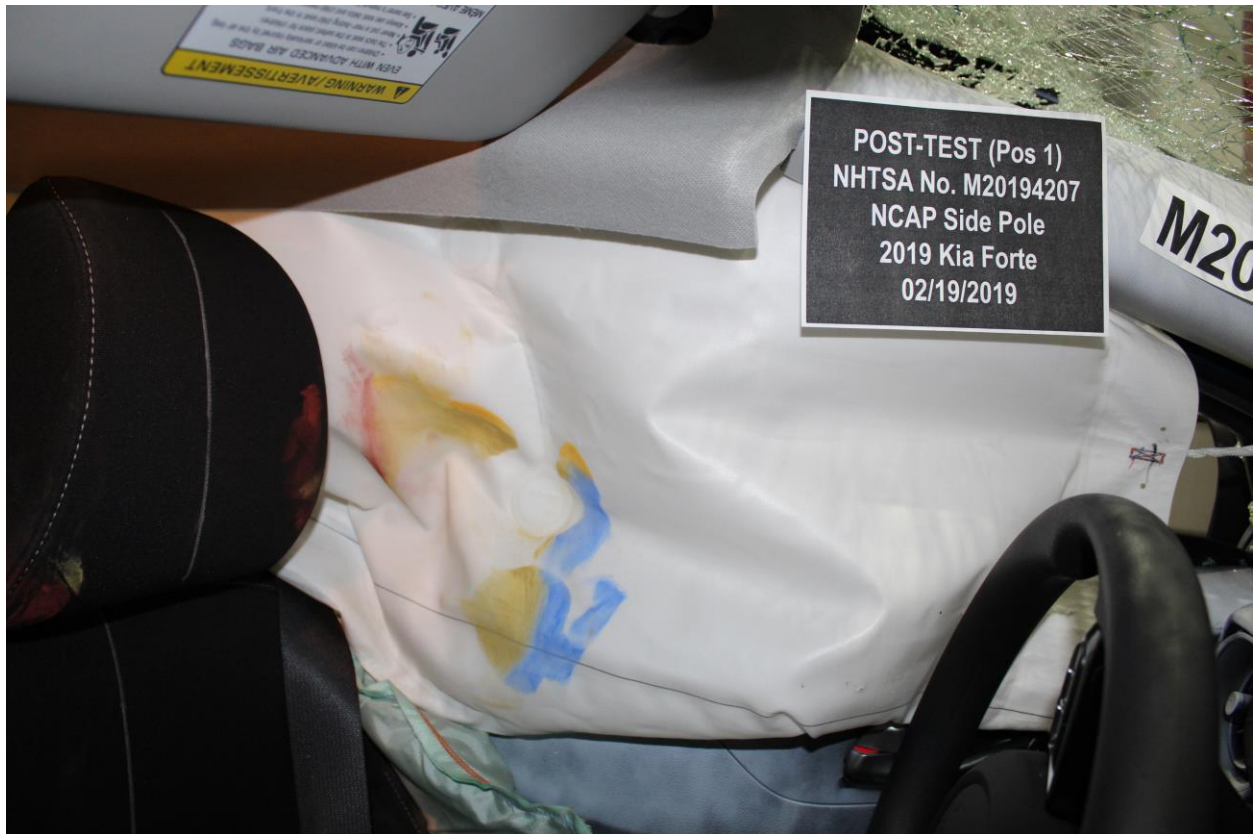
Figure A-47: Post-Test Dummy Close-Up Head Contact with Side Airbag View

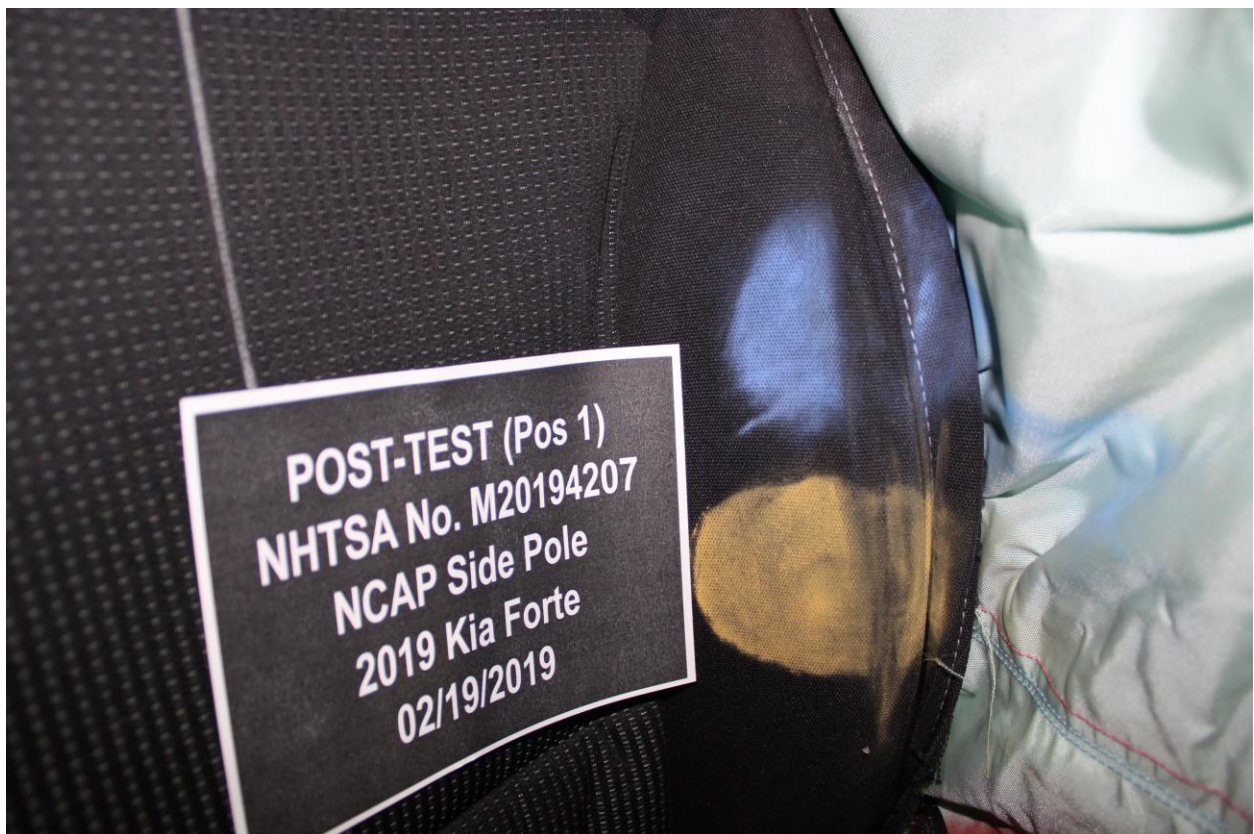
Figure A-48: Post-Test Dummy Close-Up Torso Contact with Vehicle Interior View

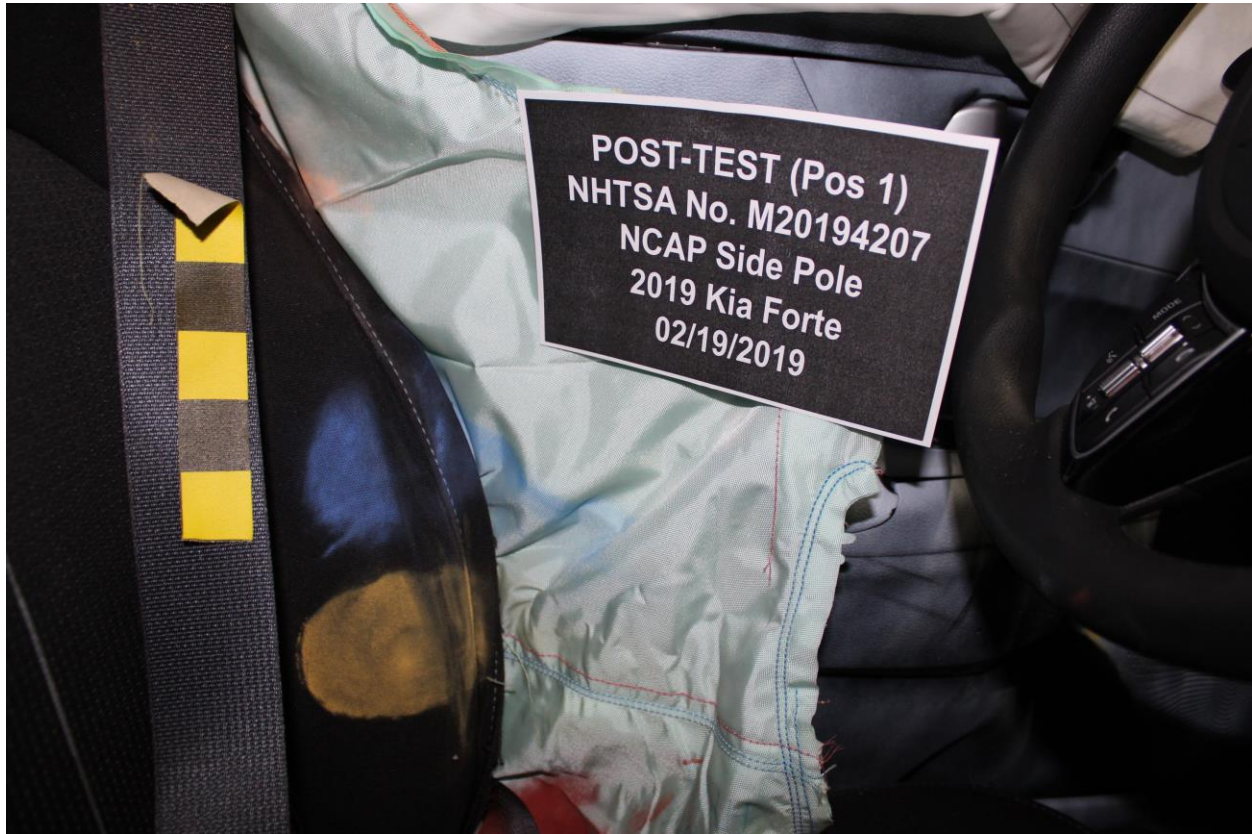
Figure A-49: Post-Test Dummy Close-Up Torso Contact with Side Airbag View

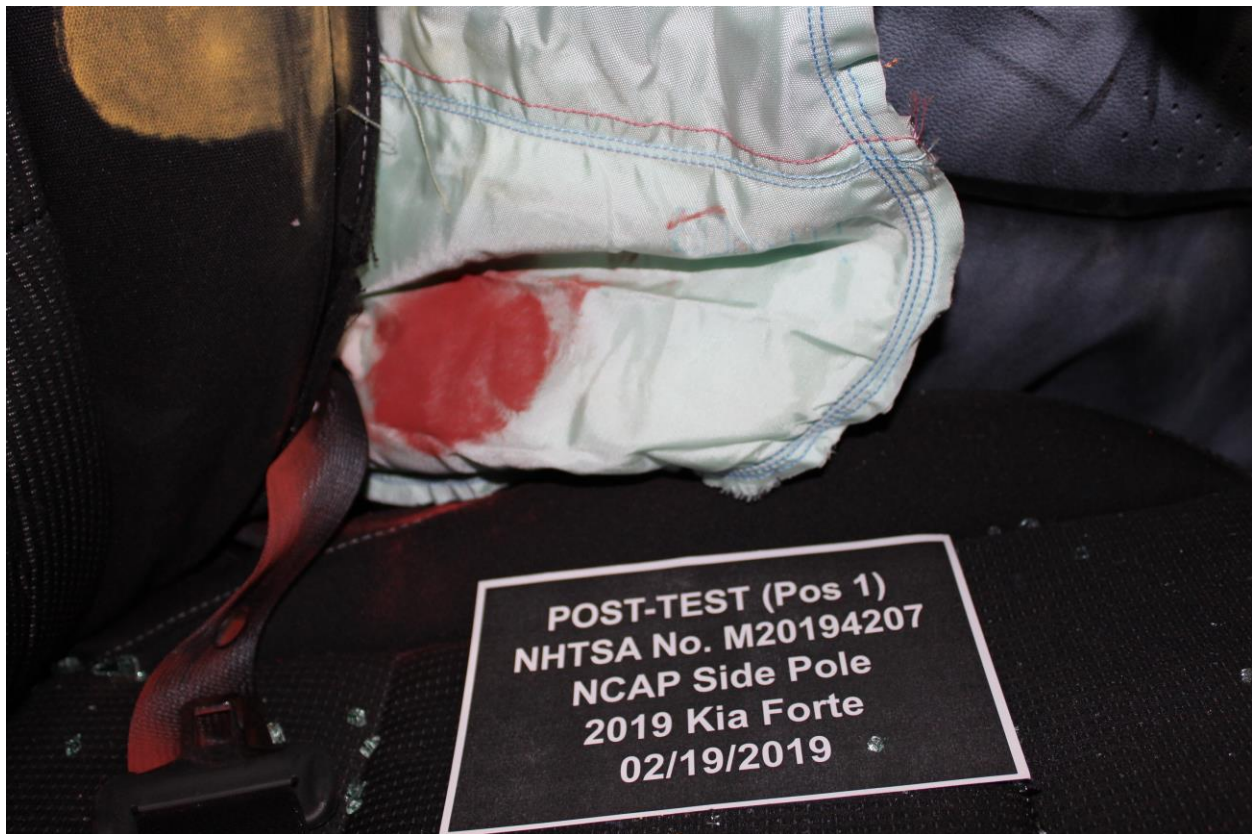
Figure A-50: Post-Test Dummy Close-Up Pelvis Contact with Vehicle Interior View

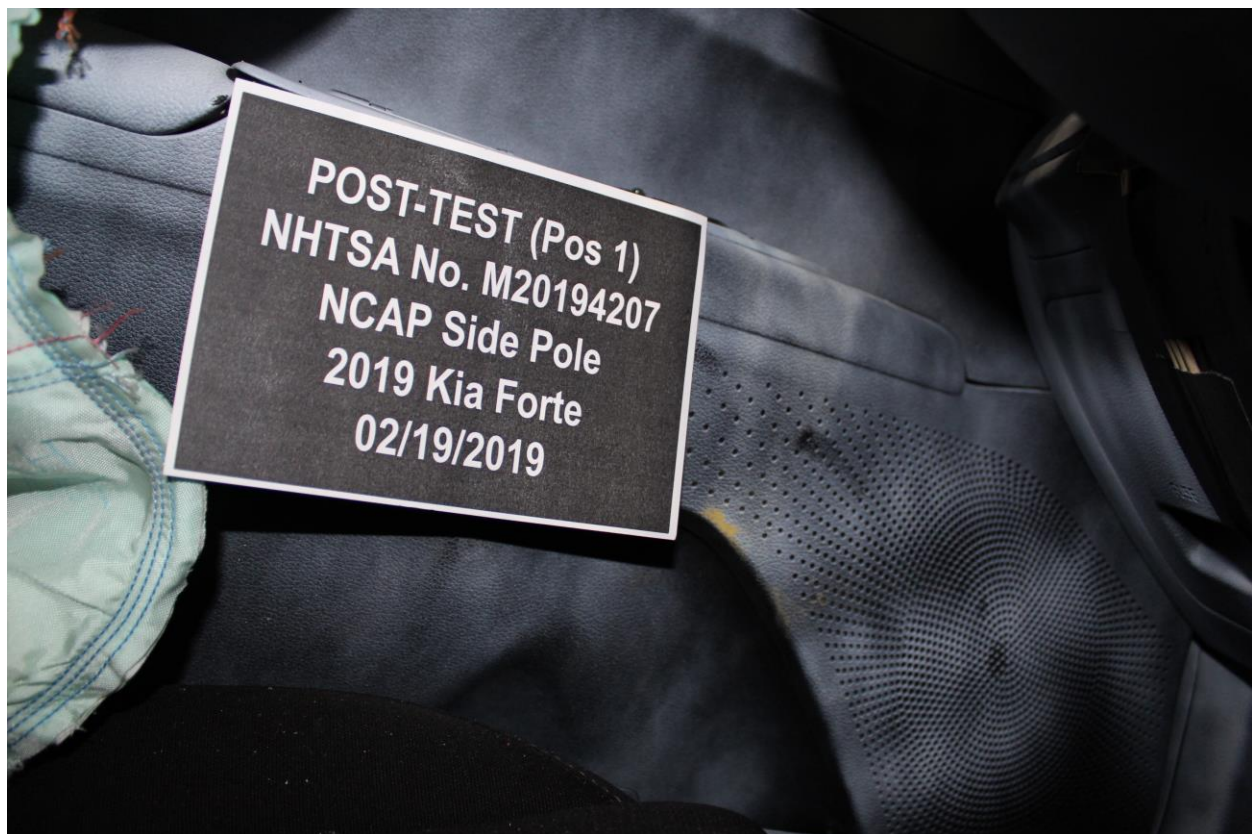
Figure A-52: Post-Test Dummy Close-Up Knee Contact with Vehicle Interior View

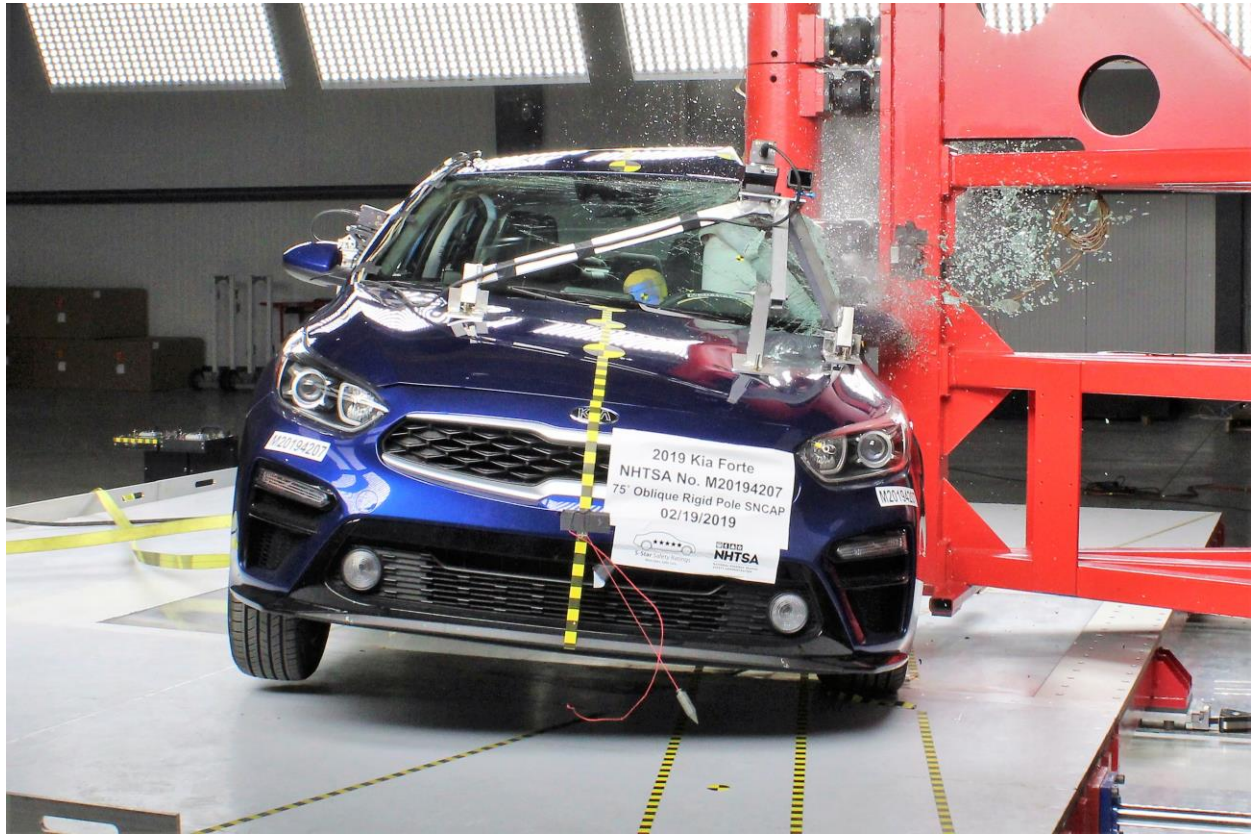
Figure A-68: Impact Event

A rigid pole side impact test was conducted on a 2019 KIA Forte four door sedan. The subject vehicle was towed into the rigid pole at an angle of 75° and a velocity of 32.21 km/h. The test was conducted by Calspan Corporation's Transportation Test Operations facility in Buffalo, New York on February 19, 2019. Pre-test and post-test photographs of the test vehicle and side impact dummy (SID-IIs) are included in Appendix A of this report.

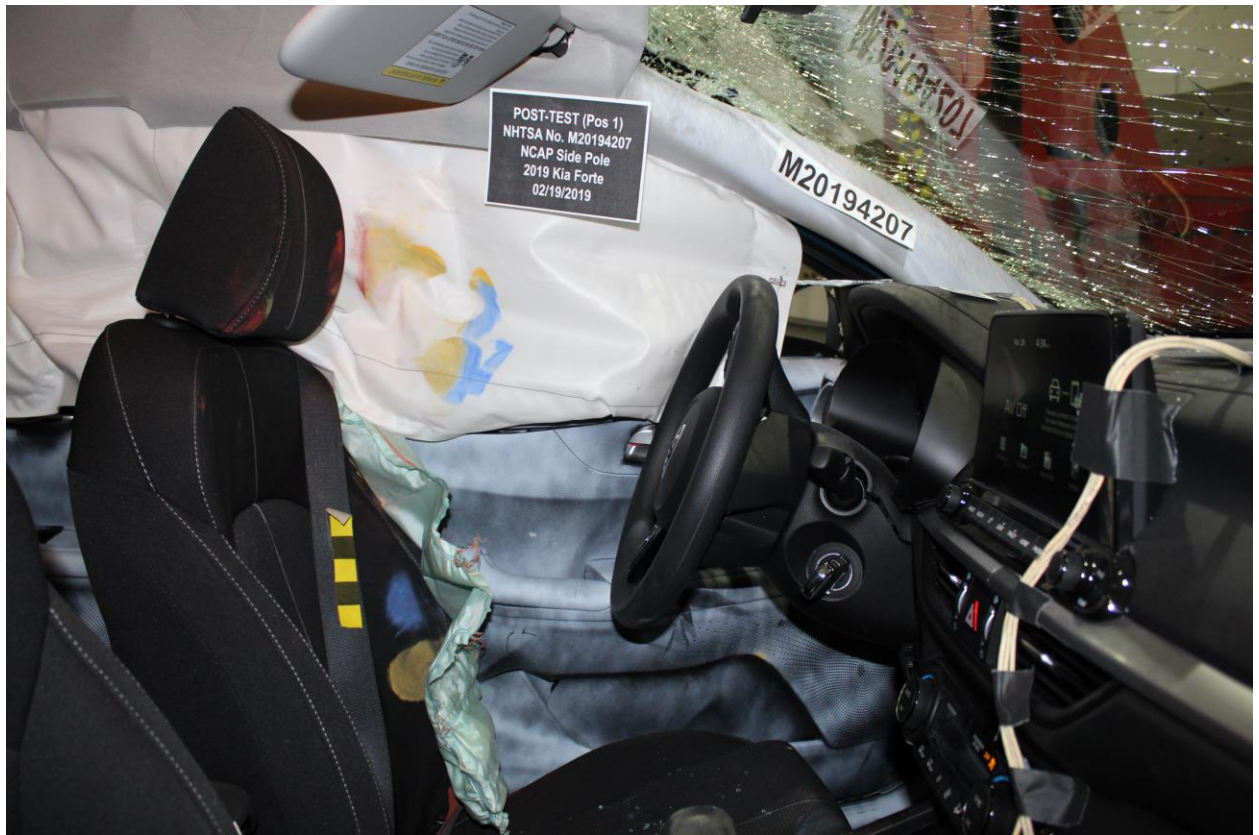
Figure A-71: Post-Test View of Shattered Vehicle Inner Door Panel (if applicable)
