REPORT NUMBER: SINCAP-CAL-19-004

**NEW CAR ASSESSMENT PROGRAM (NCAP)
MOVING DEFORMABLE BARRIER SIDE IMPACT TEST**

**KIA Motors Mexico S.A. de C.V.
2019 KIA Forte
Four Door Sedan**

NHTSA No: M20194208

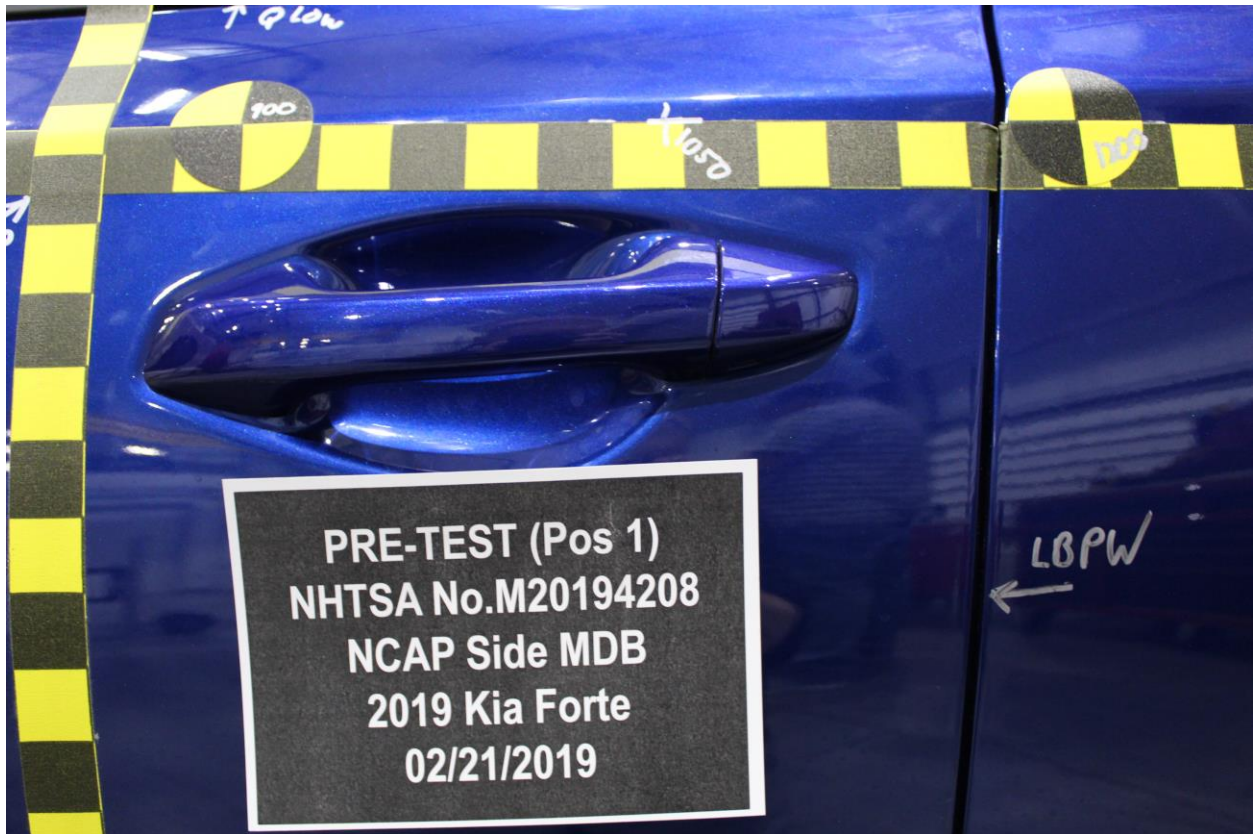
Figure A-21: Pre-Test Left Front Door Latch Close-Up

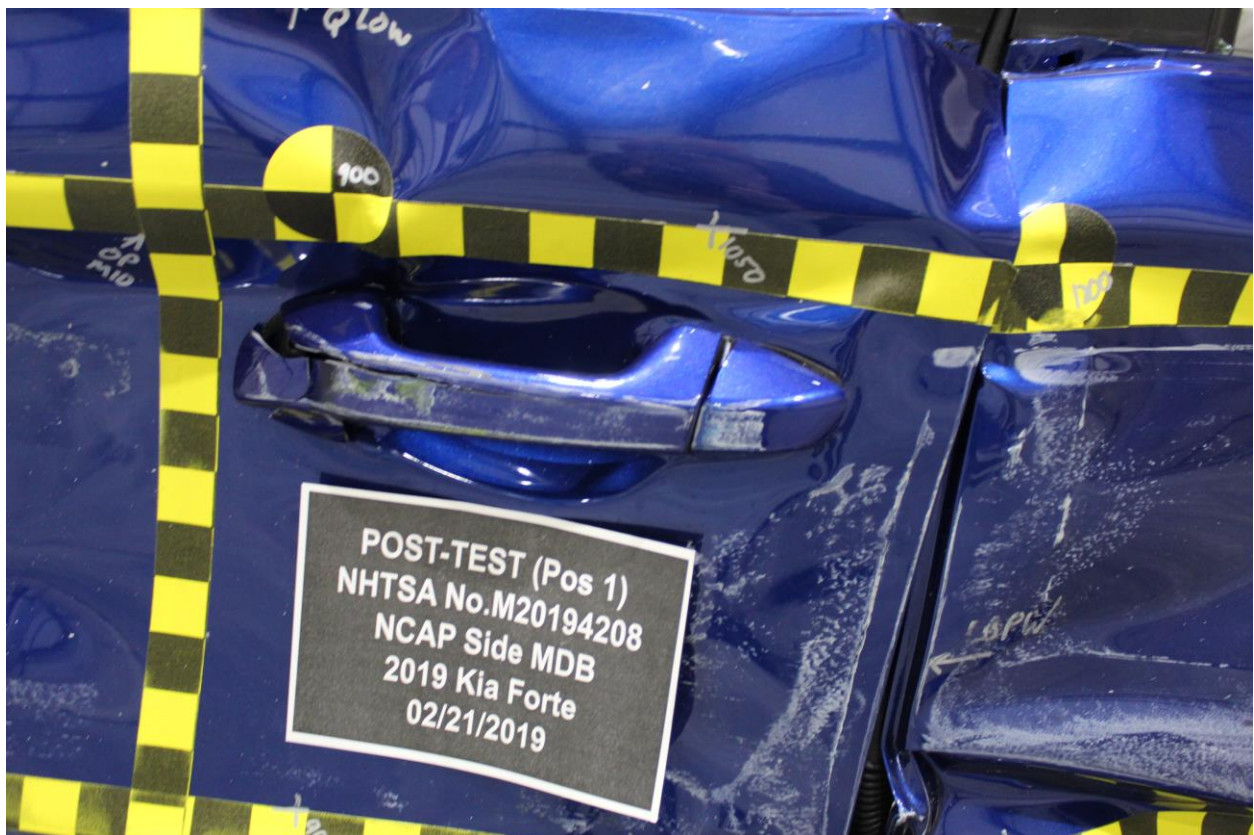
Figure A-22: Post-Test Left Front Door Latch Close-Up

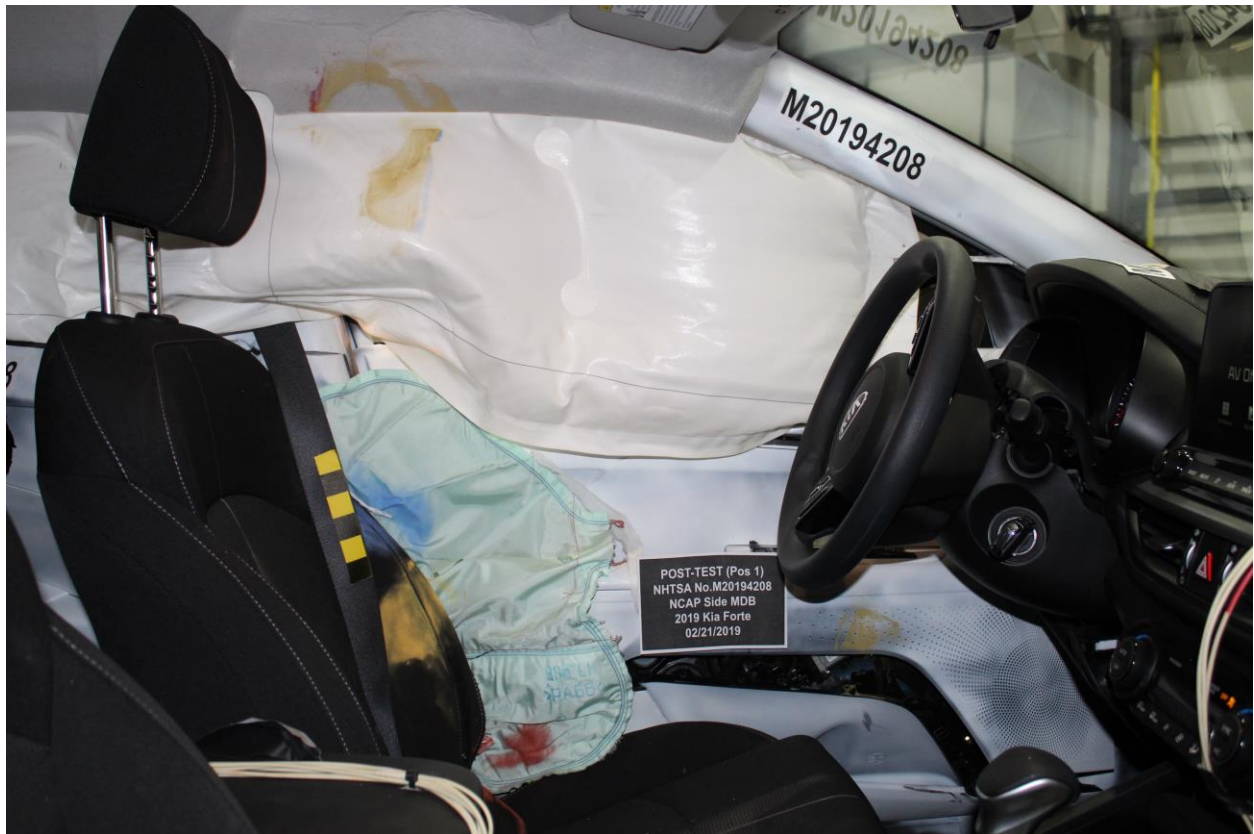
Figure A-47: Post-Test Driver Inner Door Panel View Showing Driver Dummy Contact Locations

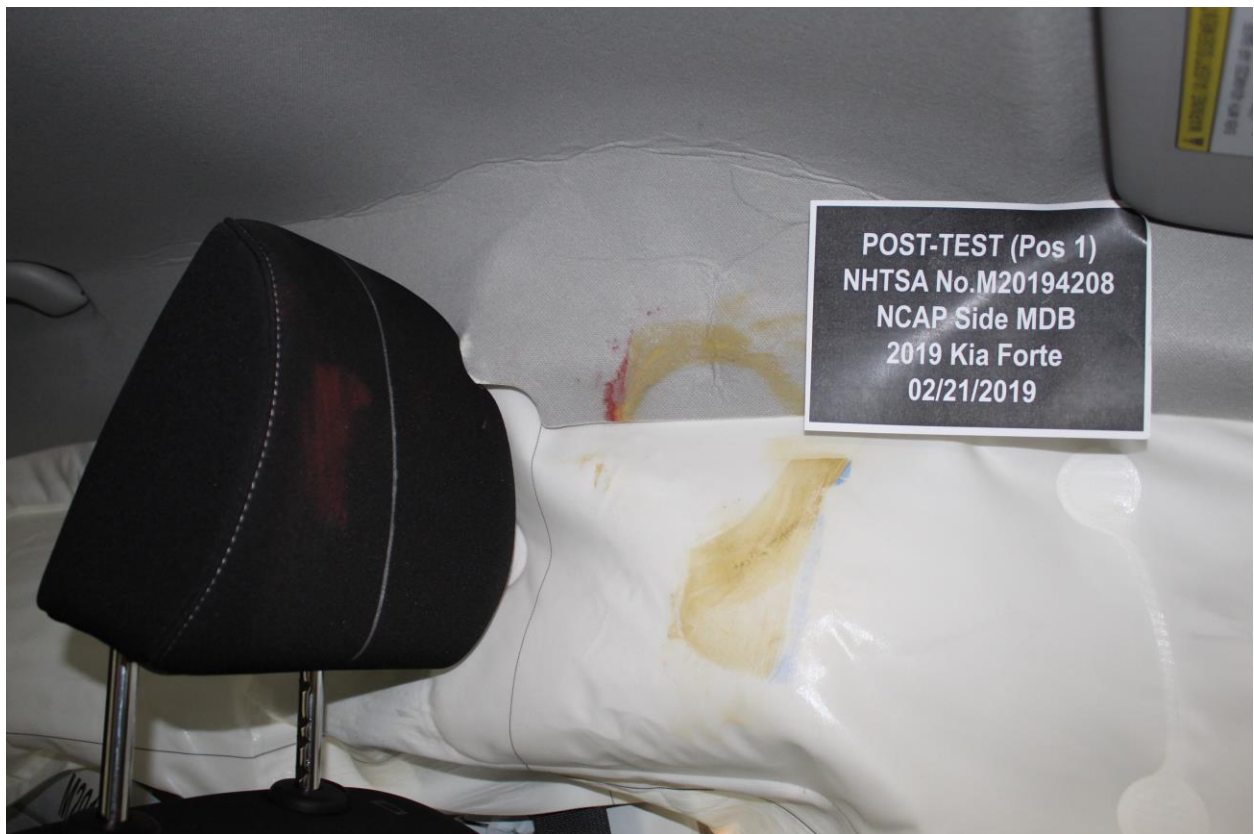
Figure A-48: Post-Test Driver Dummy Close-Up Head Contact with Vehicle View

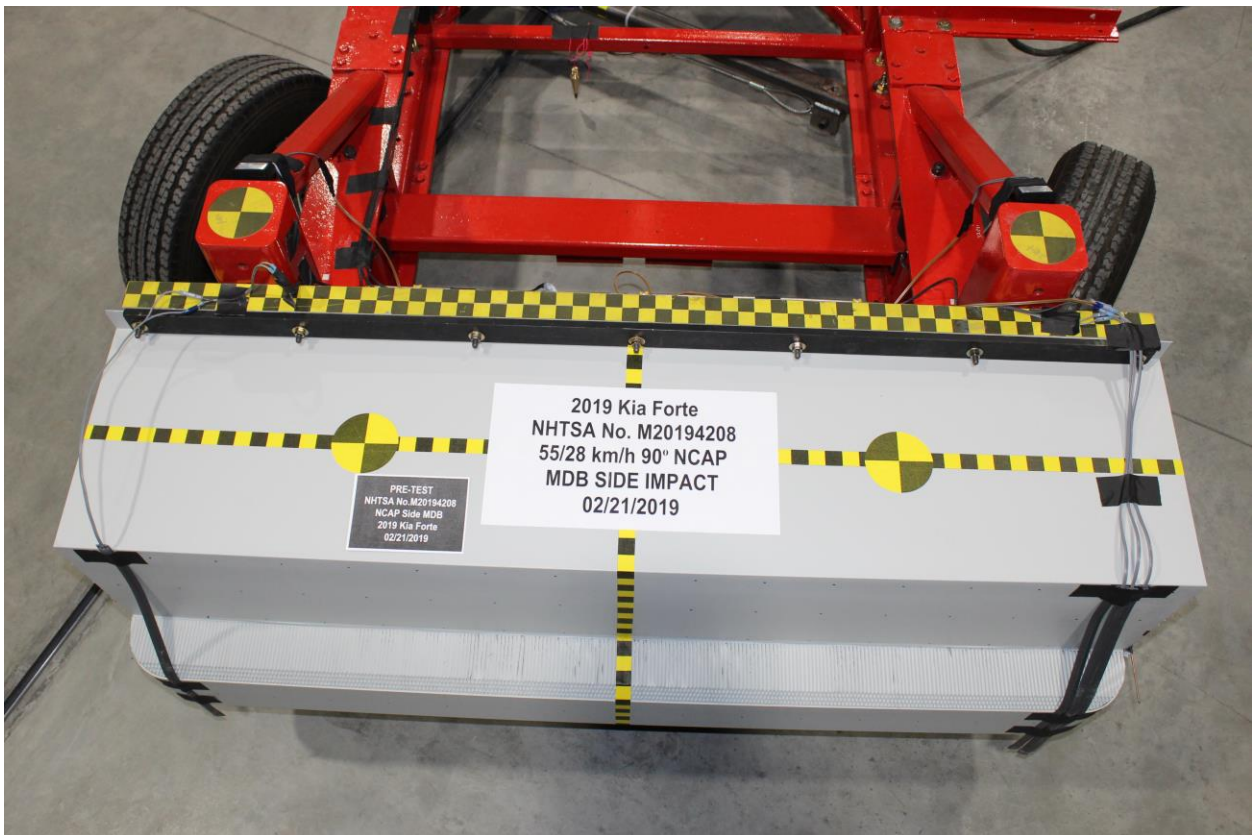
Figure A-86: Pre-Test Top View of MDB Impactor Face
