**FINAL REPORT NUMBER: SINCAP-TRC-19-002**

**NEW CAR ASSESSMENT PROGRAM (NCAP)  
MOVING DEFORMABLE BARRIER SIDE IMPACT TEST**

**GENERAL MOTORS LLC  
2019 Cadillac XT4 SUV  
NHTSA NUMBER: M20190102**

**Report Date: May 13, 2019**

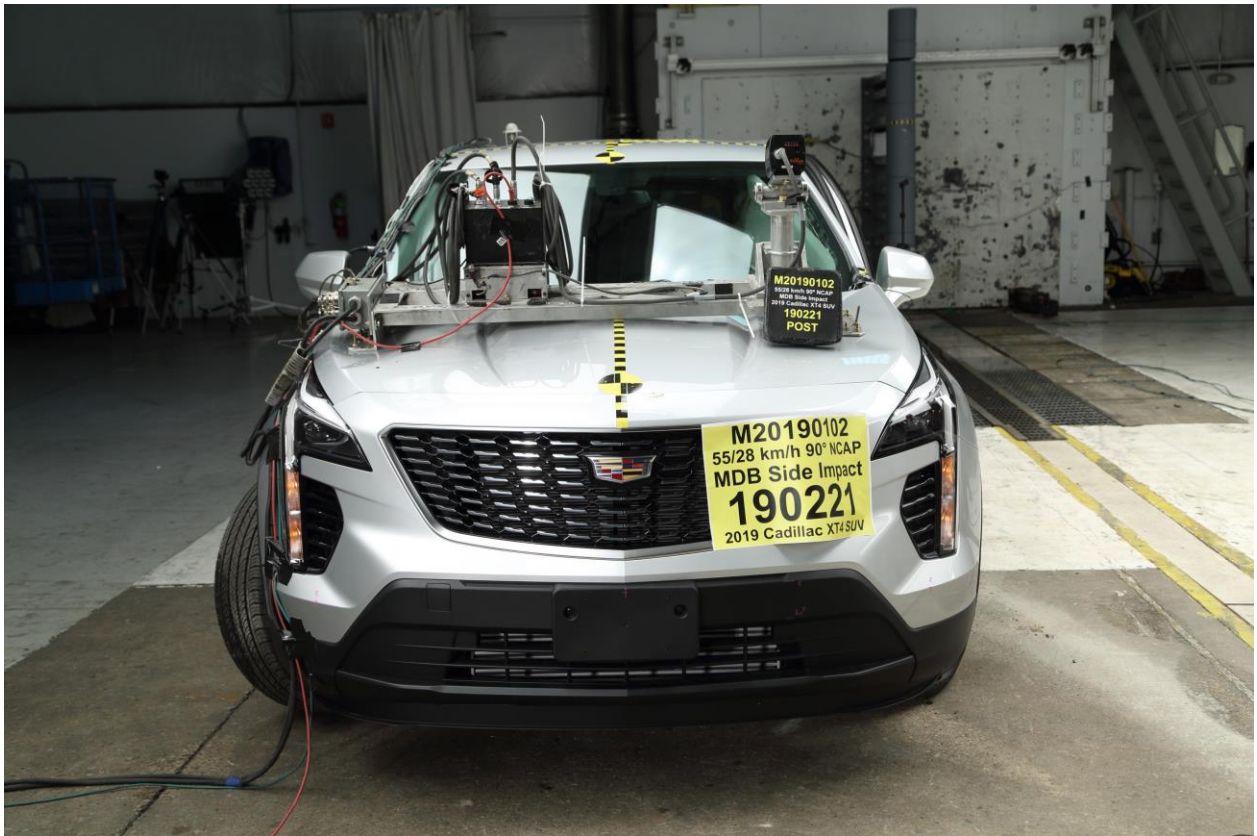
**004** Post-Test Frontal View of Test Vehicle

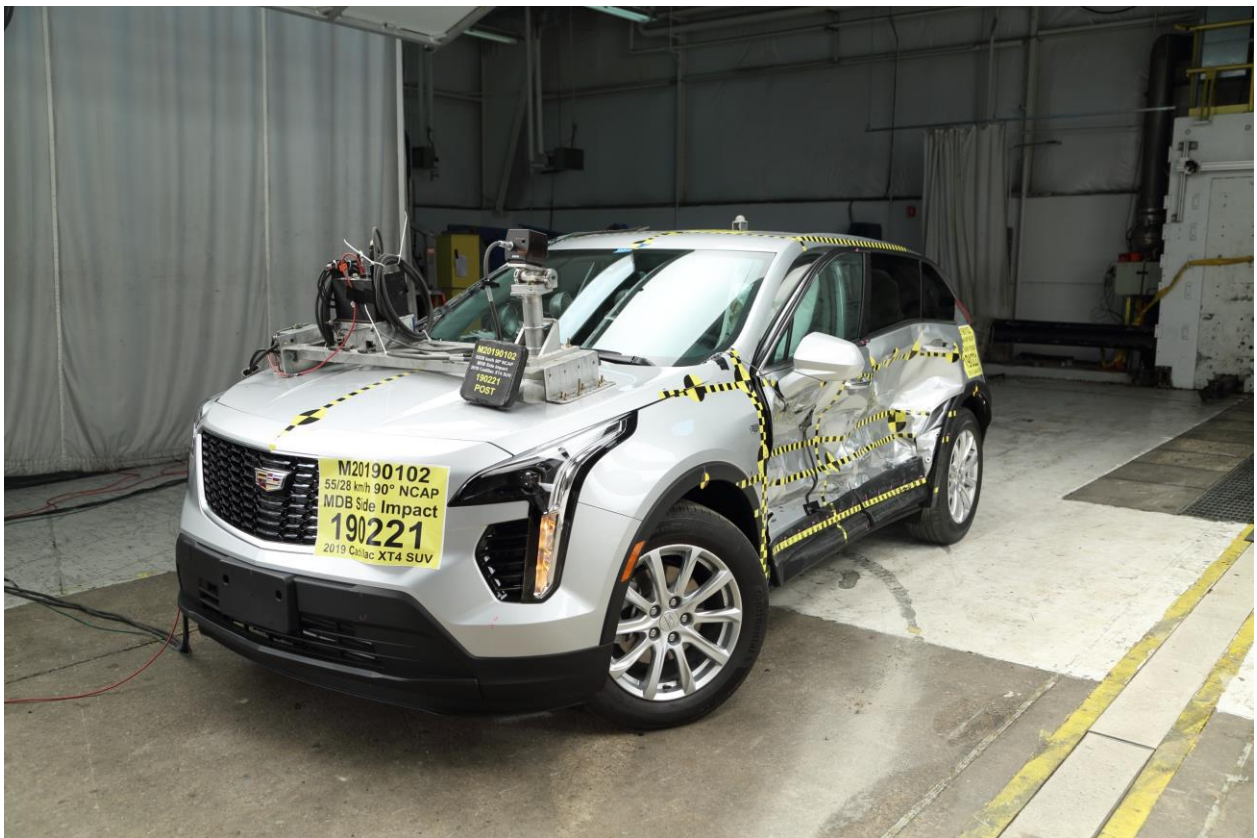
**006** Post-Test Left Front  $\frac{3}{4}$  View of Test Vehicle

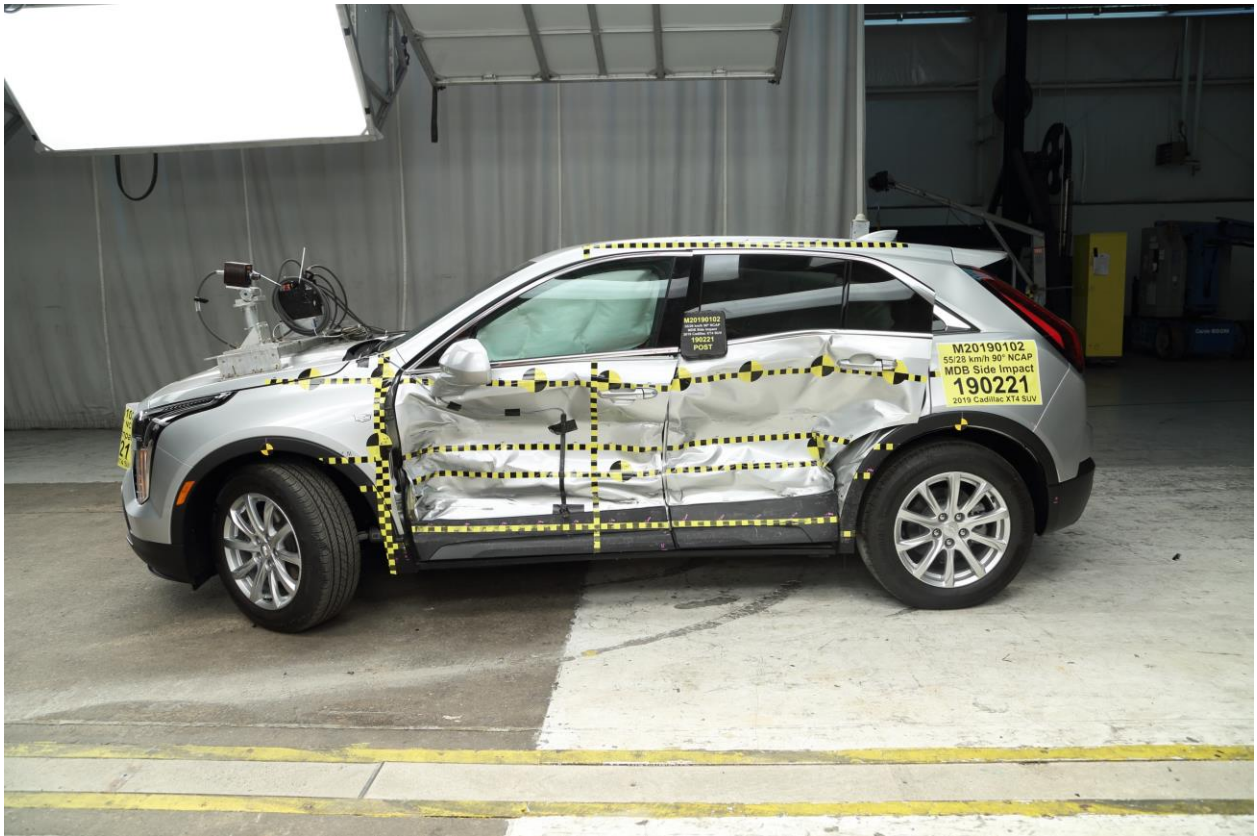
**008** Post-Test Left Side View of Test Vehicle

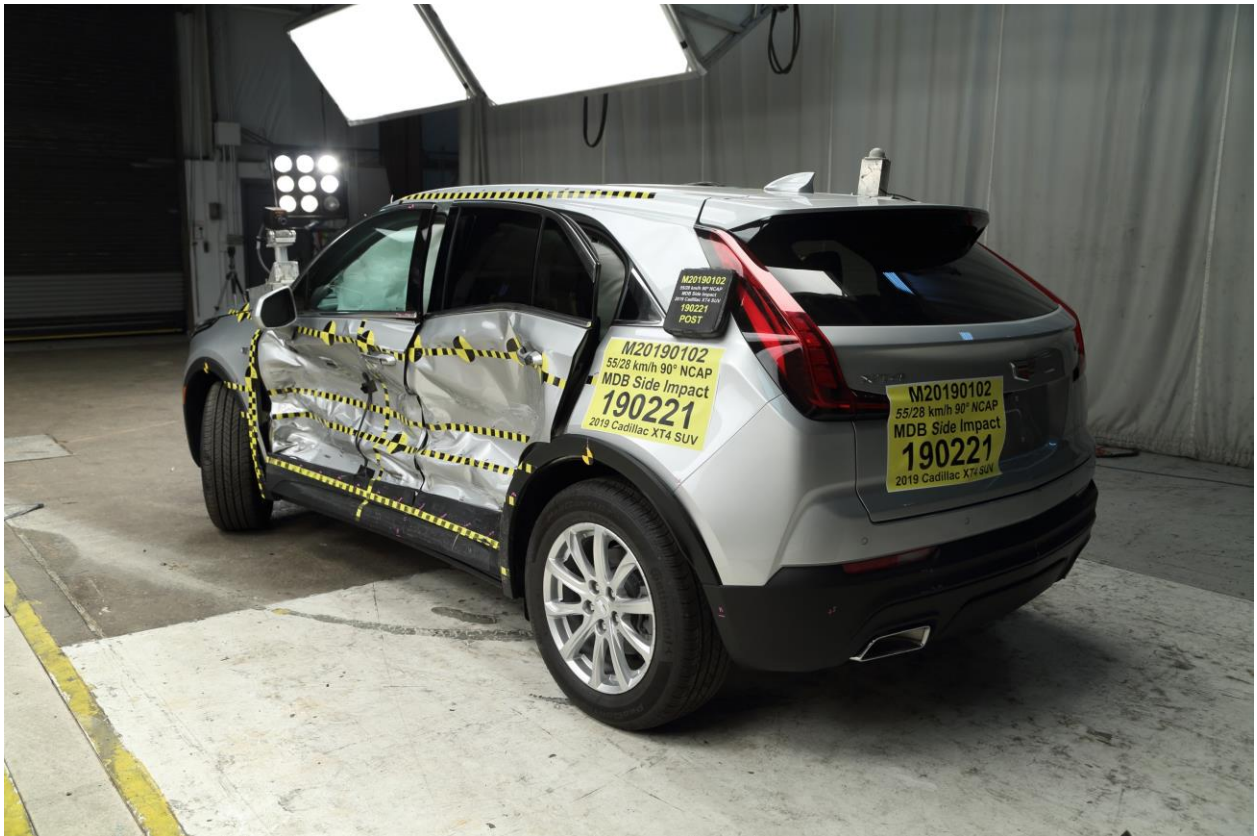
**010** Post-Test Left Rear  $\frac{3}{4}$  View of Test Vehicle

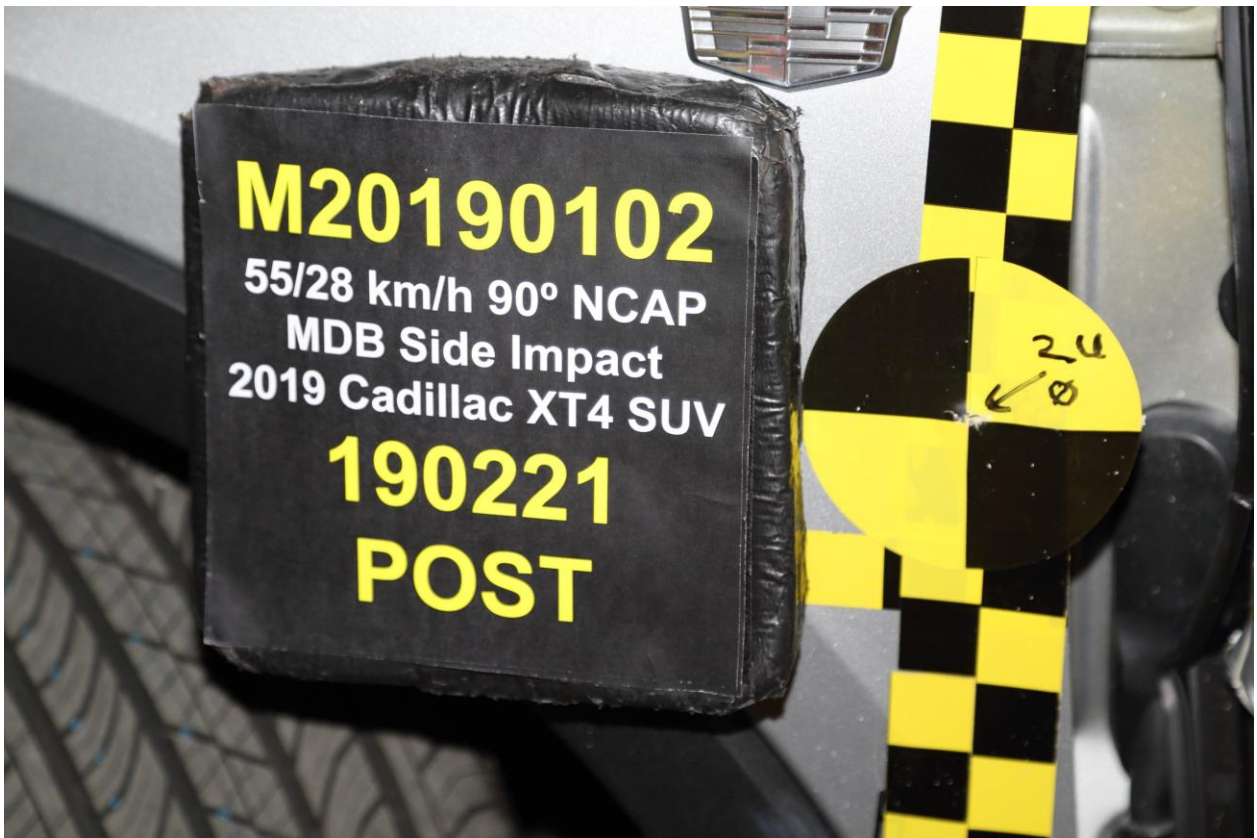
020 Post-Test Close-Up View of Impact Point Target

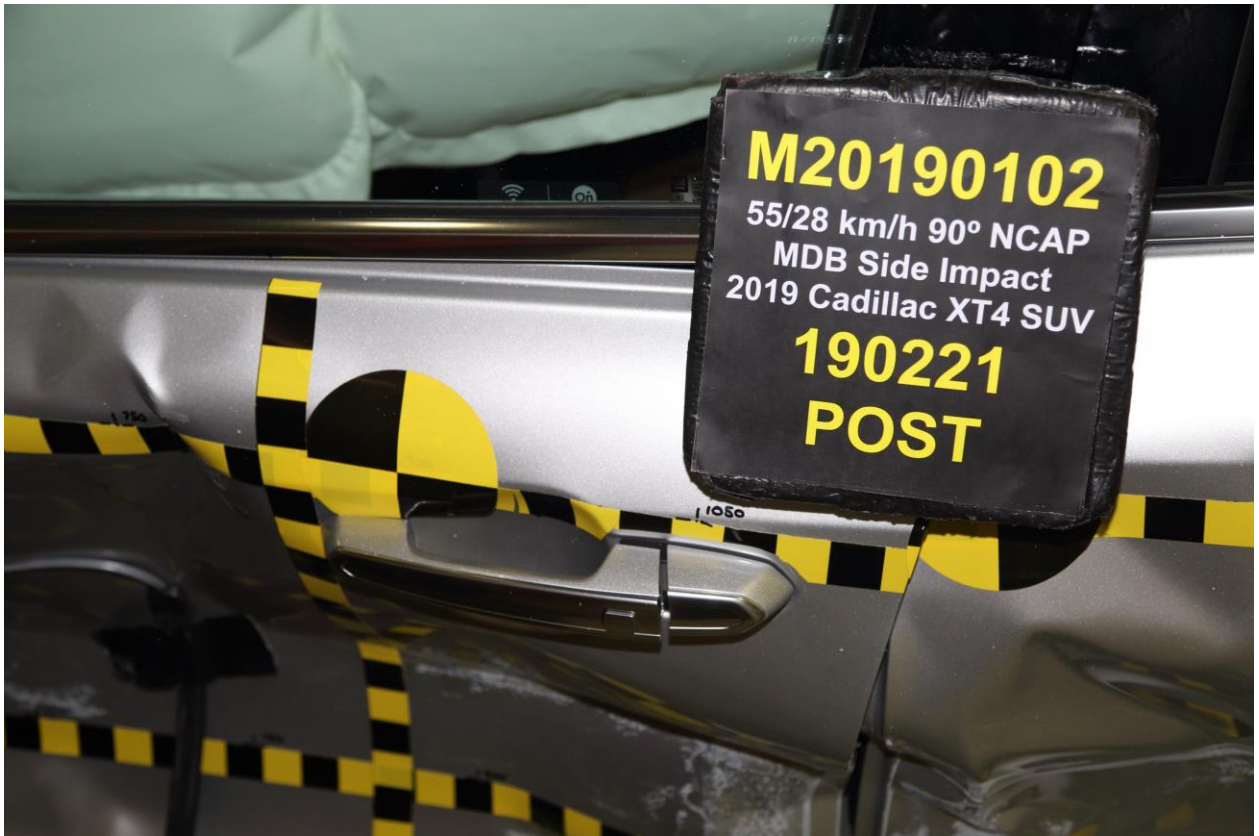
022 Post-Test Left Front Door Latch Close-Up

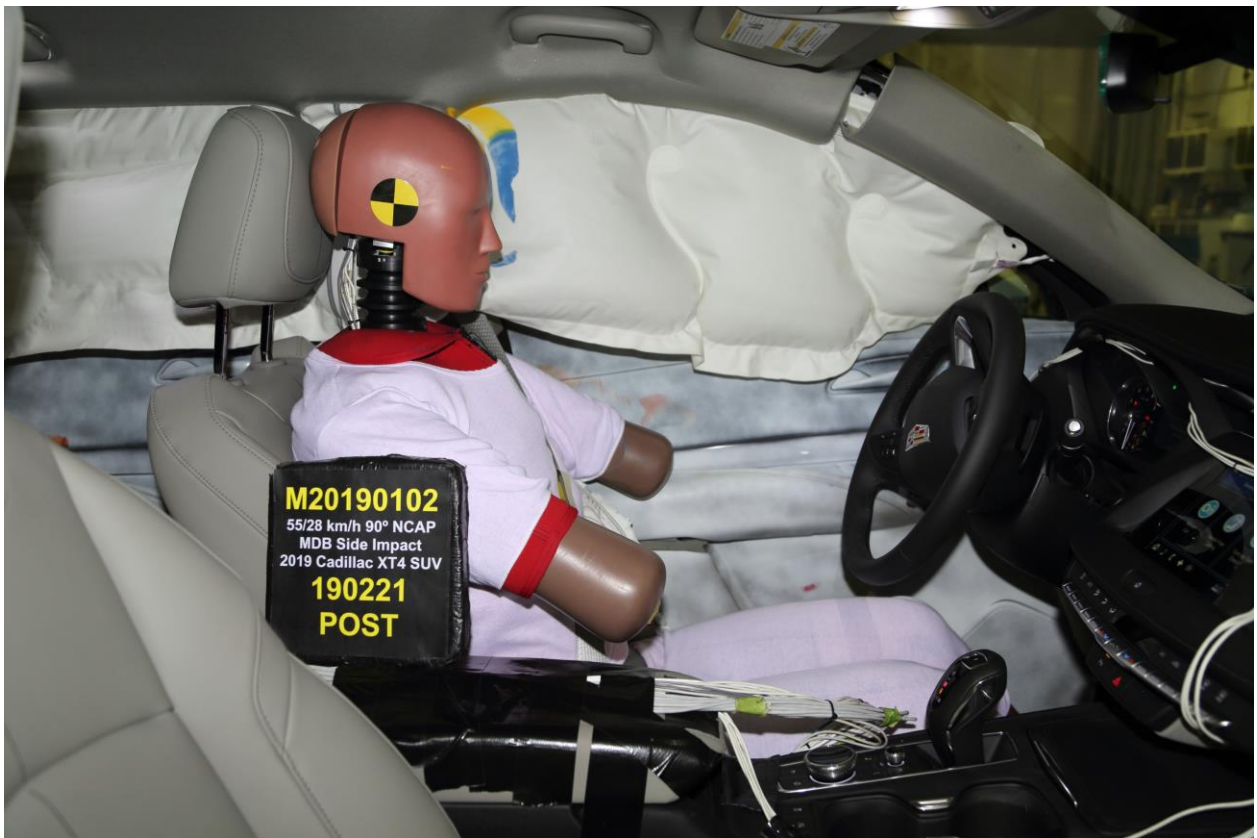
**045** Post-Test Right Side View of Driver Dummy and Front Seat of Occupant Compartment

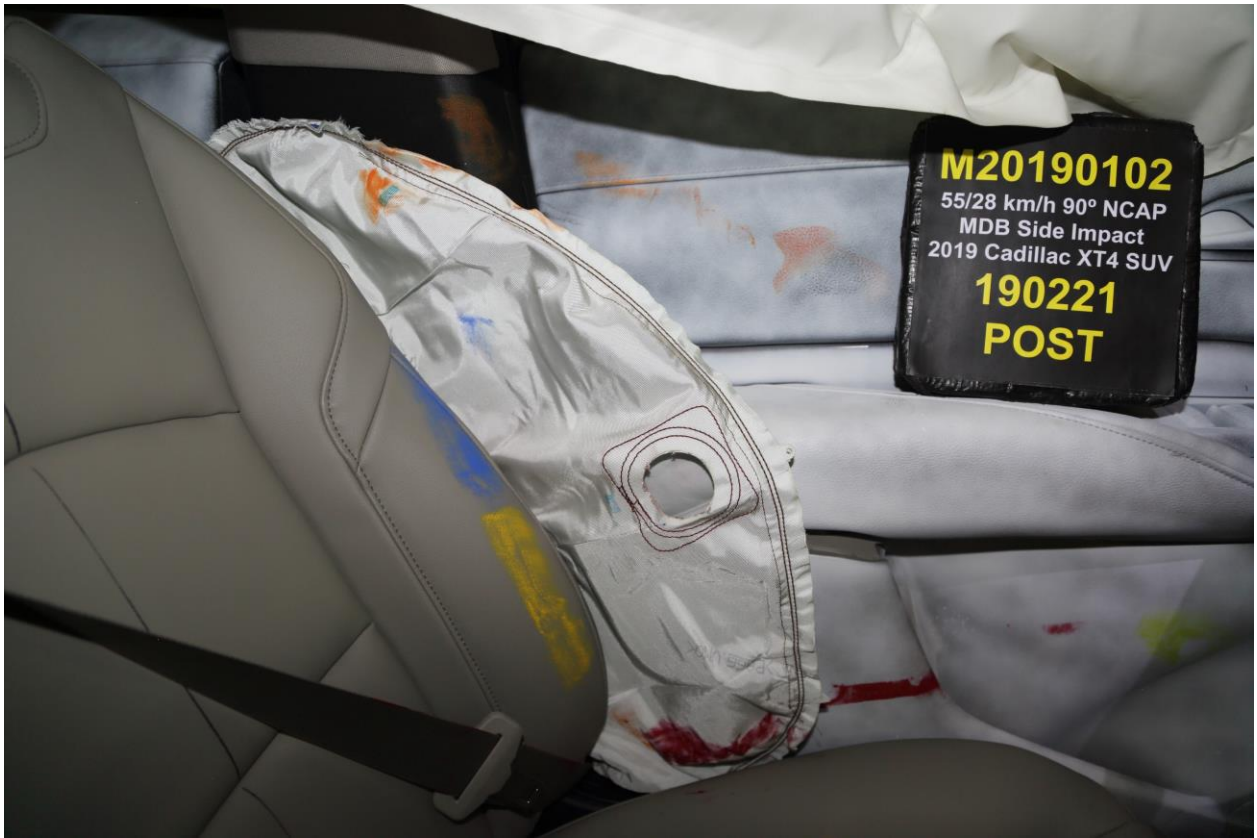
**050** Post-Test Driver Dummy Close-Up Torso Contact with Vehicle Interior View

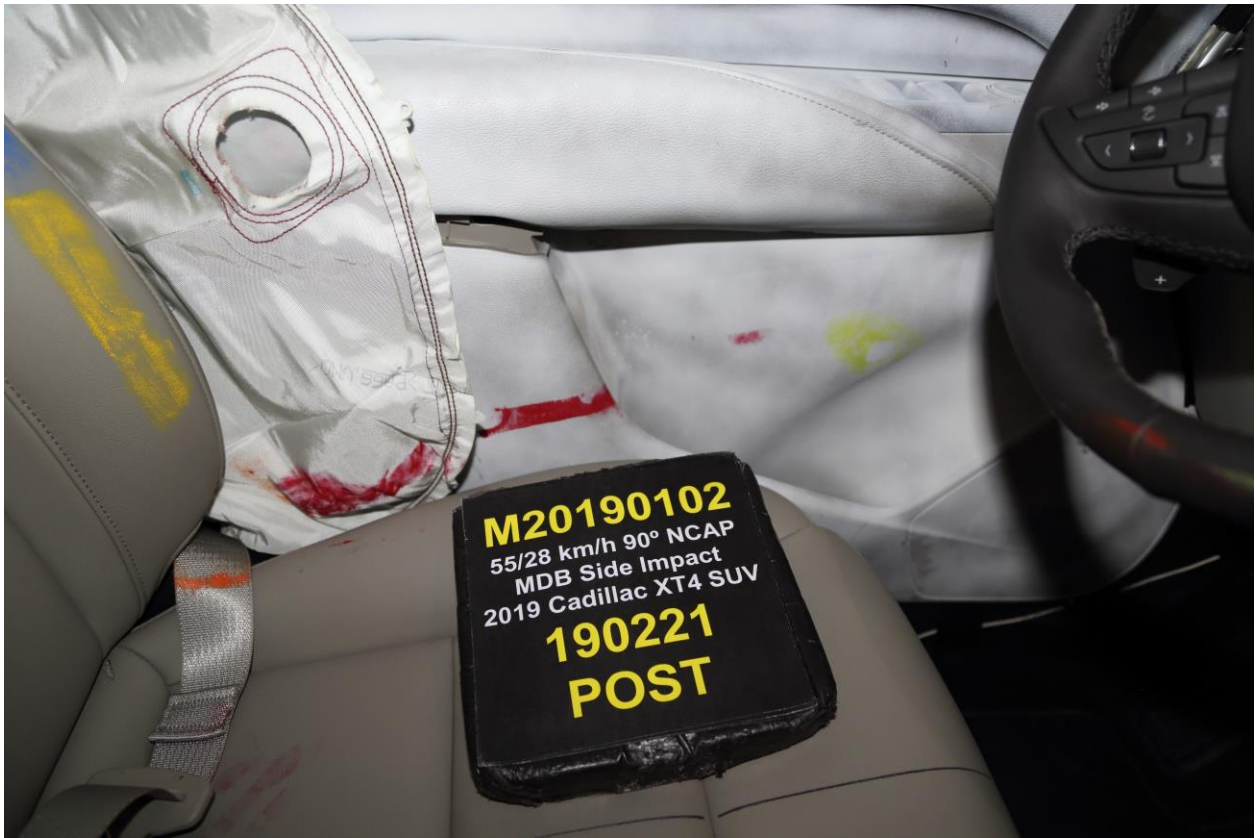
**052** Post-Test Driver Dummy Close-Up Pelvis Contact View

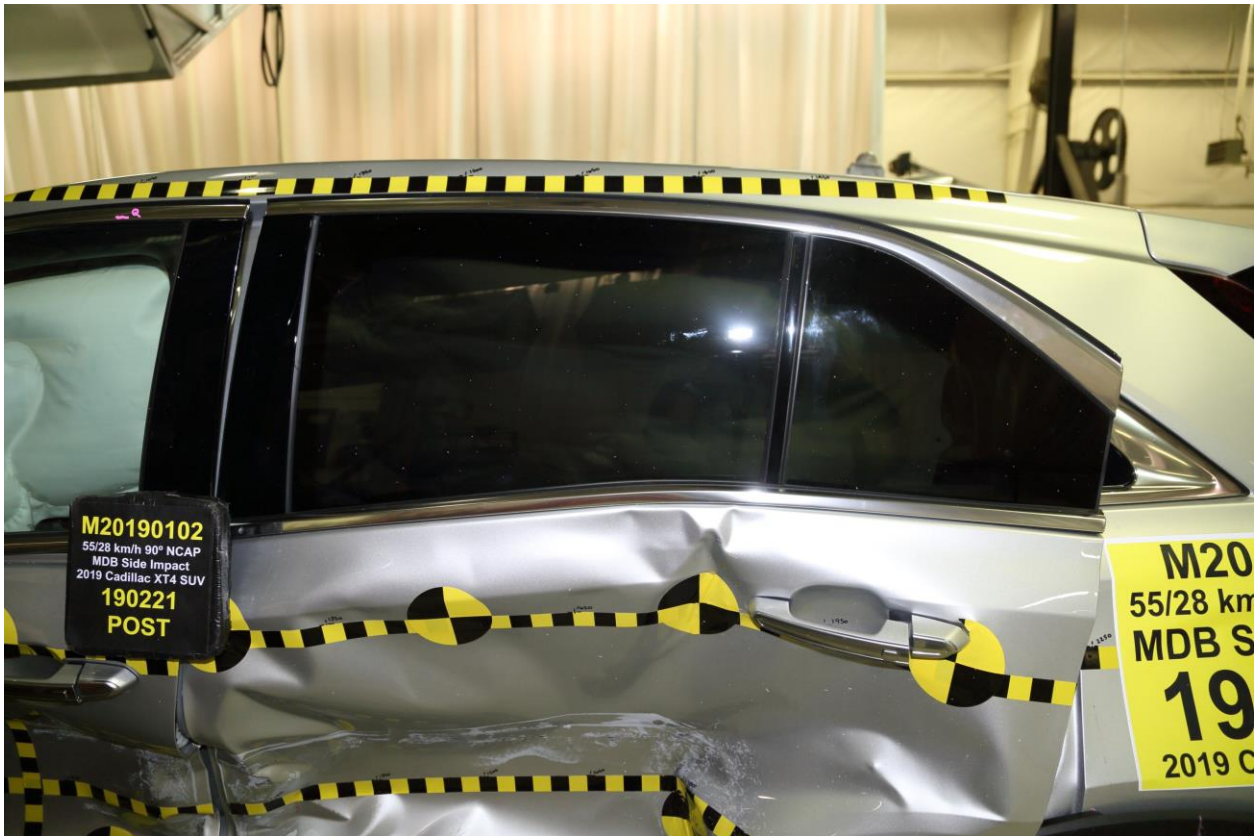
**057** Post-Test Left Side View of Passenger Dummy Shoulder and Door Top View

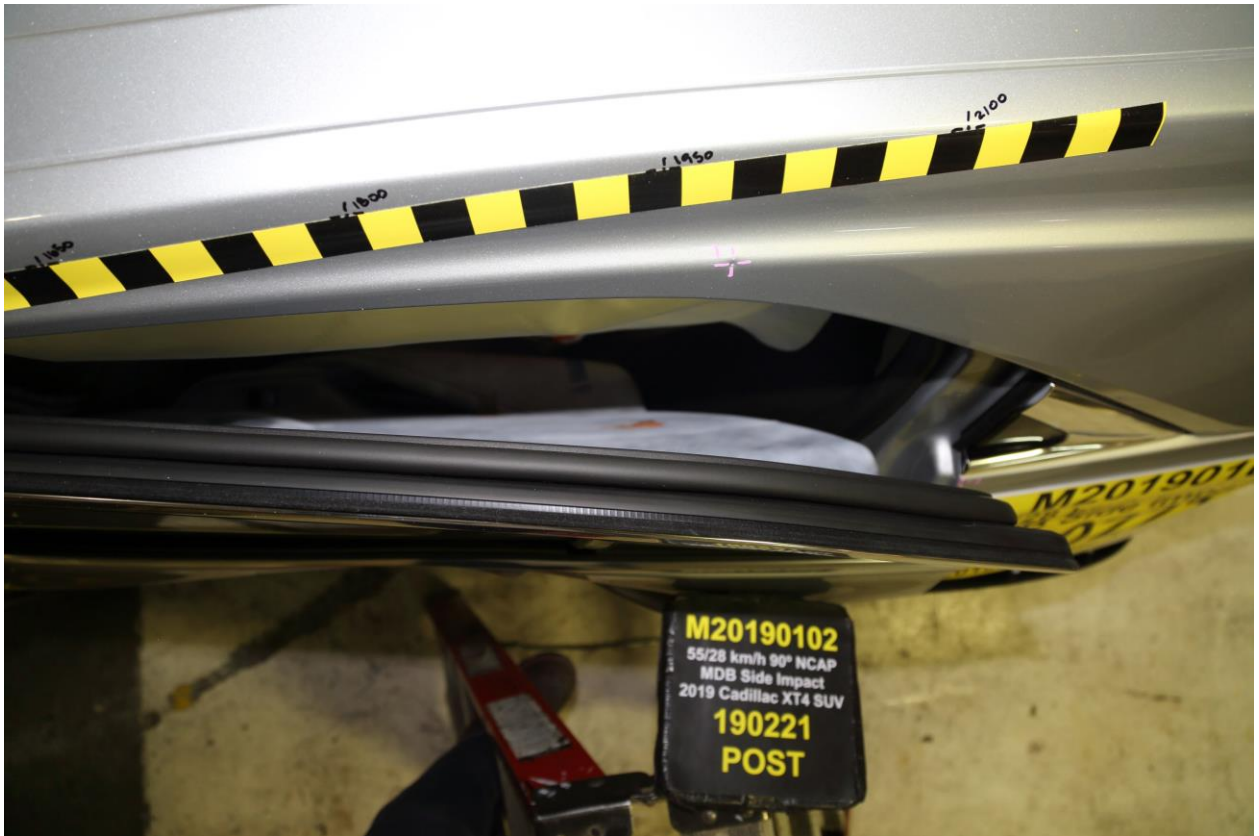
**070** Post-Test Rear Passenger Dummy and Door Clearance View

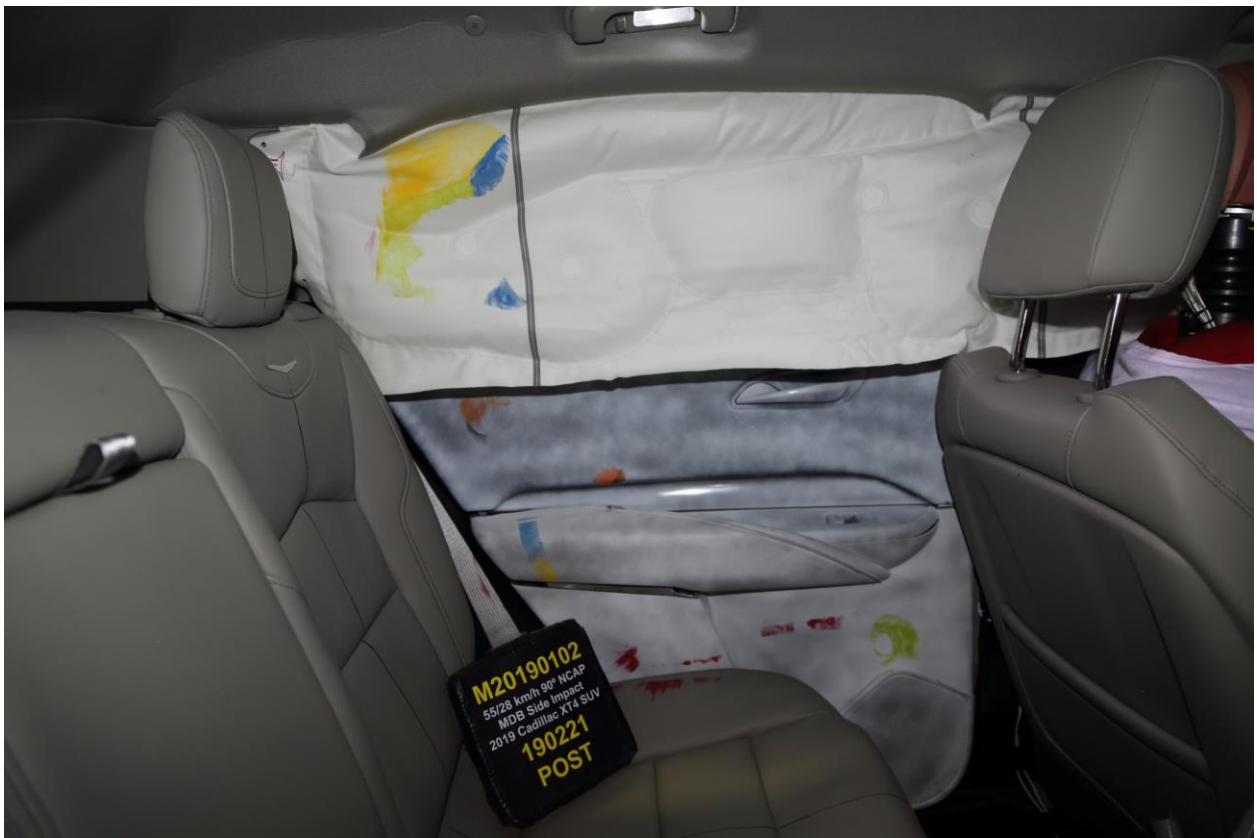
**074** Post-Test Rear Passenger Inner Door Panel View

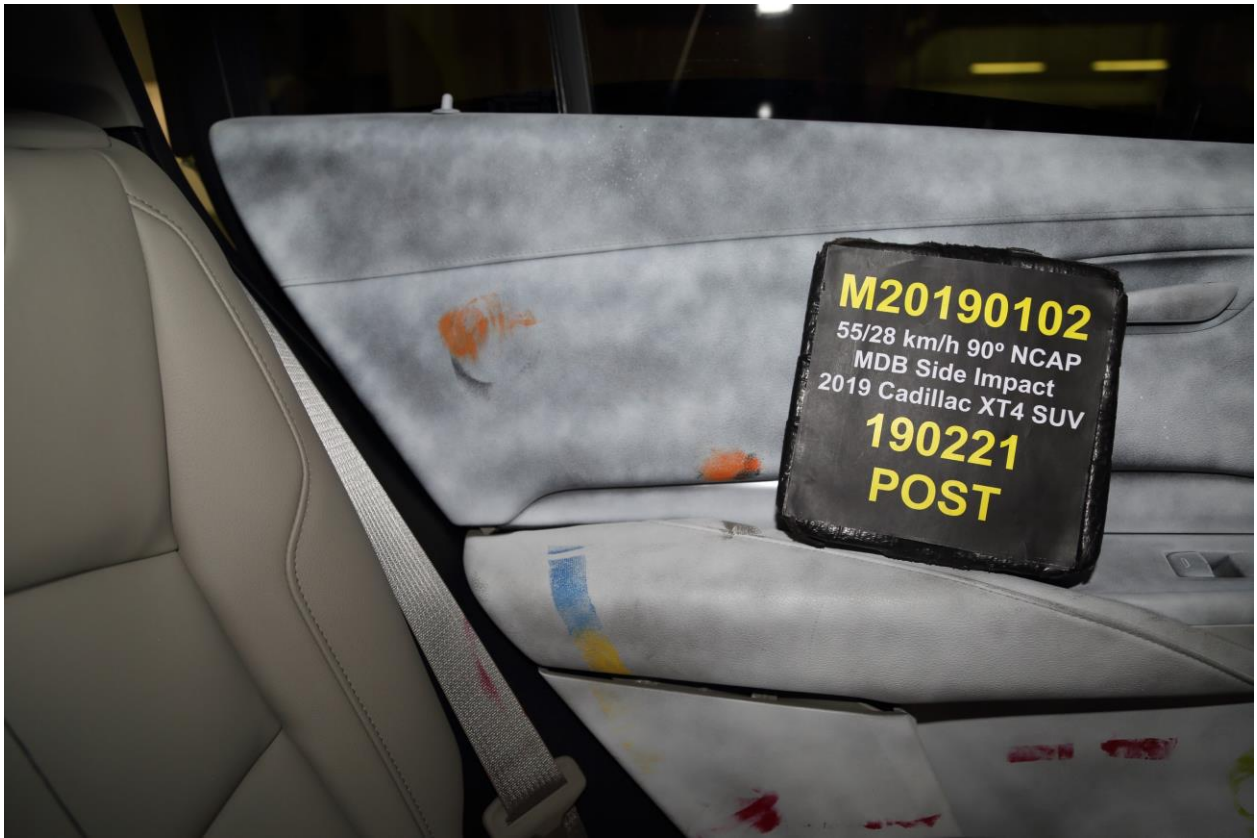
**077** Post-Test Rear Passenger Dummy Close-Up Torso Contact with Vehicle Interior View

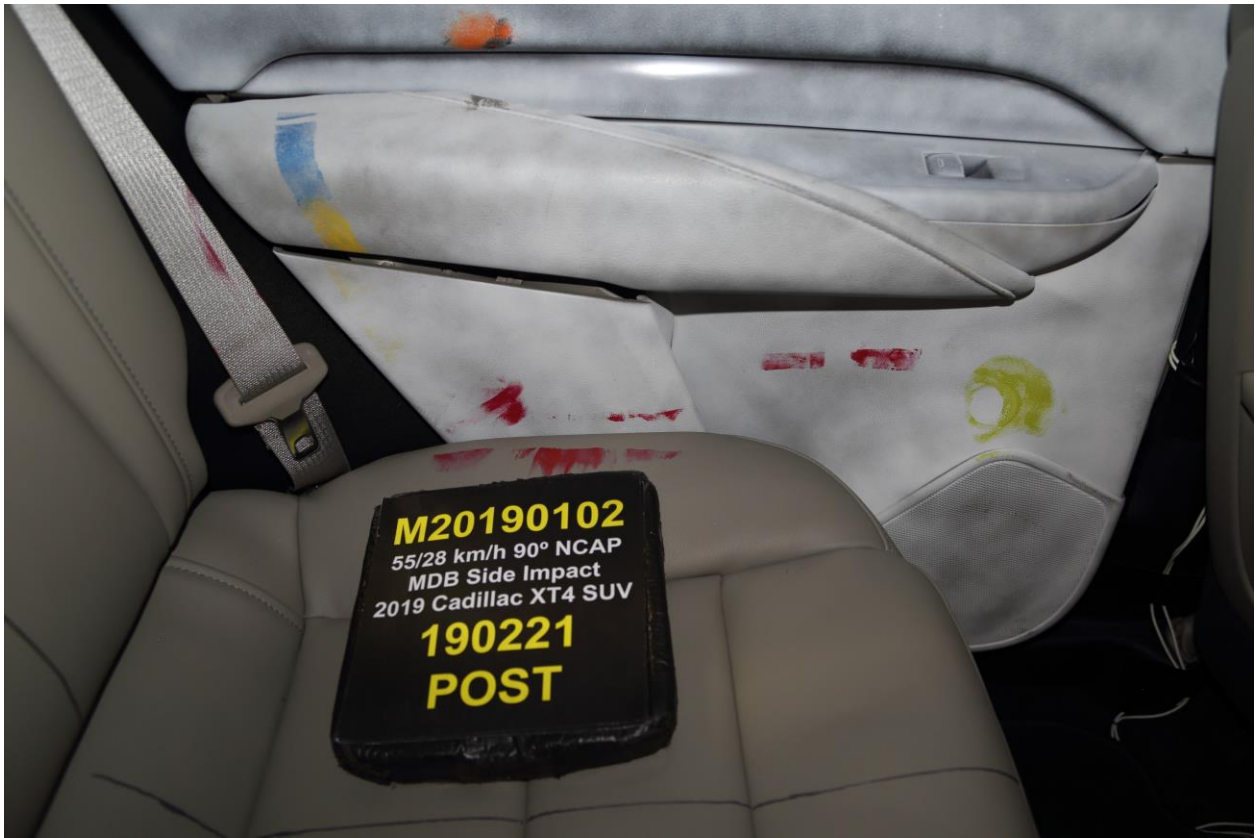
**079** Post-Test Rear Passenger Dummy Close-Up Pelvis Contact View

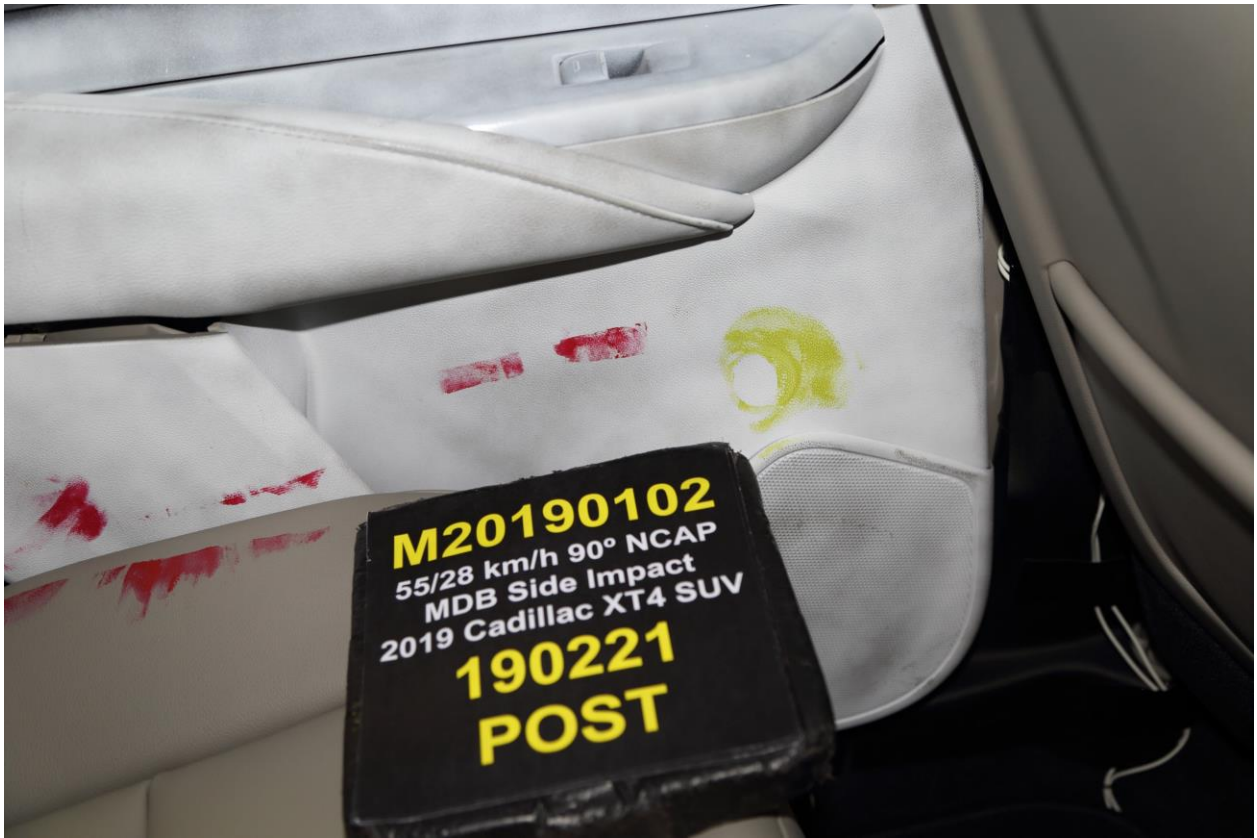
**081** Post-Test Rear Passenger Dummy Close-Up Knee Contact View

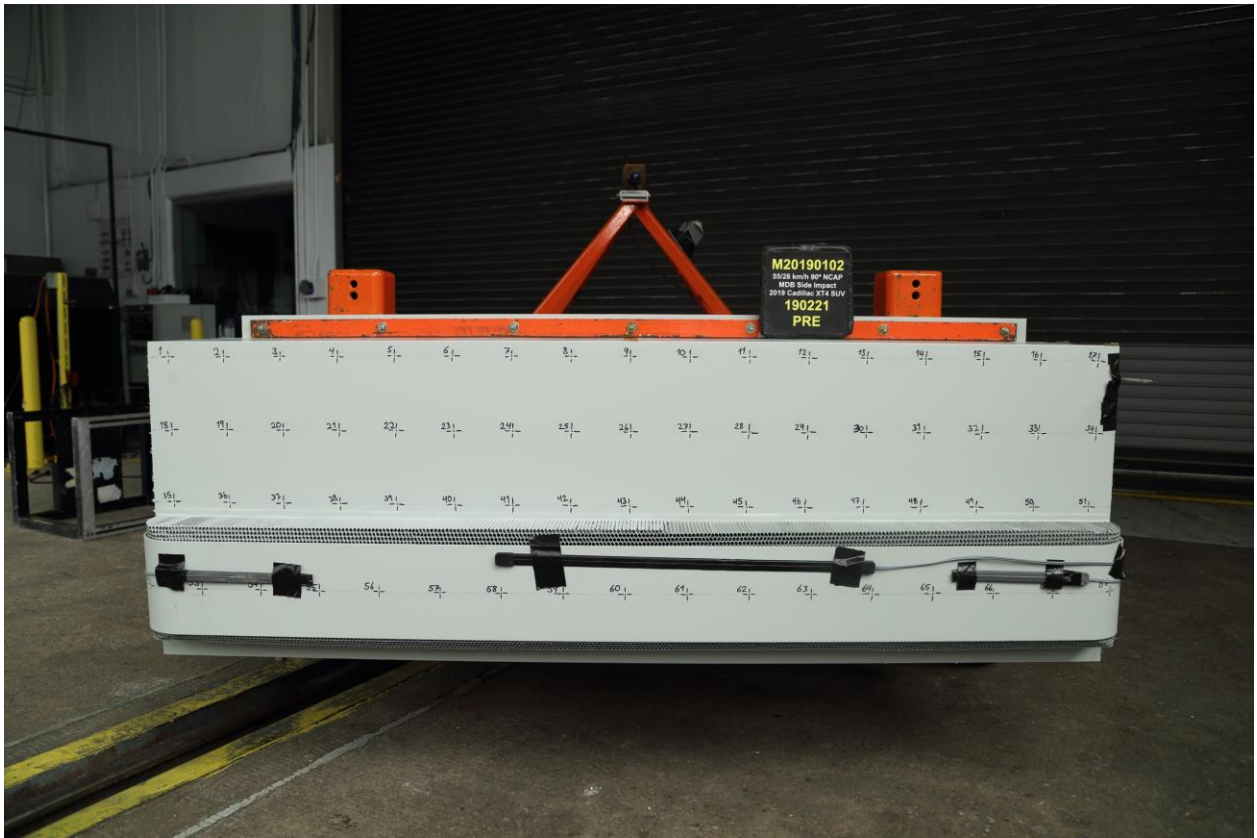
**084** Pre-Test Front View of MDB Impactor Face
