**REPORT NUMBER: SPNCAP-MGA-2019-025**

**NEW CAR ASSESSMENT PROGRAM (NCAP)  
Side Impact Pole Test**

**AUDI AG  
2019 Audi Q8 Premium 5-Door SUV  
NHTSA No.: O20195801**

**MGA RESEARCH CORPORATION  
5000 Warren Road  
Burlington, WI 53105**

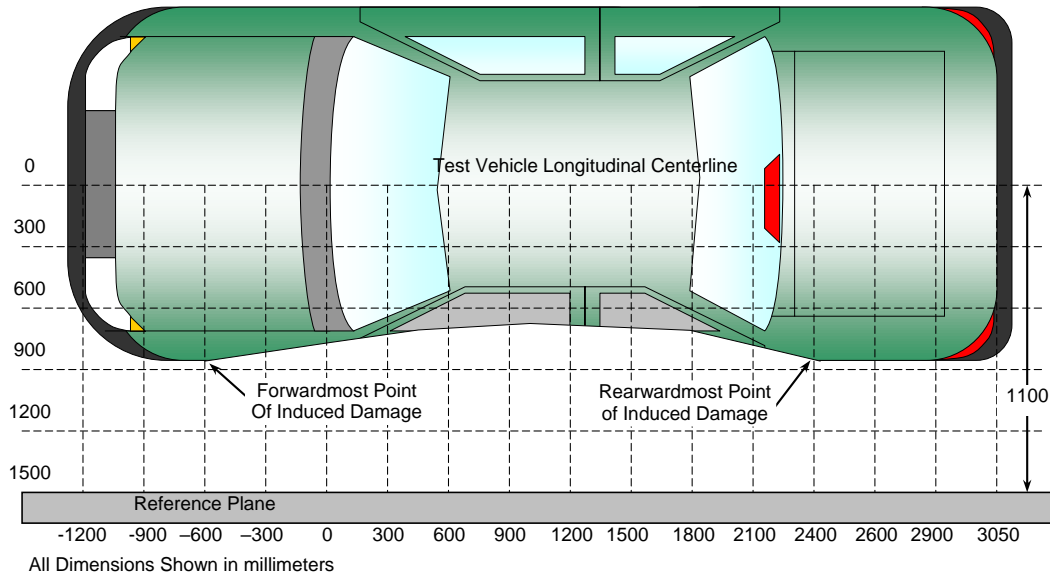
**DATA SHEET NO. 11  
VEHICLE DAMAGE PROFILE DISTANCES**

**TOP VIEW**

**DAMAGE PROFILE DISTANCES**

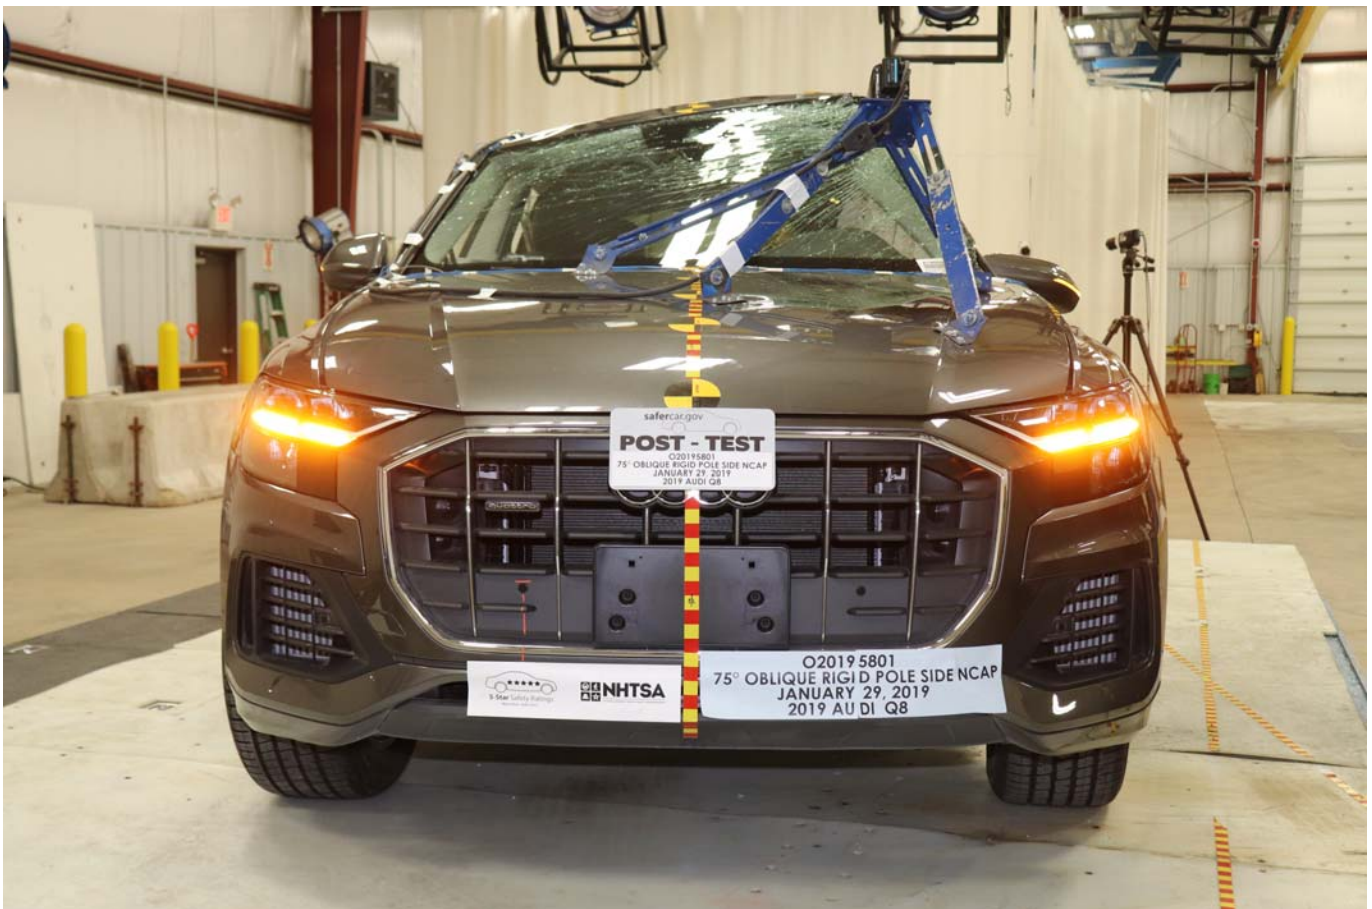
Photo No. 004 - Post-Test Frontal View of Test Vehicle

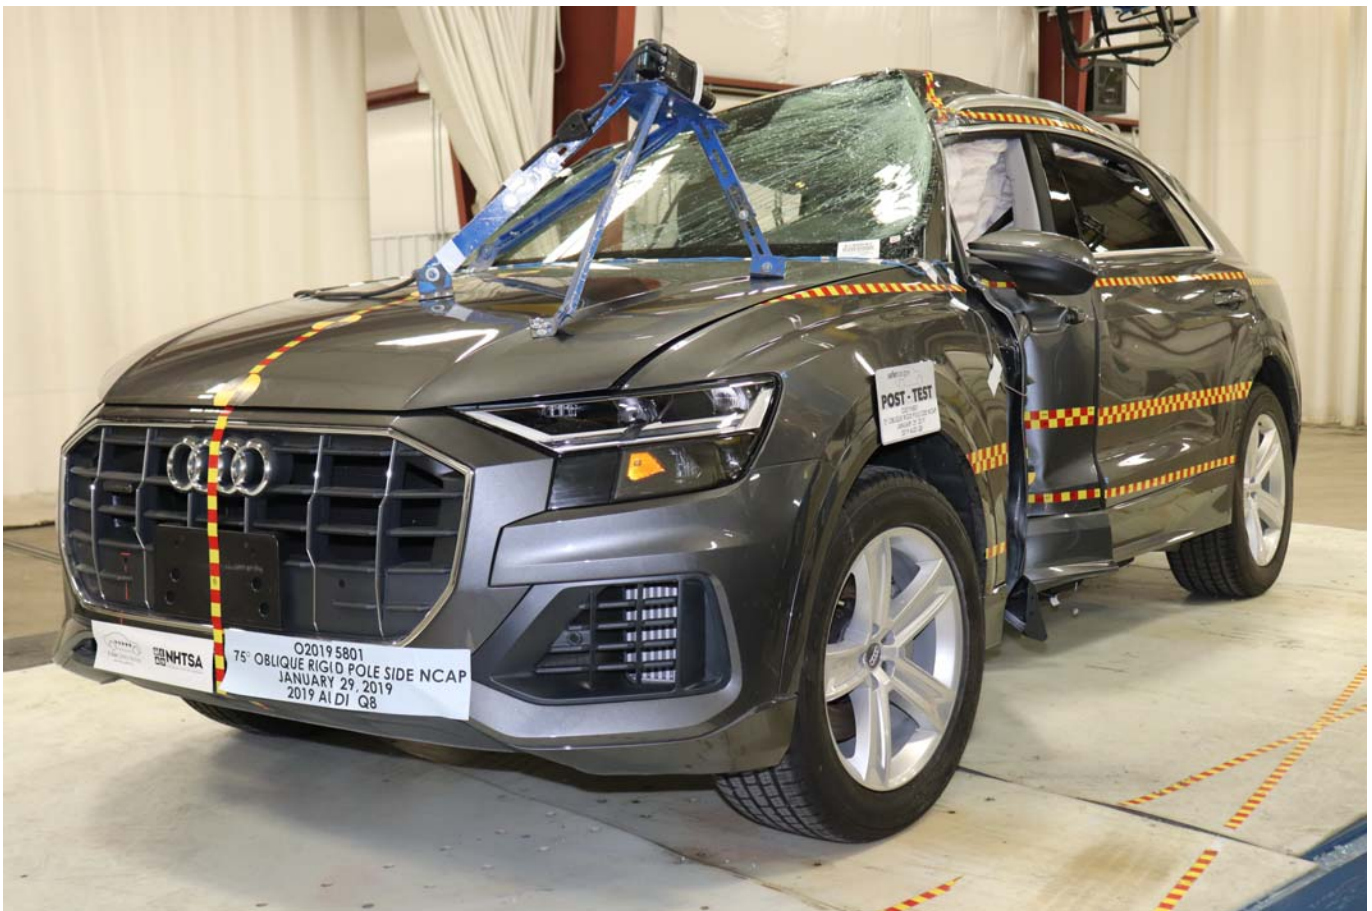
Photo No. 006 - Post-Test Left Front Three-Quarter View of Test Vehicle

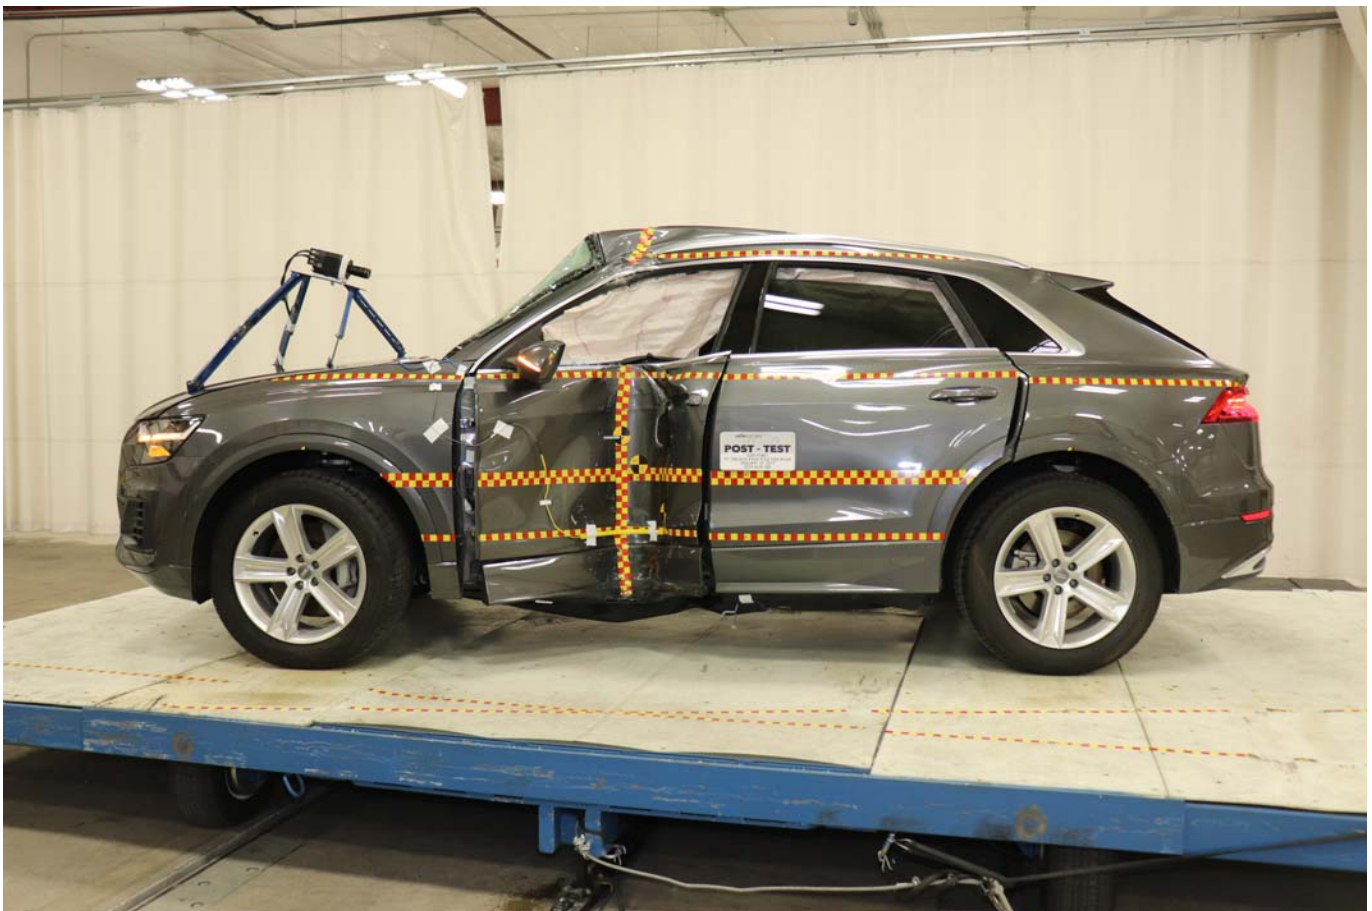
Photo No. 008 - Post-Test Left Side View of Test Vehicle

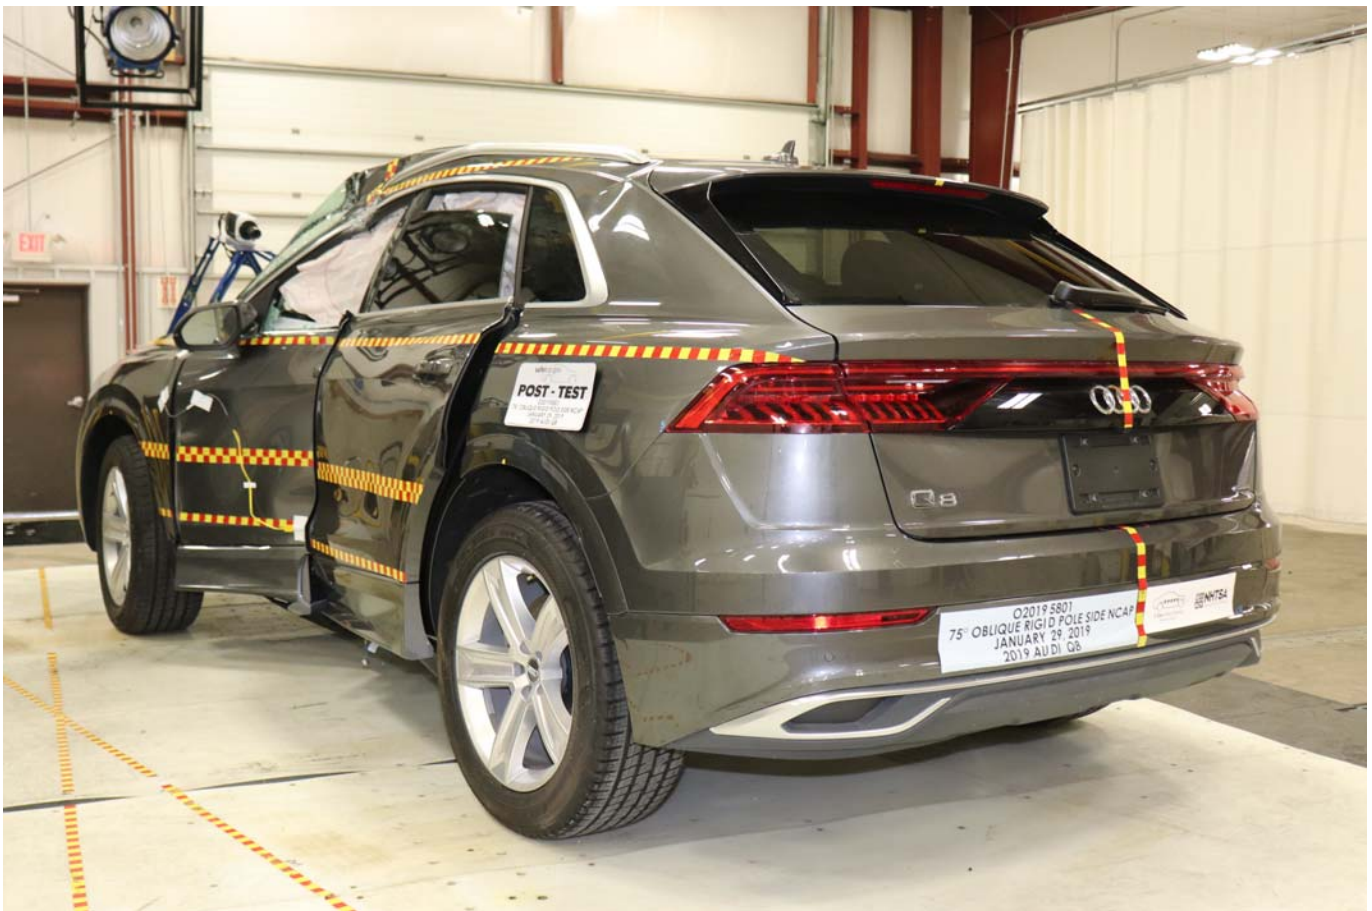
Photo No. 010 - Post-Test Left Rear Three-Quarter View of Test Vehicle

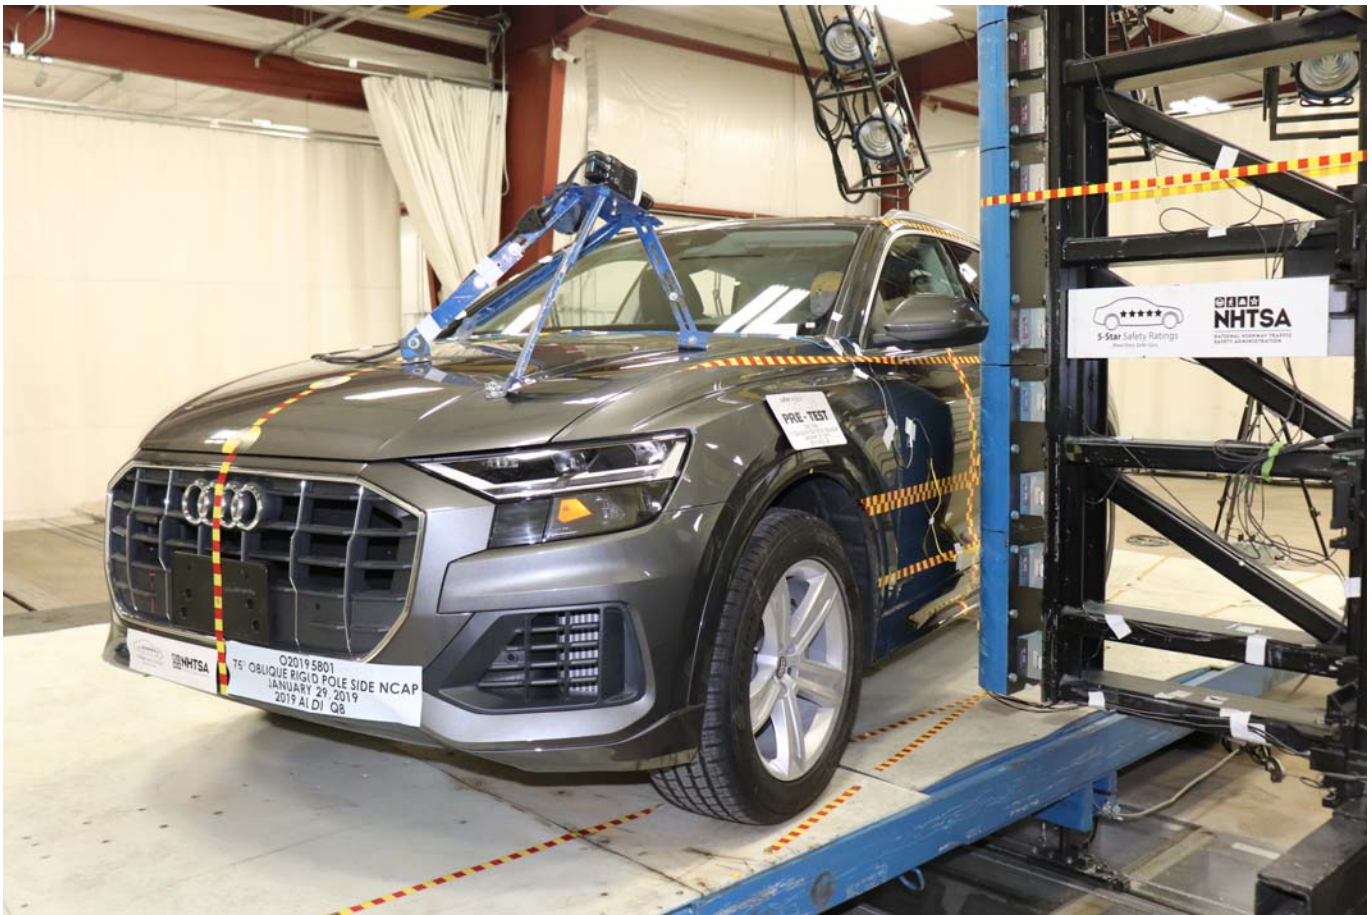
Photo No. 017 - Pre-Test Left Side View of Pole Positioned Against Side of Vehicle

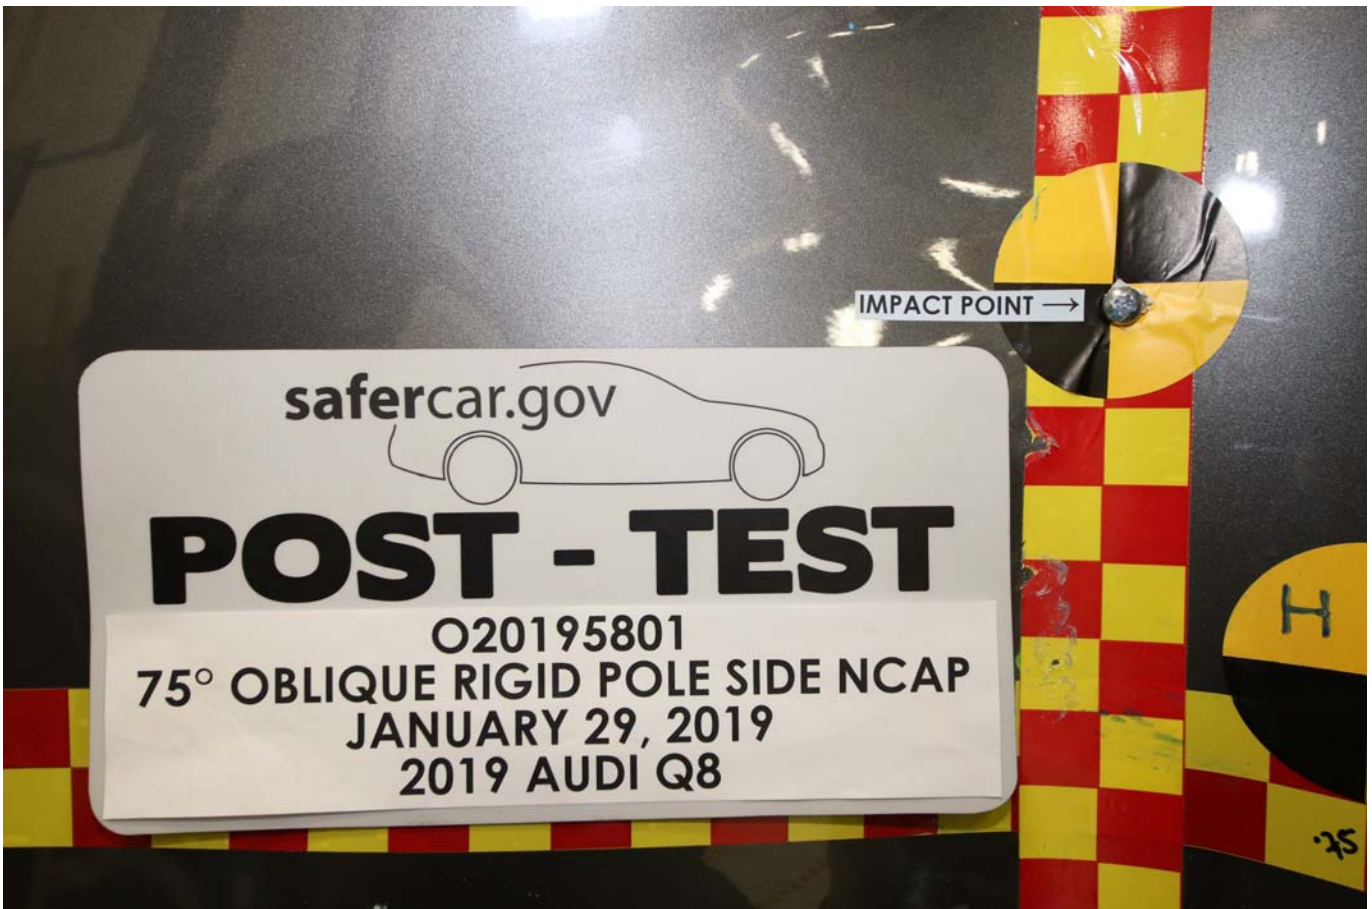
Photo No. 020 - Post-Test Close-Up View of Impact Point Target Showing Impact Location

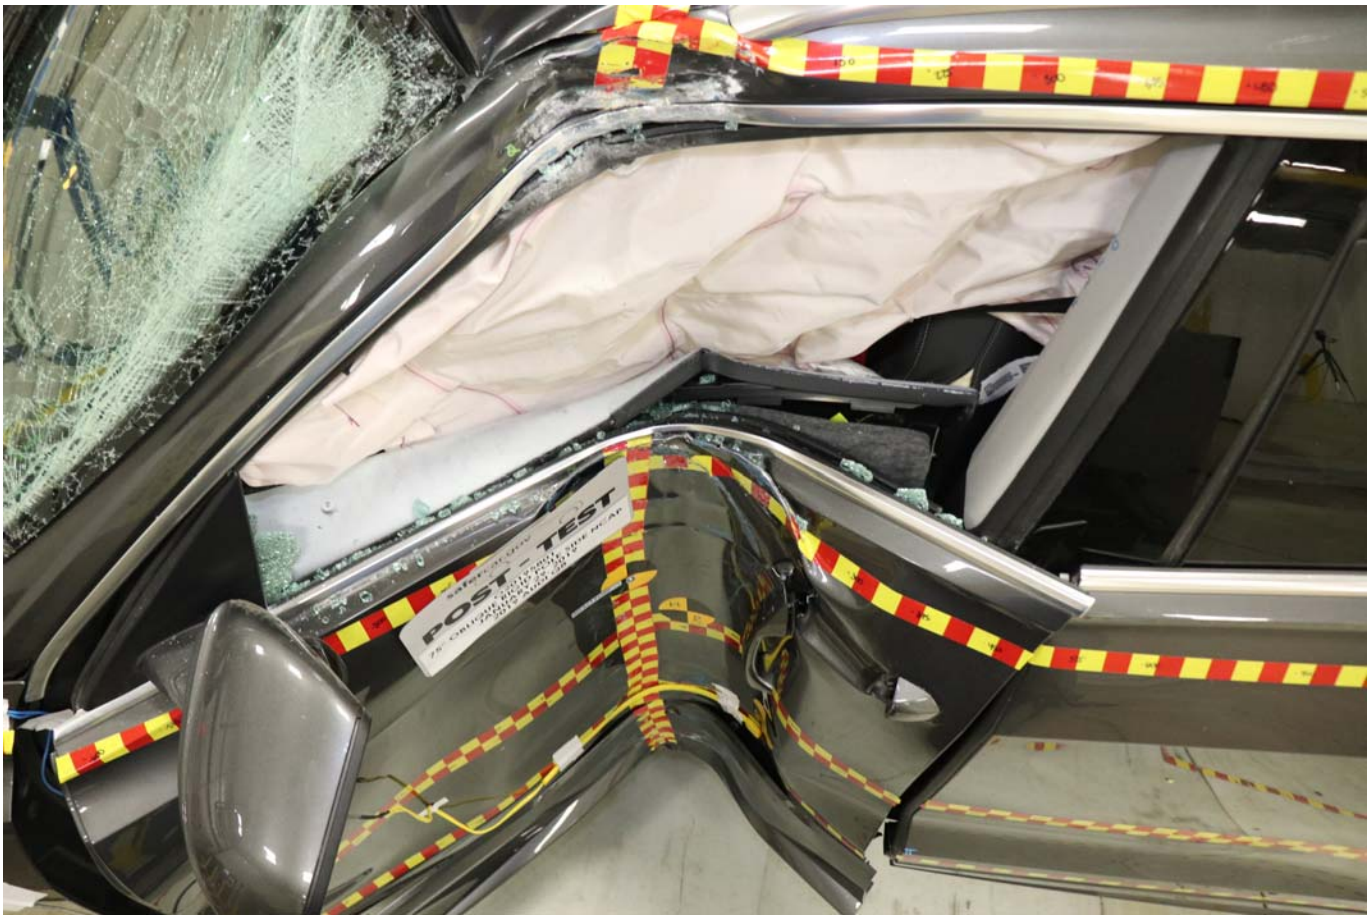
Photo No. 041 - Post-Test Dummy and Door Clearance View

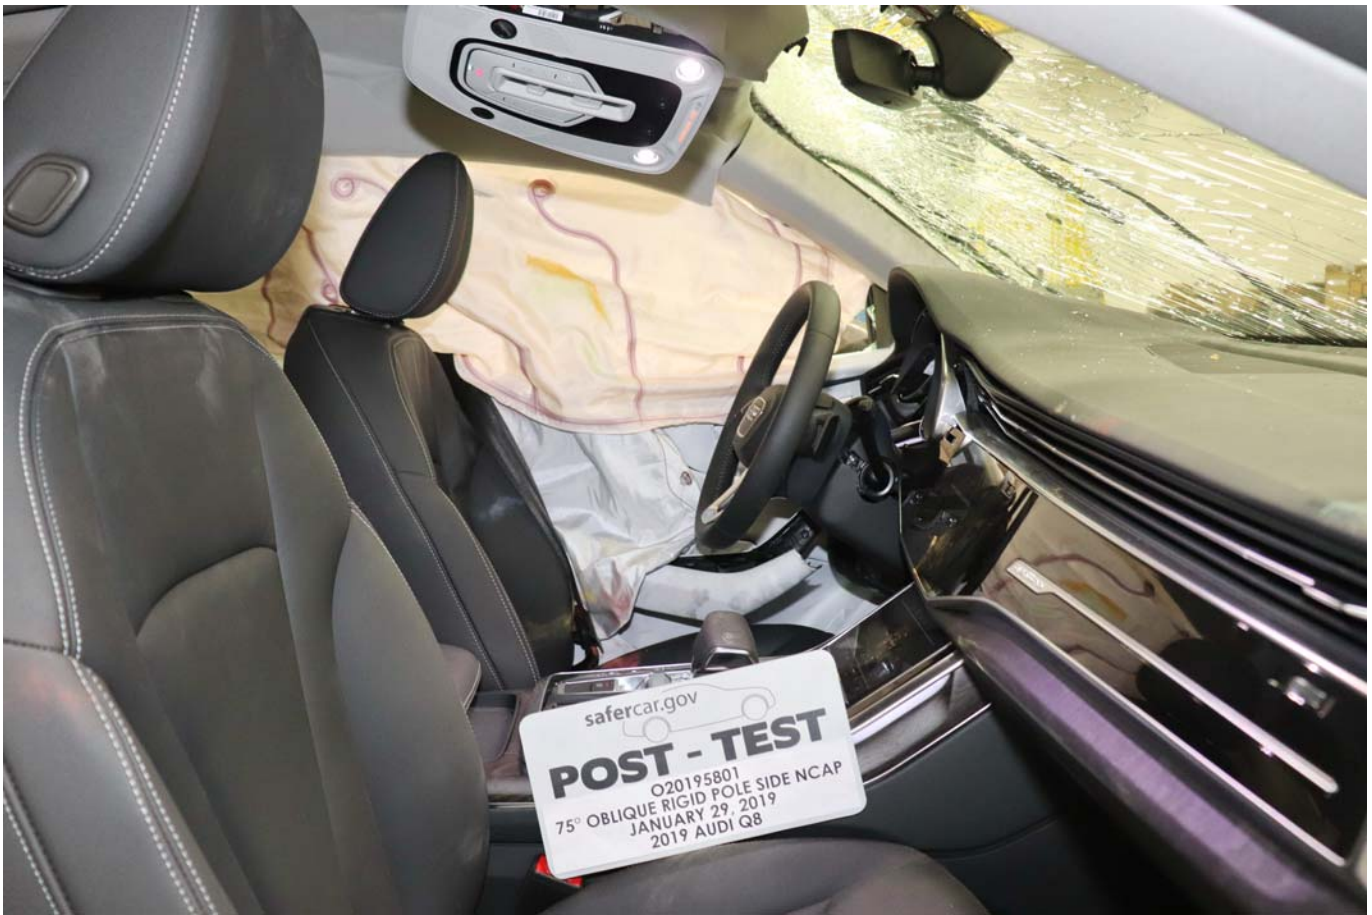
Photo No. 045 - Post-Test Inner Door Panel View Showing Dummy Contact Location

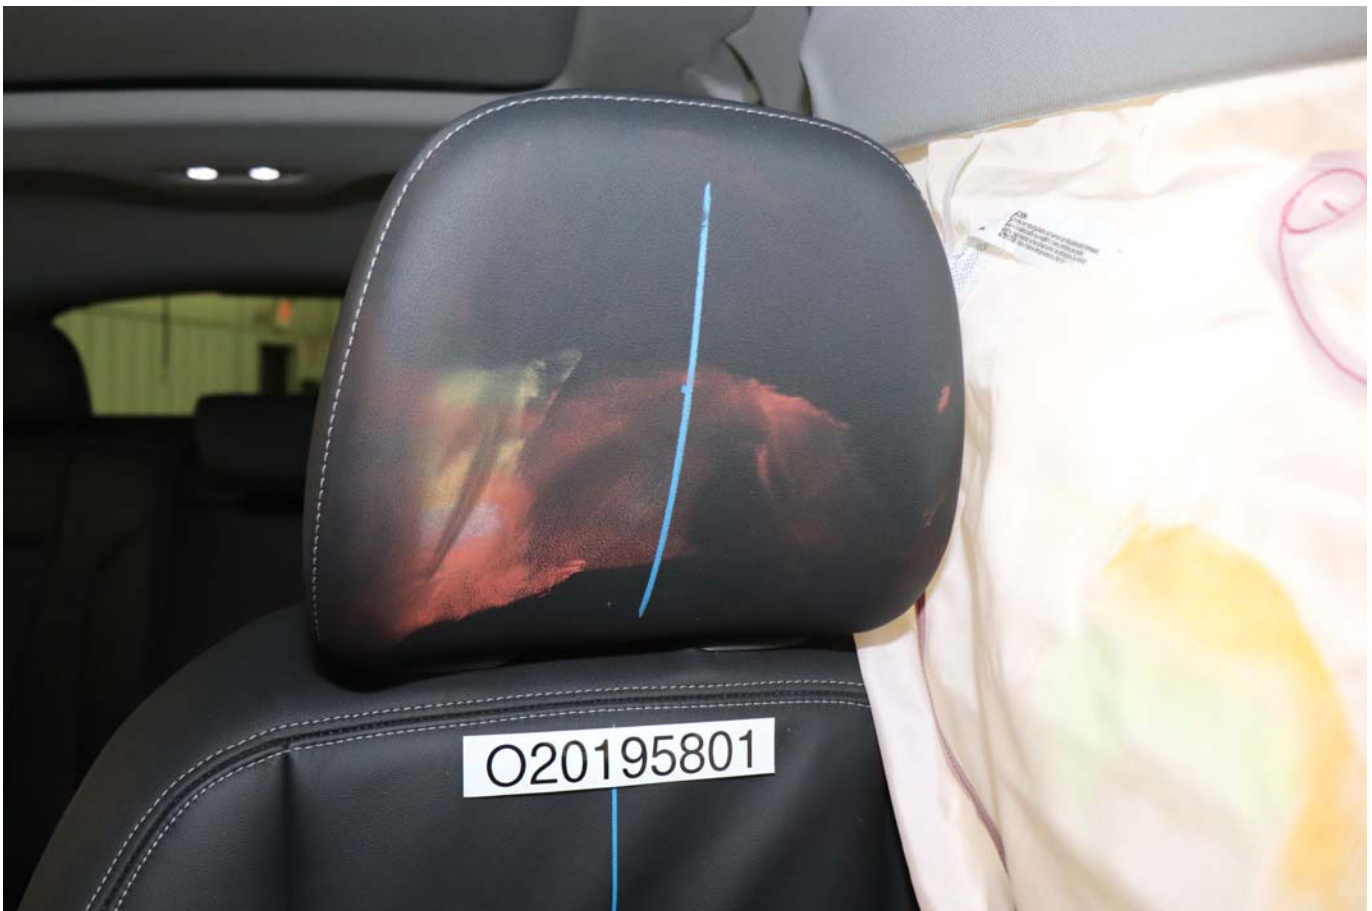
Photo No. 046 - Post-Test Dummy Close-Up Head Contact with Vehicle Interior View

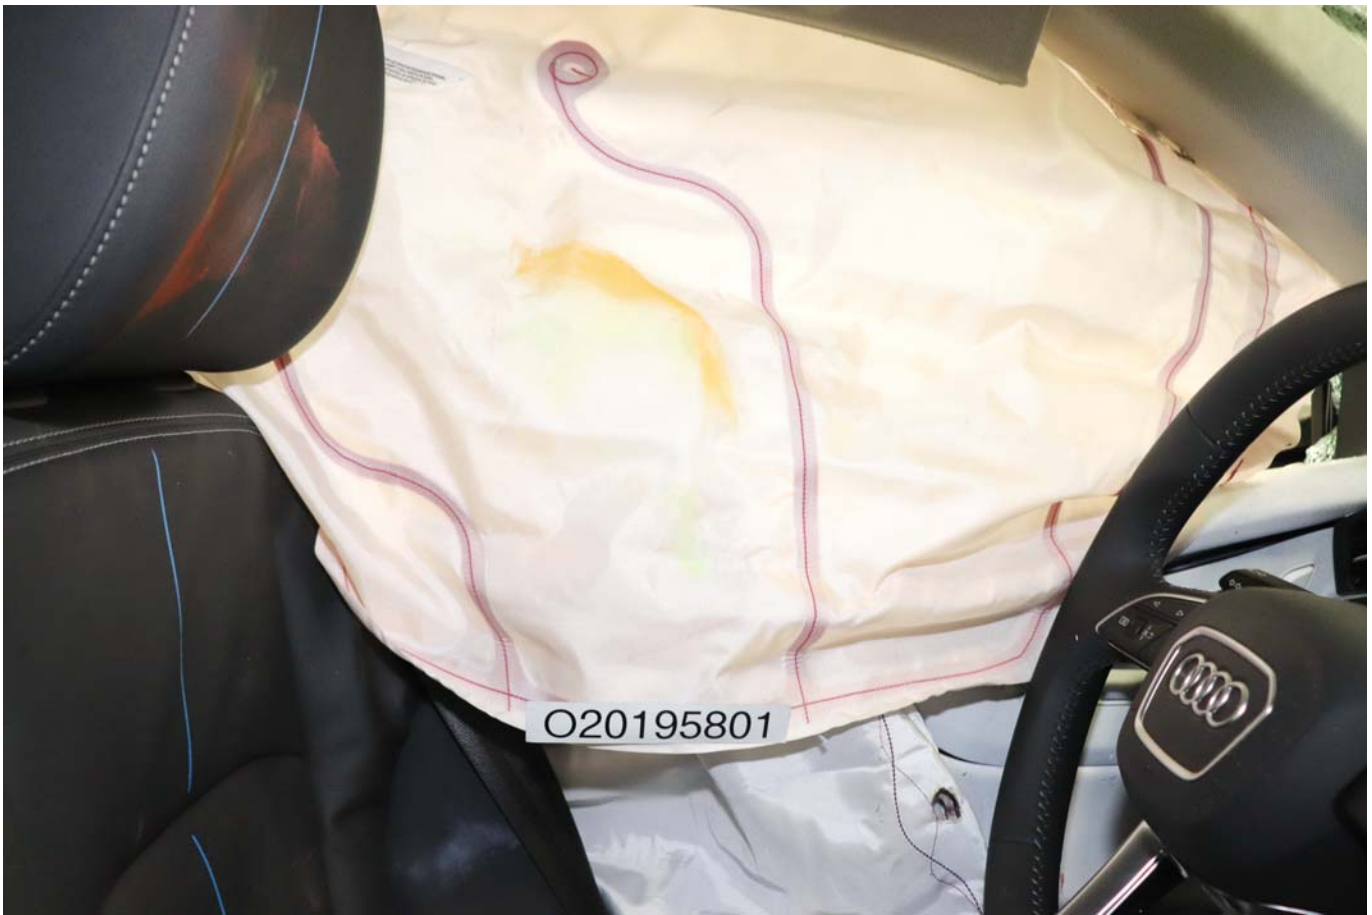
Photo No. 047 - Post-Test Dummy Close-Up Head Contact with Side Air Bag View

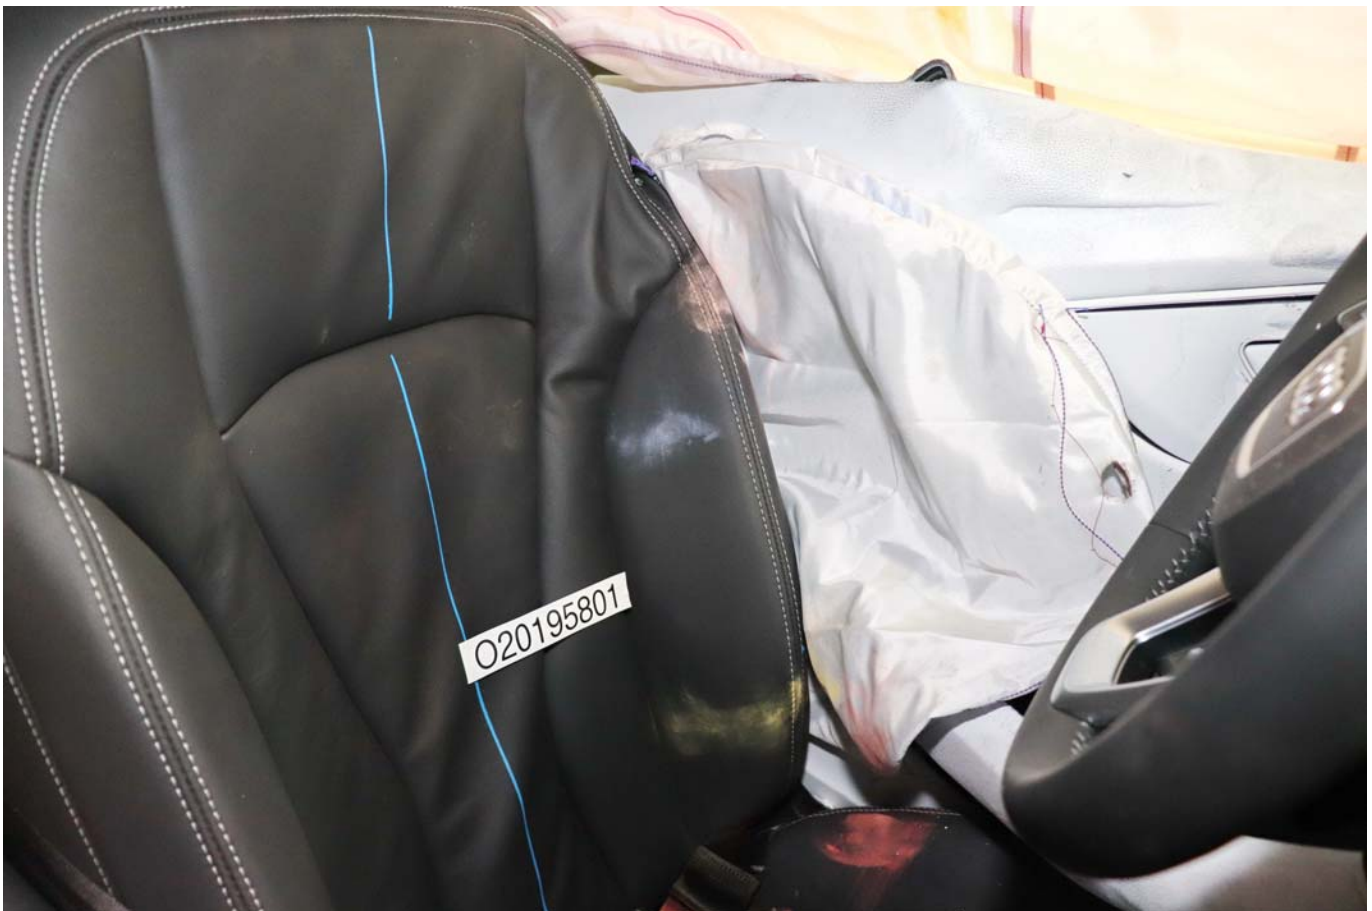
Photo No. 048 - Post-Test Dummy Close-Up Torso Contact with Vehicle Interior View

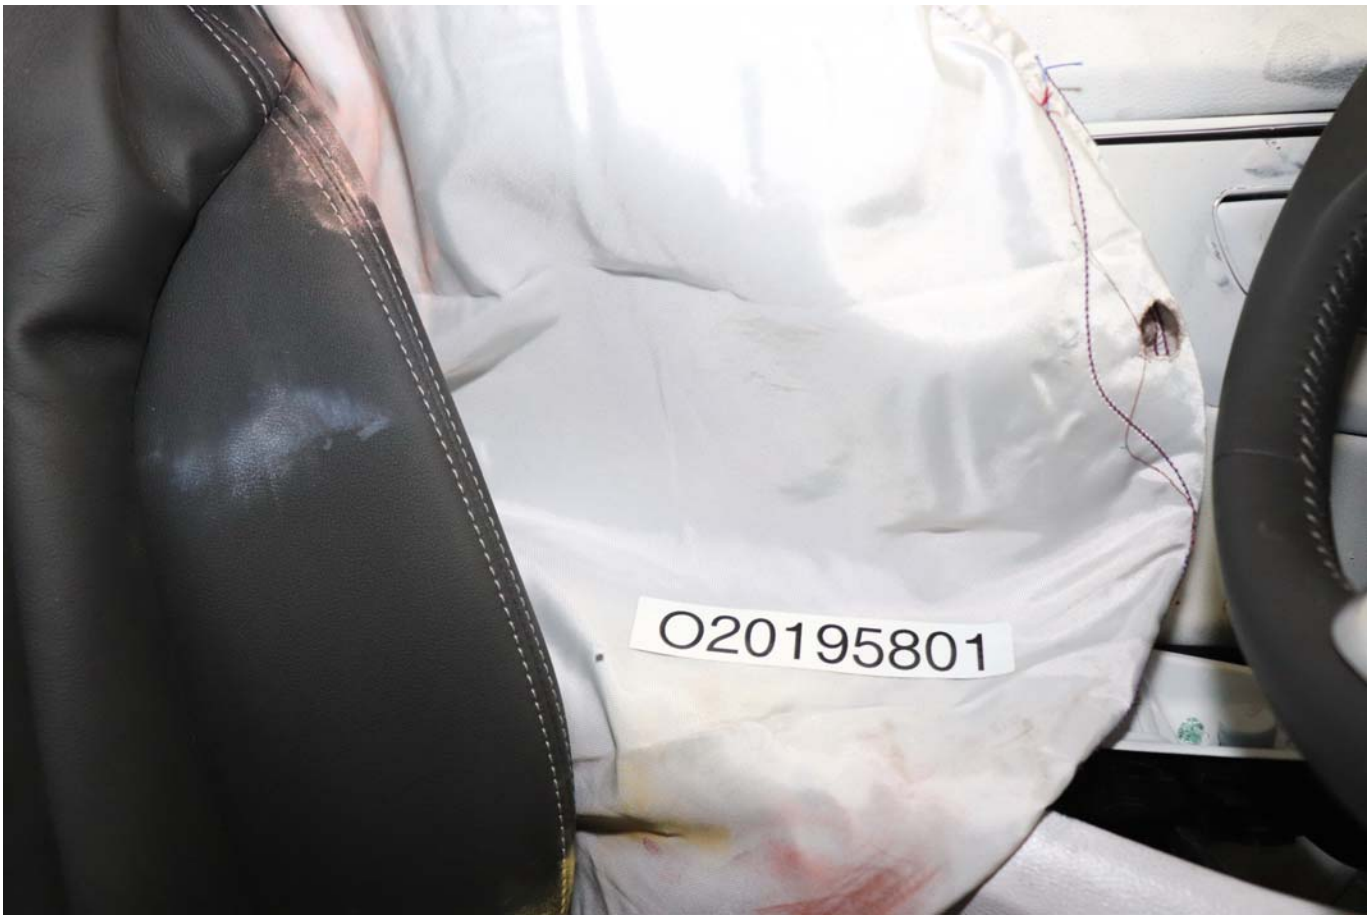
Photo No. 049 - Post-Test Dummy Close-Up Torso Contact with Side Air Bag View

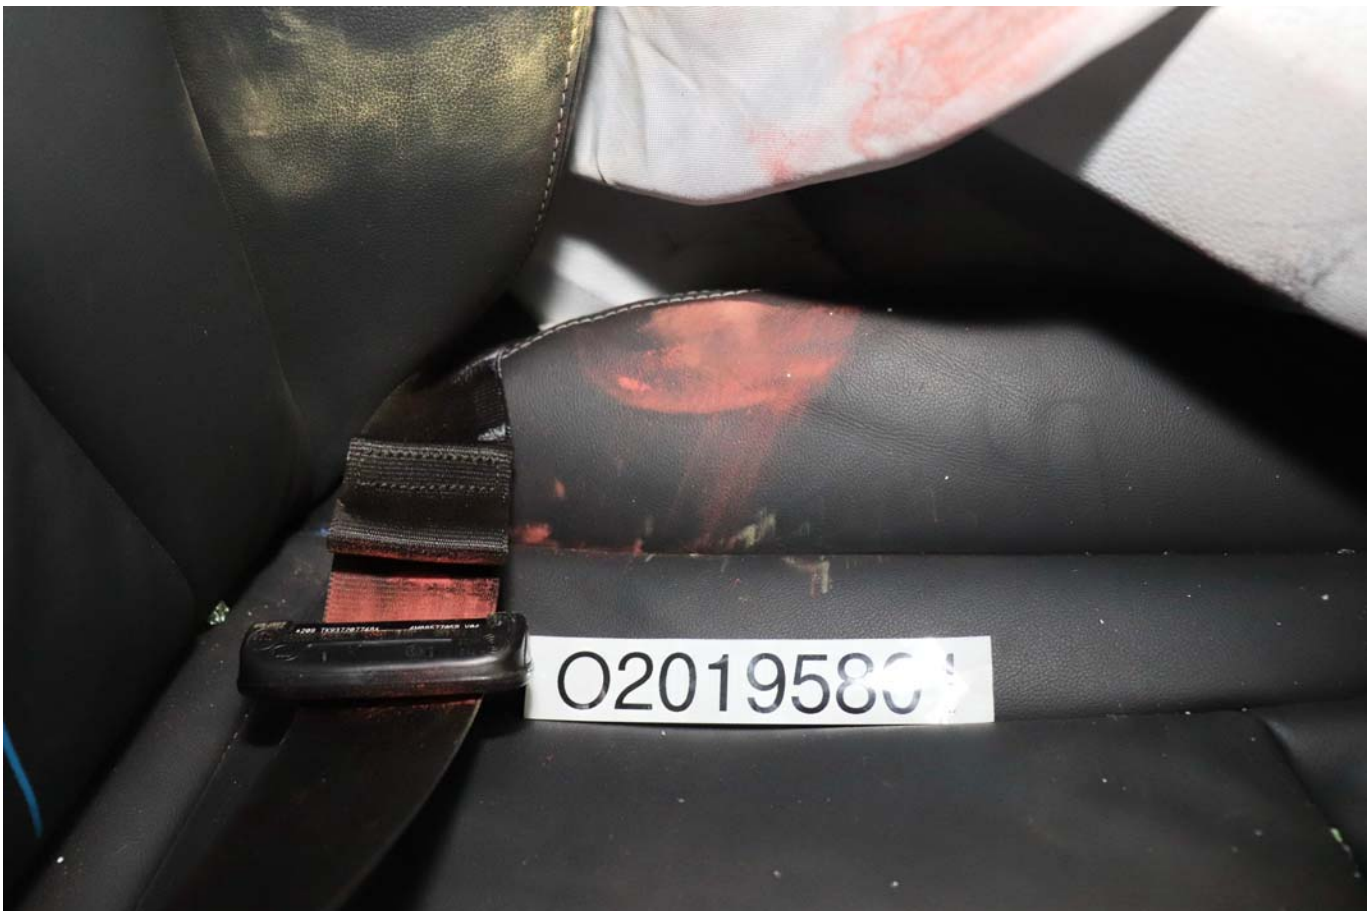
Photo No. 050 - Post-Test Dummy Close-Up Pelvis Contact with Vehicle Interior View

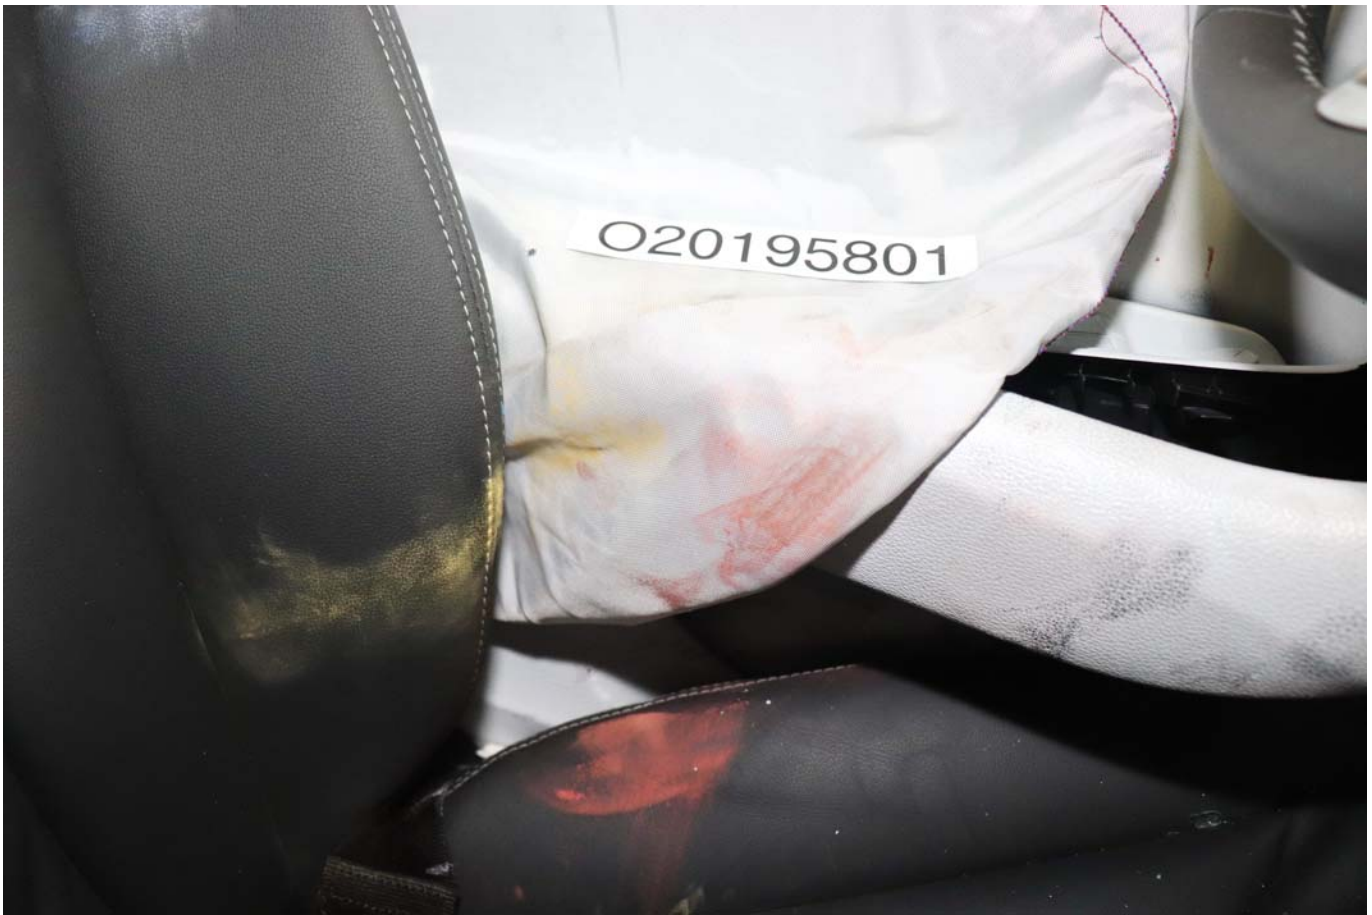
Photo No. 051 - Post-Test Dummy Close-Up Pelvis Contact with Side Air Bag View

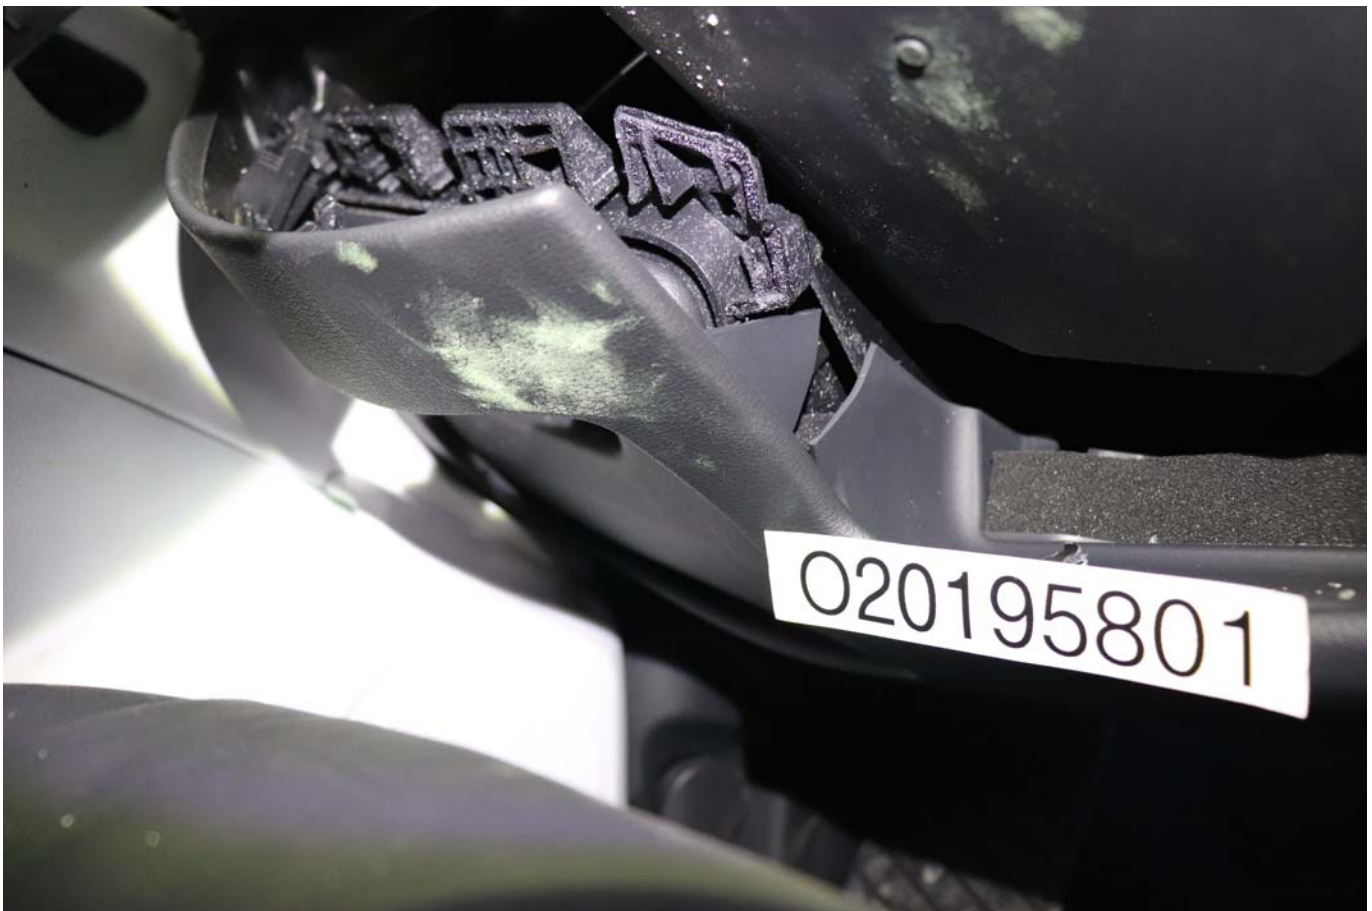
Photo No. 052 - Post-Test Dummy Close-Up Knee Contact with Vehicle Interior View

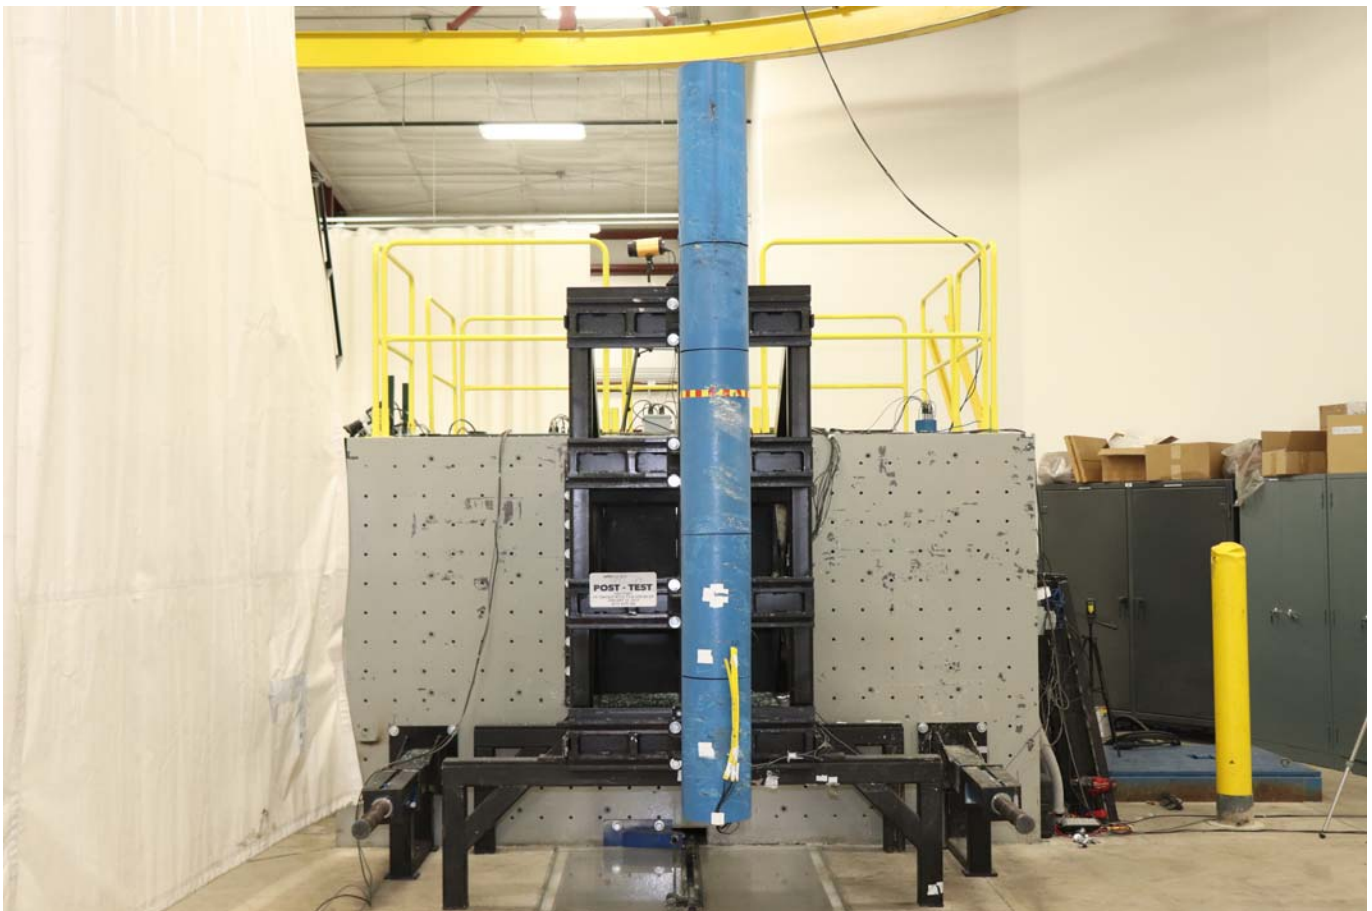
Photo No. 058 - Post-Test Pole Barrier Front View

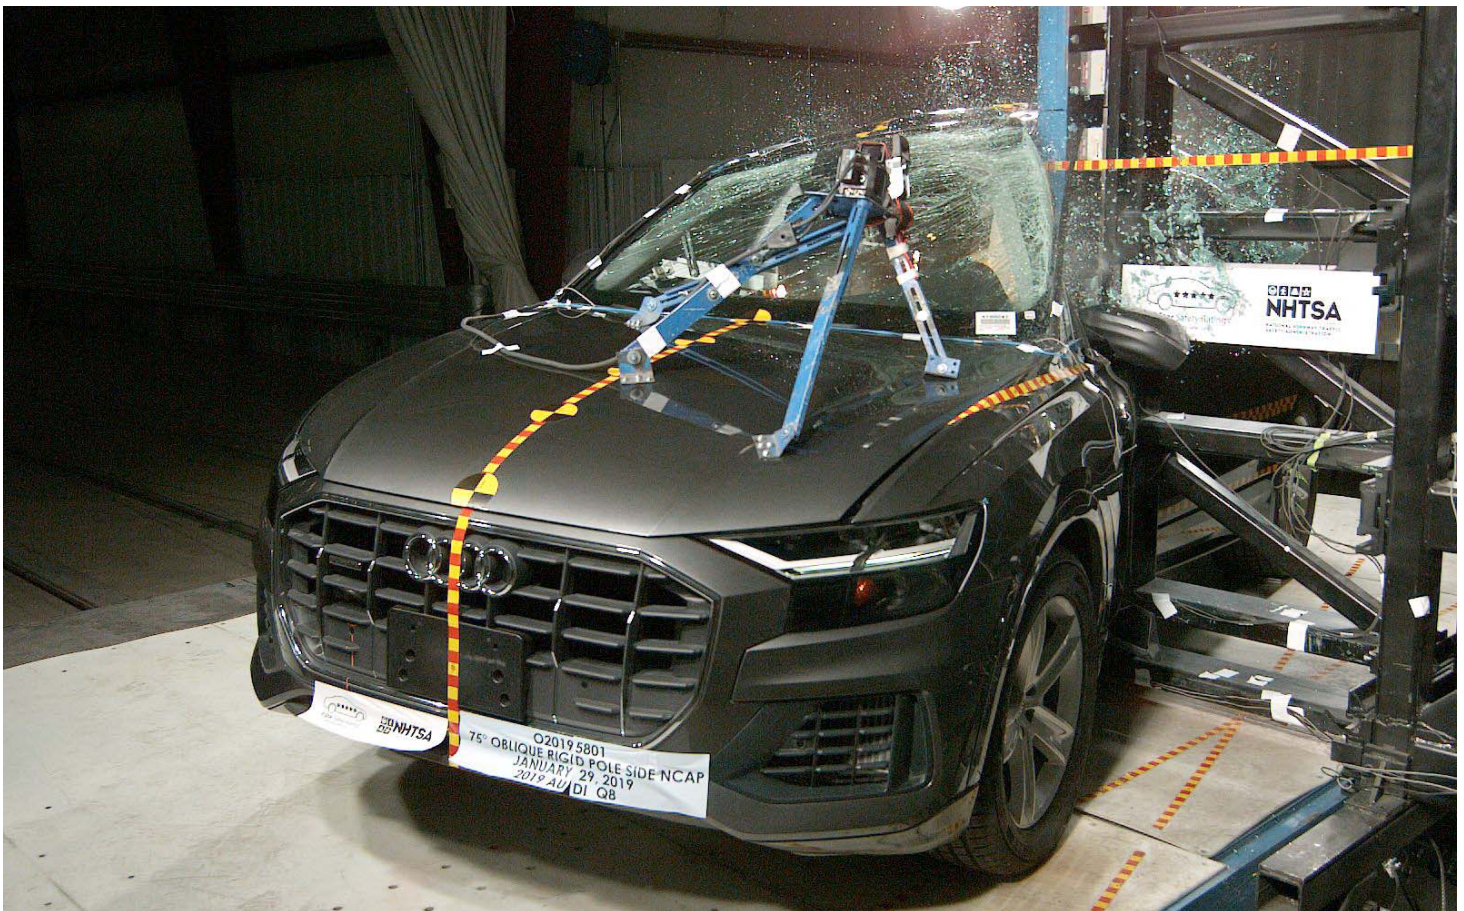
Photo No. 068 - Impact Event
