**REPORT NUMBER: SPNCAP-MGA-2019-025**

**NEW CAR ASSESSMENT PROGRAM (NCAP)  
Side Impact Pole Test**

**AUDI AG  
2019 Audi Q8 Premium 5-Door SUV  
NHTSA No.: O20195801**

**MGA RESEARCH CORPORATION  
5000 Warren Road  
Burlington, WI 53105**

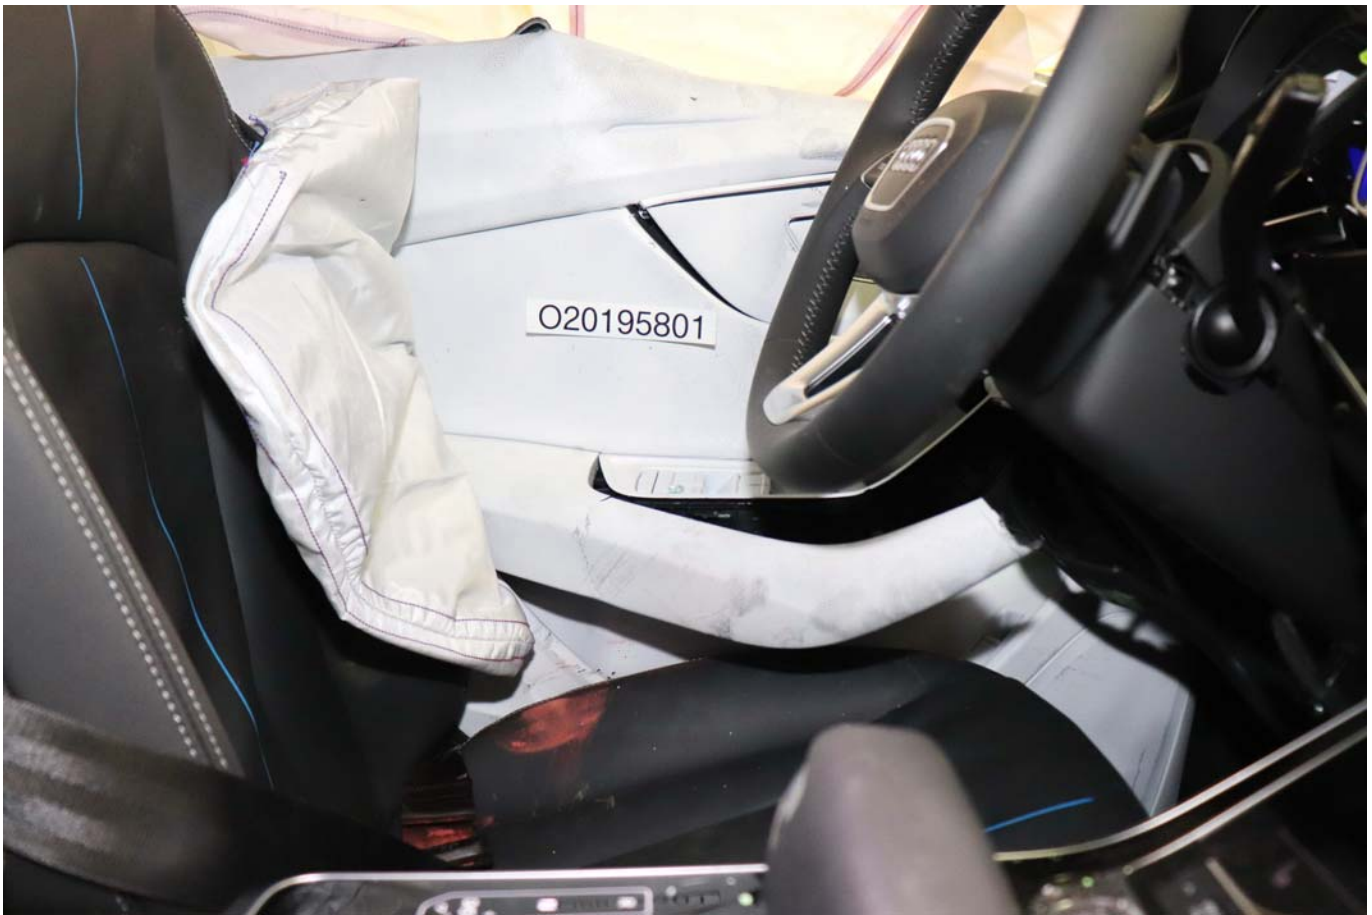
Photo No. 071 - Post-Test View of Shattered Vehicle Inner Door Panel

Critical Areas of Performance	Observations and Conclusions
Pillar Performance	No Separation
Sill Separation	None
Windshield Damage	Cracked
Side Window Damage	Left Front Window Broken
Other Notable Effects	None
