REPORT NUMBER: NCAP-MGA-2019-032

**NEW CAR ASSESSMENT PROGRAM (NCAP)
Frontal Barrier Impact Test**

**GENERAL MOTORS LLC
2019 Chevrolet Tahoe 4WD LS 5-Door SUV
NHTSA No.: O20190103**

**MGA RESEARCH CORPORATION
5000 Warren Road
Burlington, WI 53105**

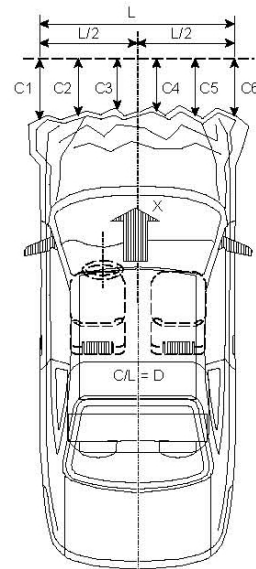
ACCELEROMETER DATA

Accelerometer Locations: As per measurements on Page 15
Cal. Procedure/Interval: MGA procedure / 6 month
Integration Algorithm: Trapezoidal
Linearity: > 99%
Impact Velocity (km/h): 56.73
Velocity Change (km/h): 63.5
Time of Separation (msec): 105

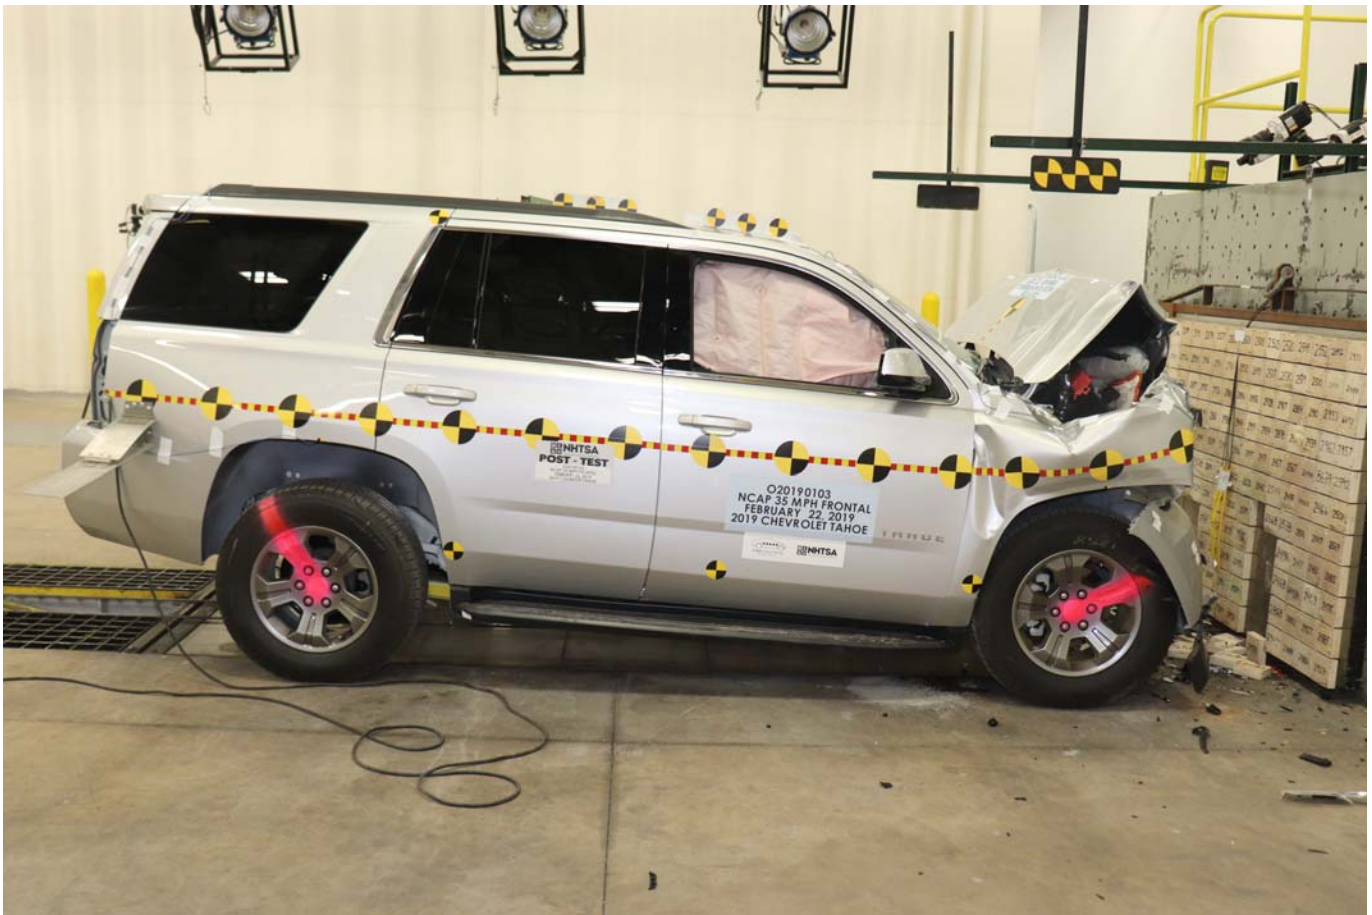
Photo No. 013 - Post-Test Right View of Test Vehicle

Collision Deformation Classification: 12FDEW2
Midpoint of Damage: Centerline
Damage Region Length (mm): 1220
Impact Mode: Frontal

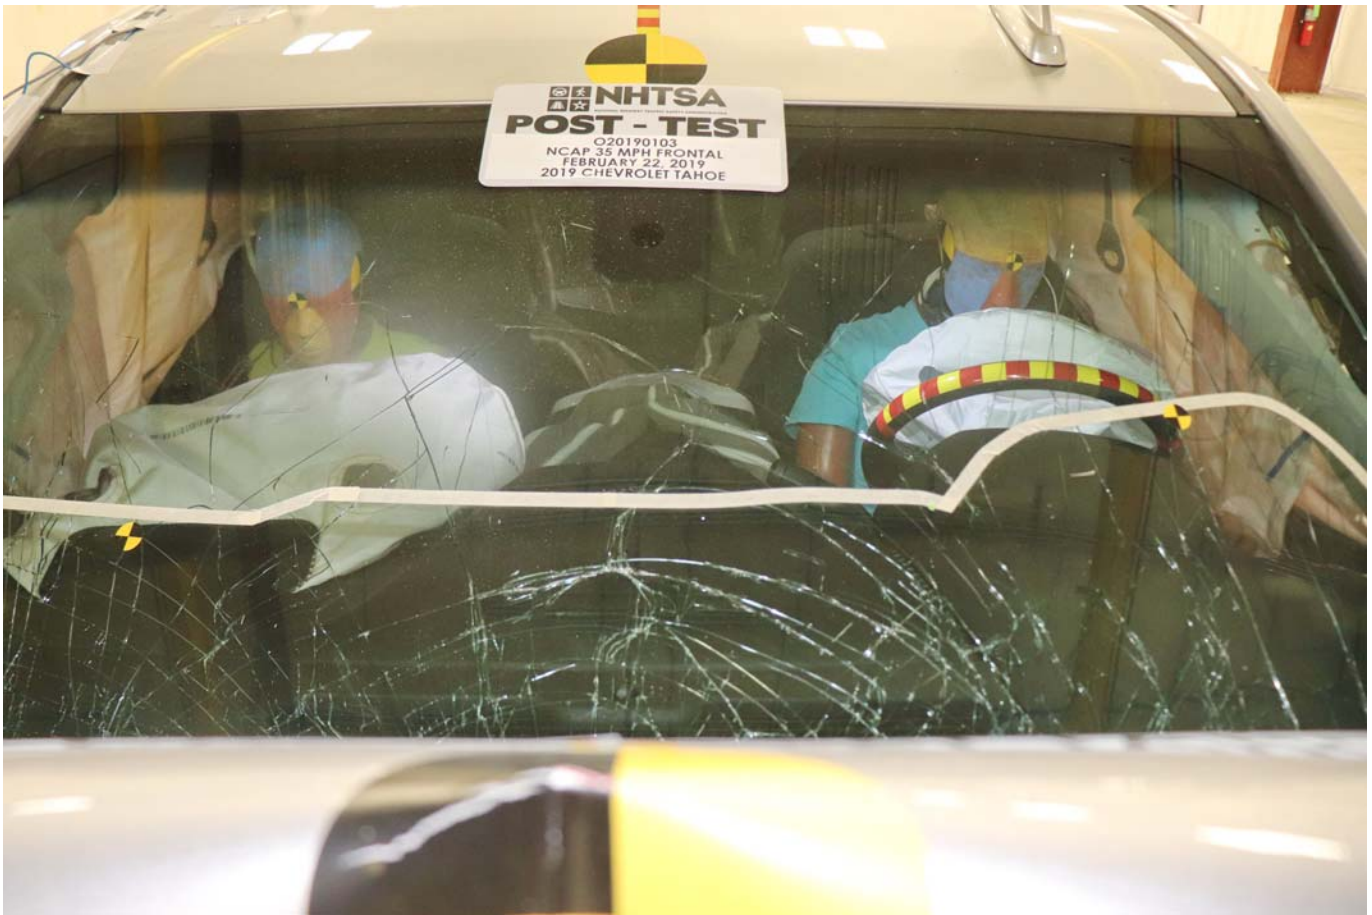
Photo No. 019 - Post-Test Windshield View

There was 91 percent windshield retention and no intrusion into the protected zone of the windshield during the event. There was no Stoddard Solvent leakage after the event or during any phase of the static rollover.

Measurement	Pre-Test (mm)	Post-Test (mm)	% of Retention
Left Side	2312	2136	92.4
Right Side	2312	2081	90.0
Total	4624	4217	91.2

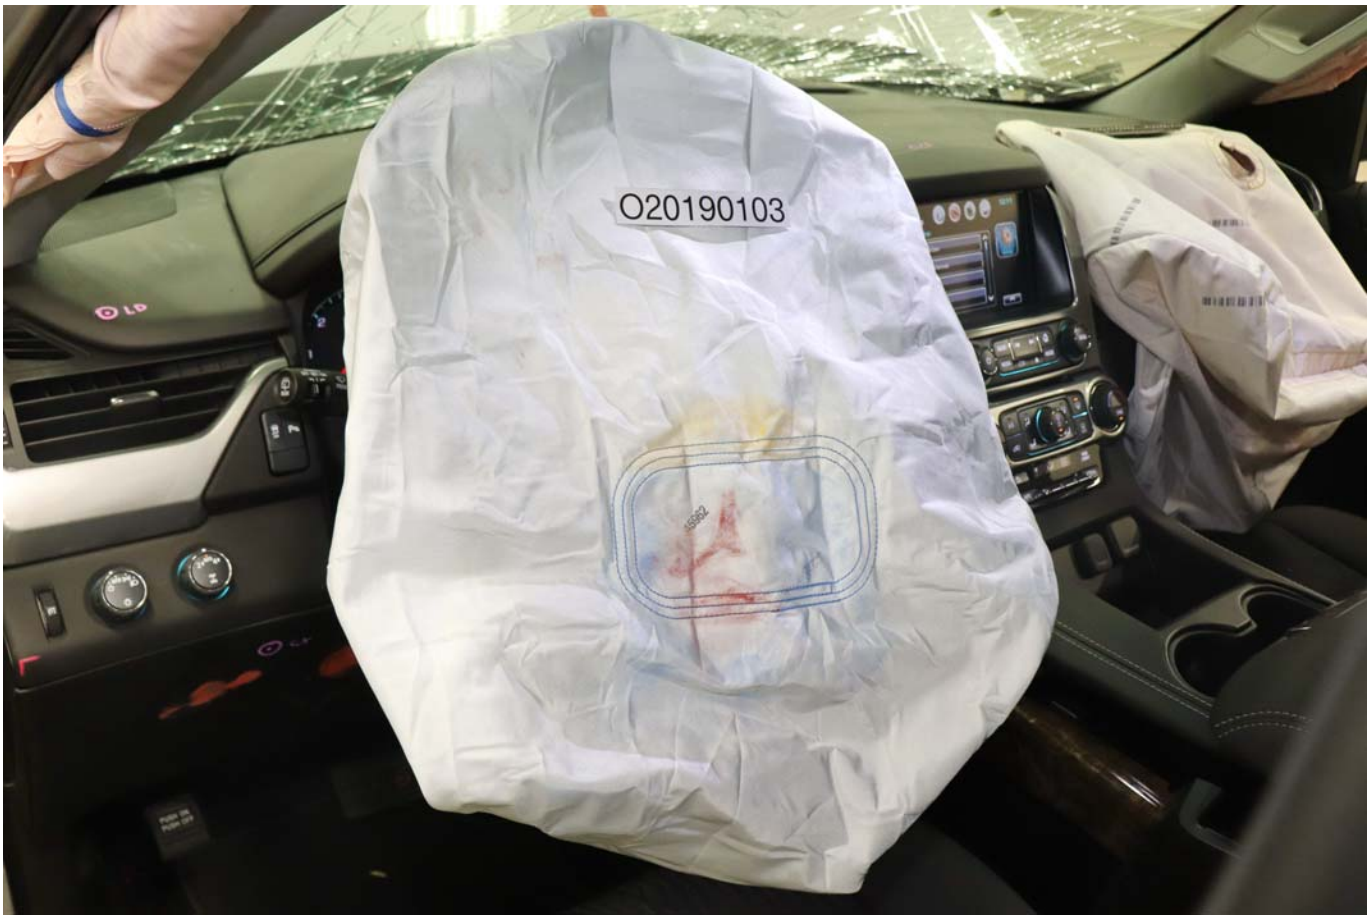
Photo No. 047 - Post-Test Driver Dummy Contact with Airbag

The driver's visible contact points were as follows: The driver's head contacted the airbag. The driver's head also contacted the headrest. The driver's knees contacted the knee bolster. The passenger's visible contact points were as follows: The passenger's head contacted the airbag. The passenger's head also contacted the headrest. The passenger's knees contacted the glove box.

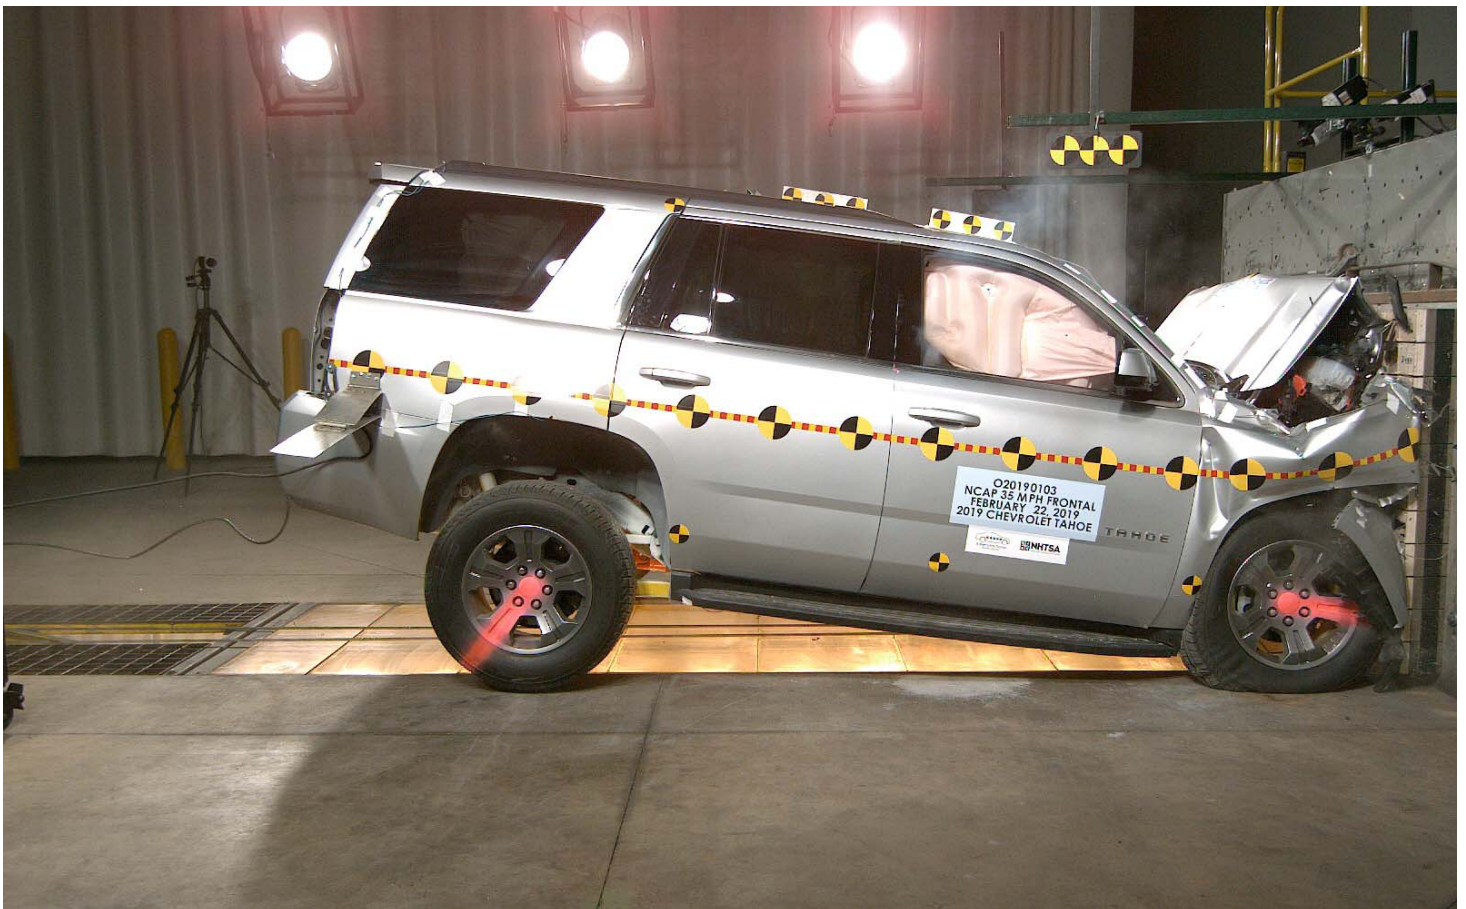
Photo No. 078 - 2019 Chevrolet Tahoe 4WD LS 5-Door SUV Frontal Impact Event

A load cell barrier consisting of 176 load cells was impacted by a 2019 Chevrolet Tahoe 4WD LS 5-Door SUV at a velocity of 56.73 km/h. The test was performed at MGA Research Corporation on February 22, 2019. Pre-test and post-test photographs of the vehicle and dummies can be found in Appendix A.
