Re: Supplement to FCA US Petition for Determination of Inconsequential Noncompliance with Federal Motor Vehicle Safety Standard ("FMVSS") 108 (Recalls 19V-199 and 19E-025 dated April 5, 2019)

Subject: Follow-up FCA US LLC Subjective Evaluation of Dodge Journey Front Side Reflex Reflectors.

Location: FCA Canada Inc. Automotive Research and Development Center Lighting Tunnel, Windsor, Ontario, Canada.

Date: April 26, 2019.

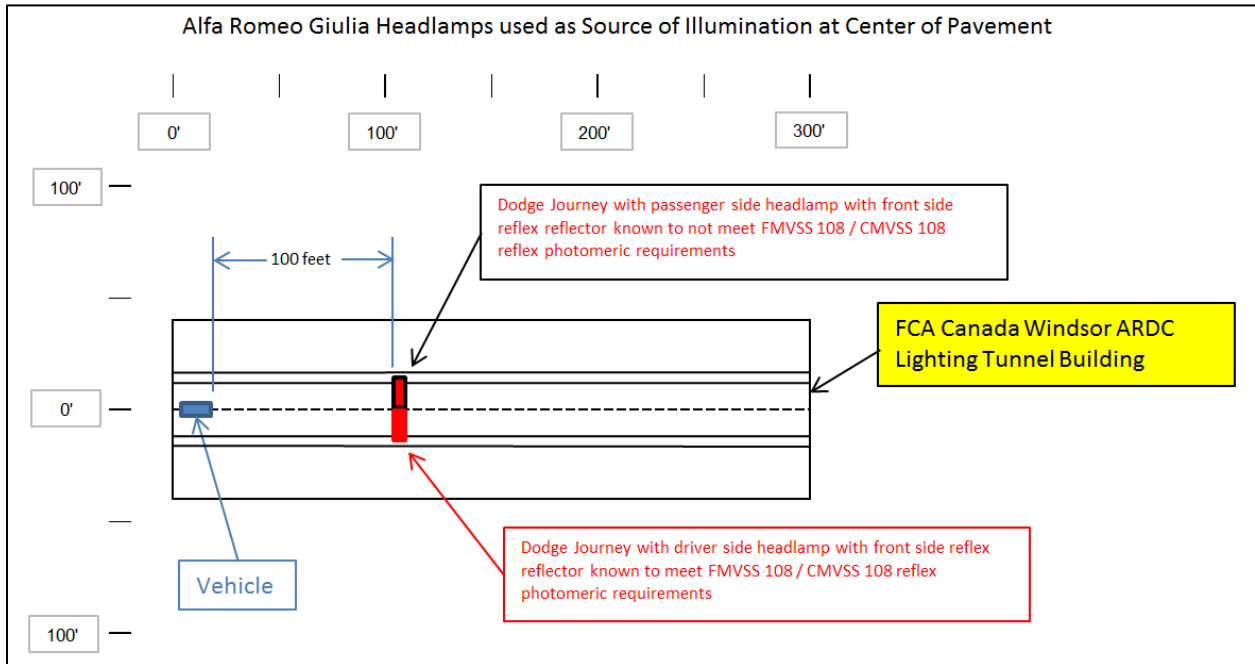
Figure 11 - Diagram of Subjective Evaluation of Dodge Journey Front Side Reflex Reflectors viewed from center of pavement with Alfa Romeo Giulia Low Beam Headlamps used as source of illumination.

Subjective Evaluation F: Alfa Romeo Giulia Low Beam Headlamps used as light source at center of the pavement shining towards the two Dodge Journey vehicles. See Figures 11 and 12.

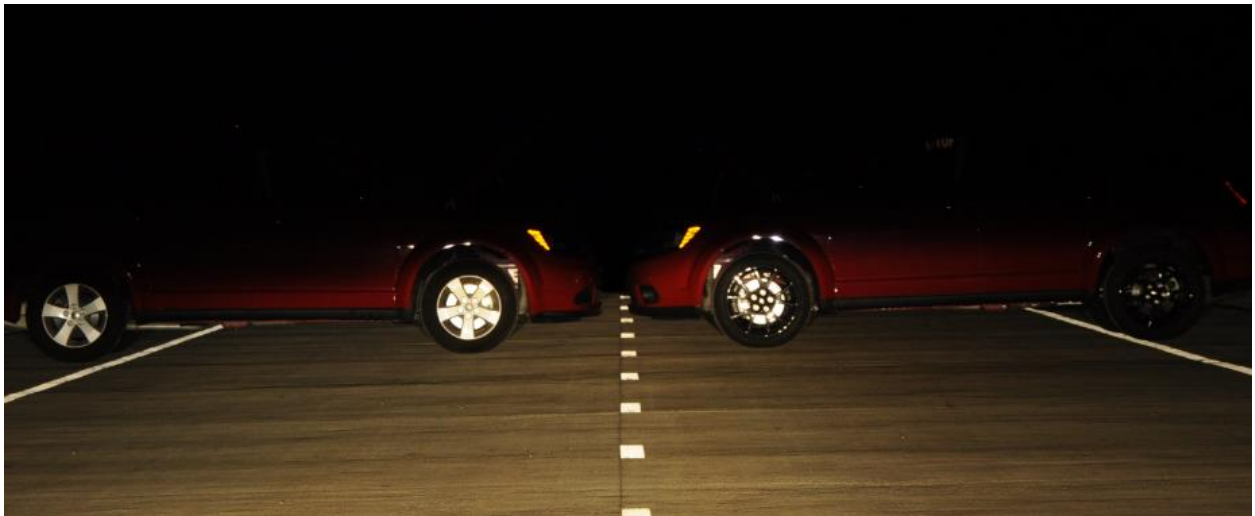
Figure 12 - Photograph of Subjective Evaluation using Alfa Romeo Giulia Low Beam Headlamps as source of illumination. Camera lens set at centerline of road, centerline of the Alfa Romeo Giulia, and height above ground of 46.0 inches (eye level of average height female driver sitting in the driver's seat of the Alfa Romeo Giulia).

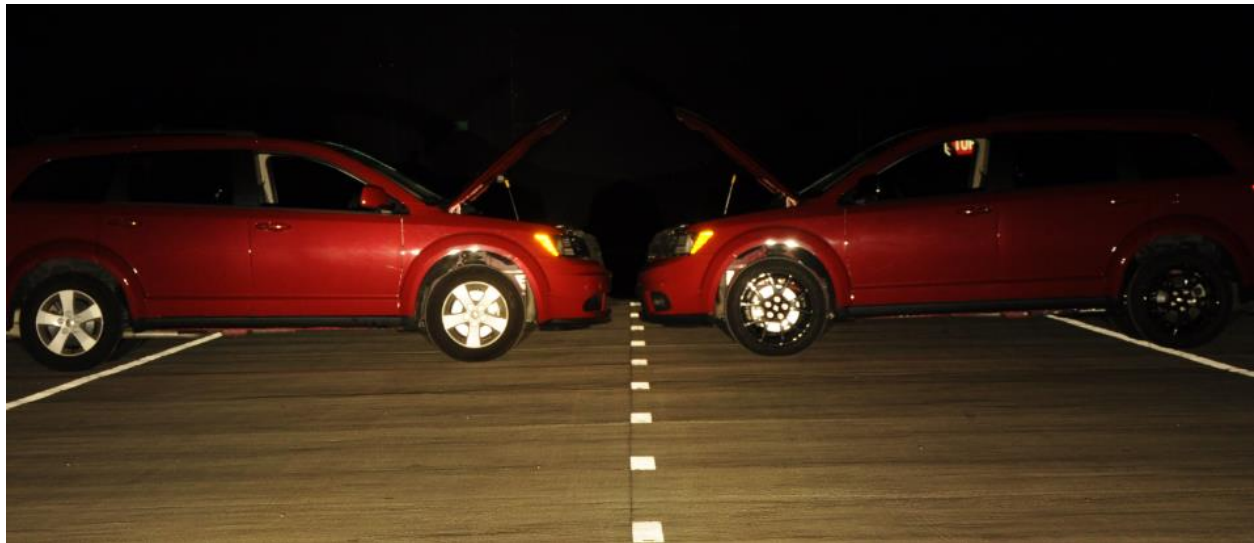
Figure 14 - Photograph of Subjective Evaluation using Alfa Romeo Giulia High Beam Headlamps as source of illumination. Camera lens set at centerline of road, centerline of the Alfa Romeo Giulia, and height above ground of 46.0 inches (eye level of average height female driver sitting in the driver's seat of the Alfa Romeo Giulia).

Subjective Evaluation G: Alfa Romeo Giulia High Beam Headlamps used as light source at center of the pavement shining towards the two Dodge Journey vehicles. See Figures 13 and 14.

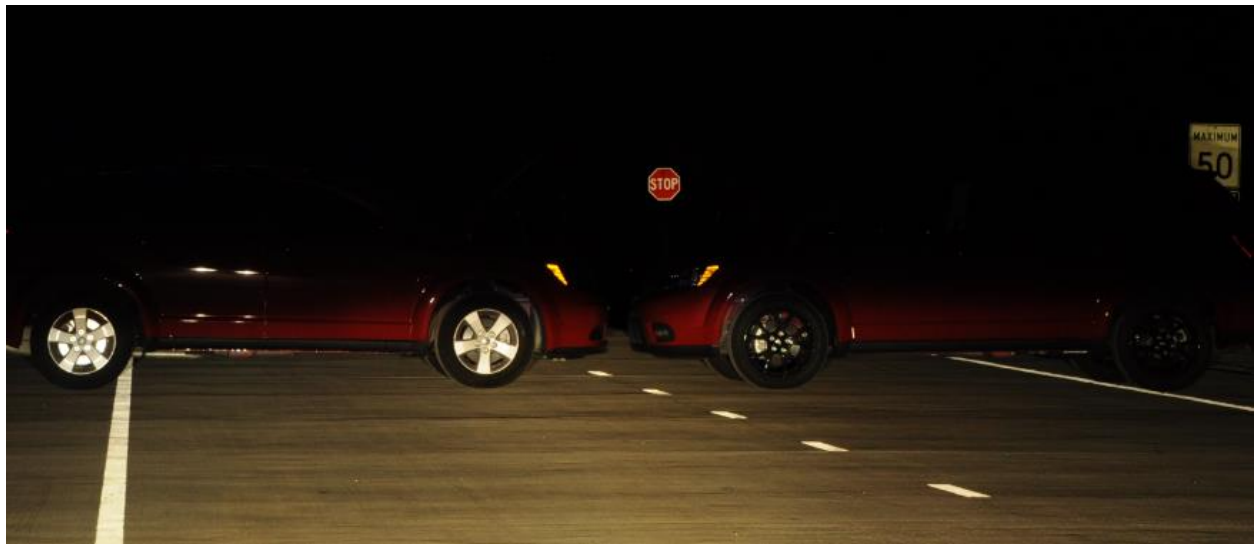
Figure 16 - Photograph of Subjective Evaluation using Alfa Romeo Giulia Low Beam Headlamps as source of illumination. Camera lens set at left edge of pavement, centerline of the Alfa Romeo Giulia, and height above ground of 46.0 inches (eye level of average height female driver sitting in the driver's seat of the Alfa Romeo Giulia).

Subjective Evaluation H: Alfa Romeo Giulia Low Beam Headlamps used as light source at the left edge of pavement (146 inches to the left of the centerline of pavement) shining towards the two Dodge Journey vehicles. See Figures 15 and 16.

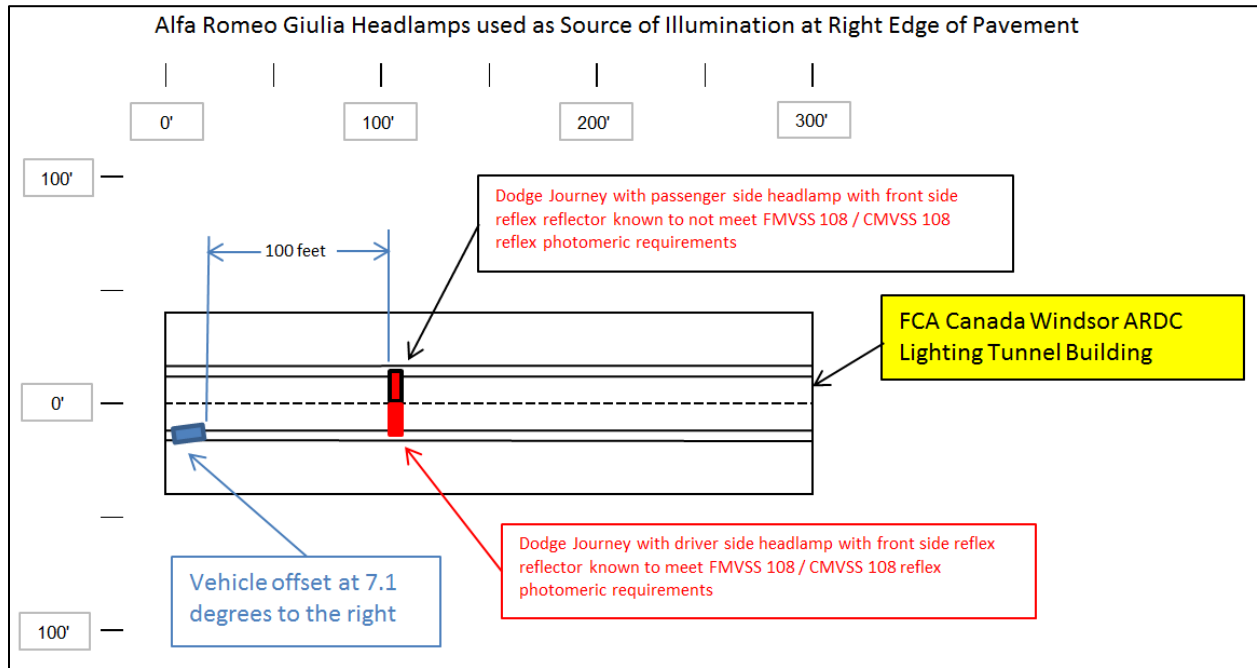
Figure 17 - Diagram of Subjective Evaluation of Dodge Journey Front Side Reflex Reflectors viewed from right edge of pavement with Alfa Romeo Giulia Low Beam Headlamps used as source of illumination.

Subjective Evaluation J: Alfa Romeo Giulia Low Beam Headlamps used as light source at the right edge of pavement (150 inches to the right of the centerline of pavement) shining towards the two Dodge Journey vehicles. See Figures 17 and 18.

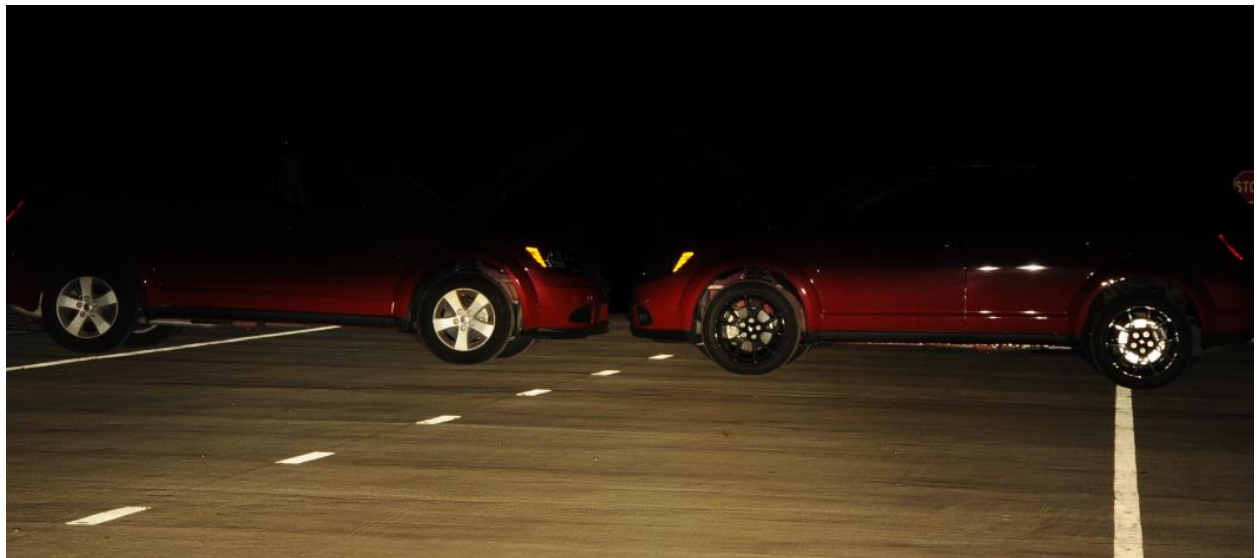
Figure 18 - Photograph of Subjective Evaluation using Alfa Romeo Giulia Low Beam Headlamps as source of illumination. Camera lens set at right edge of pavement, centerline of the Alfa Romeo Giulia, and height above ground of 46.0 inches (eye level of average height female driver sitting in the driver's seat of the Alfa Romeo Giulia).

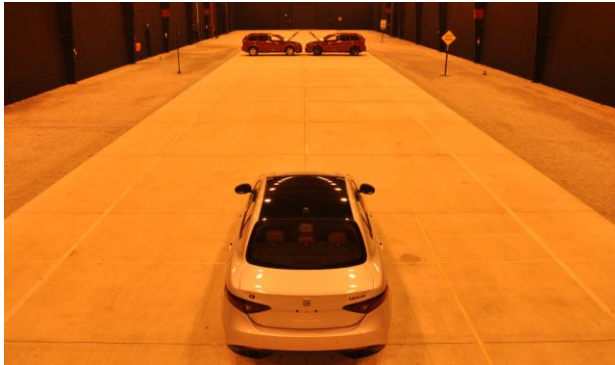
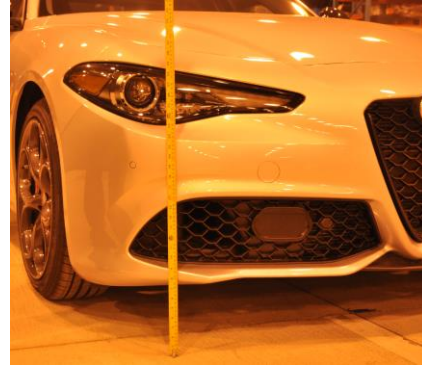
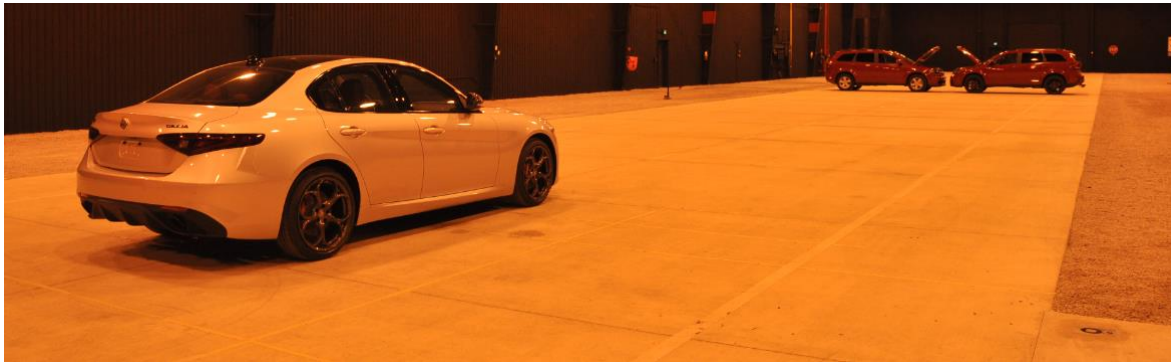
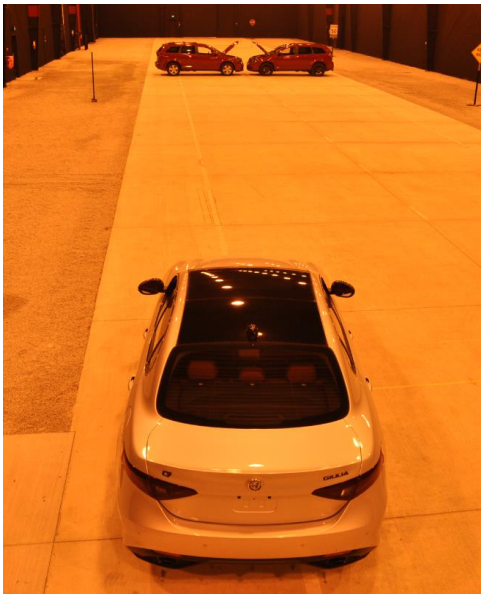
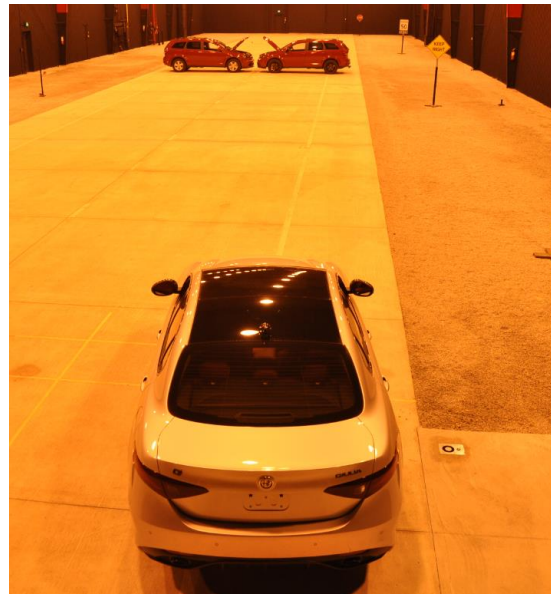
Appendix G: Additional images that depict the setup of the subjective evaluations of the Dodge Journey Front Side Reflex Reflectors using an Alfa Romeo Giulia as source of illumination inside the FCA Canada Automotive Research and Development Center Lighting Tunnel, located in Windsor, Ontario, Canada.

Additional images that depict the setup of these subjective evaluations are shown in Appendix G.
