**OCAS-DRI-CIB-19-14
NEW CAR ASSESSMENT PROGRAM
CRASH IMMINENT BRAKE SYSTEM CONFIRMATION TEST**

2019 Kia Forte

DYNAMIC RESEARCH, INC.
355 Van Ness Avenue, STE 200
Torrance, California 90501

Final Report

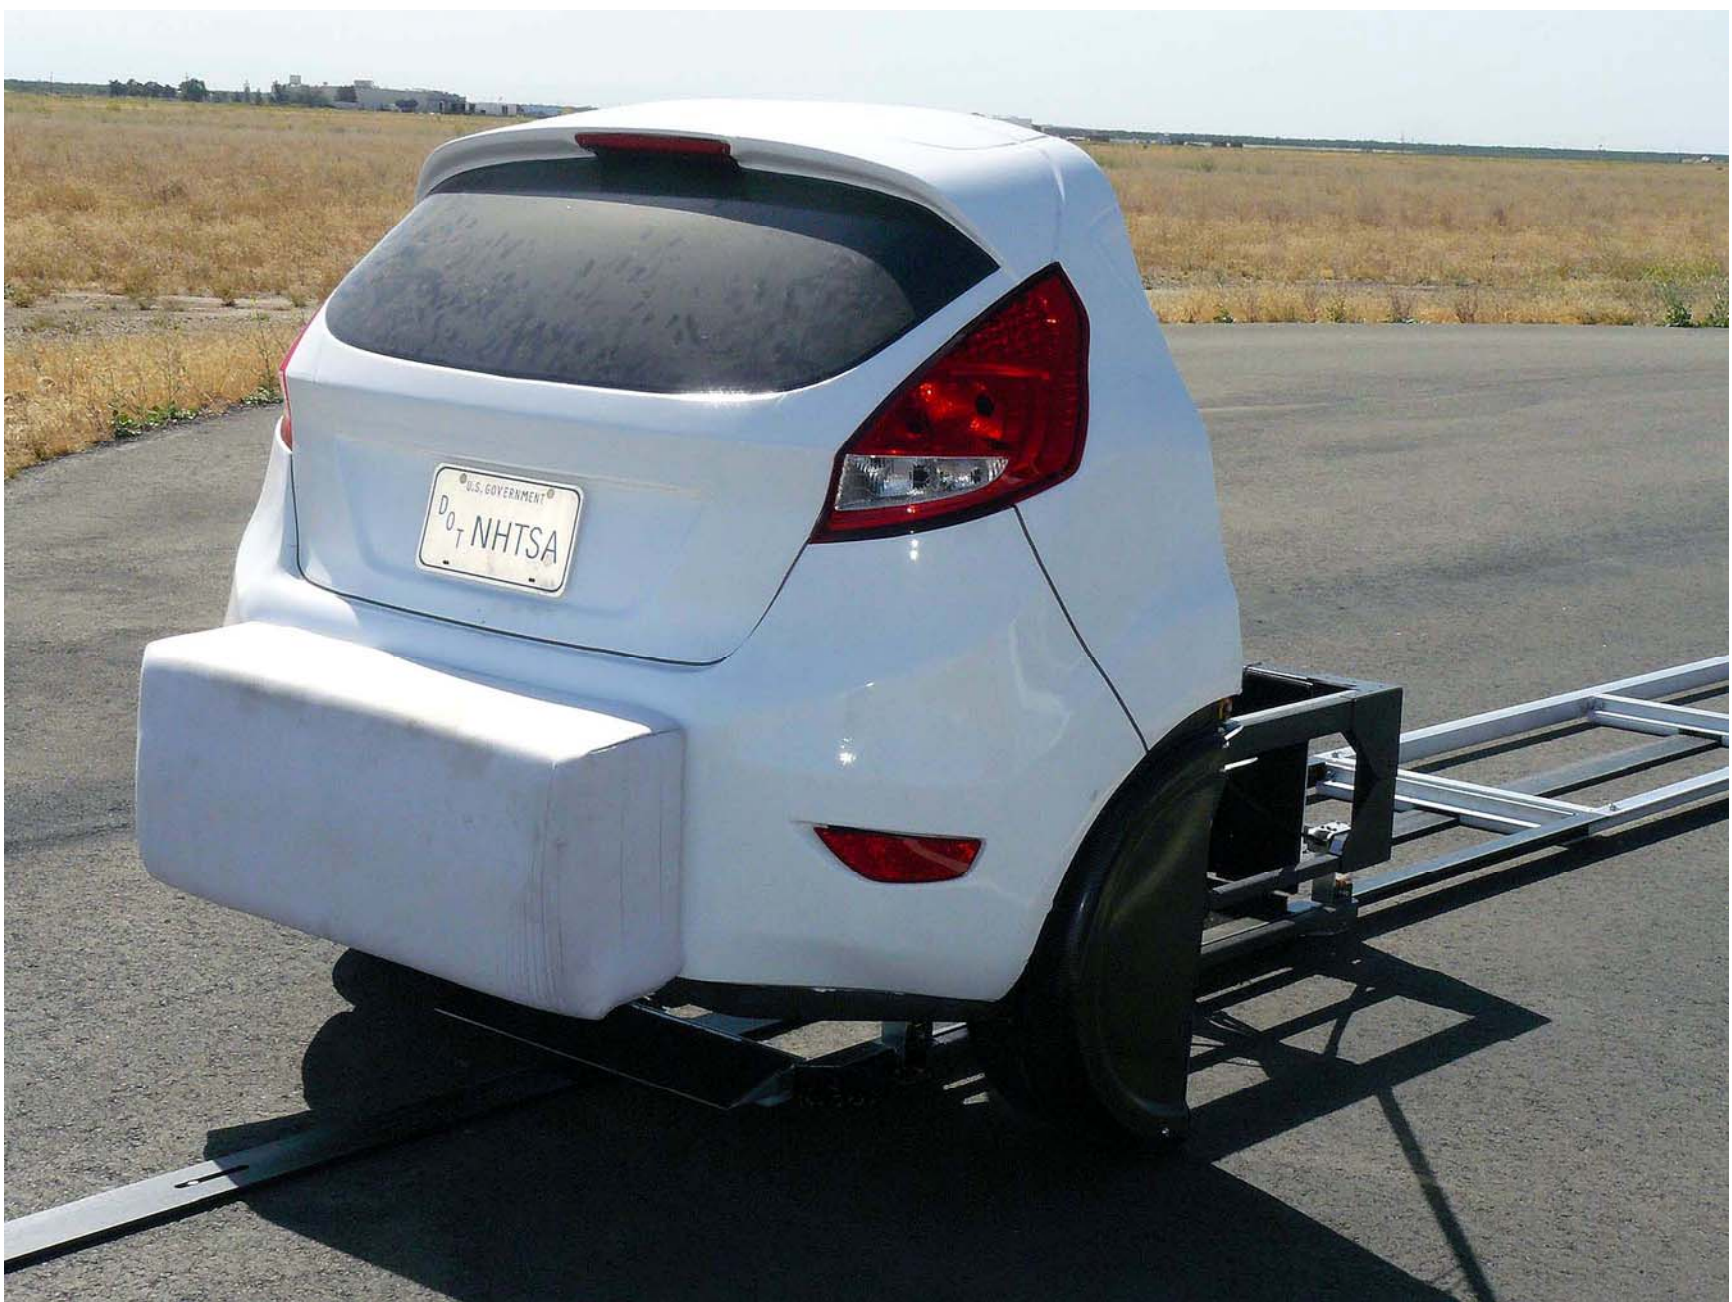
Figure A6. Rear View of Principal Other Vehicle (SSV)

CIB testing requires a POV that realistically represents typical vehicles, does not suffer damage or cause damage to a test vehicle in the event of collision, and can be accurately positioned and moved during the tests. The tests reported herein made use of the NHTSA developed Strikeable Surrogate Vehicle (SSV).

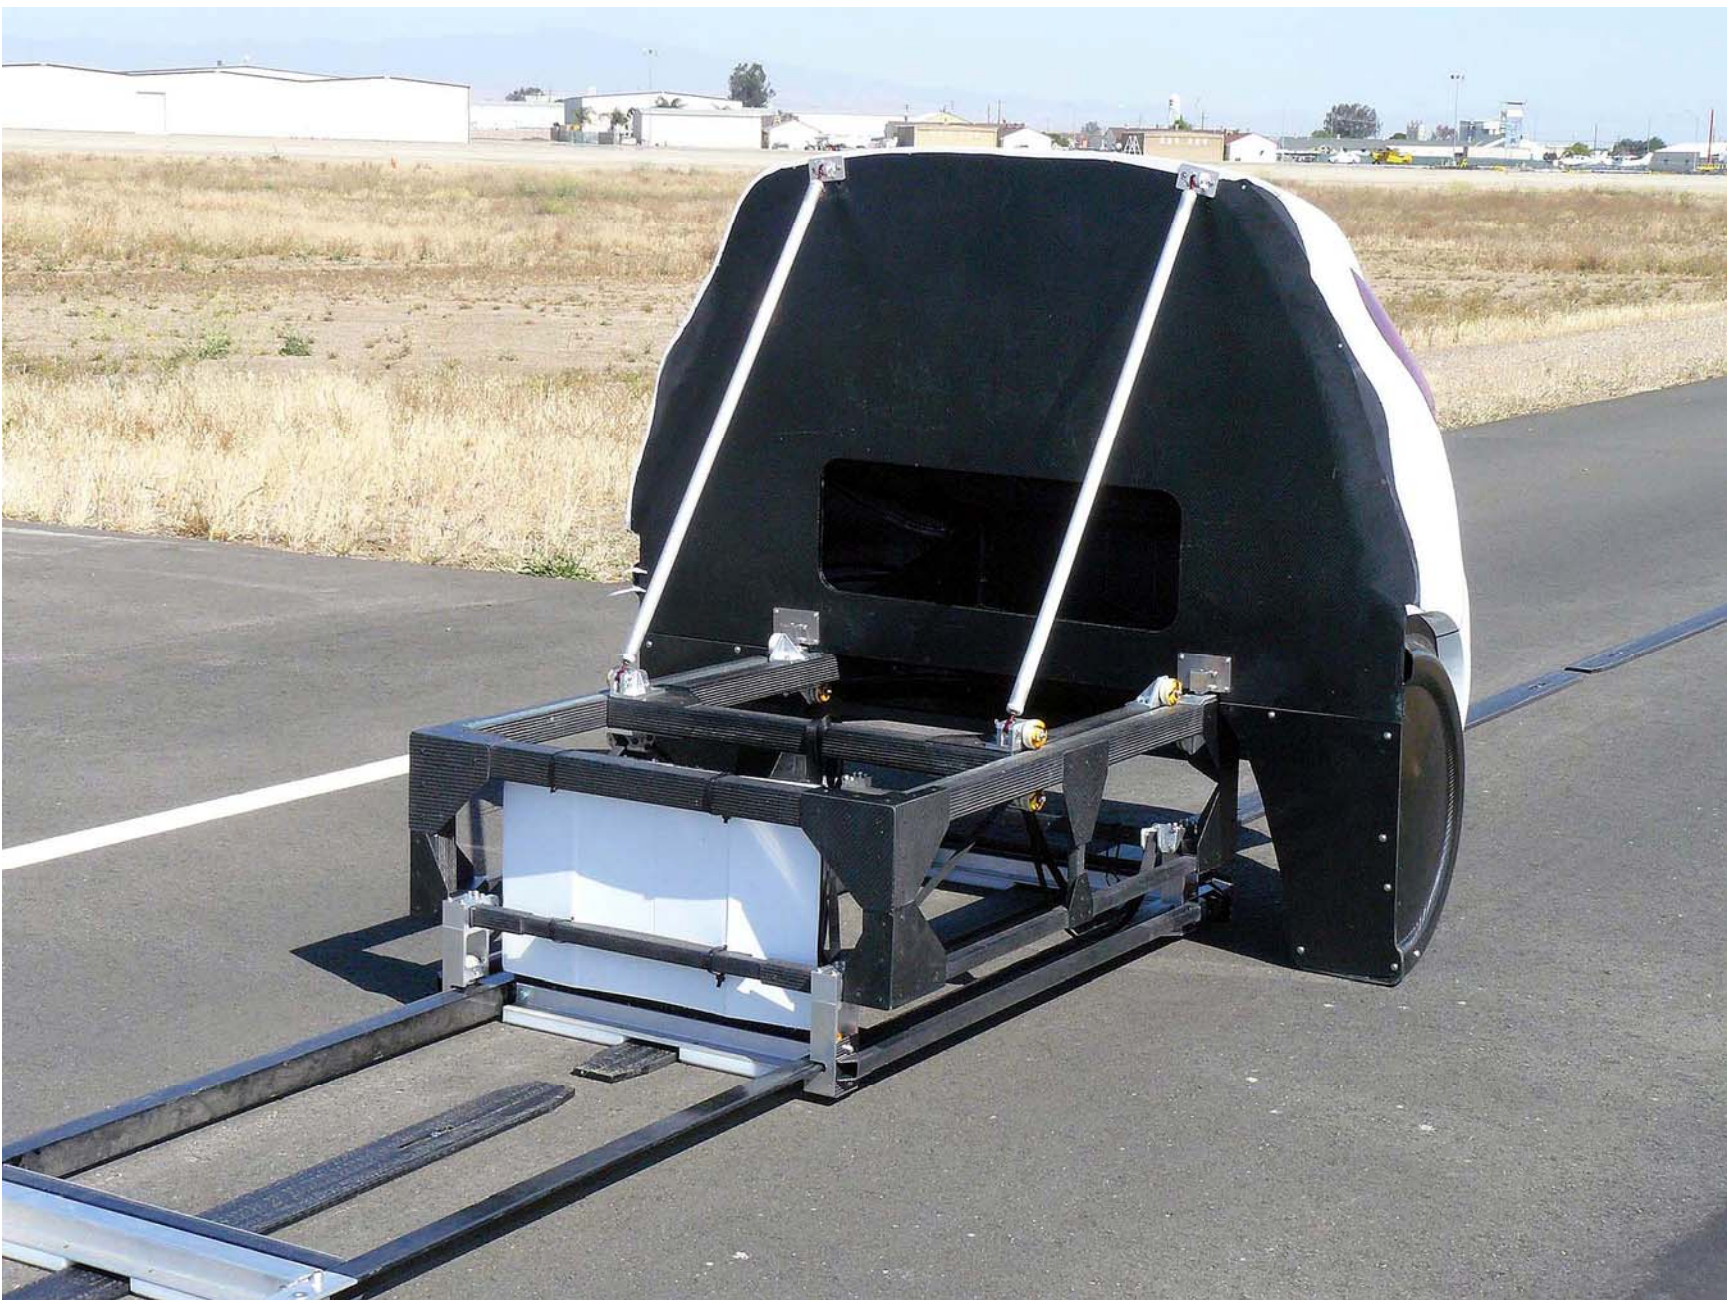
Figure A7. Load Frame/Slider of SSV

from the SV. The forward end of the rail has a cushioned stop to restrain forward motion of the shell/roller assembly. After impacting the SSV, the SV driver uses the steering wheel to maintain SV position in the center of the travel lane, thereby straddling the two-rail track. The SV driver must manually apply the SV brakes after impact. The SSV system is shown in Figures A6 through A8 and a detailed description can be found in the NHTSA report: NHTSA'S STRIKEABLE SURROGATE VEHICLE PRELIMINARY DESIGN + OVERVIEW, May 2013.

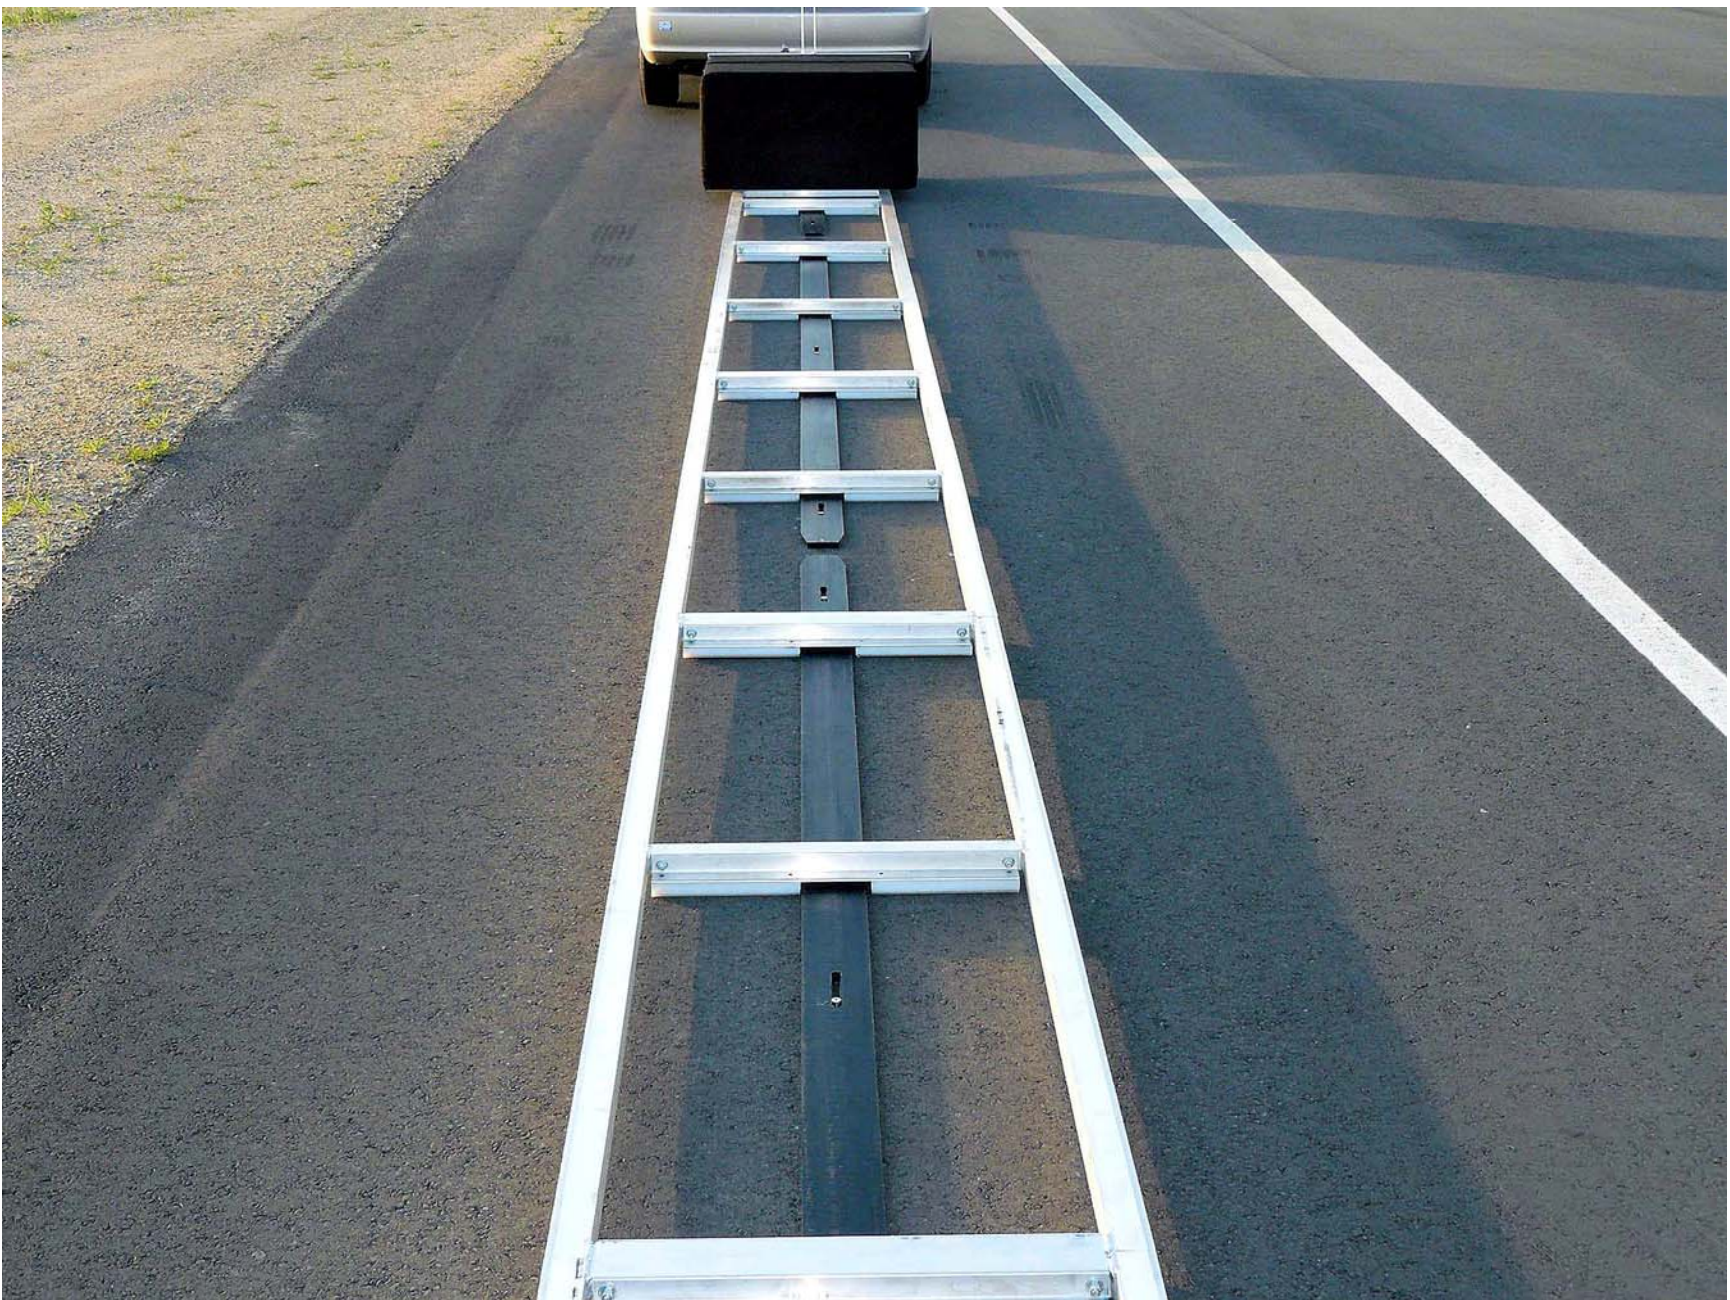
Figure A8. Two-Rail Track and Road-Based Lateral Restraint Track

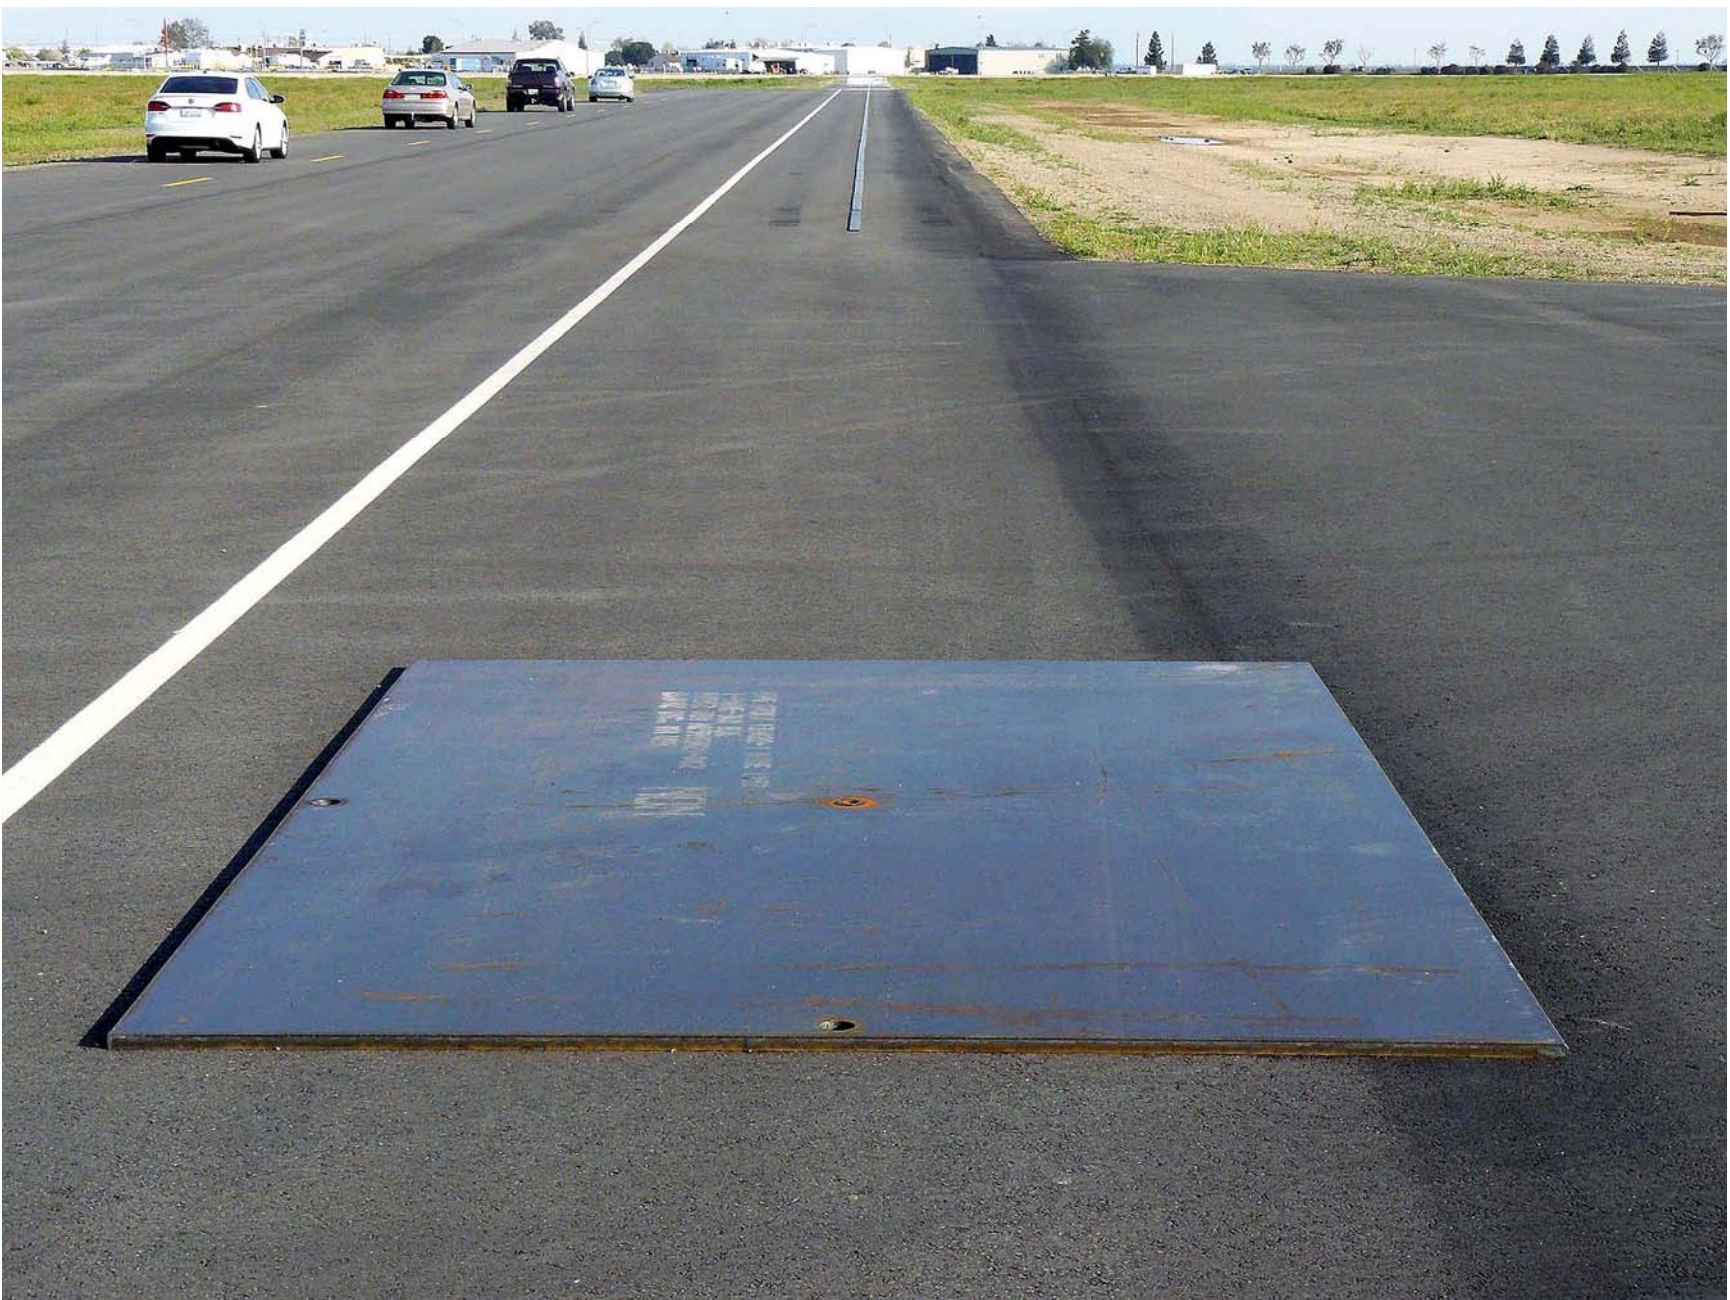
Figure A9. Steel Trench Plate

The false positive suppression test series evaluates the ability of a CIB system to differentiate a steel trench plate (STP) from an object presenting a genuine safety risk to the SV. Although the STP is large and metallic, it is designed to be driven over without risk of injury to the driver or damage to the SV. Therefore, in this scenario, the automatic braking available from CIB is not necessary and should be suppressed. The test condition is nearly equivalent to that previously defined for Test 1, the stopped POV condition, but with an STP in the SV forward path in lieu of a POV.

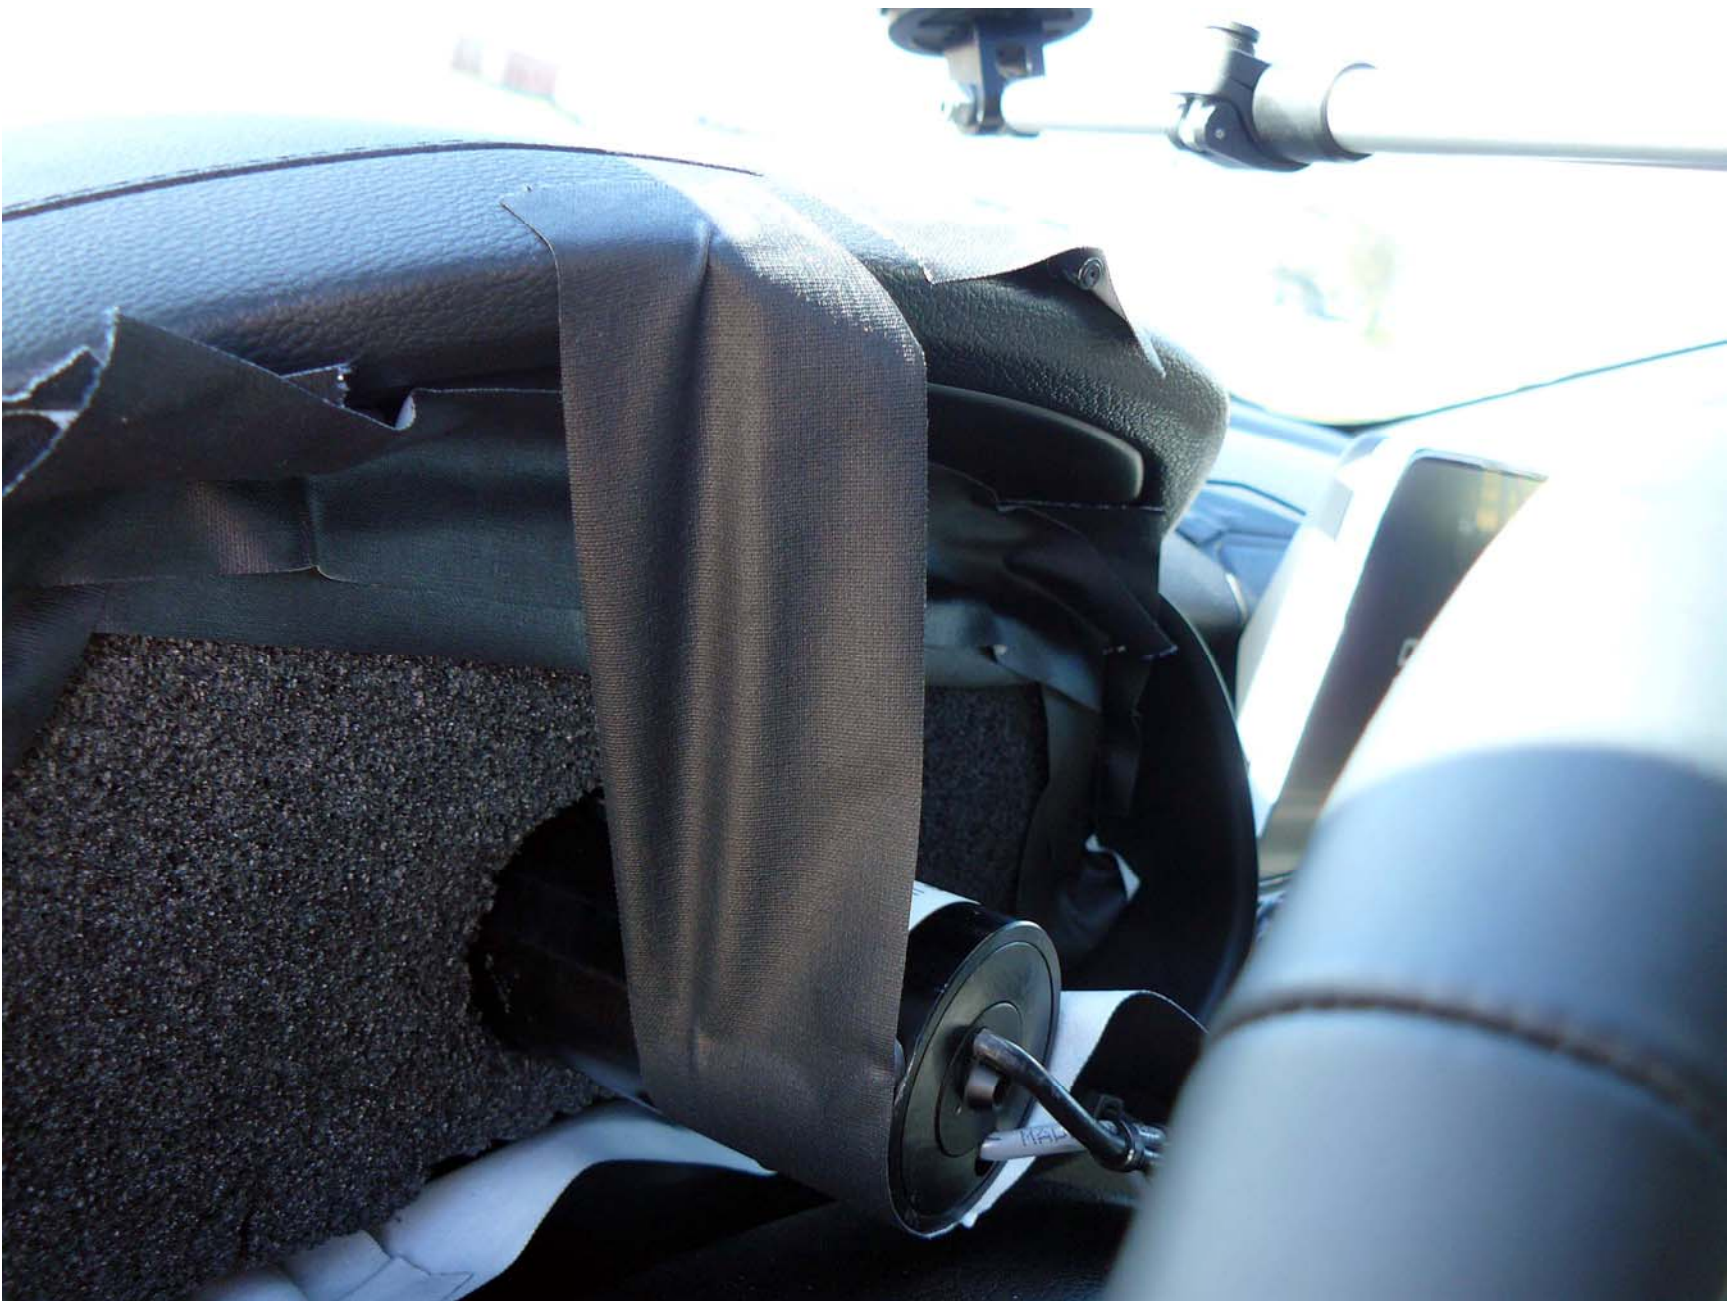
Figure A11. Sensors for Detecting Auditory and Visual Alerts

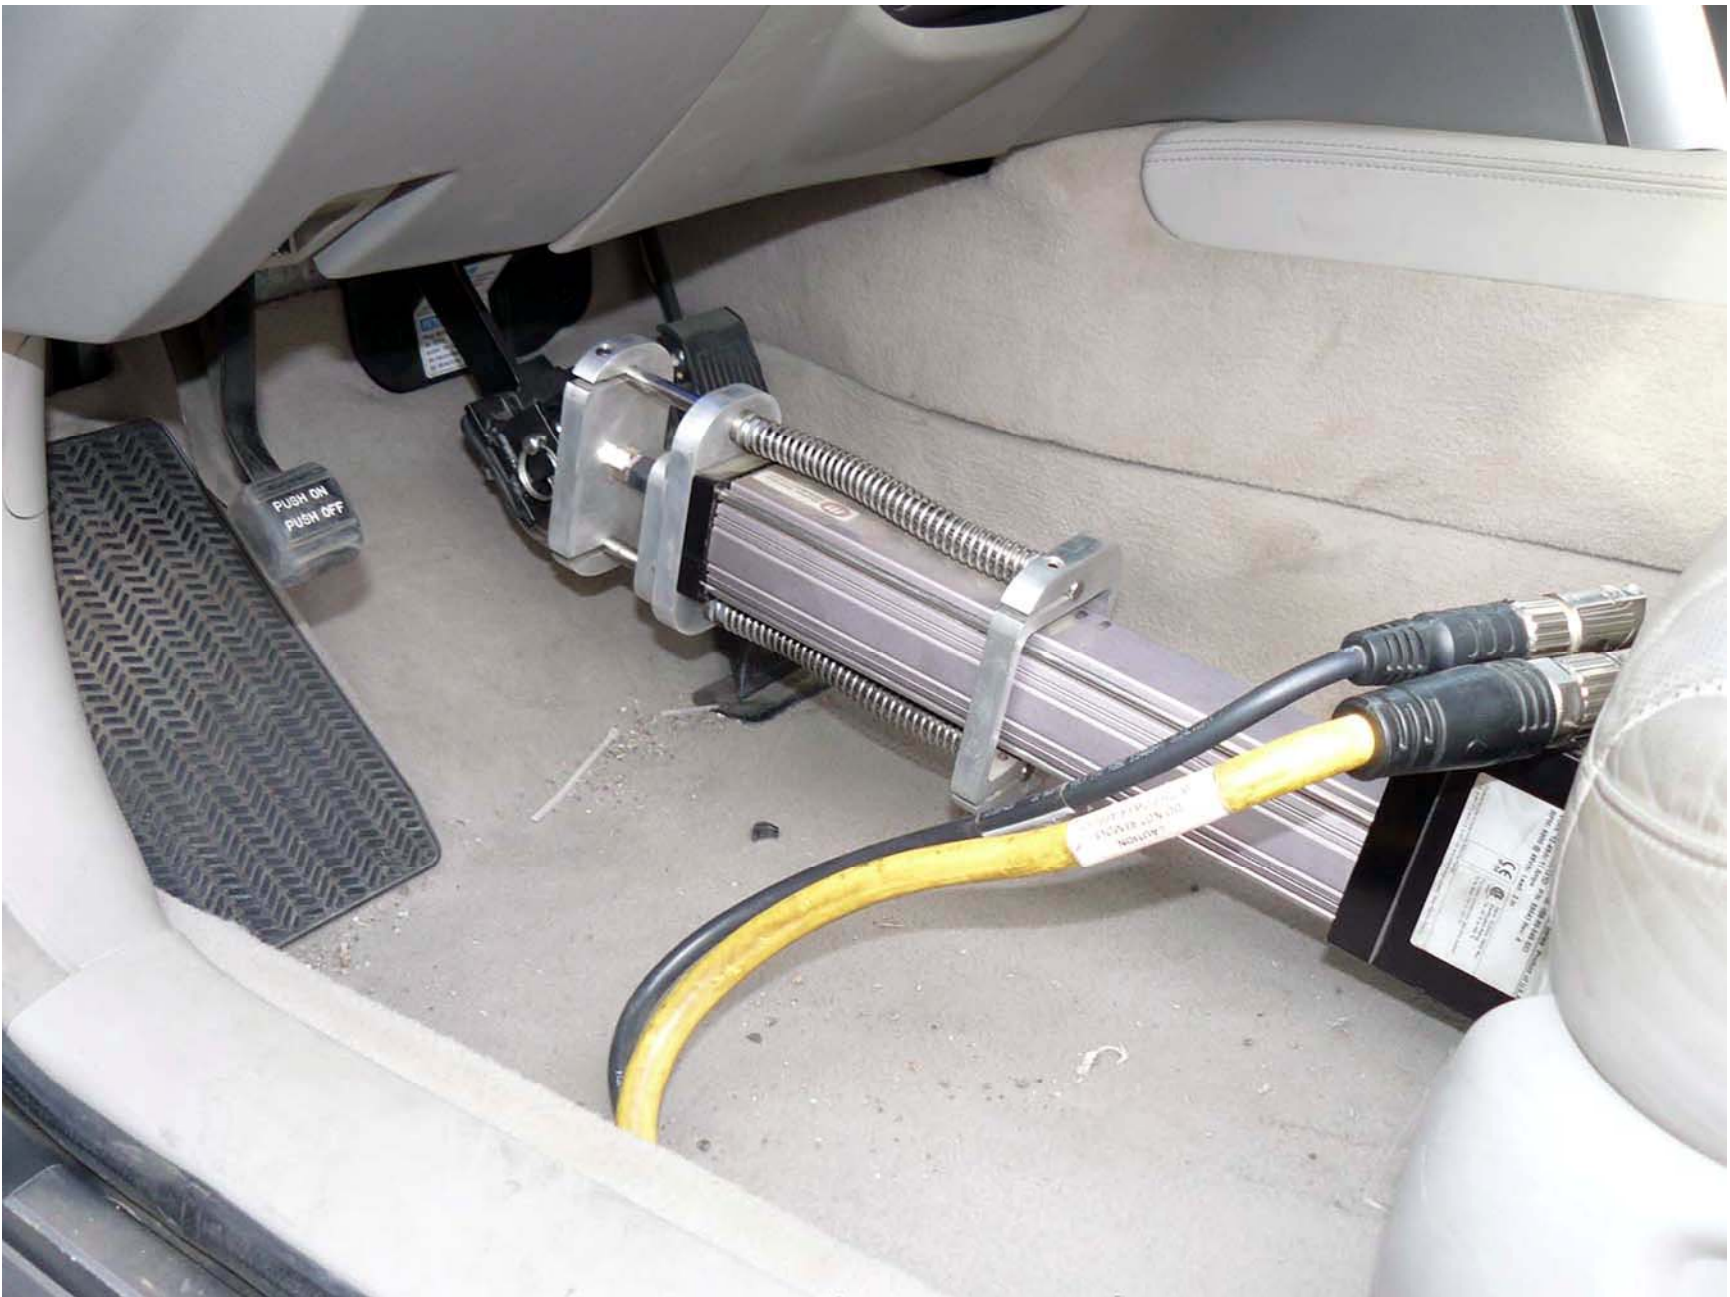
Figure A13. Brake Actuator Installed in POV System
