**REPORT NUMBER: SINCAP-CAL-19-005**

# NEW CAR ASSESSMENT PROGRAM (NCAP) MOVING DEFORMABLE BARRIER SIDE IMPACT TEST

Toyota Motor Manufacturing Canada INC. 2019 Toyota RAV-4 Four Door SUV

NHTSA No: M20195103

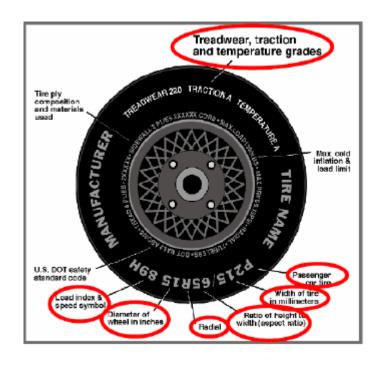
# **VEHICLE TIRE INFORMATION**

Collected for year, make, model, & VIN, all items circled in red, tire manufacturer and tire name.

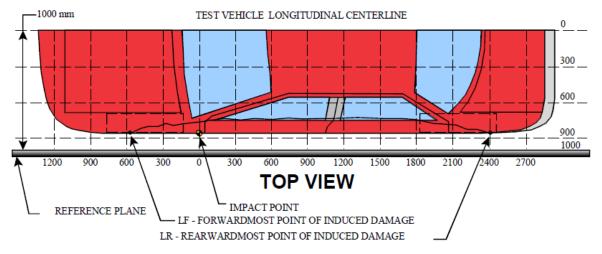
# DATA SHEET NO. 13 VEHICLE AND MDB DAMAGE PROFILE DISTANCES

For guidance regarding damage profile distance measurements, please refer to the latest version of the *NHTSA Test Reference Guide*. *Volume 1: Vehicle Tests*.

Forward of the impact point (towards front of vehicle) is considered negative (—). Rearward of the impact point (toward rearend of vehicle) is considered positive (+).

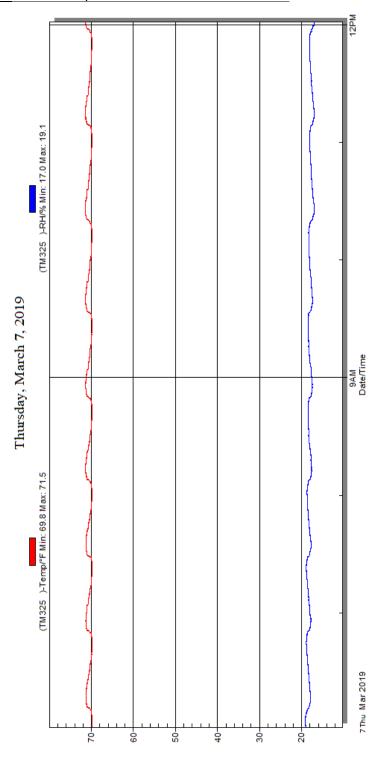
# DATA SHEET NO. 15 DUMMY/VEHICLE TEMPERATURE AND HUMIDITY STABILIZATION DATA

Temperature and Humidity Stabilization Chart/Data for Dummies and Test Vehicle

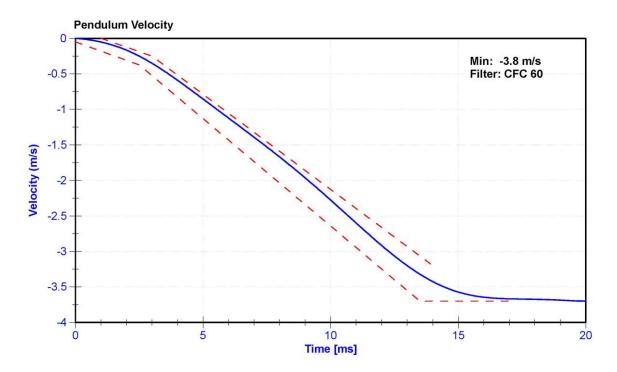
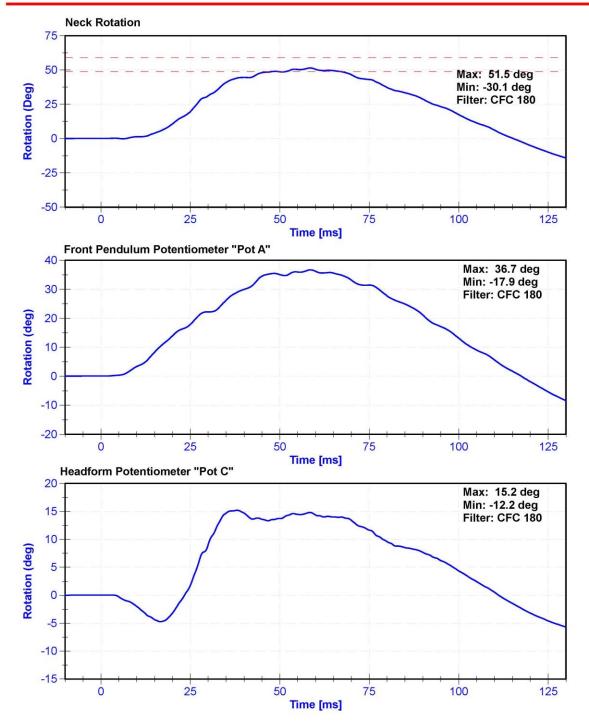
#### Certification Report ES-2re Neck Flexion - CFR 572

Test Parameter	Minimum Specification	Maximum Specification	Unit	Result	Pass/Fail
Temperature	20.6	22.2	°C	21.4	Pass
Humidity	10	70	%	23.7	Pass
Velocity	3.3	3.5	m/s	3.38	Pass
Lateral Neck Rotation	49	59	deg	51.5	Pass
Time at Maximum Rotation	54	66	ms	58.5	Pass
Time of Rotation Decay from Maximum	53	88	ms	56.8	Pass

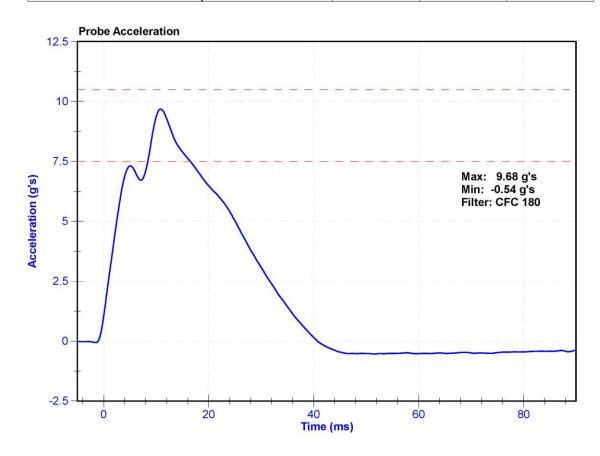
#### Certification Report ES-2re Shoulder Impact - CFR 572

Test Parameter	Minimum Specification	Maximum Specification	Unit	Result	Pass/Fail
Temperature	20.6	22.2	°C	21.5	Pass
Humidity	10	70	%	25.0	Pass
Velocity	4.2	4.4	m/s	4.20	Pass
Probe Acceleration	7.5	10.5	g's	9.68	Pass

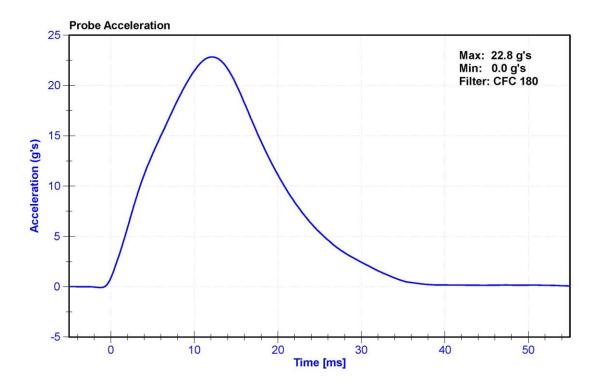
# Certification Report ES-2re F034 Pelvis Impact - CFR 572

Test Parameter	Minimum Specification	Maximum Specification	Unit	Result	Pass/Fail
Temperature	20.6	22.2	°C	21.5	Pass
Humidity	10	70	%	26.2	Pass
Velocity	4.2	4.4	m/s	4.39	Pass
Resistive Force	4700	5400	N	5209.8	Pass
Time at Peak Resistive Force	11.8	16.1	ms	12.10	Pass
Pubic Force	-1590	-1230	N	-1354.2	Pass
Time at Peak Pubic Force	12.2	17.0	ms	13.00	Pass
