REPORT NUMBER: SPNCAP-CAL-19-004

**NEW CAR ASSESSMENT PROGRAM (NCAP)
SIDE IMPACT POLE TEST**

**Toyota Motor Corporation
2019 Toyota RAV-4
SUV**

NHTSA No: M20195102

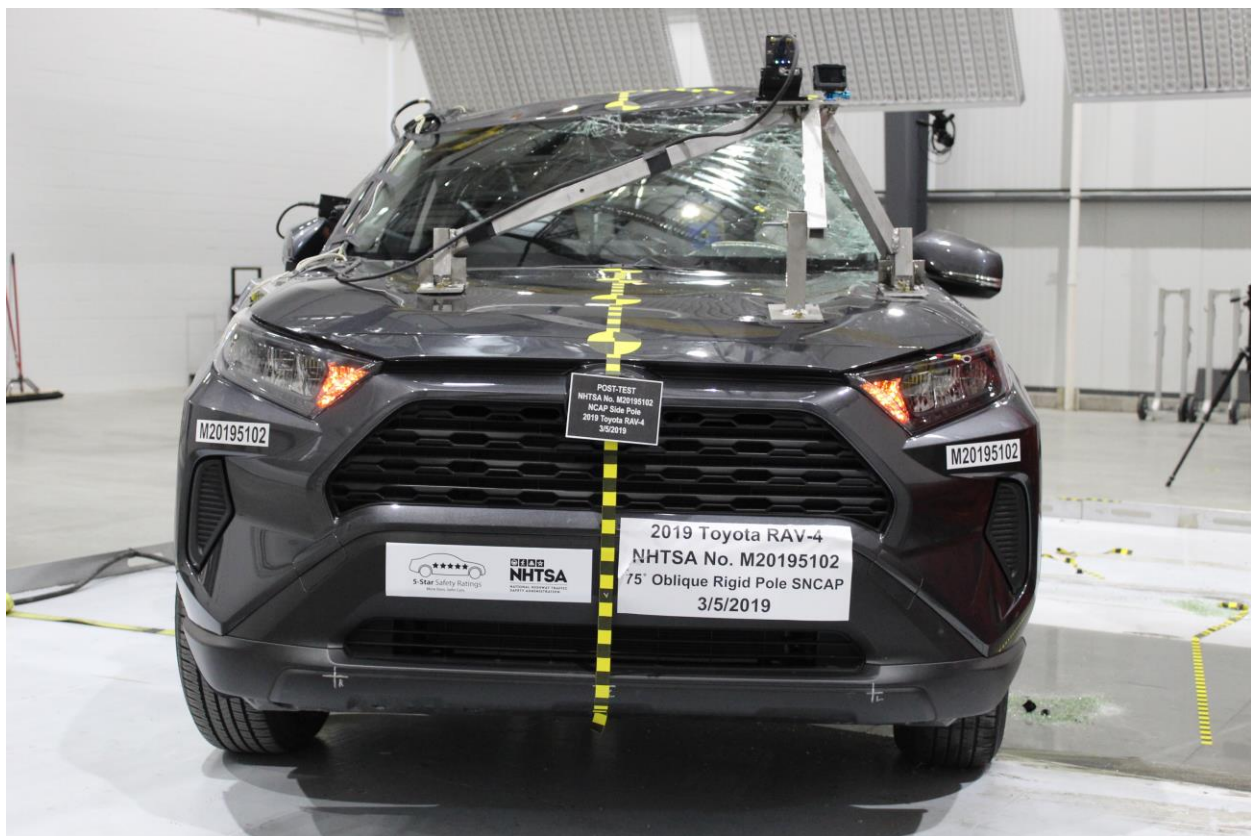
Figure A-4: Post-Test Frontal View of Test Vehicle

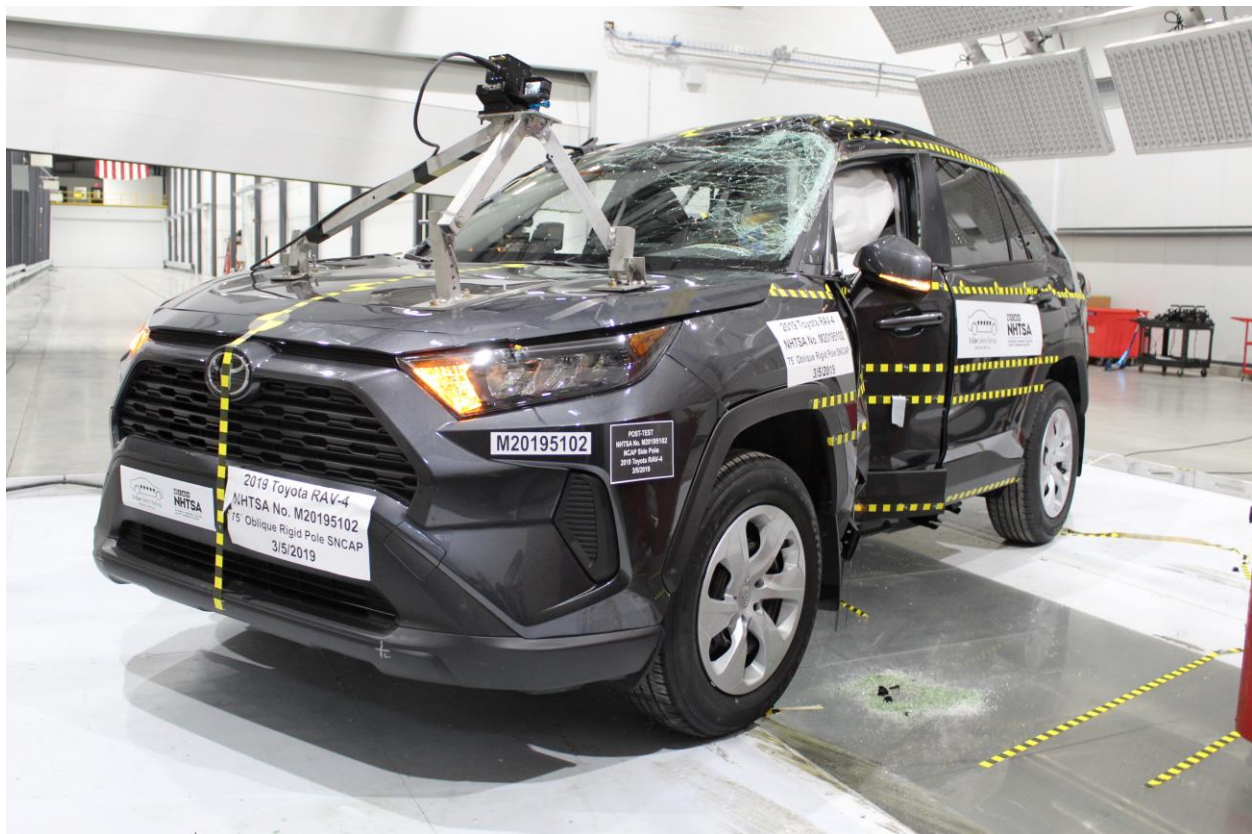
Figure A-6: Post-Test Left Front $\frac{3}{4}$ View of Test Vehicle

Critical Areas of Performance	Observations and Conclusions
Pillar Performance	A-Pillar buckled
Sill Separation	None
Windshield Damage	Cracks throughout and separation along driver A-Pillar
Side Window Damage	Driver's window shattered during impact
Other Notable Effects	None

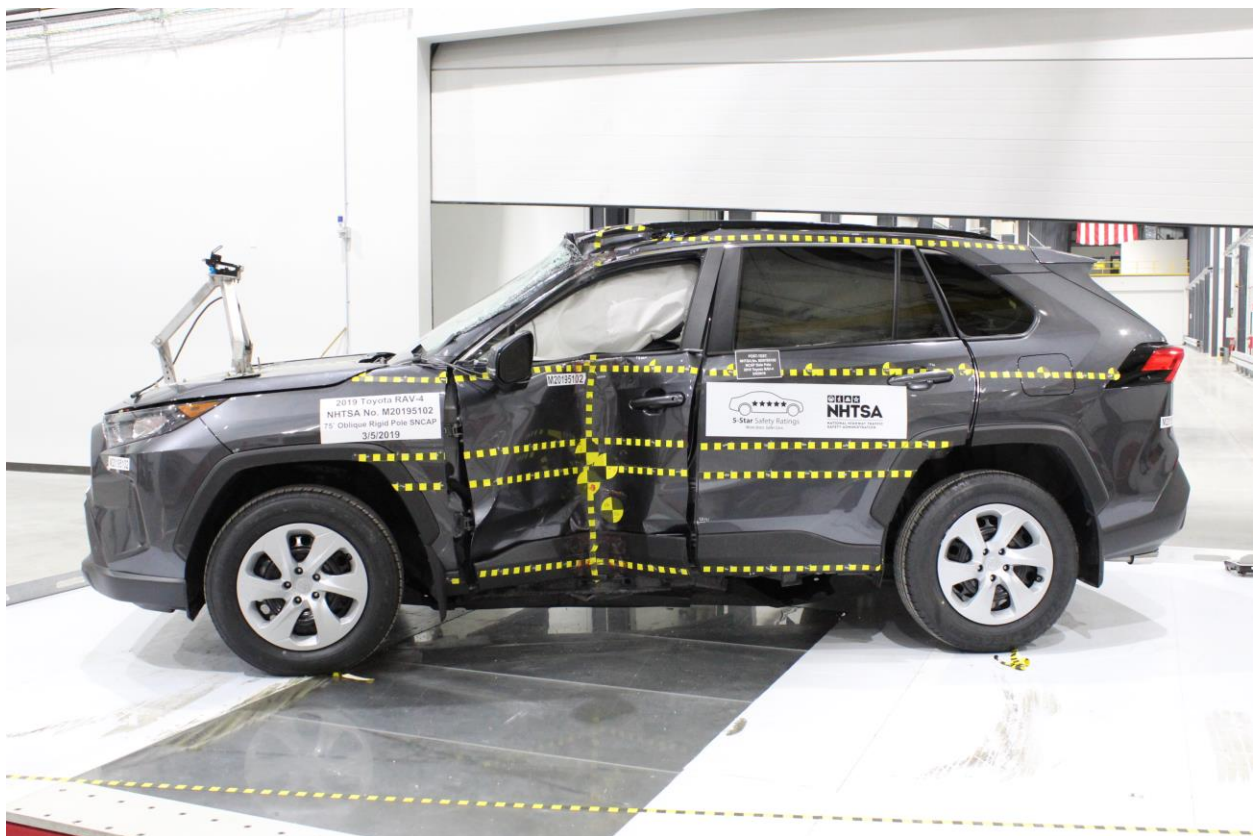
Figure A-8: Post-Test Left Side View of Test Vehicle

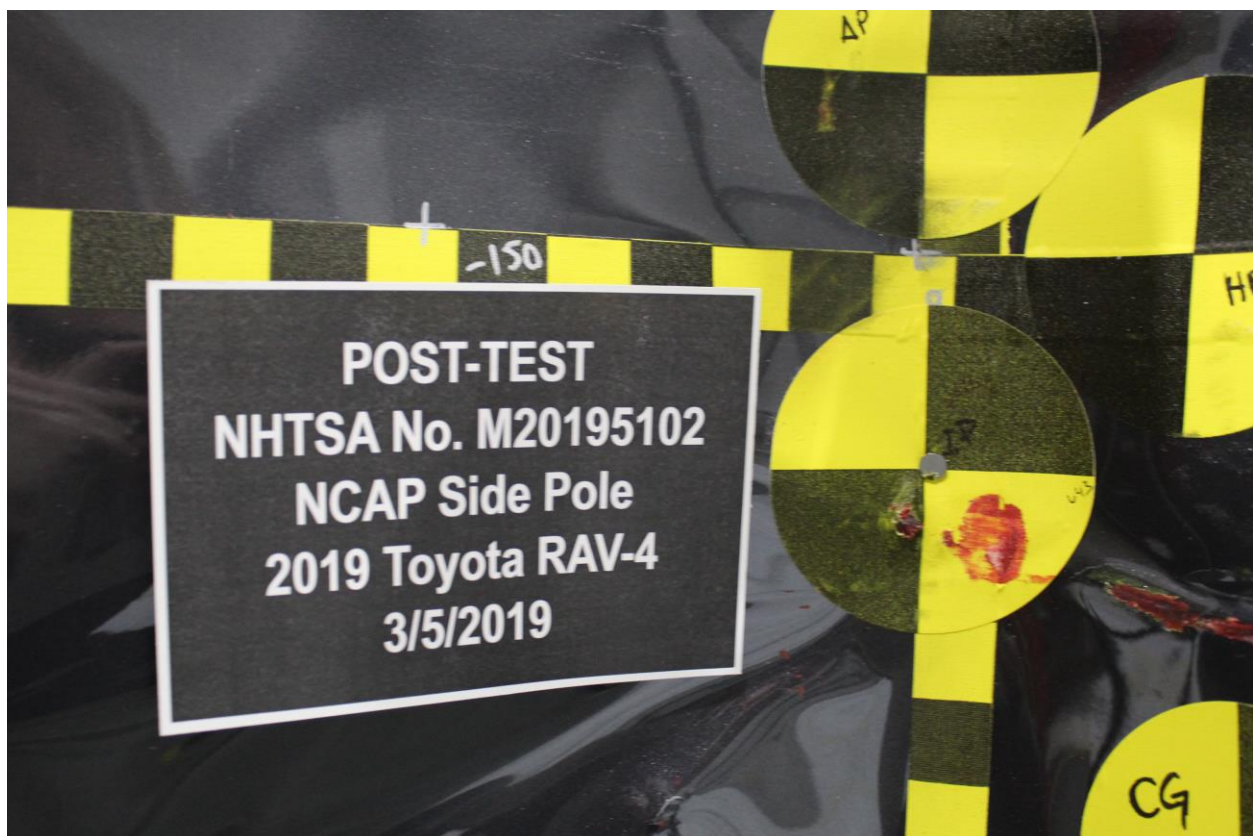
Figure A-20: Post-Test Close-Up View of Impact Point Target Showing Impact Location

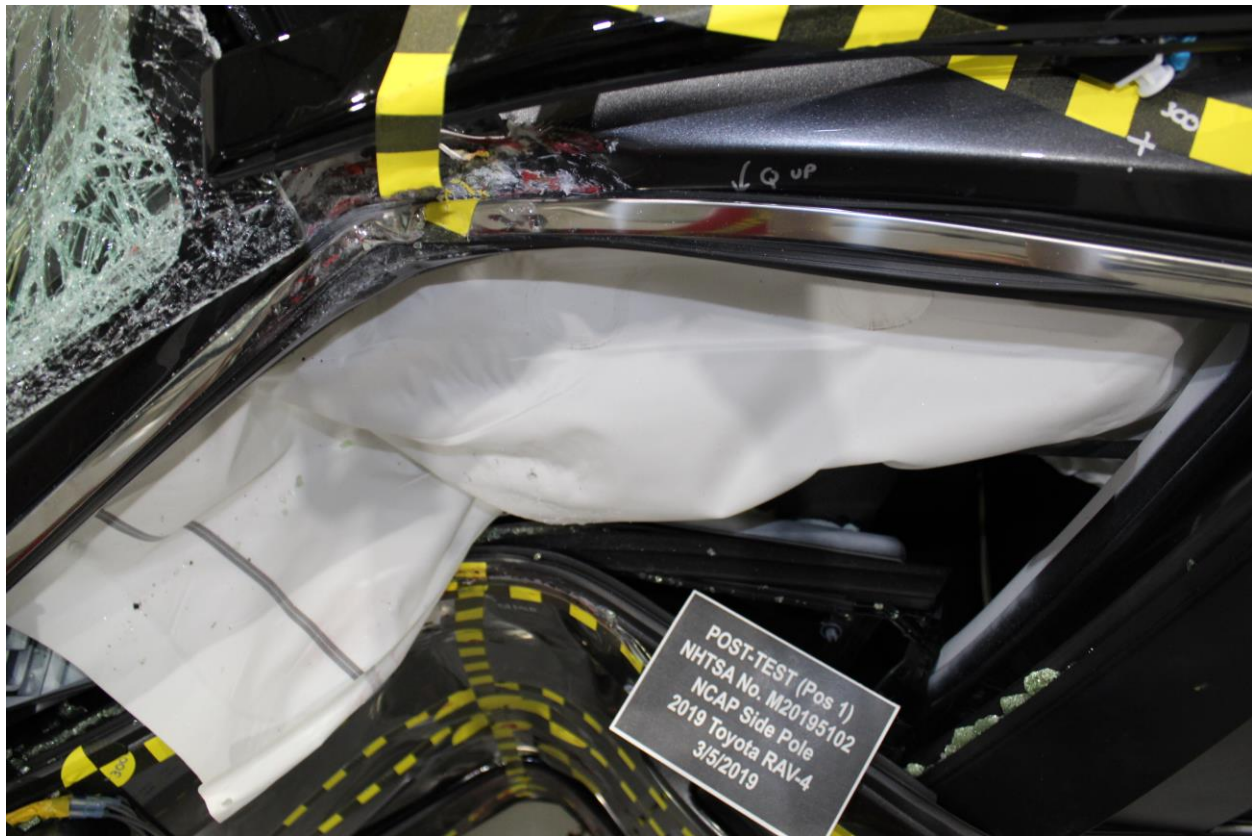
Figure A-41: Post-Test Dummy and Door Clearance View

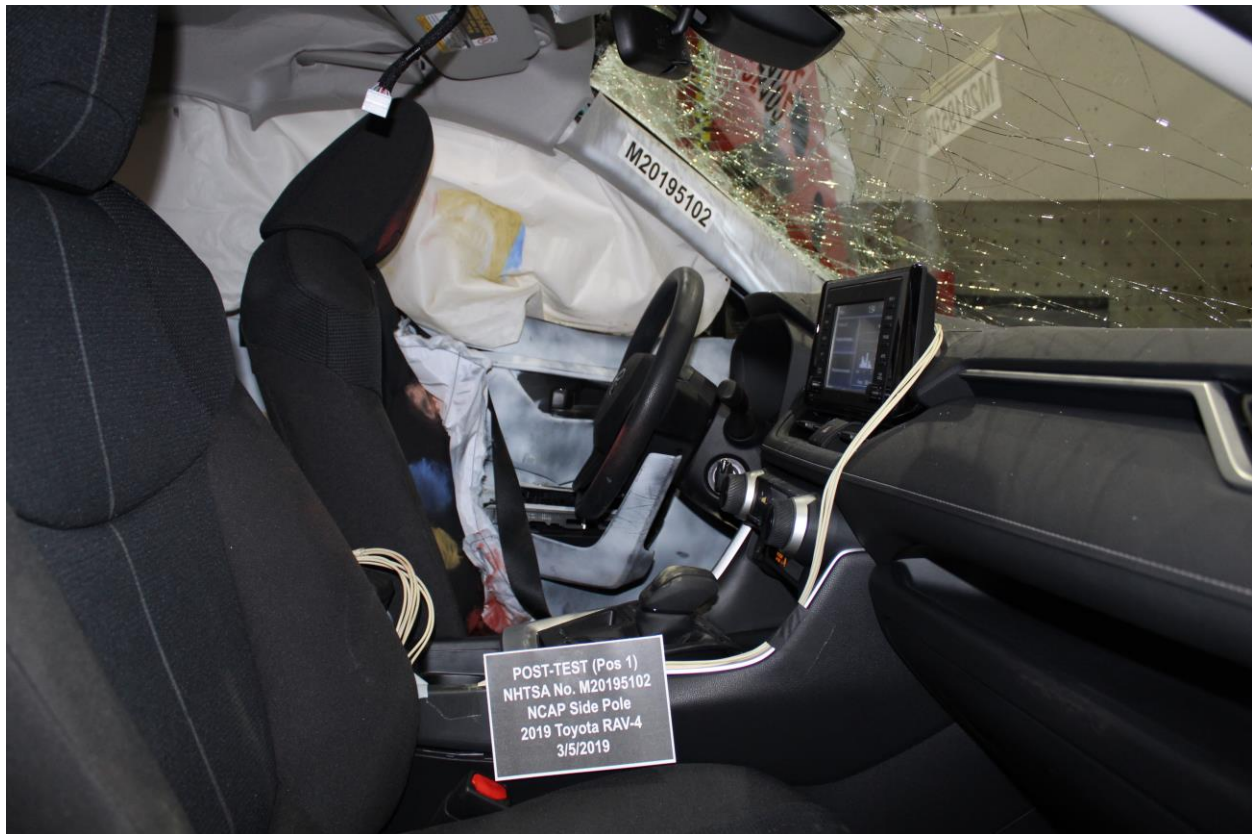
Figure A-45: Post-Test Inner Door Panel View Showing Dummy Contact Location

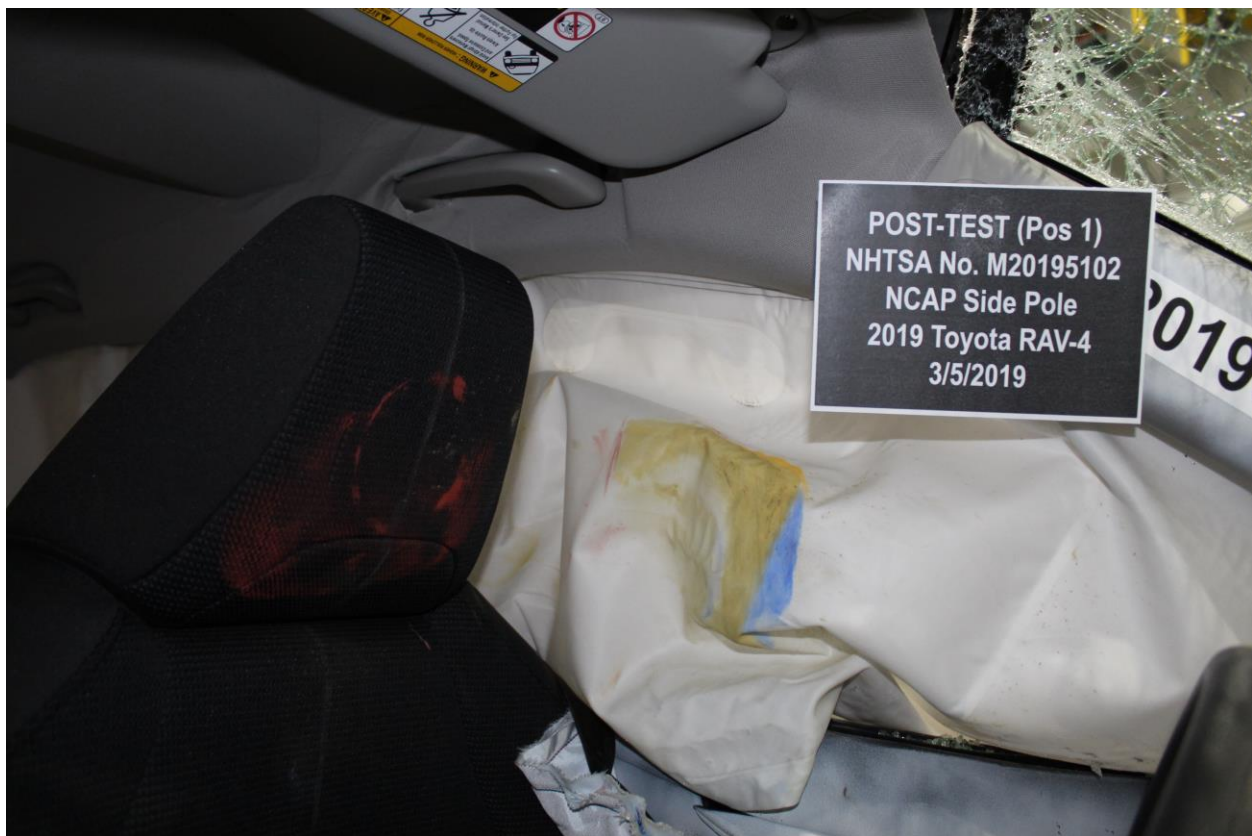
Figure A-46: Post-Test Dummy Close-Up Head Contact with Vehicle Interior View

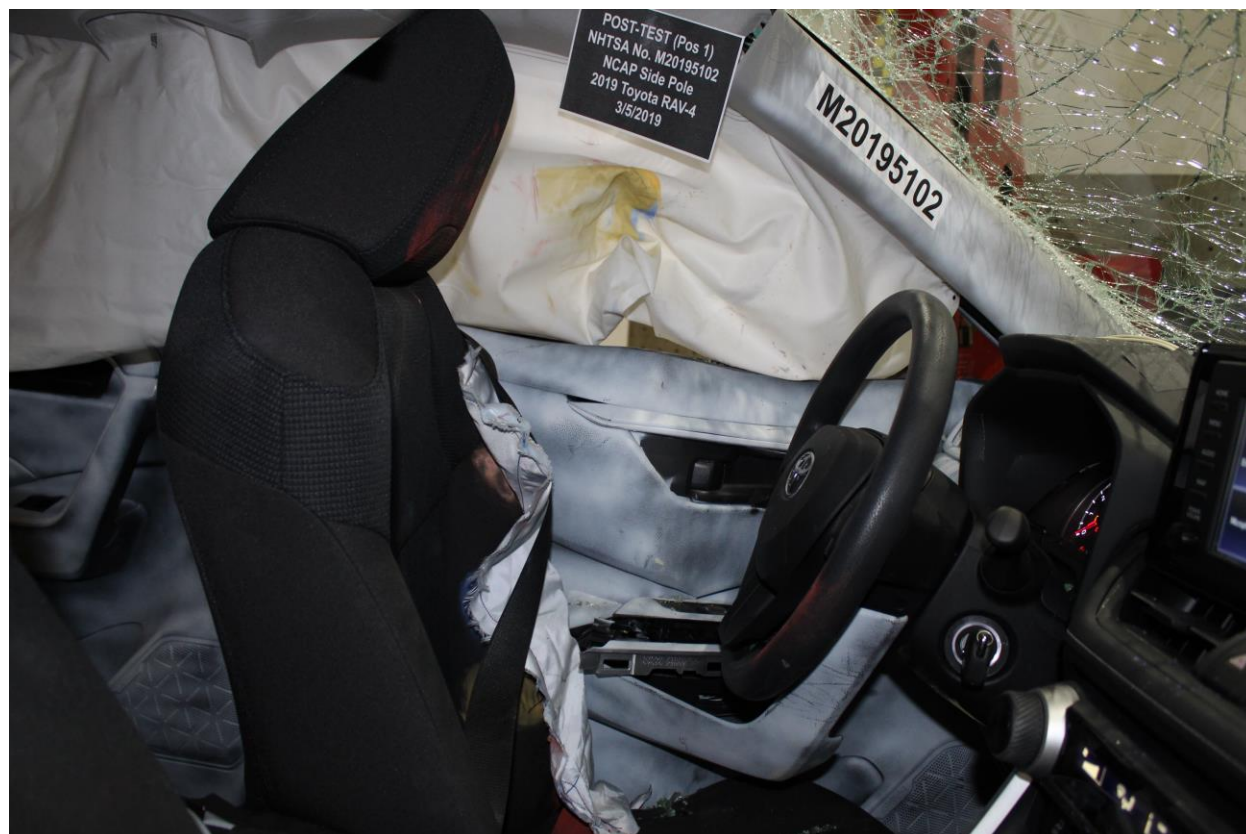
Figure A-71: Post-Test View of Shattered Vehicle Inner Door Panel (if applicable)
