REPORT NUMBER: NCAP-CAL-19-007

**NEW CAR ASSESSMENT PROGRAM (NCAP)
FRONTAL BARRIER IMPACT TEST**

**Ford Motor Co.
2019 Ford F-250 Crew Cab
Four Door Truck**

NHTSA No: M20190205

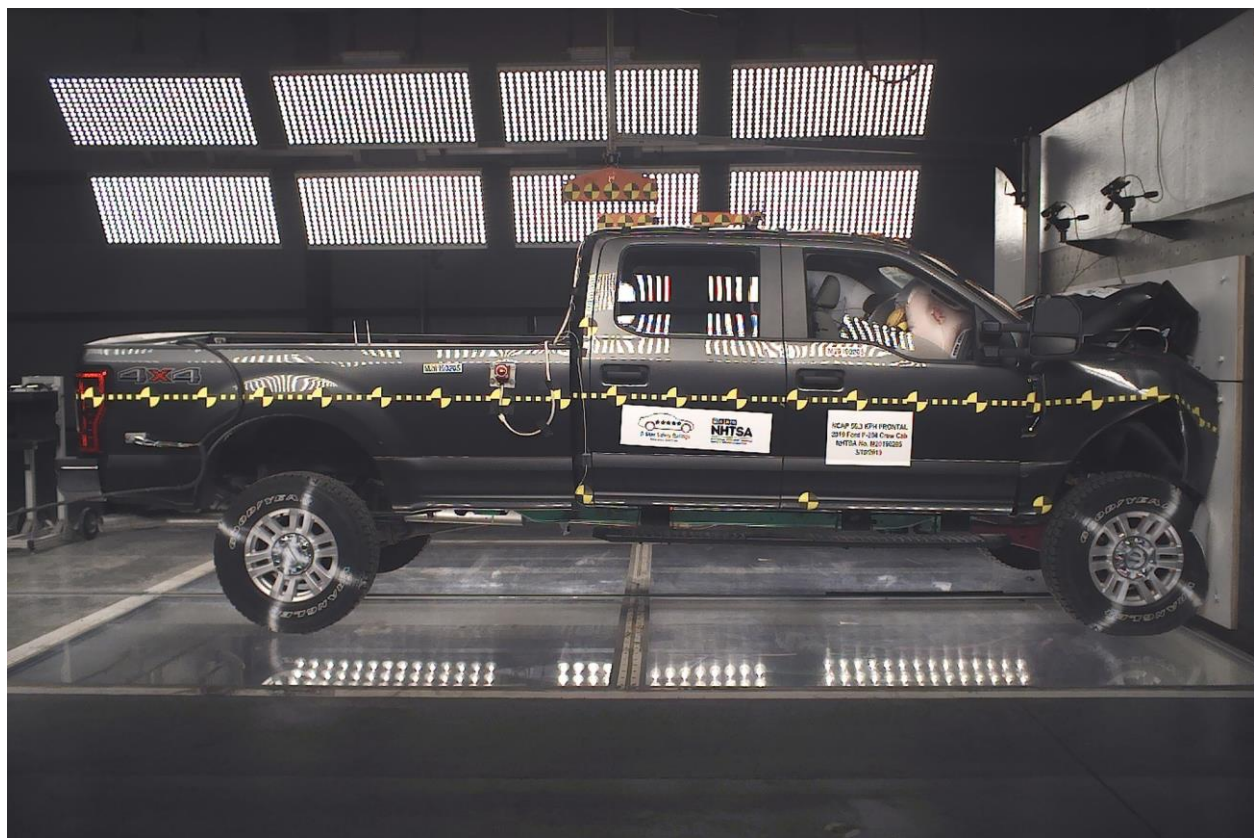
Figure A-78: 2019 Ford F-250 Frontal Impact Event

A ridged fixed barrier was impacted by a 2019 Ford F-250 four door Truck at a velocity of 56.29 km/h. The test was performed at Calspan Corporation's Transportation Test Operations facility in Buffalo, New York on March 19, 2019. Pre- and post-test photographs of the vehicle and dummies to document the test can be found in Appendix A. One real-time camera and 14 high-speed cameras were used to document the frontal barrier impact event. Camera locations and other pertinent camera information can be found in Data Sheet 6 of this report.
