**REPORT NUMBER: SPNCAP-KAR-19-018
NEW CAR ASSESSMENT PROGRAM (NCAP)
SIDE IMPACT POLE TEST**

**BAYERISCHE MOTOREN WERKE AG
2019 BMW X3 SDRIVE30I 5-DOOR MPV**

NHTSA No: M20194101

**PREPARED BY:
APPLUS IDIADA KARCO ENGINEERING, LLC.
9270 HOLLY ROAD
ADELANTO, CA 92301**

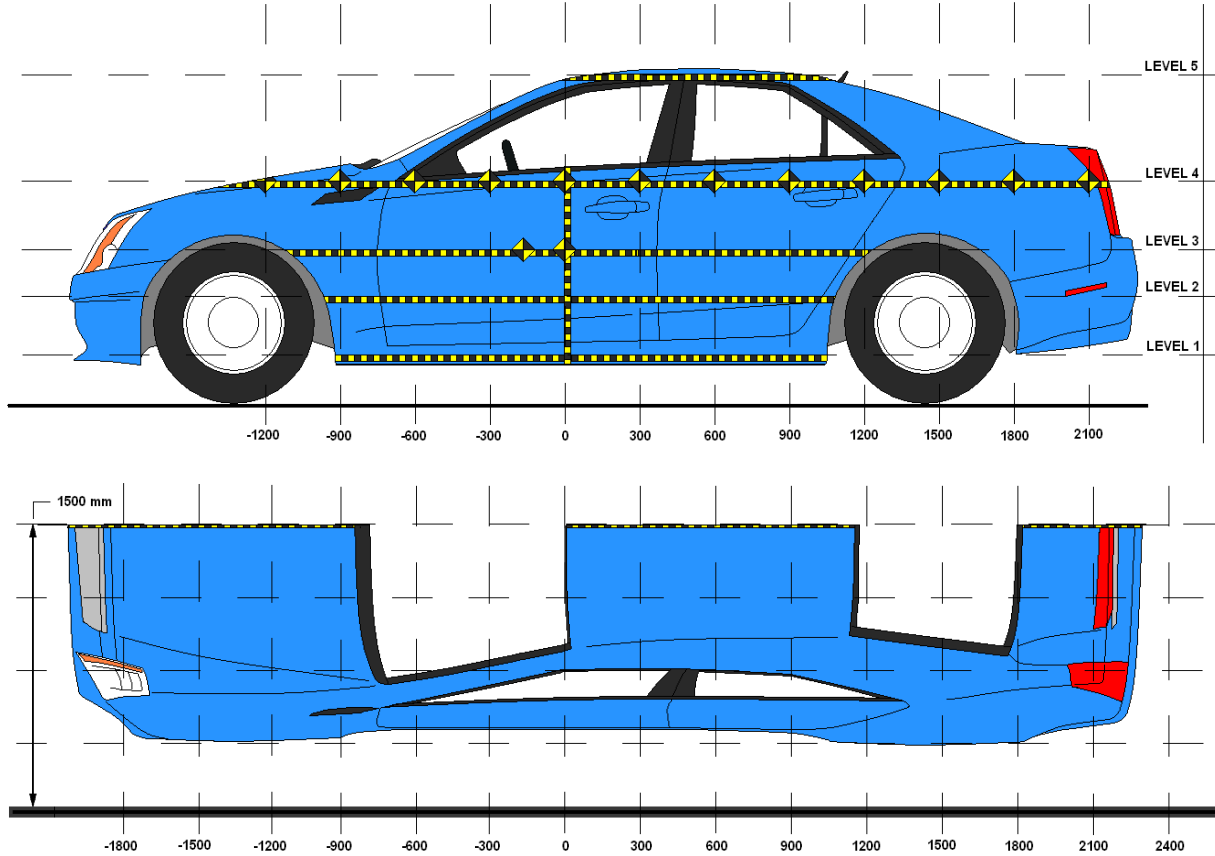
TEST VEHICLE EXTERIOR CRUSH MEASUREMENTS

NOTE: All measurements in mm with tolerance of ± 3 mm

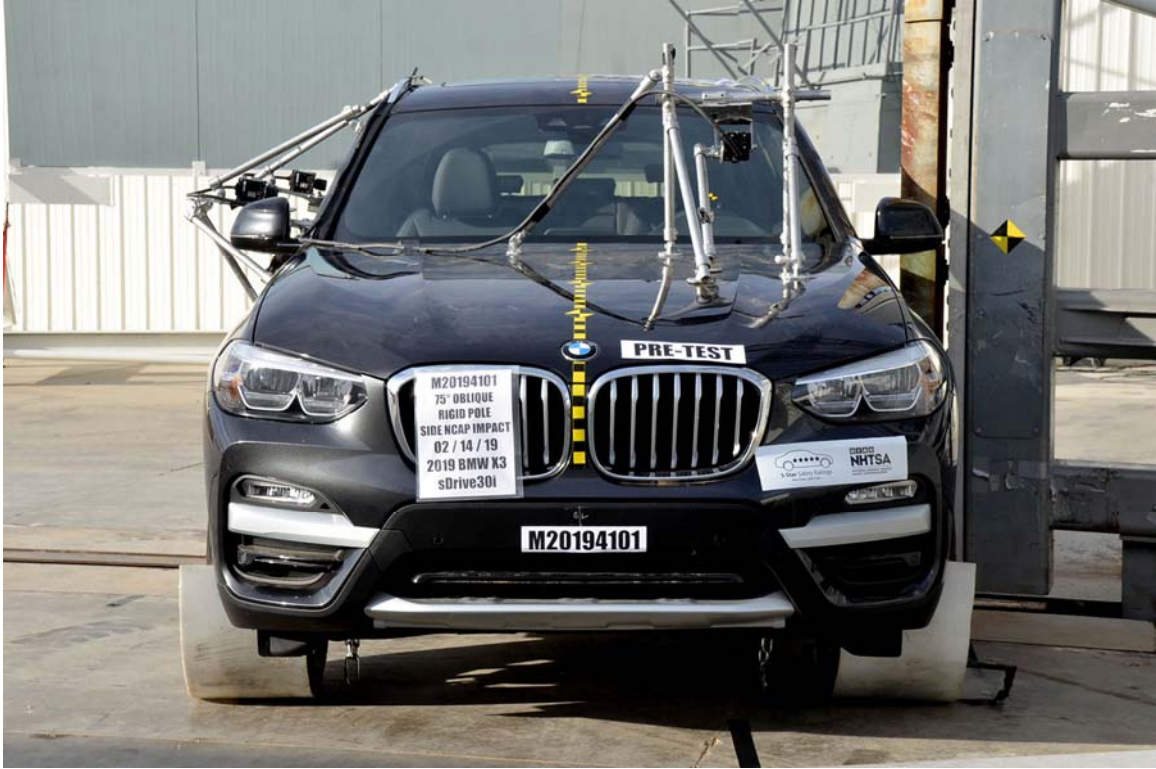
FIGURE 3. Pre-Test Frontal View of Test Vehicle

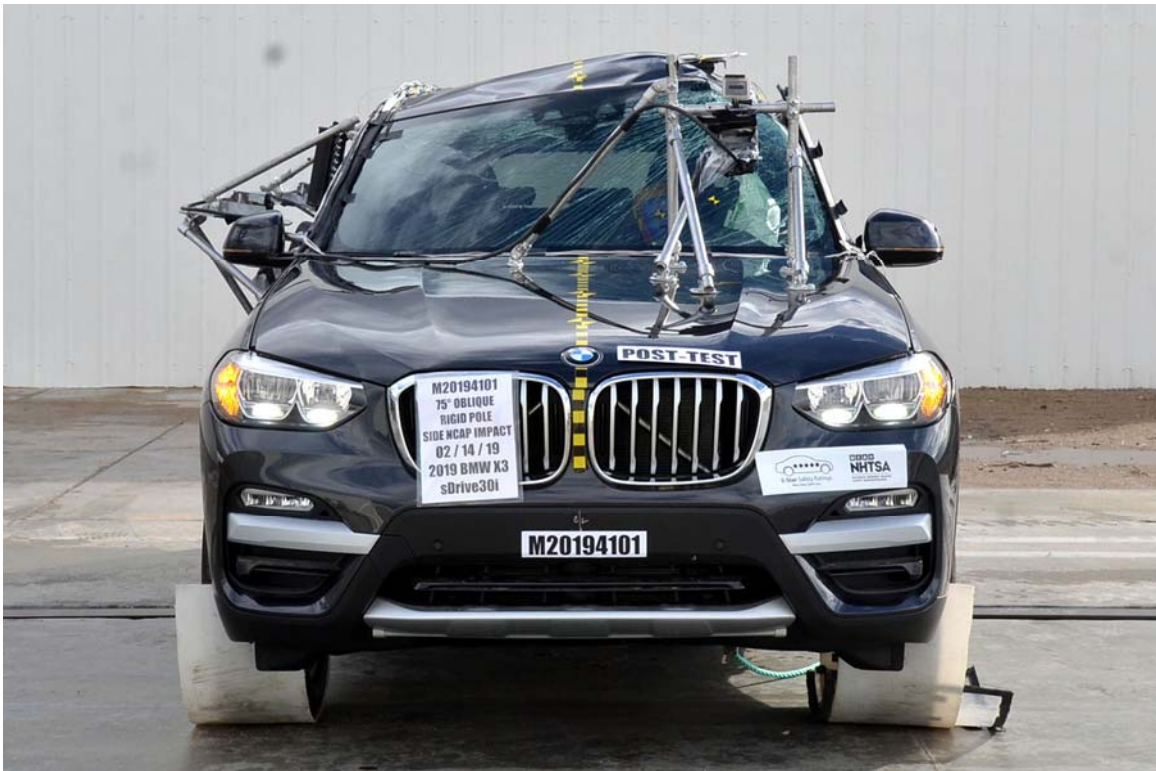
FIGURE 4. Post-Test Frontal View of Test Vehicle

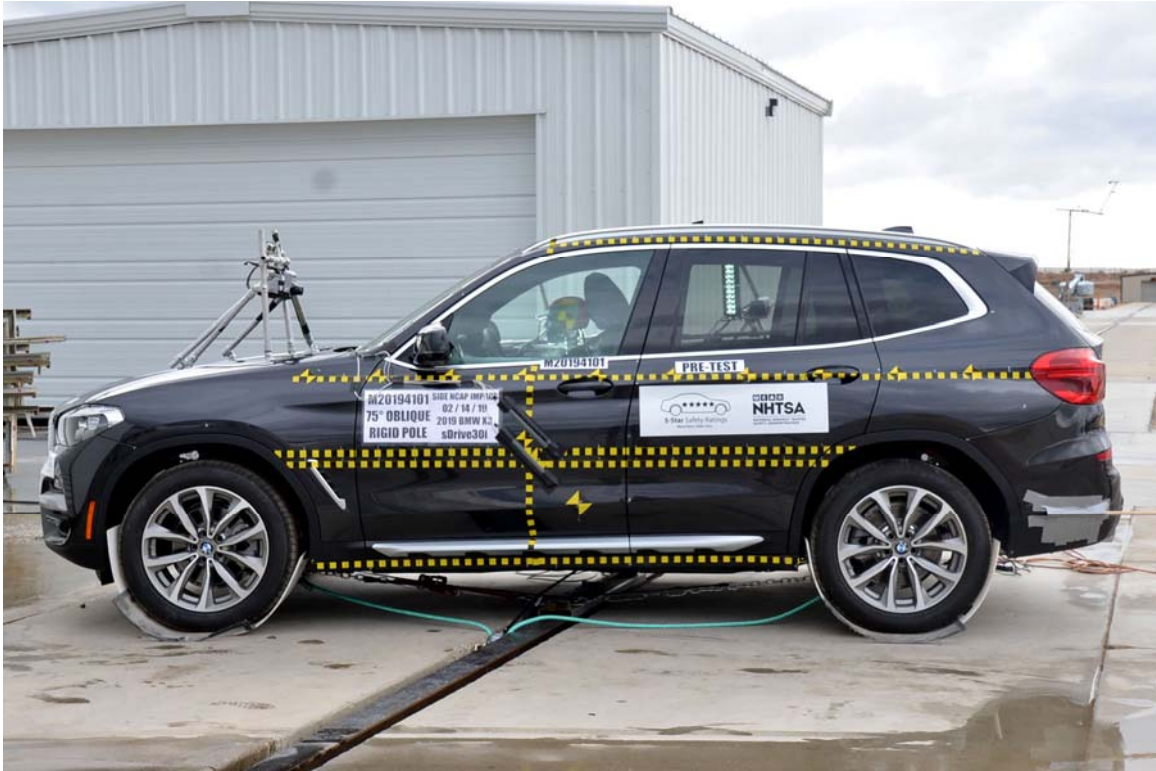
FIGURE 7. Pre-Test Left Side View of Test Vehicle

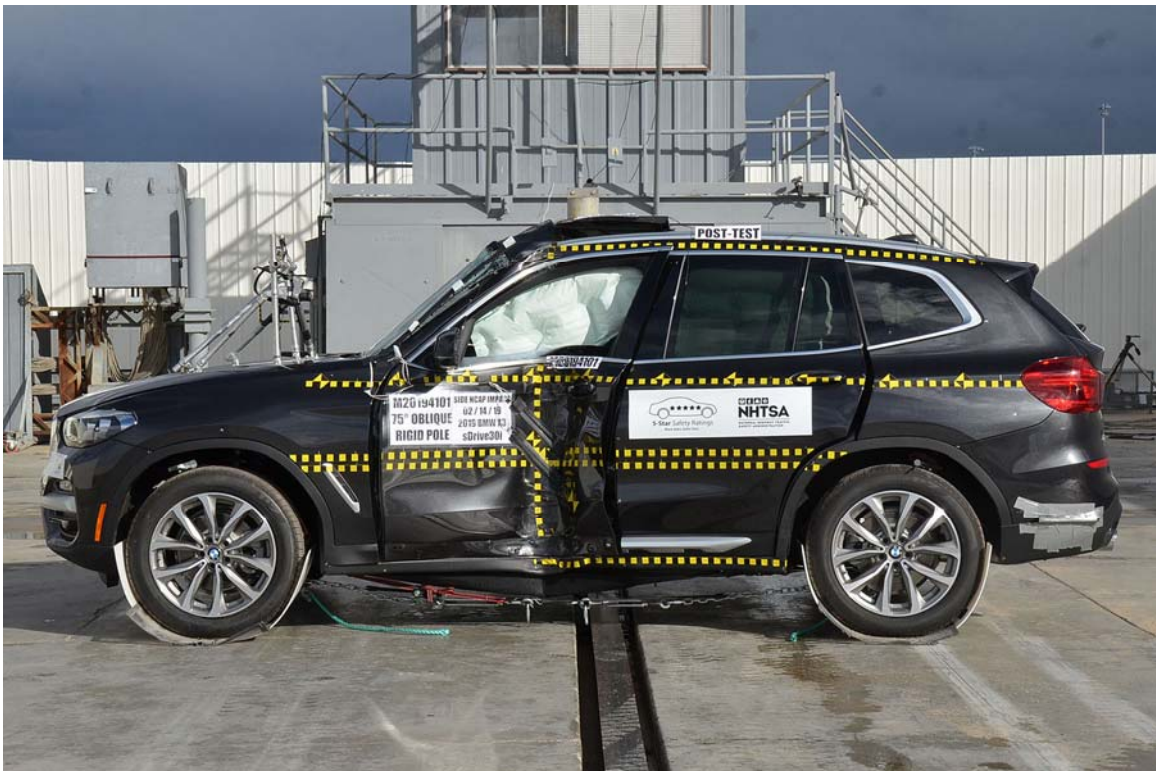
FIGURE 8. Post-Test Left Side View of Test Vehicle

The struck side doors of the vehicle were jammed shut. There was no separation at the hinges or latches. The remaining doors remained closed and latched. There were no ATD values that exceeded limits. The Driver Lower Thorax Rib Y channel failed at 77.3 ms to 145.6 ms and after 211.0 ms. The Left Floor Sill Y had questionable data from 30.0 ms to 35.0 ms. Left Lower A-Post Y channel failed at 49.1 ms, Left Mid A-Post Y channel failed at 120.2 ms, Left B-Post at Sill Y channel failed at 70.0 ms, and the Left Mid B-Post Y channel failed at 55.0 ms.

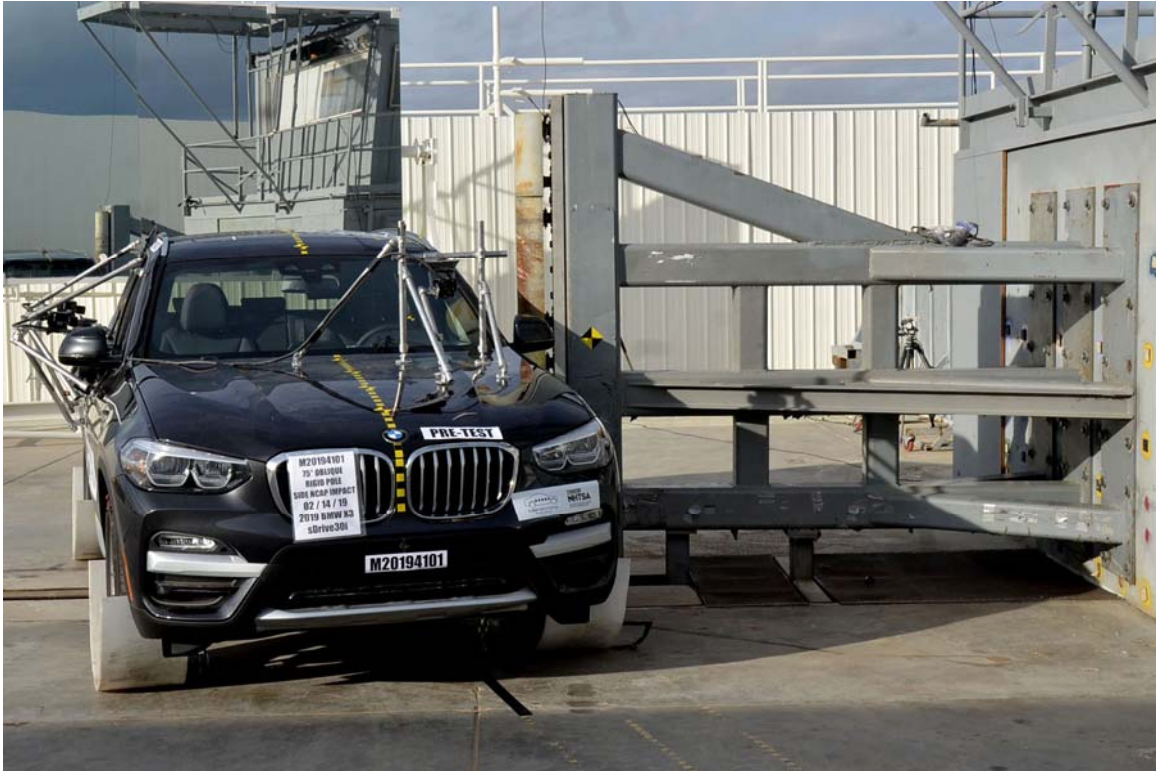
FIGURE 17. Pre-Test Left Side View of Pole Positioned Against Side of Vehicle

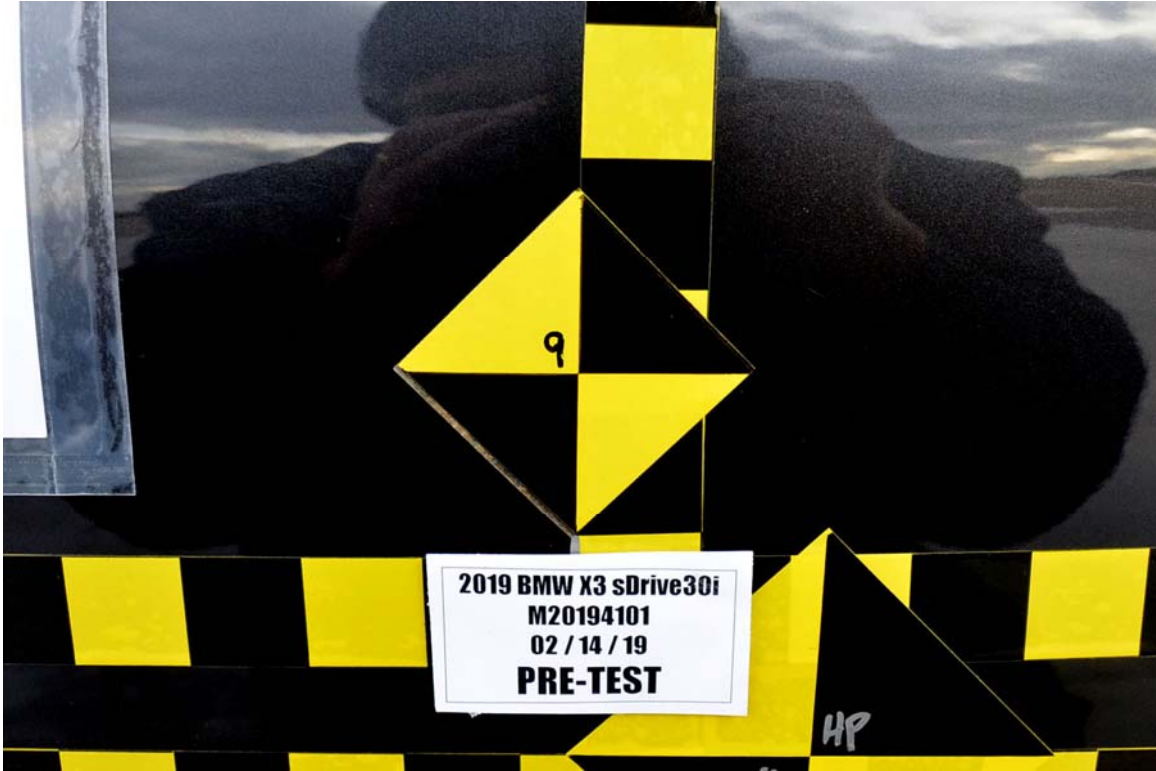
FIGURE 19. Pre-Test Close-Up View of Impact Point Target

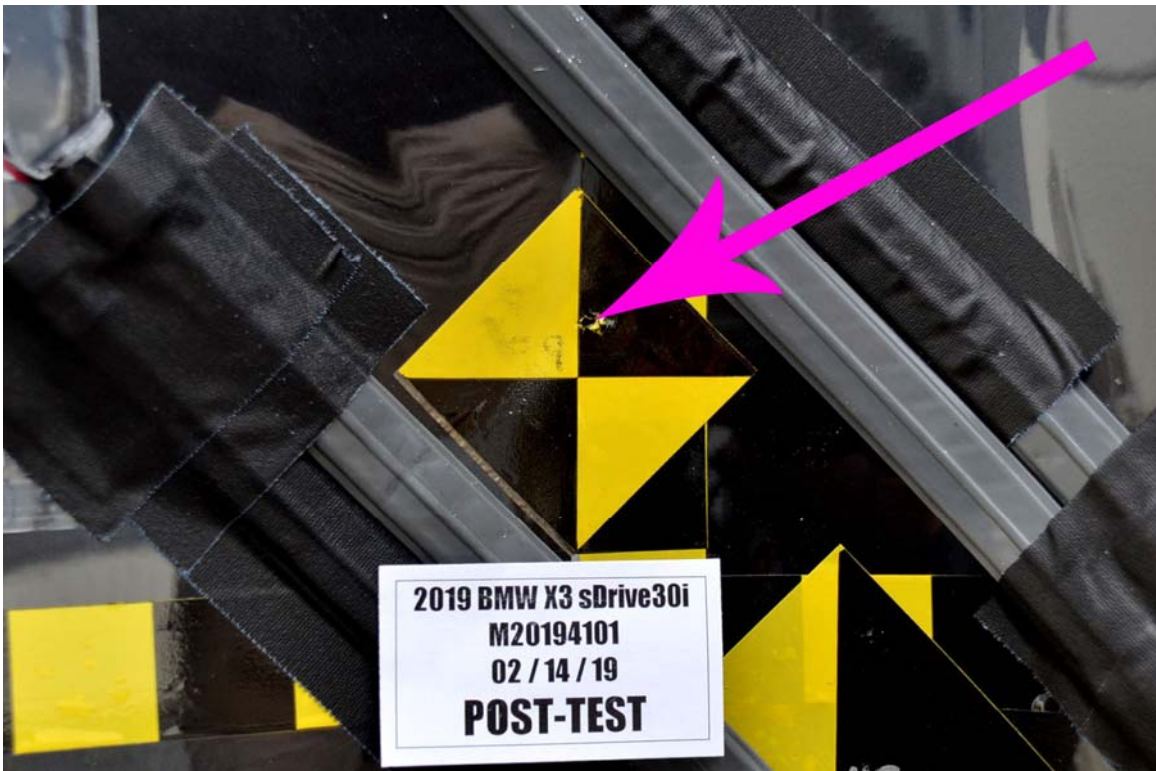
FIGURE 20. Post-Test Close-Up View of Impact Point Target Showing Impact Location

A rigid pole side impact test was conducted on a 2019 BMW X3 sDrive30i 5-door MPV. The subject vehicle was towed into the rigid pole at an angle of 75.8° and a velocity of 31.42 km/h. The test was conducted by Applus IDIADA KARCO Engineering, LLC. in Adelanto, California on February 14, 2019. Pre- and post-test photographs of the test vehicle and side impact dummy (SID-IIs) are included in Appendix A of this report.

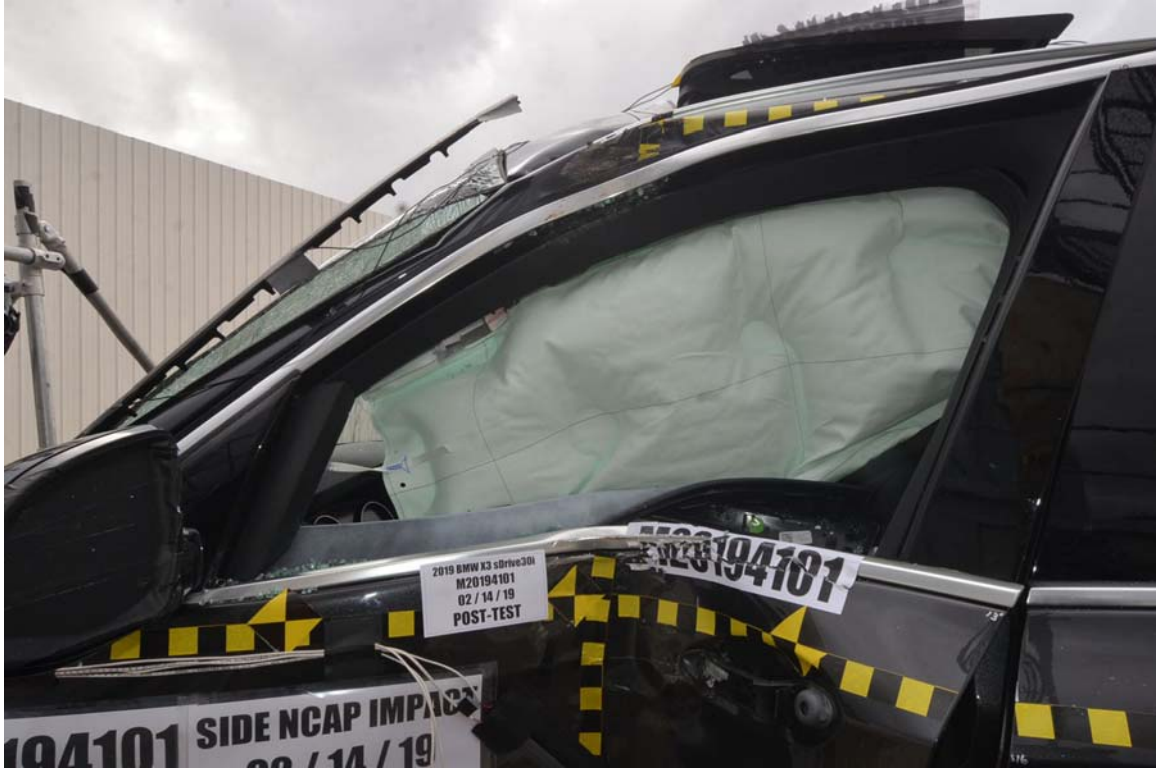
FIGURE 25. Post-Test Left Side View of Dummy Shoulder and Door Top View

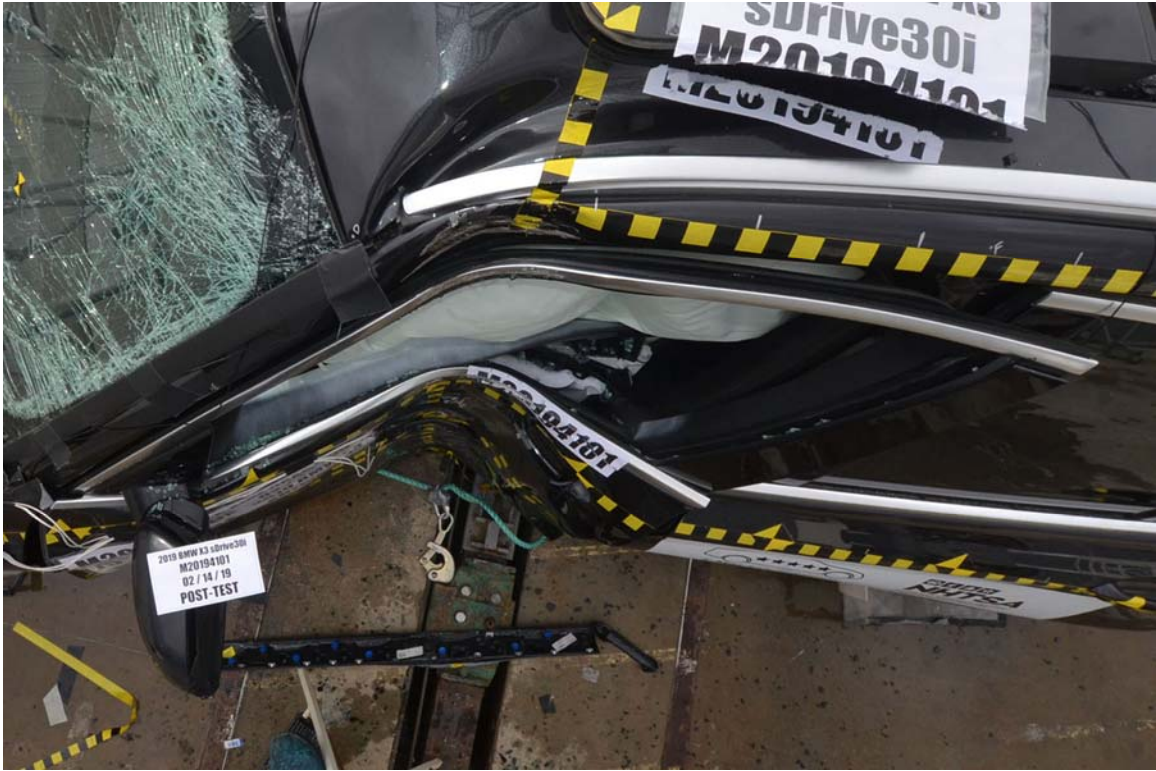
FIGURE 41. Post-Test Dummy and Door Clearance View

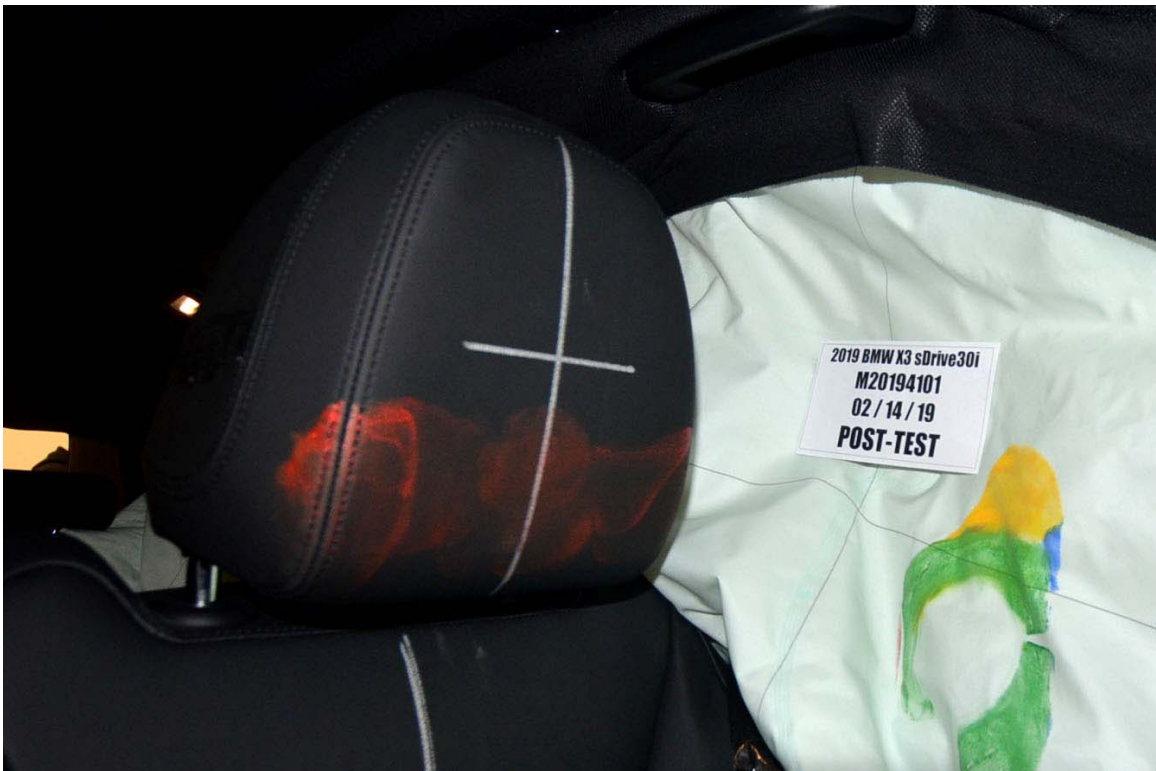
FIGURE 46. Post-Test Dummy Close-Up Head Contact with Vehicle Interior View

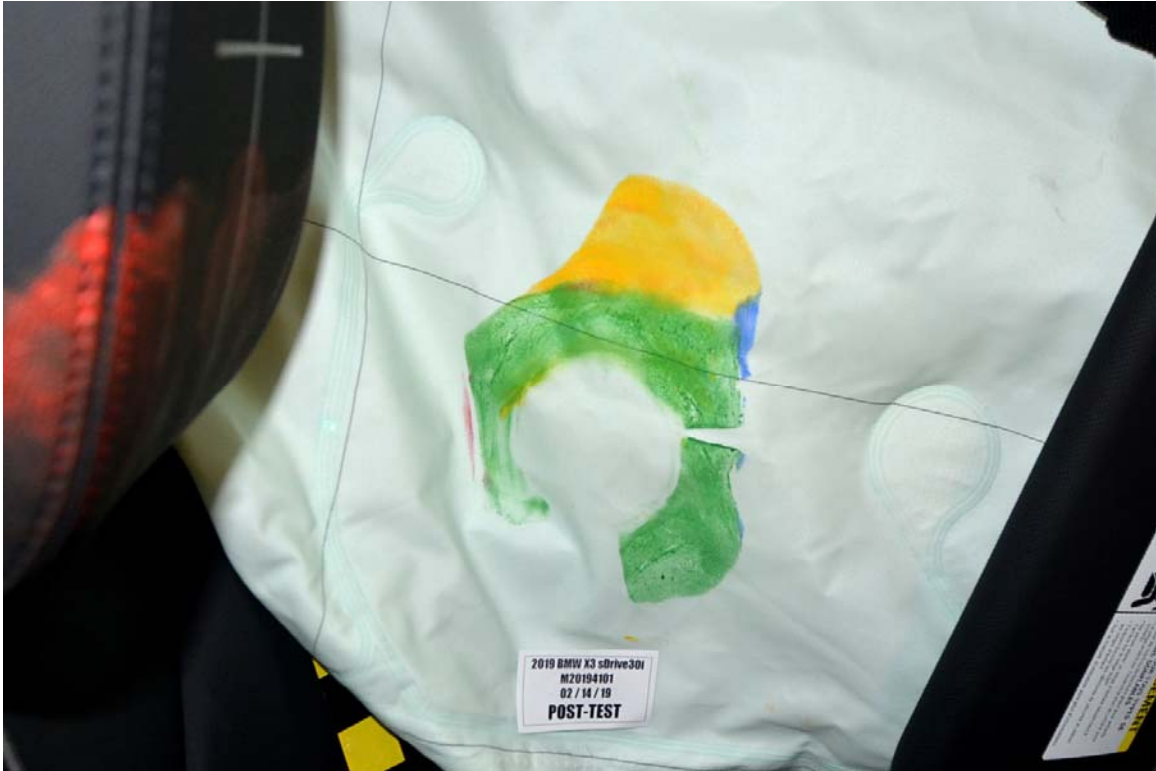
FIGURE 47. Post-Test Dummy Close-Up Head Contact With Side Airbag View

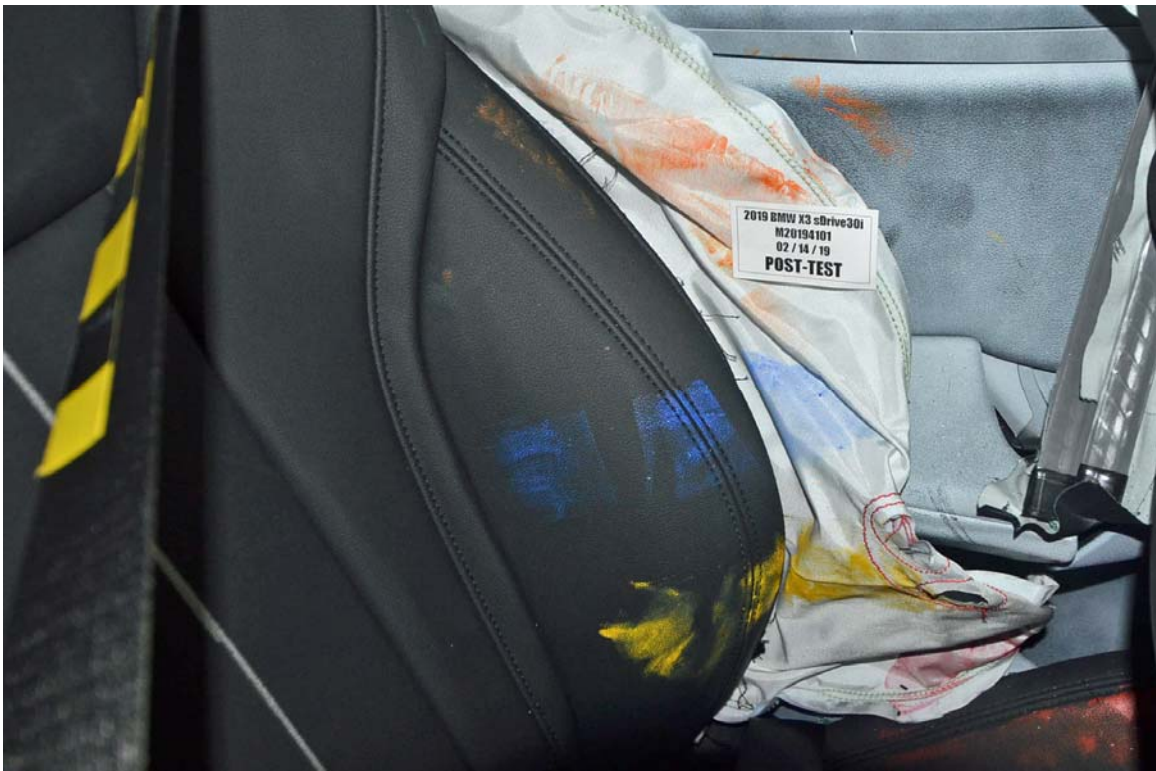
FIGURE 48. Post-Test Dummy Close-Up Torso Contact With Vehicle Interior View

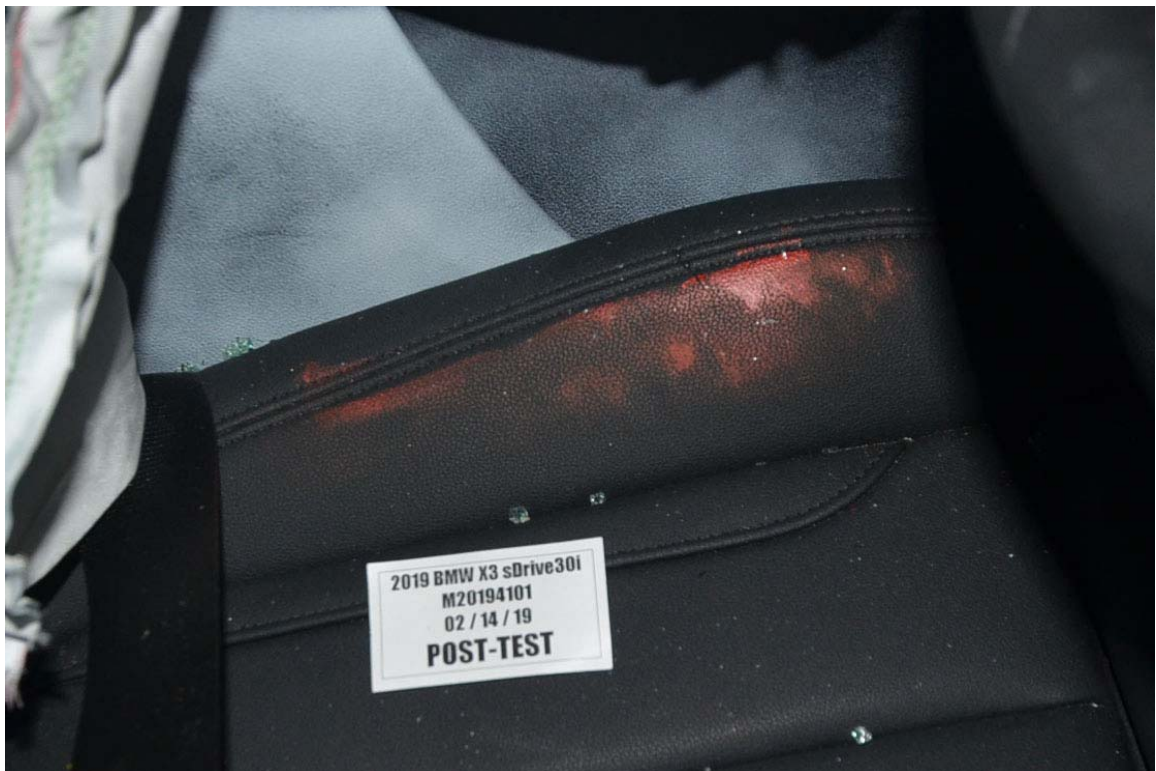
FIGURE 50. Post-Test Dummy Close-Up Pelvis Contact With Vehicle Interior View

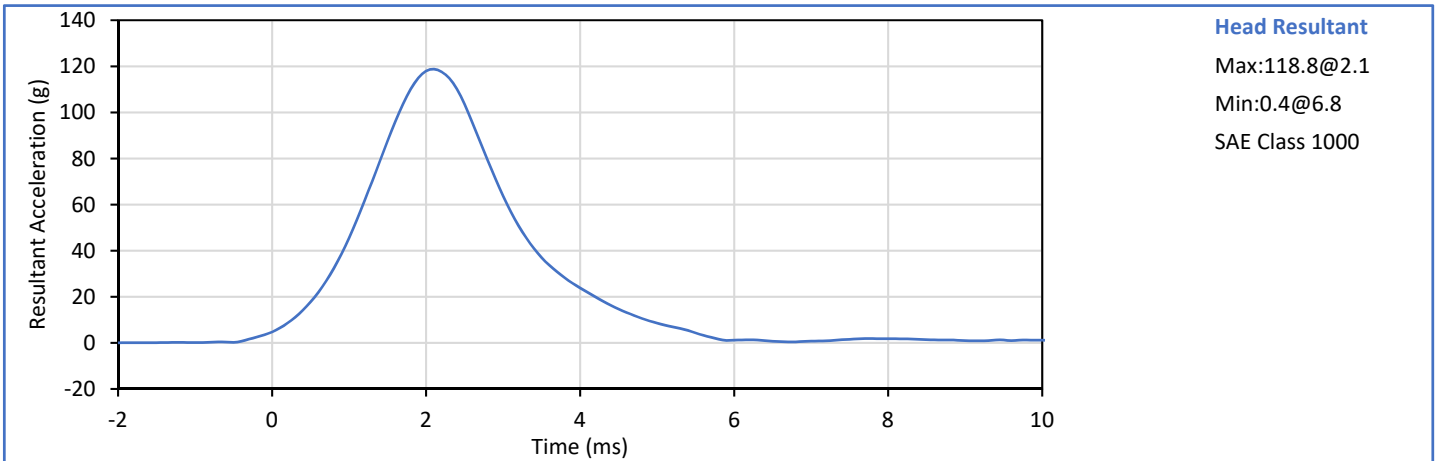
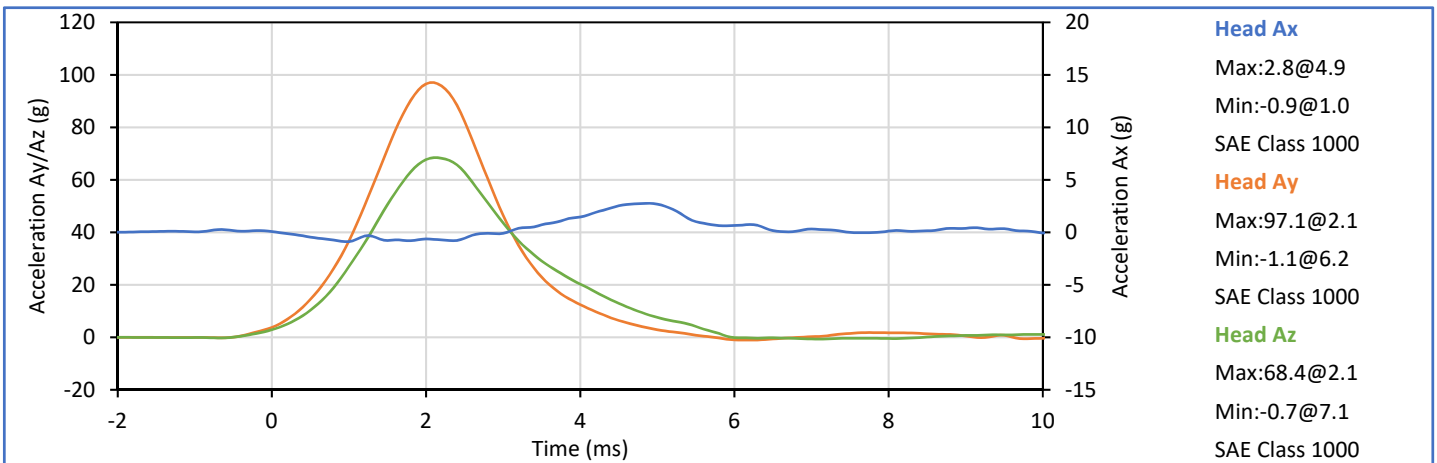
Tested Parameter	Units	Spec. Low	Spec. High	Result	Pass/Fail
Laboratory Temperature	°C	18.9	25.6	21.9	Pass
Laboratory Humidity	%	10	70	33	Pass
Peak Resultant Acceleration	g	115.0	137.0	118.8	Pass
Peak Head Ax	g	-15.0	15.0	-0.9	Pass
Oscillations After Main Pulse	%	0.0	15.0	1.6	Pass
Is Acceleration Unimodal?	Yes/No	Yes		Yes	Pass
Overall Test Results					Pass

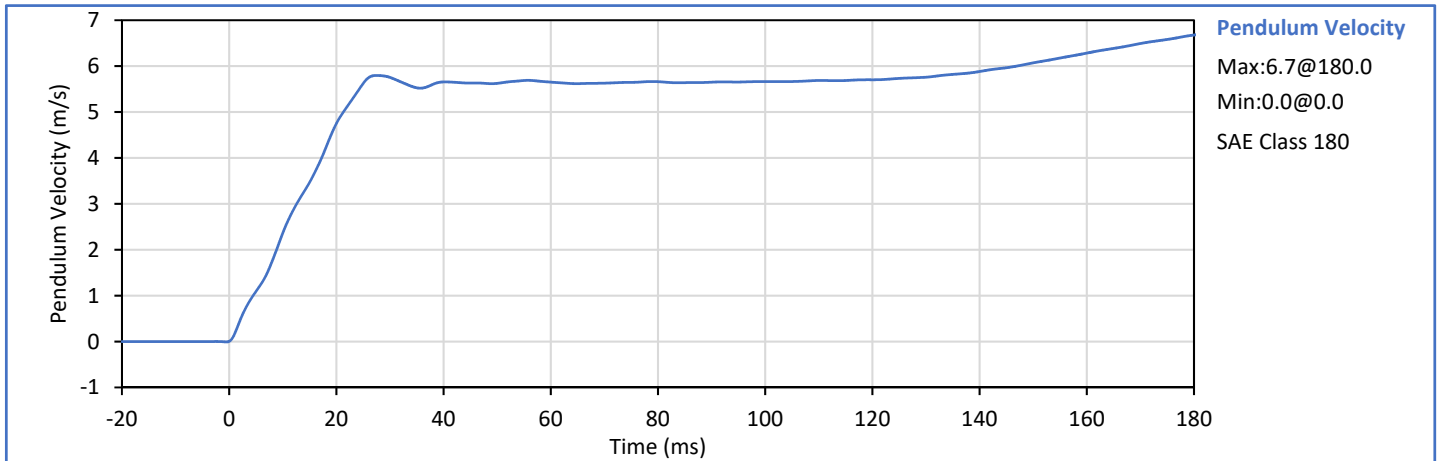
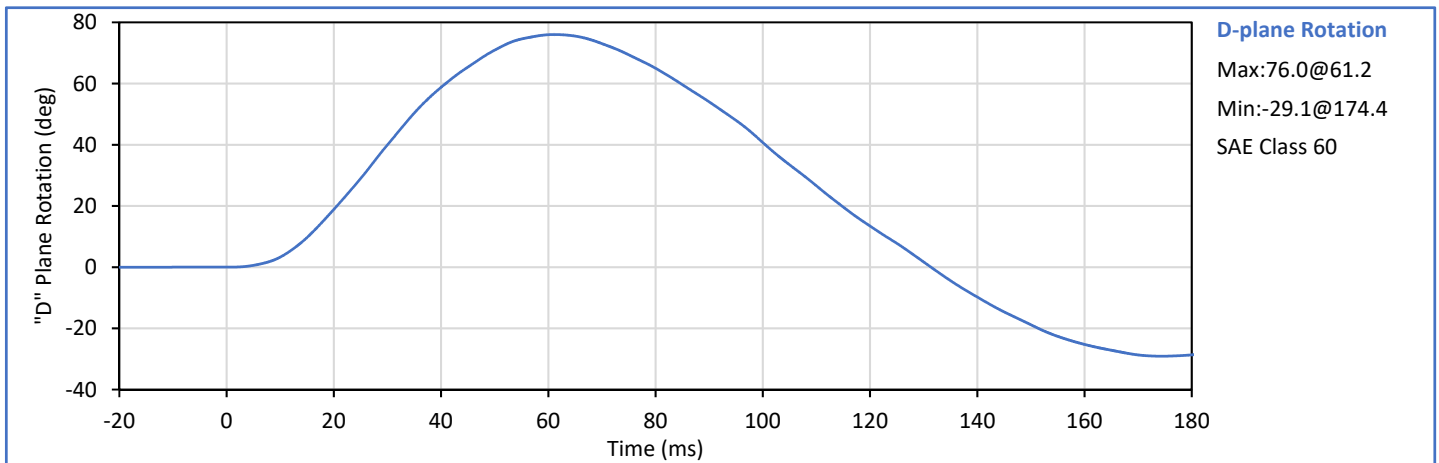
Tested Parameter	Units	Spec. Low	Spec. High	Result	Pass/Fail
Laboratory Temperature	°C	20.6	22.2	21.7	Pass
Laboratory Humidity	%	10	70	29	Pass
Pendulum Velocity	m/s	5.51	5.63	5.52	Pass
Pendulum Decel at 10 ms	m/s	2.20	2.80	2.36	Pass
Pendulum Decel at 15 ms	m/s	3.30	4.10	3.47	Pass
Pendulum Decel at 20 ms	m/s	4.40	5.40	4.75	Pass
Pendulum Decel at 25 ms	m/s	5.40	6.10	5.62	Pass
Pendulum Decel from 25-100 ms	m/s	5.50	6.20	5.80	Pass
Peak "D" Plane Rotation	deg	71.0	81.0	76.0	Pass
Time of Peak "D" Plane Rotation	ms	50.0	70.0	61.2	Pass
Peak Occ. Condyle Moment	Nm	-44.0	-36.0	-42.5	Pass
Time of Moment Decay to 0 Nm	ms	102.0	126.0	111.7	Pass
Overall Test Results					Pass
