**REPORT NUMBER: SINCAP-KAR-19-017**

**NEW CAR ASSESSMENT PROGRAM (NCAP)  
MOVING DEFORMABLE BARRIER SIDE IMPACT TEST**

**BAYERISCHE MOTOREN WERKE AG  
2019 BMW X3 SDRIVE30I 5-DOOR MPV**

**NHTSA No: M20194102**

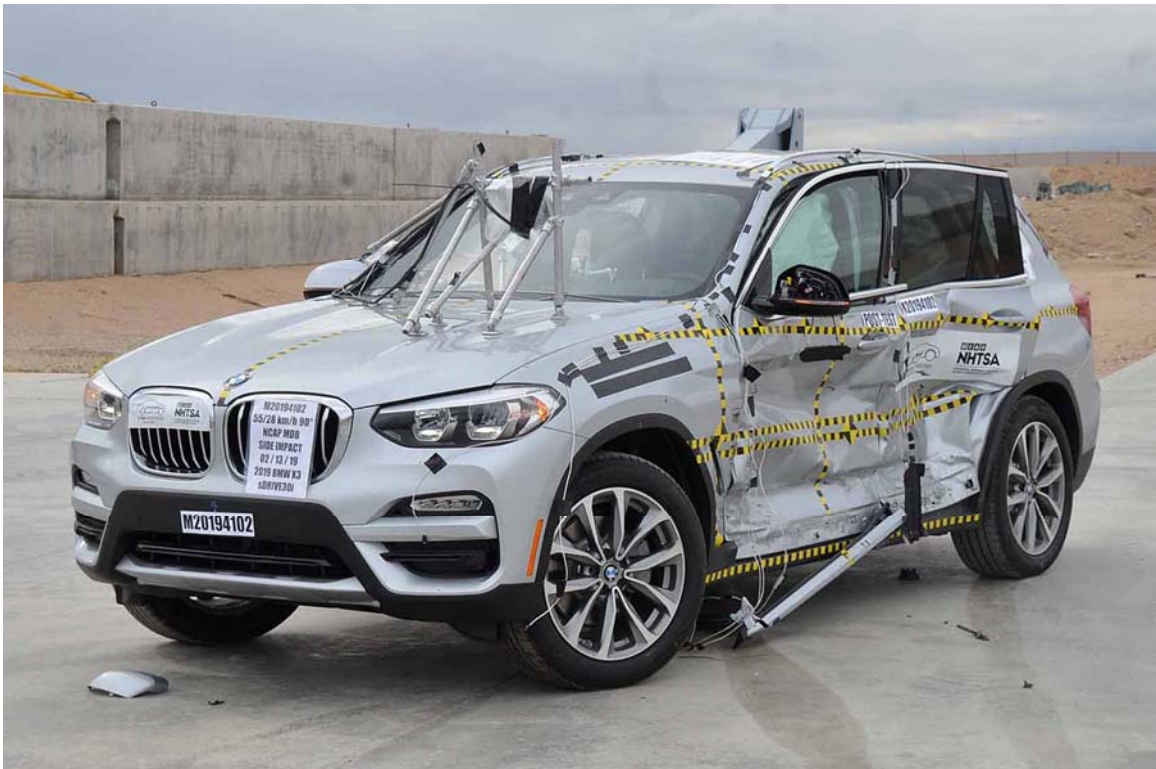
FIGURE 6. Post-Test Left Front  $\frac{3}{4}$  View of Test Vehicle

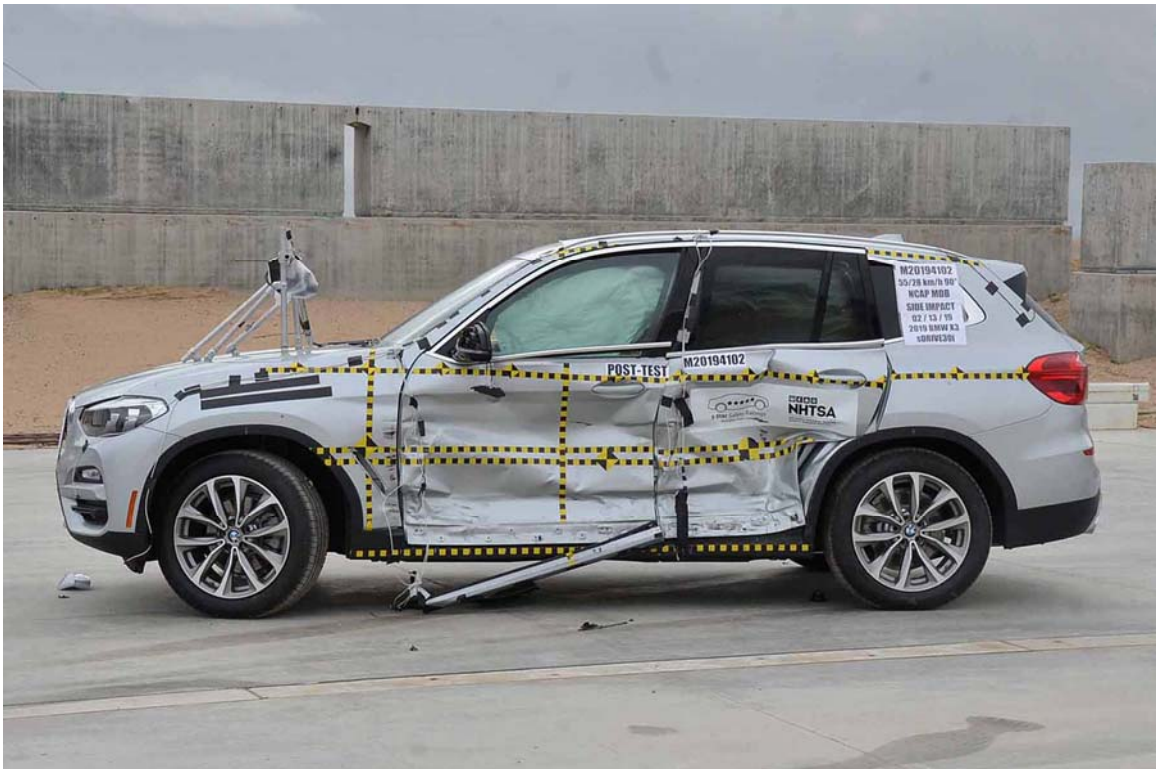
FIGURE 8. Post-Test Left Side View of Test Vehicle

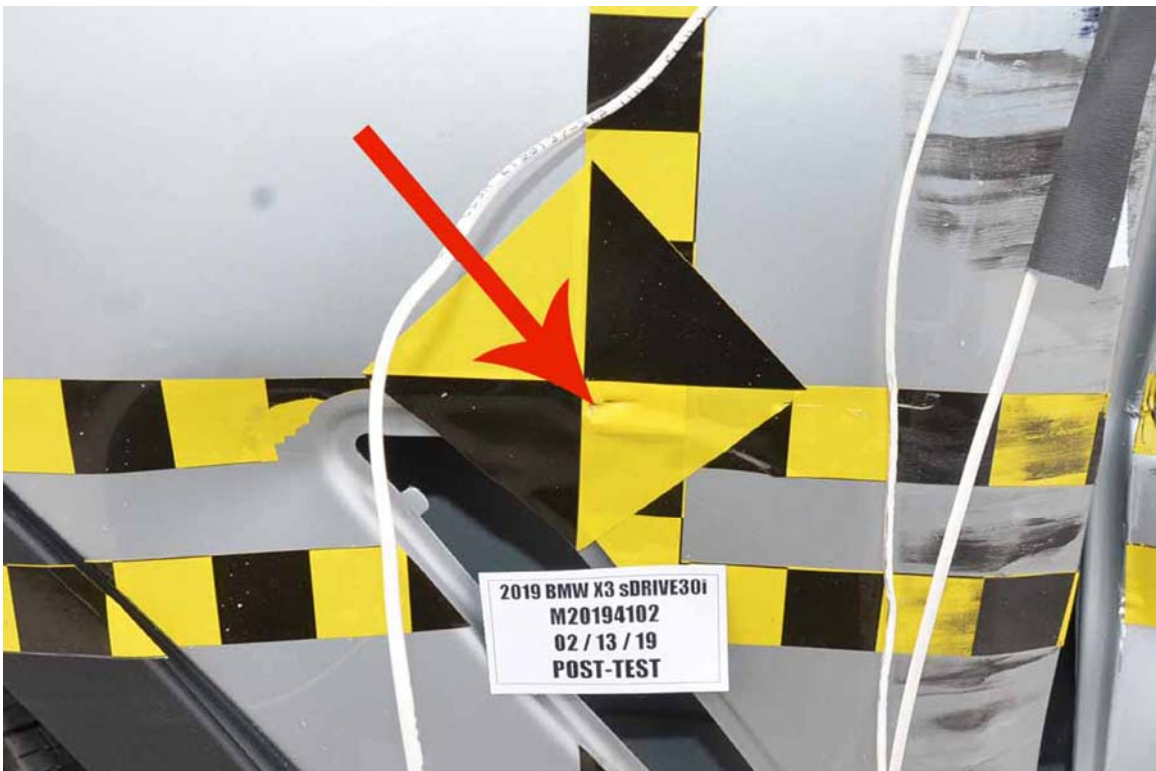
FIGURE 20. Post-Test Close-Up View of Impact Point Target

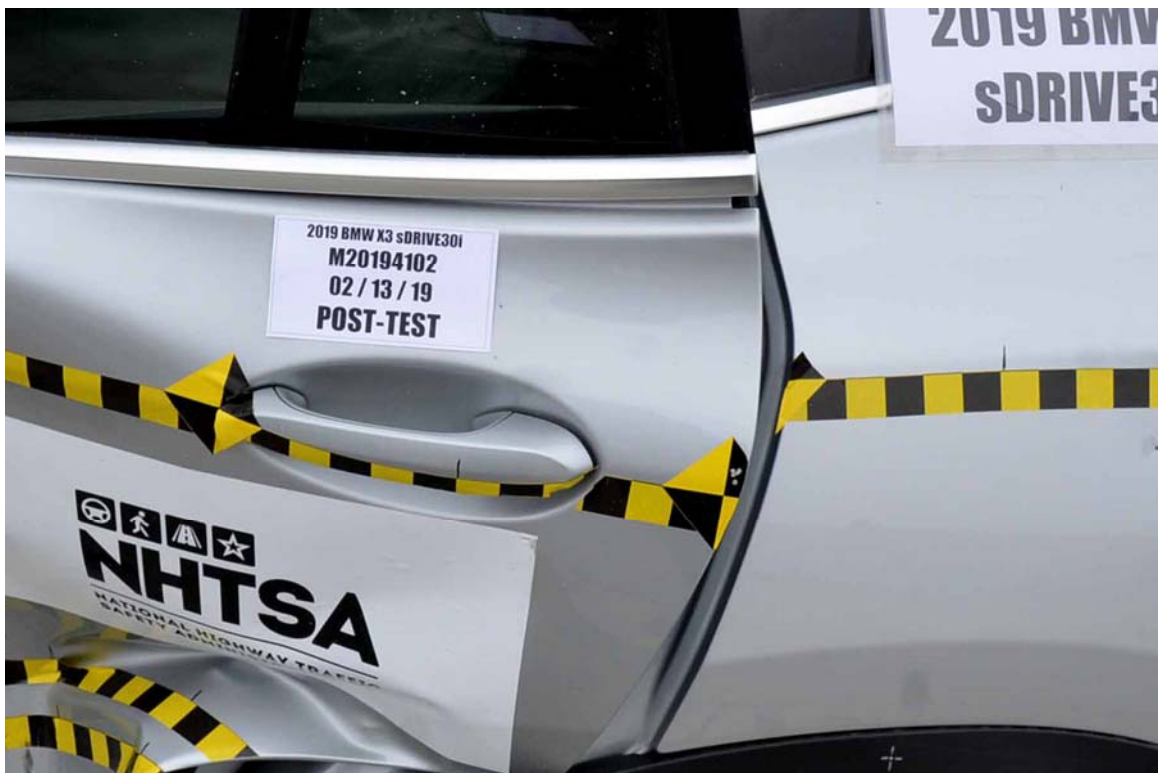
FIGURE 24. Post-Test Left Rear Door Latch Close-Up

The doors on the struck side of the vehicle remained closed and latched. There was no separation at the hinges or latches. The doors on the non-struck side remained closed and latched. There was no ATD value that exceeded its limit. The Left Lower A-Post Y channel failed at 4.5 ms and the Left Mid A-Post Y channel failed at 10.0 ms.

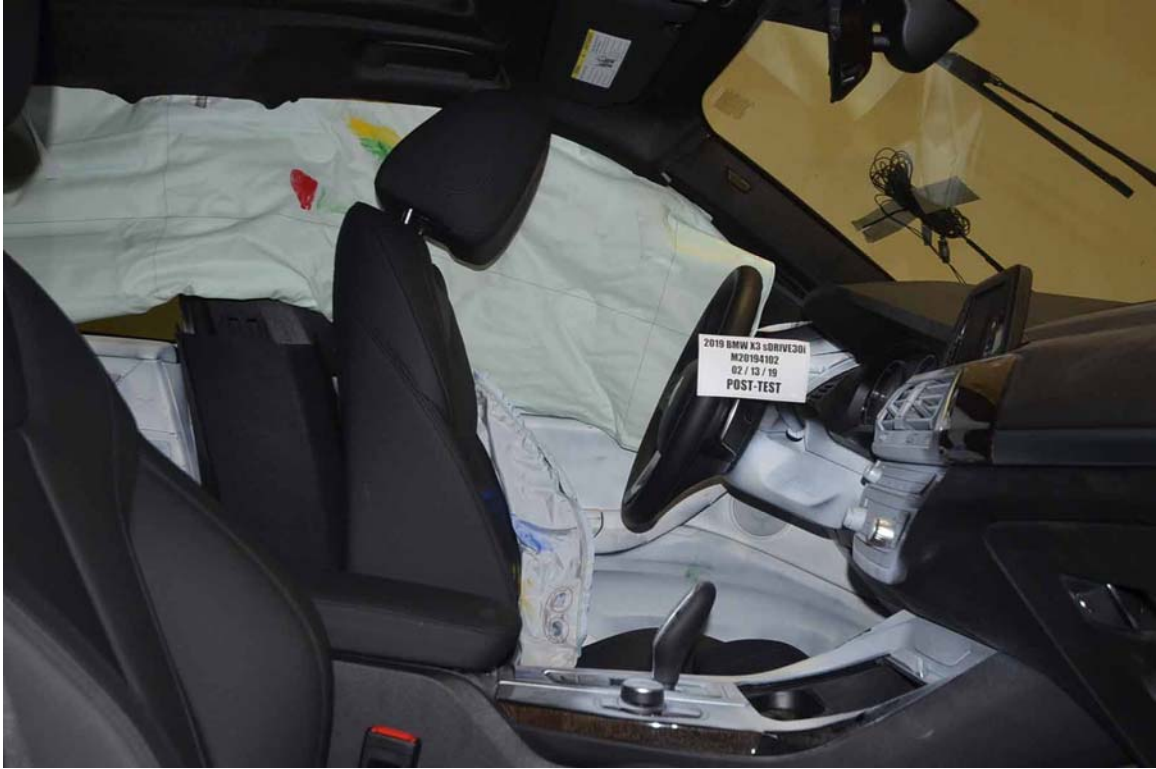
FIGURE 47. Post-Test Driver Inner Door Panel View  
Showing Driver Dummy Contact Locations

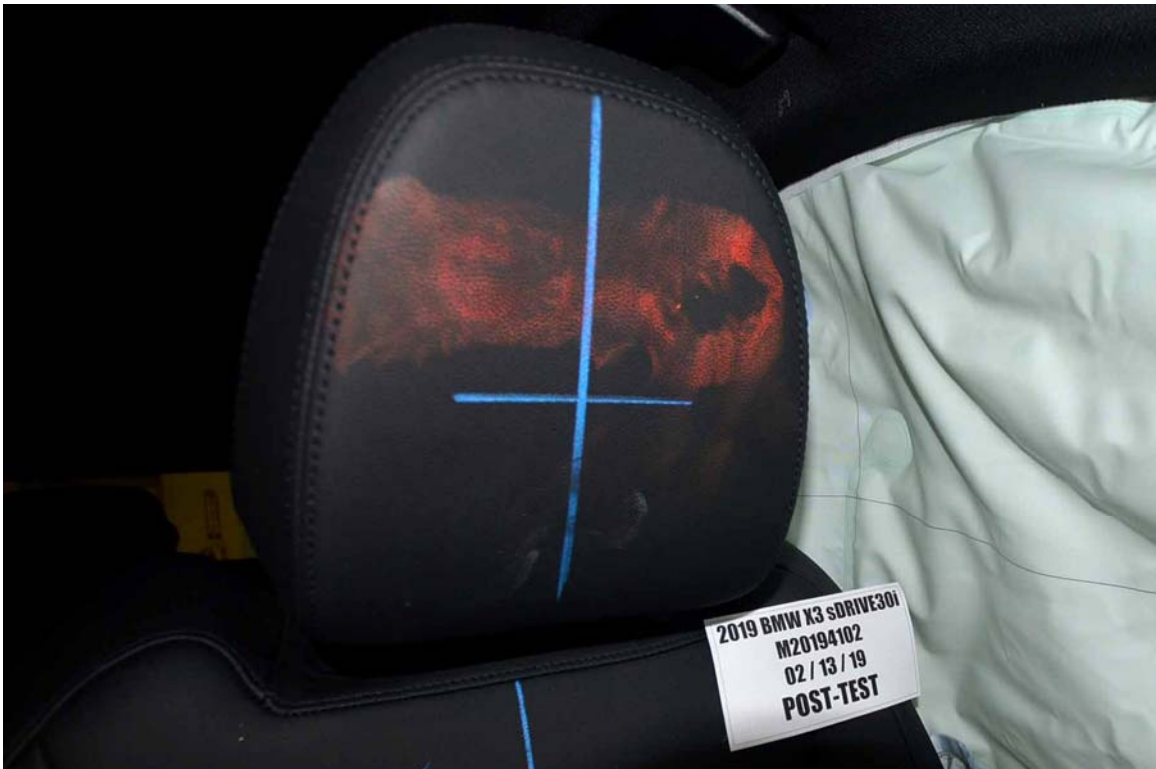
FIGURE 48. Post-Test Driver Dummy Close-Up Head Contact  
with Vehicle Interior View

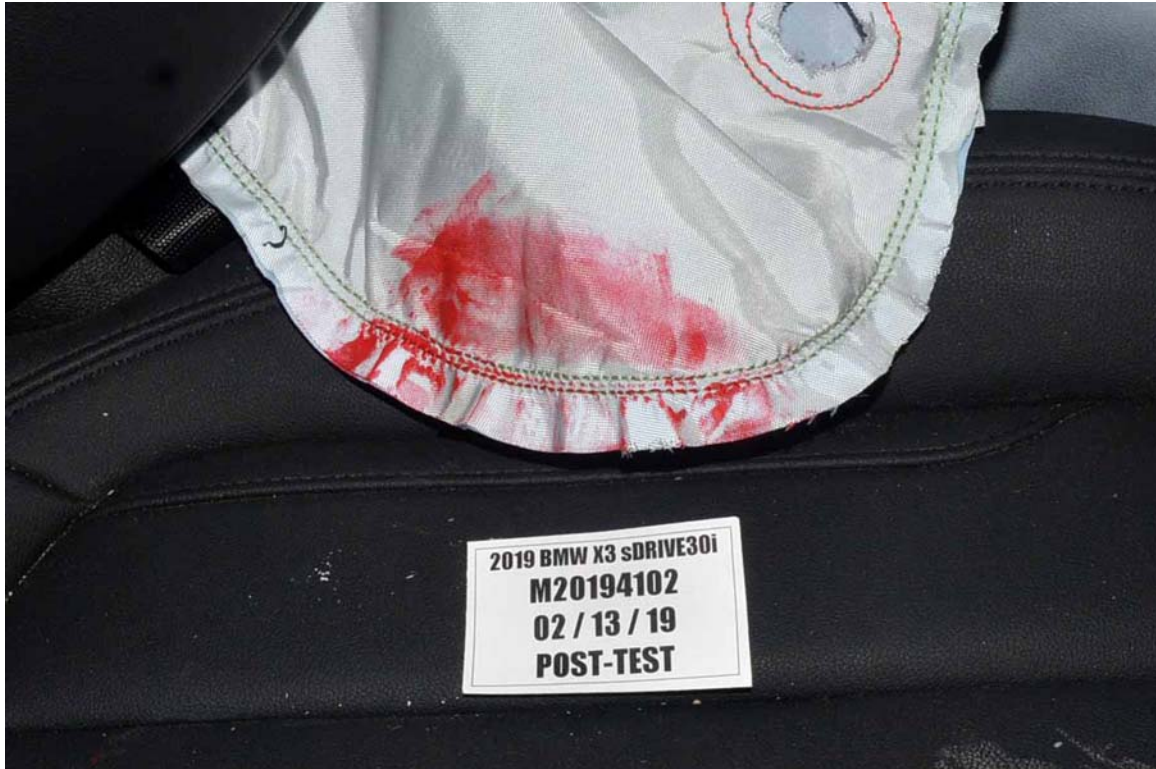
FIGURE 53. Post-Test Driver Dummy Close-Up Pelvis Contact with Side Airbag View

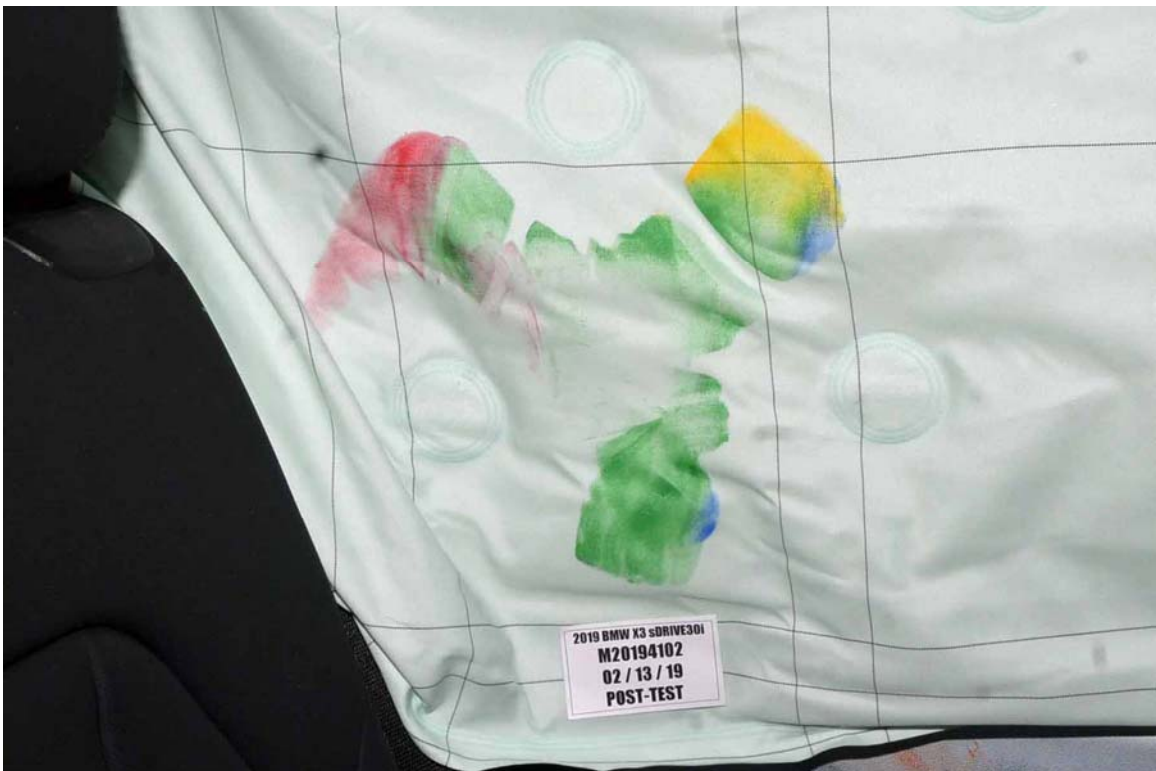
FIGURE 76. Post-Test Rear Passenger Dummy Close-Up  
Head Contact with Side Airbag View

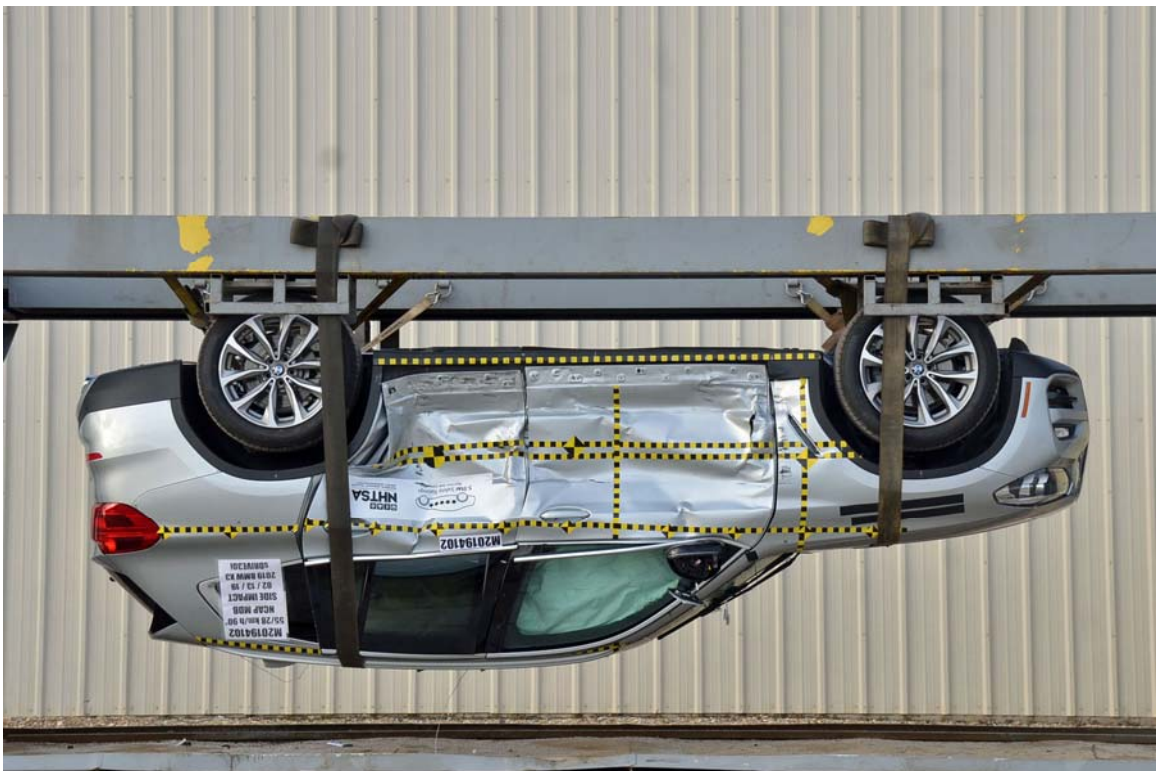
FIGURE 98. FMVSS No. 301 Static Rollover 180 Degrees
