REPORT NUMBER: SINCAP-CAL-17-007

NEW CAR ASSESSMENT PROGRAM (NCAP) MOVING DEFORMABLE BARRIER SIDE IMPACT TEST

Nissan Motor Co., LTD 2017 Nissan Titan Crew Cab Truck

NHTSA No: M20175205

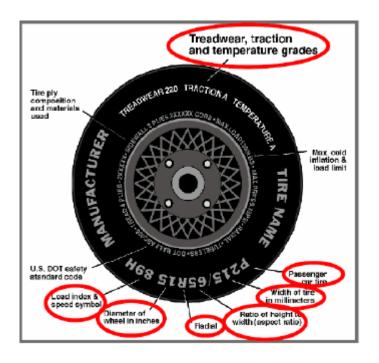
VEHICLE TIRE INFORMATION

Collected for year, make, model, & VIN, all items circled in red, tire manufacturer and tire name.

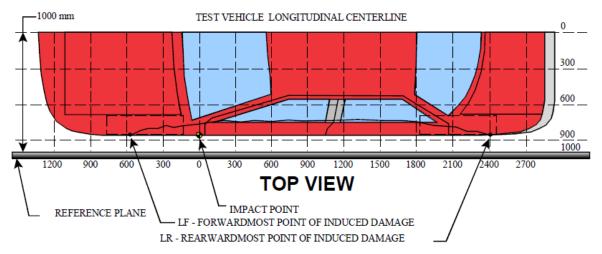
For guidance regarding damage profile distance measurements, pelase refer to the latest version of the *NHTSA Test Reference Guide*, *Volume 1: Vehicle Tests*.

Forward of the impact point (towards front of vehicle) is considered negative (—). Rearward of the impact point (toward rearend of vehicle) is considered positive (+).

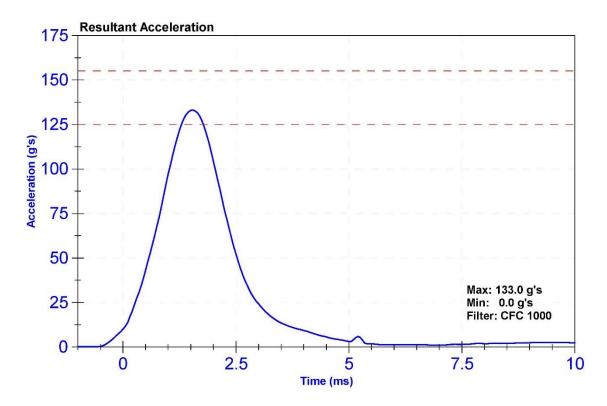
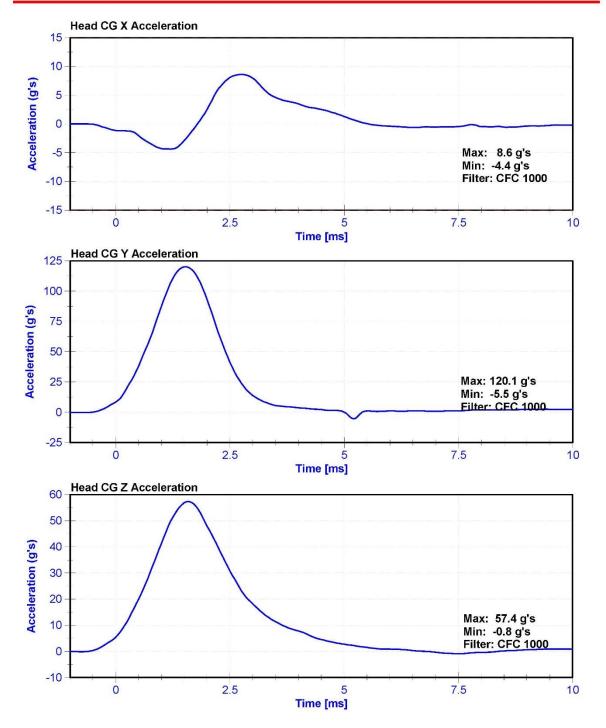
Test Parameter	Minimum Specification	Maximum Specification	Unit	Result	Pass/Fail
Temperature	20.6	22.2	°C	21.4	Pass
Humidity	10	70	%	34.2	Pass
Resultant Acceleration	125	155	g's	133.0	Pass
Oscillation	0	15	%	4.47	Pass
Fore-Aft Acceleration	-15	15	g's	8.6	Pass

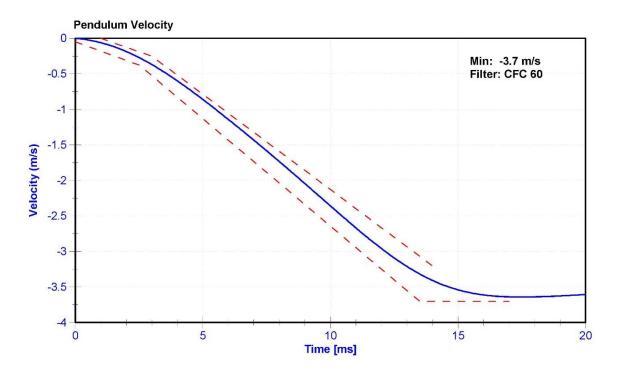
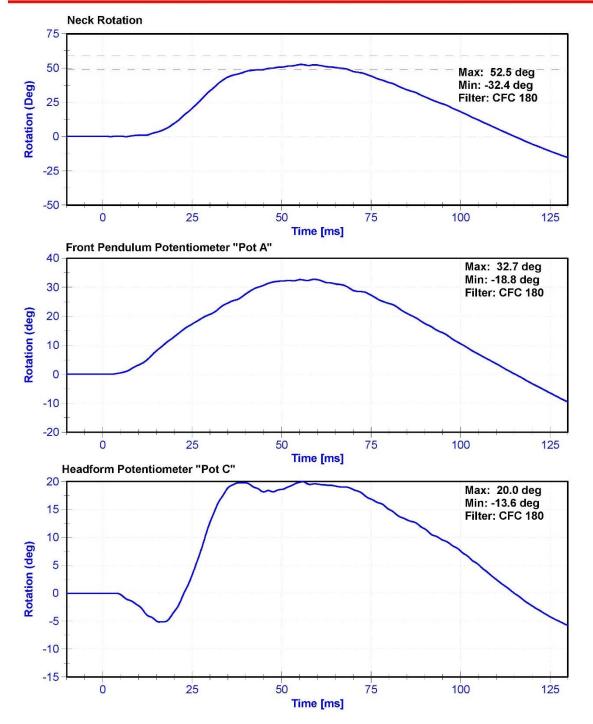
Certification Report ES-2re Neck Flexion - CFR 572

Test Parameter	Minimum Specification	Maximum Specification	Unit	Result	Pass/Fail
Temperature	20.6	22.2	°C	21.5	Pass
Humidity	10	70	%	32.9	Pass
Velocity	3.3	3.5	m/s	3.42	Pass
Lateral Neck Rotation	49	59	deg	52.5	Pass
Time at Maximum Rotation	54	66	ms	55.5	Pass
Time of Rotation Decay from Maximum	53	88	ms	59.7	Pass

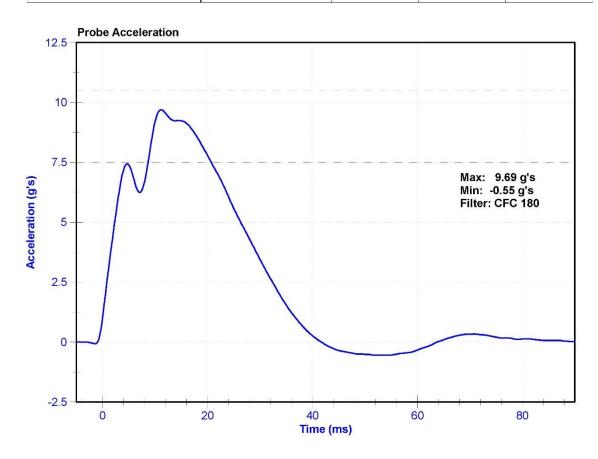
Certification Report ES-2re Shoulder Impact - CFR 572

Test Parameter	Minimum Specification	Maximum Specification	Unit	Result	Pass/Fail
Temperature	20.6	22.2	°C	21.5	Pass
Humidity	10	70	%	43.1	Pass
Velocity	4.2	4.4	m/s	4.22	Pass
Probe Acceleration	7.5	10.5	g's	9.69	Pass

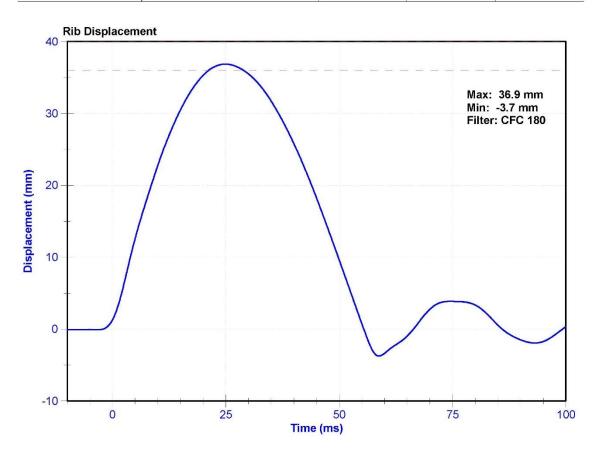
Certification Report ES-2re Upper Rib Drop 3 m/s - CFR 572

Test Parameter	Minimum Specification	Maximum Specification	Unit	Result	Pass/Fail
Temperature	20.6	22.2	°C	21.9	Pass
Humidity	10	70	%	41.8	Pass
Rib Displacement	36	40	mm	36.9	Pass

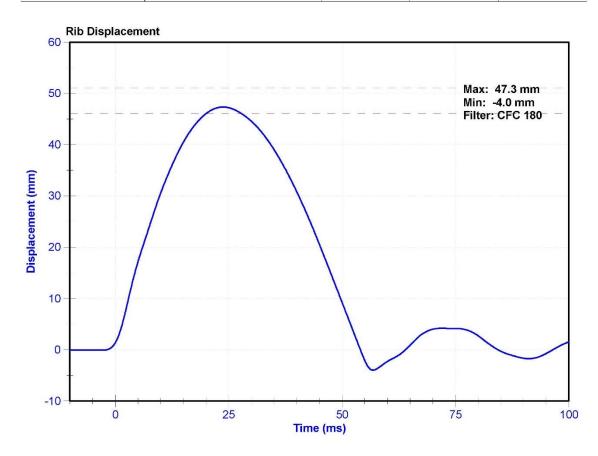
Certification Report ES-2re Upper Rib Drop 4 m/s - CFR 572

Test Parameter	Minimum Specification	Maximum Specification	Unit	Result	Pass/Fail
Temperature	20.6	22.2	°C	21.9	Pass
Humidity	10	70	%	41.8	Pass
Rib Displacement	46	51	mm	47.3	Pass

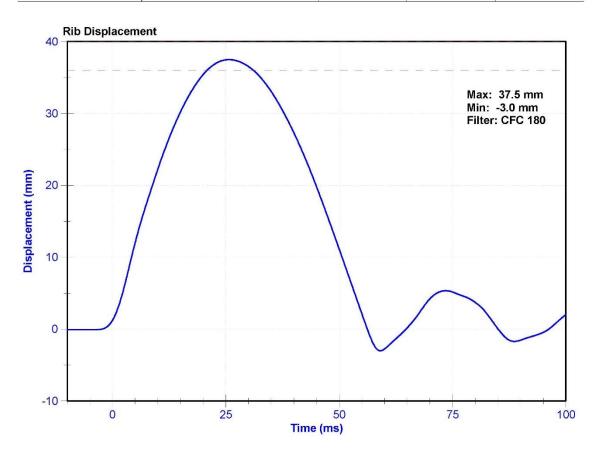
Certification Report ES-2re Middle Rib Drop 3 m/s - CFR 572

Test Parameter	Minimum Specification	Maximum Specification	Unit	Result	Pass/Fail
Temperature	20.6	22.2	°C	21.9	Pass
Humidity	10	70	%	41.8	Pass
Rib Displacement	36	40	mm	37.5	Pass

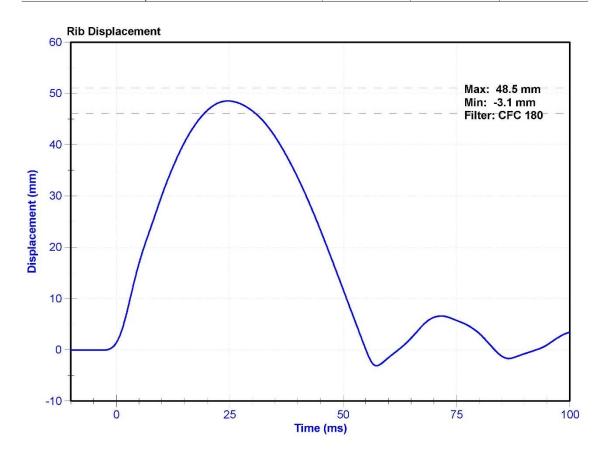
Certification Report ES-2re Middle Rib Drop 4 m/s - CFR 572

Test Parameter	Minimum Specification	Maximum Specification	Unit	Result	Pass/Fail
Temperature	20.6	22.2	°C	21.9	Pass
Humidity	10	70	%	41.8	Pass
Rib Displacement	46	51	mm	48.5	Pass

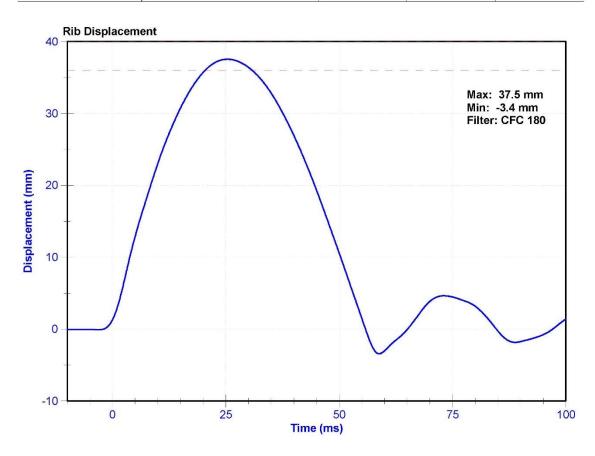
Certification Report ES-2re Lower Rib Drop 3 m/s - CFR 572

Test Parameter	Minimum Specification	Maximum Specification	Unit	Result	Pass/Fail
Temperature	20.6	22.2	°C	21.9	Pass
Humidity	10	70	%	41.8	Pass
Rib Displacement	36	40	mm	37.5	Pass

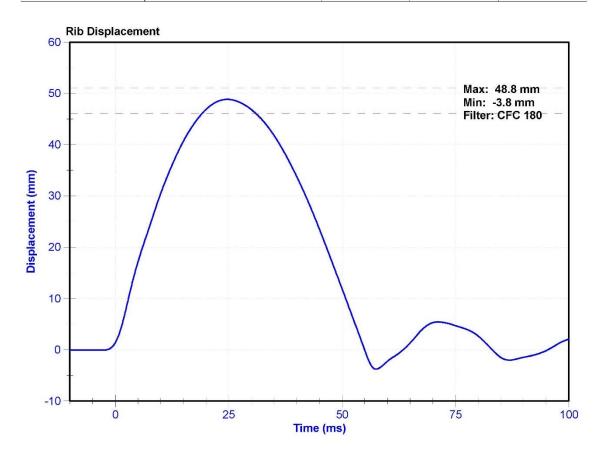
Certification Report ES-2re Lower Rib Drop 4 m/s - CFR 572

Test Parameter	Minimum Specification	Maximum Specification	Unit	Result	Pass/Fail
Temperature	20.6	22.2	°C	21.9	Pass
Humidity	10	70	%	41.8	Pass
Rib Displacement	46	51	mm	48.8	Pass

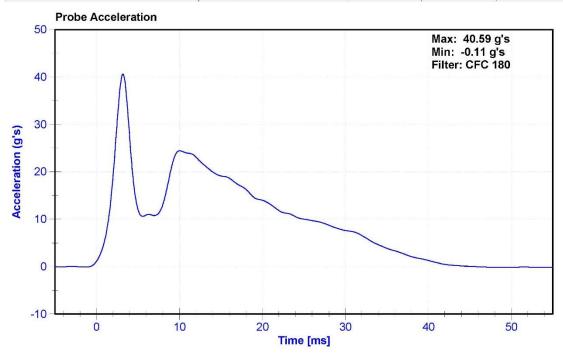
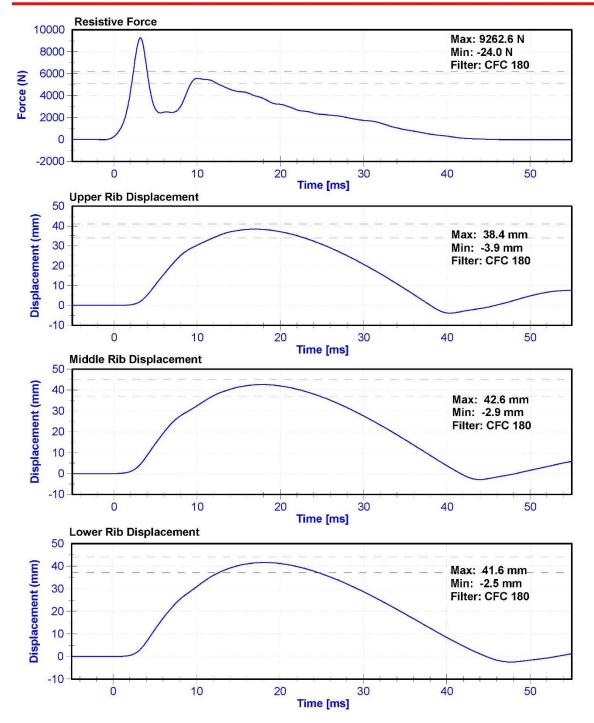
Certification Report ES-2re Thorax Impact - CFR 572

Test Parameter	Minimum Specification	Maximum Specification	Unit	Result	Pass/Fail
Temperature	20.6	22.2	°C	21.5	Pass
Humidity	10	70	%	43.1	Pass
Velocity	5.4	5.6	m/s	5.60	Pass
Resistive Force after 6ms	5100	6200	N	5577.3	Pass
Upper Thorax Rib Deflection	34	41	mm	38.4	Pass
Mid Thorax Rib Deflection	37	45	mm	42.6	Pass
Lower Thorax Rib Deflection	37	44	mm	41.6	Pass

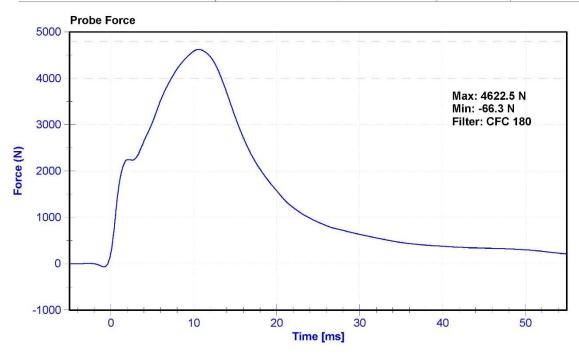
Certification Report ES-2re Abdomen Impact - CFR 572

Test Parameter	Minimum Specification	Maximum Specification	Unit	Result	Pass/Fail
Temperature	20.6	22.2	°C	21.9	Pass
Humidity	10	70	%	42.2	Pass
Velocity	3.9	4.1	m/s	4.06	Pass
Combined Abdomen Force	2200	2700	N	2658.5	Pass
Time at Peak Abdomen Force	10.0	12.3	ms	10.50	Pass
Resistive Probe Force	4000	4800	N	4622.5	Pass
Time at Peak Resistive Force	10.6	13.0	ms	10.60	Pass
