REPORT NUMBER: SPNCAP-MGA-2019-040

**NEW CAR ASSESSMENT PROGRAM (NCAP)
Side Impact Pole Test**

**TOYOTA MOTOR CORPORATION
2019 Lexus UX 200 F Sport 5-Door Hatchback
NHTSA No.: O20195111**

**MGA RESEARCH CORPORATION
5000 Warren Road
Burlington, WI 53105**

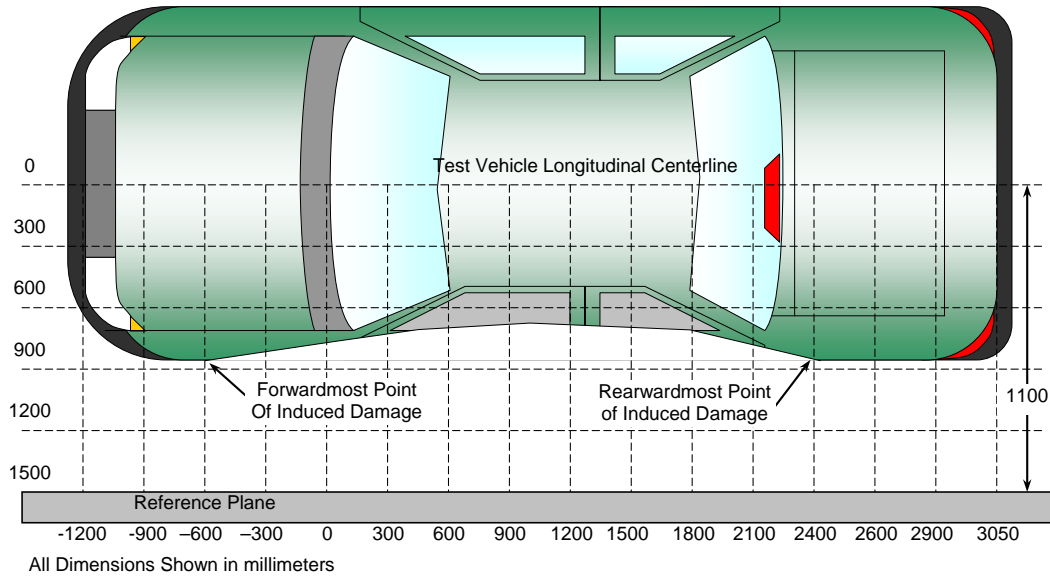
**DATA SHEET NO. 11
VEHICLE DAMAGE PROFILE DISTANCES**

TOP VIEW

DAMAGE PROFILE DISTANCES

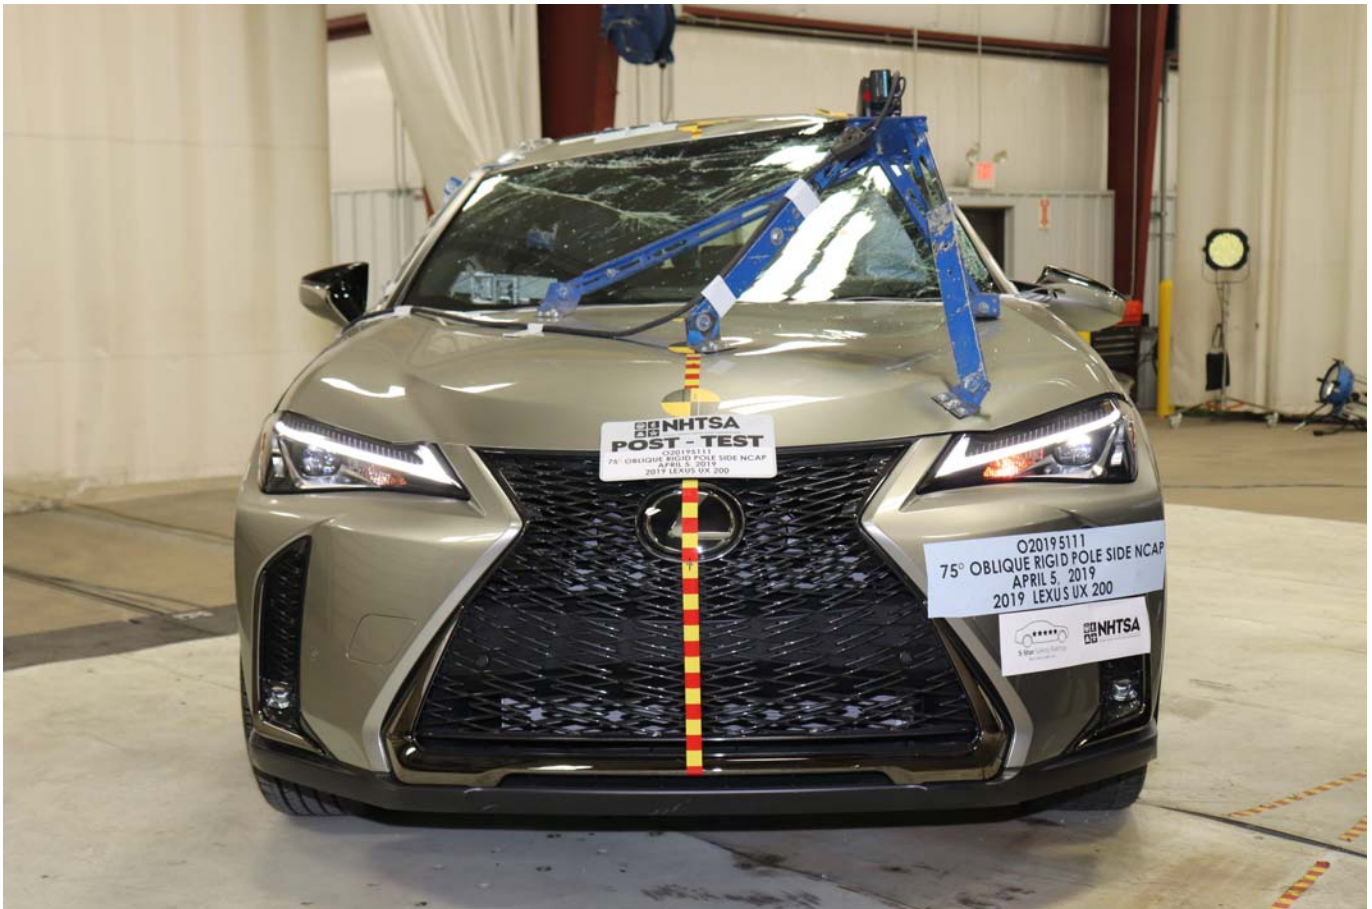
Photo No. 004 - Post-Test Frontal View of Test Vehicle

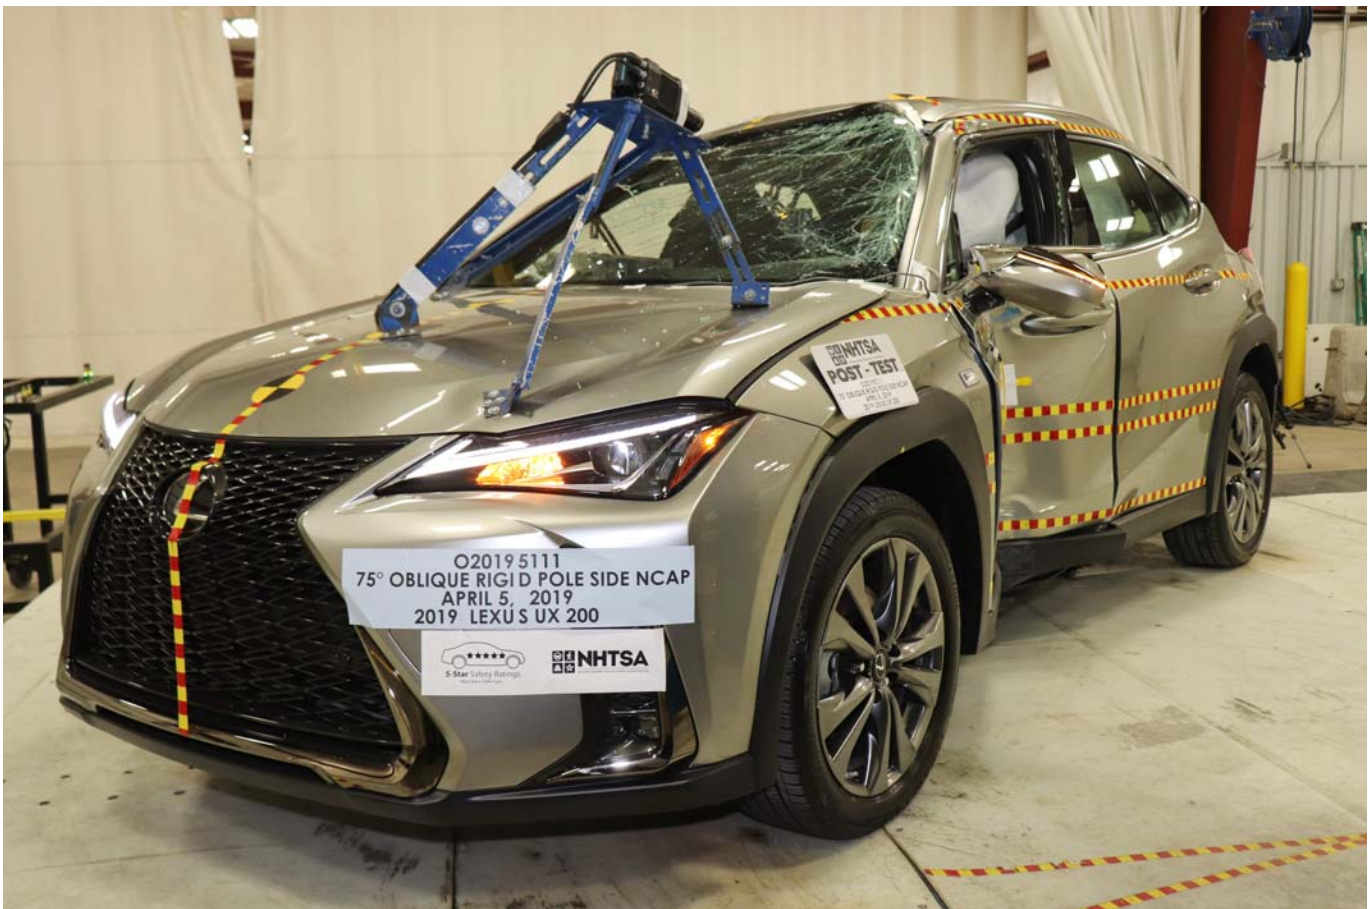
Photo No. 006 - Post-Test Left Front Three-Quarter View of Test Vehicle

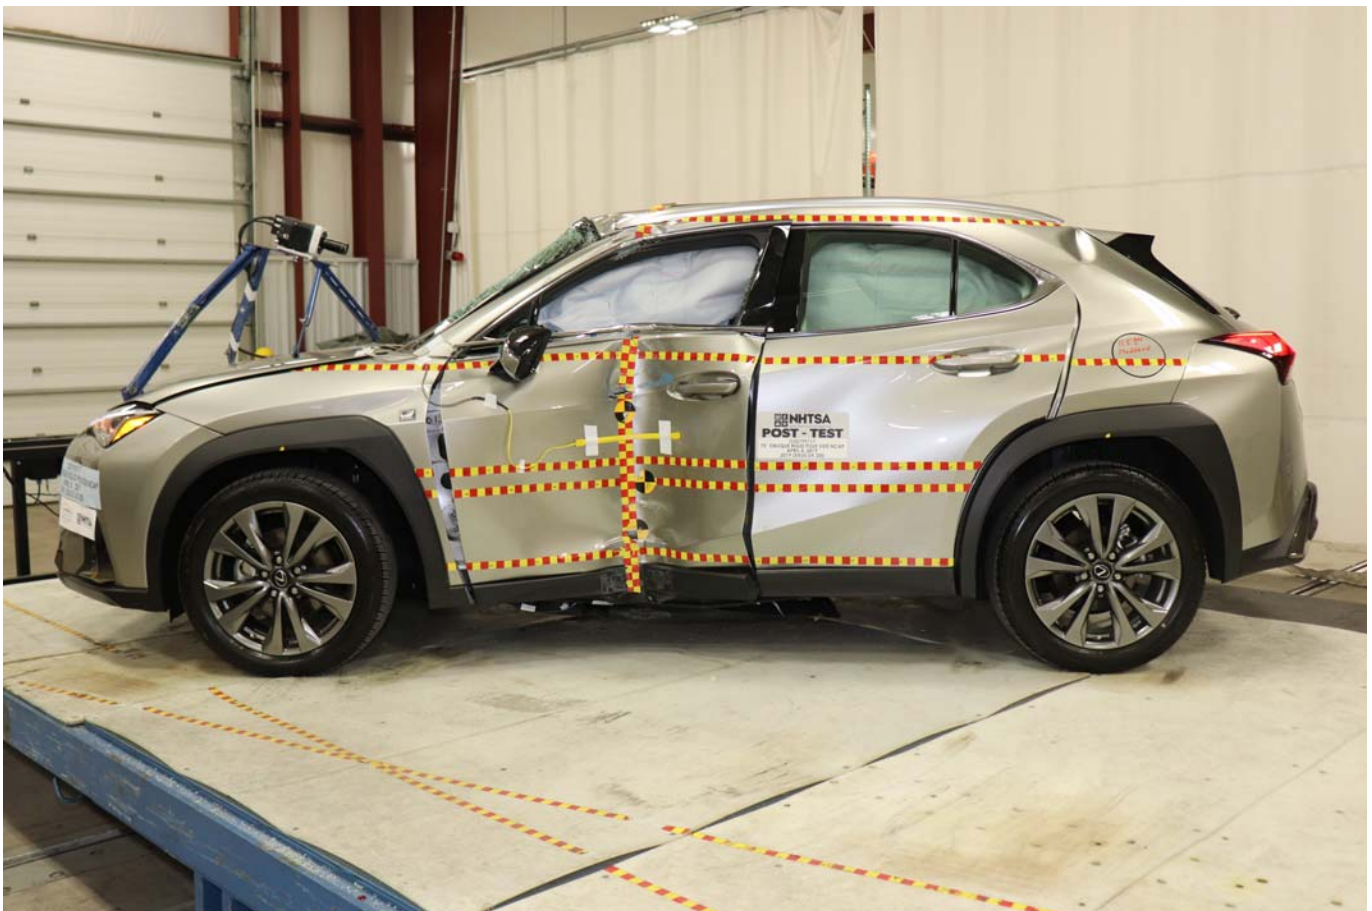
Photo No. 008 - Post-Test Left Side View of Test Vehicle

Critical Areas of Performance	Observations and Conclusions
Pillar Performance	No Separation
Sill Separation	None
Windshield Damage	None
Side Window Damage	LF Window Broken
Other Notable Effects	None

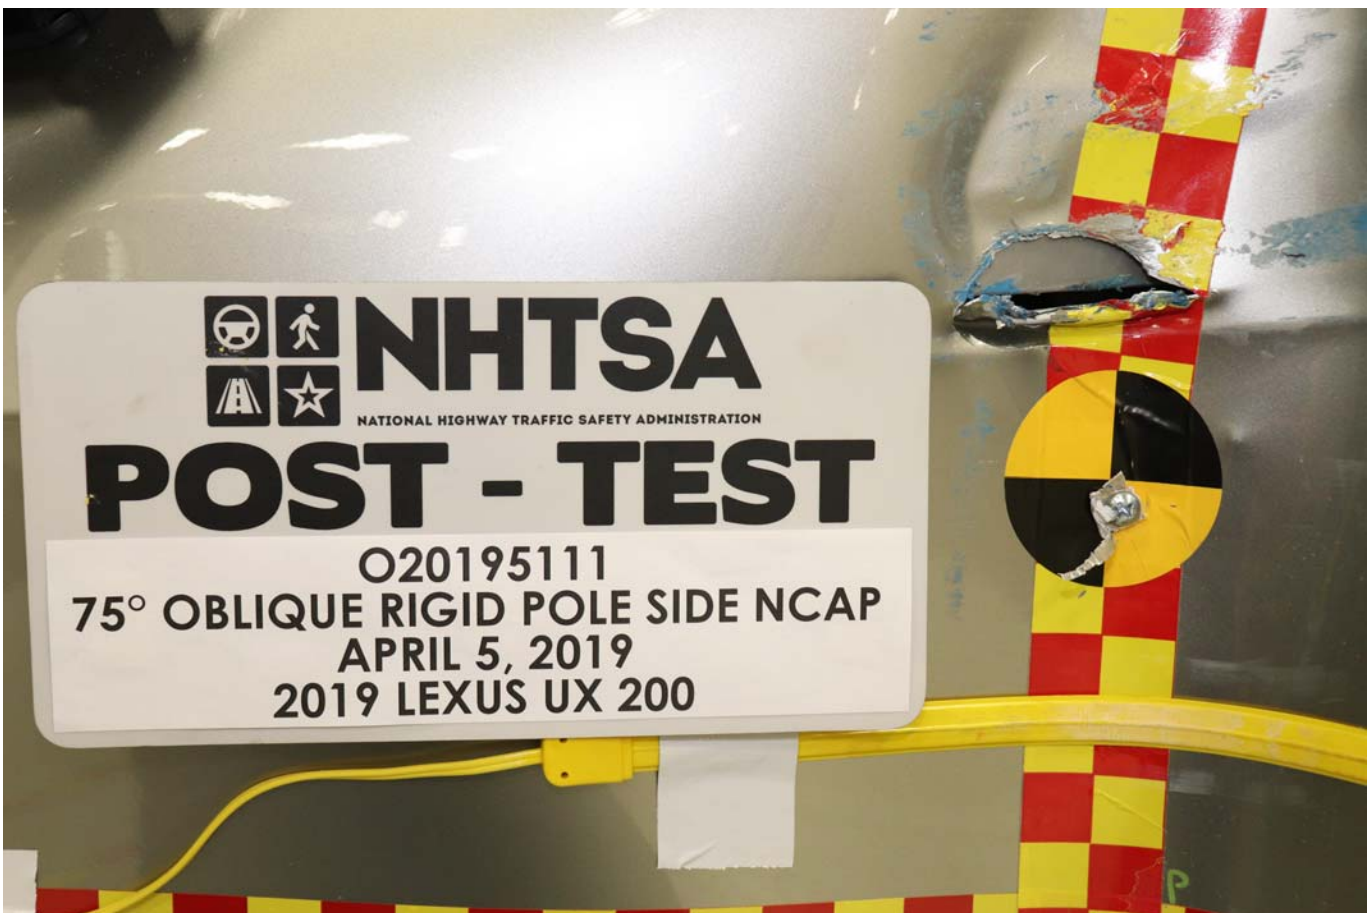
Photo No. 020 - Post-Test Close-Up View of Impact Point Target Showing Impact Location

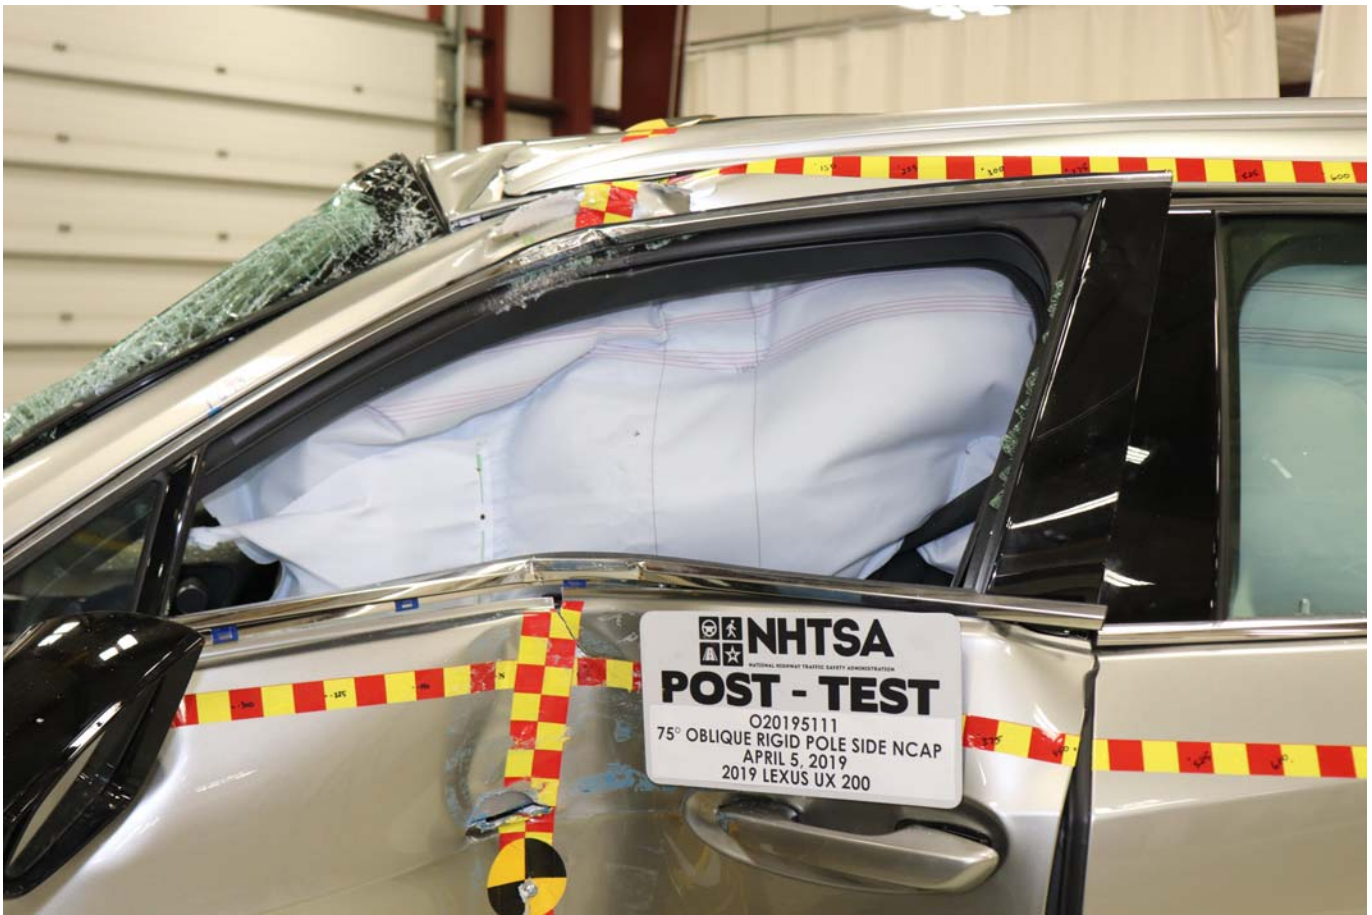
Photo No. 025 - Post-Test Left Side View of Dummy Shoulder and Door Top View

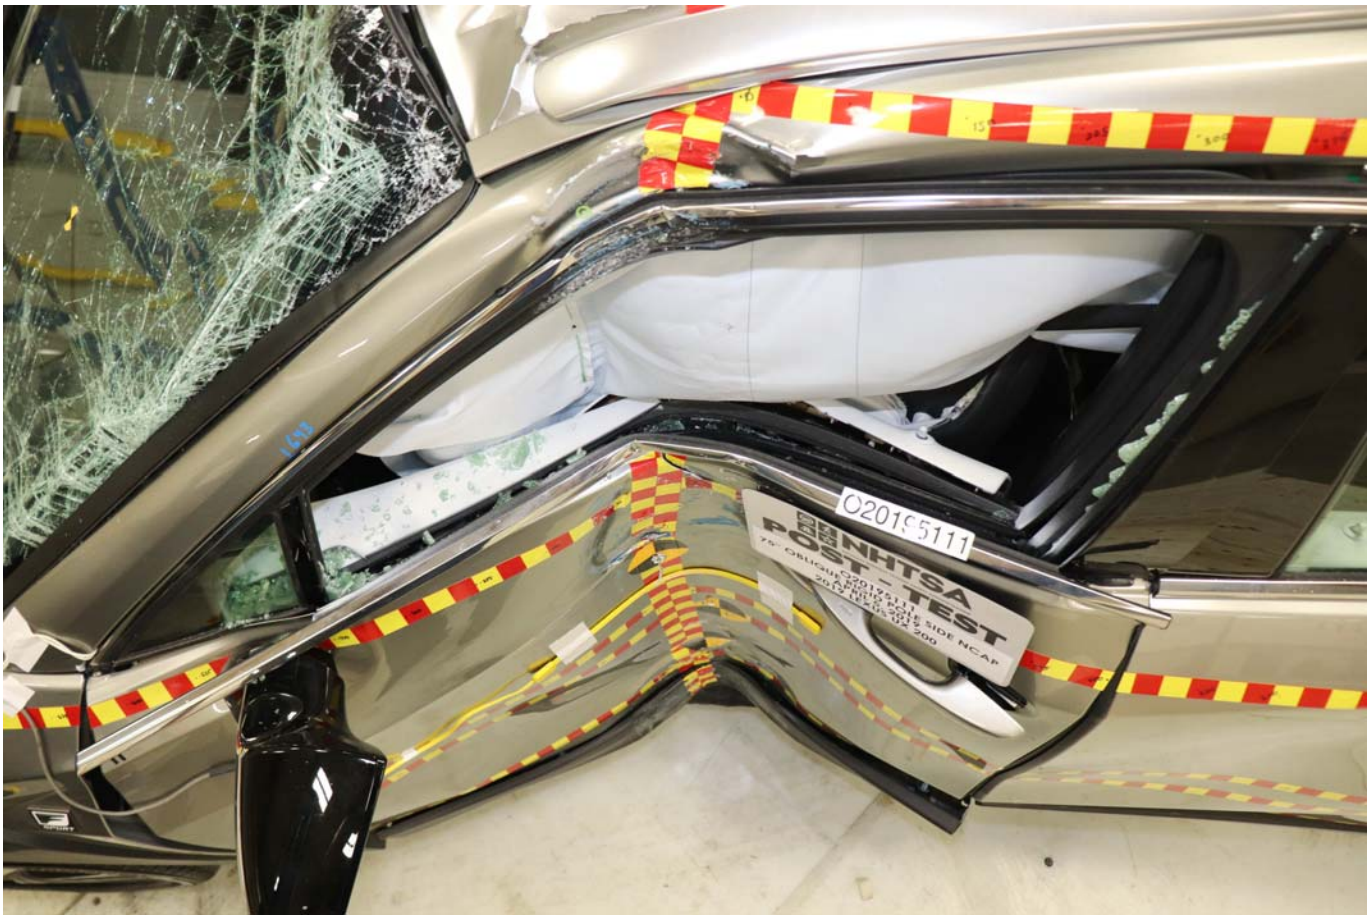
Photo No. 041 - Post-Test Dummy and Door Clearance View

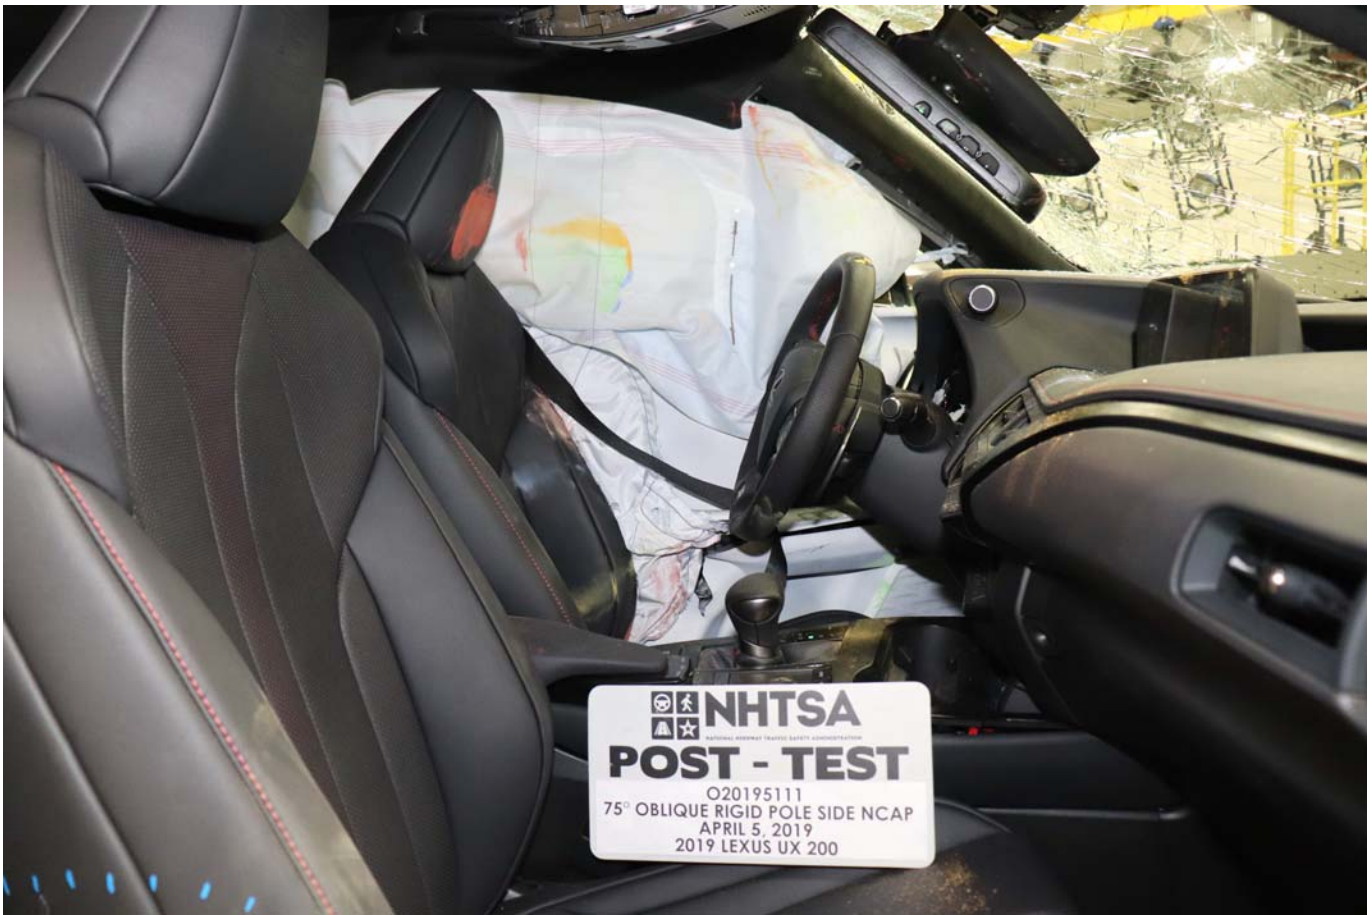
Photo No. 045 - Post-Test Inner Door Panel View Showing Dummy Contact Location

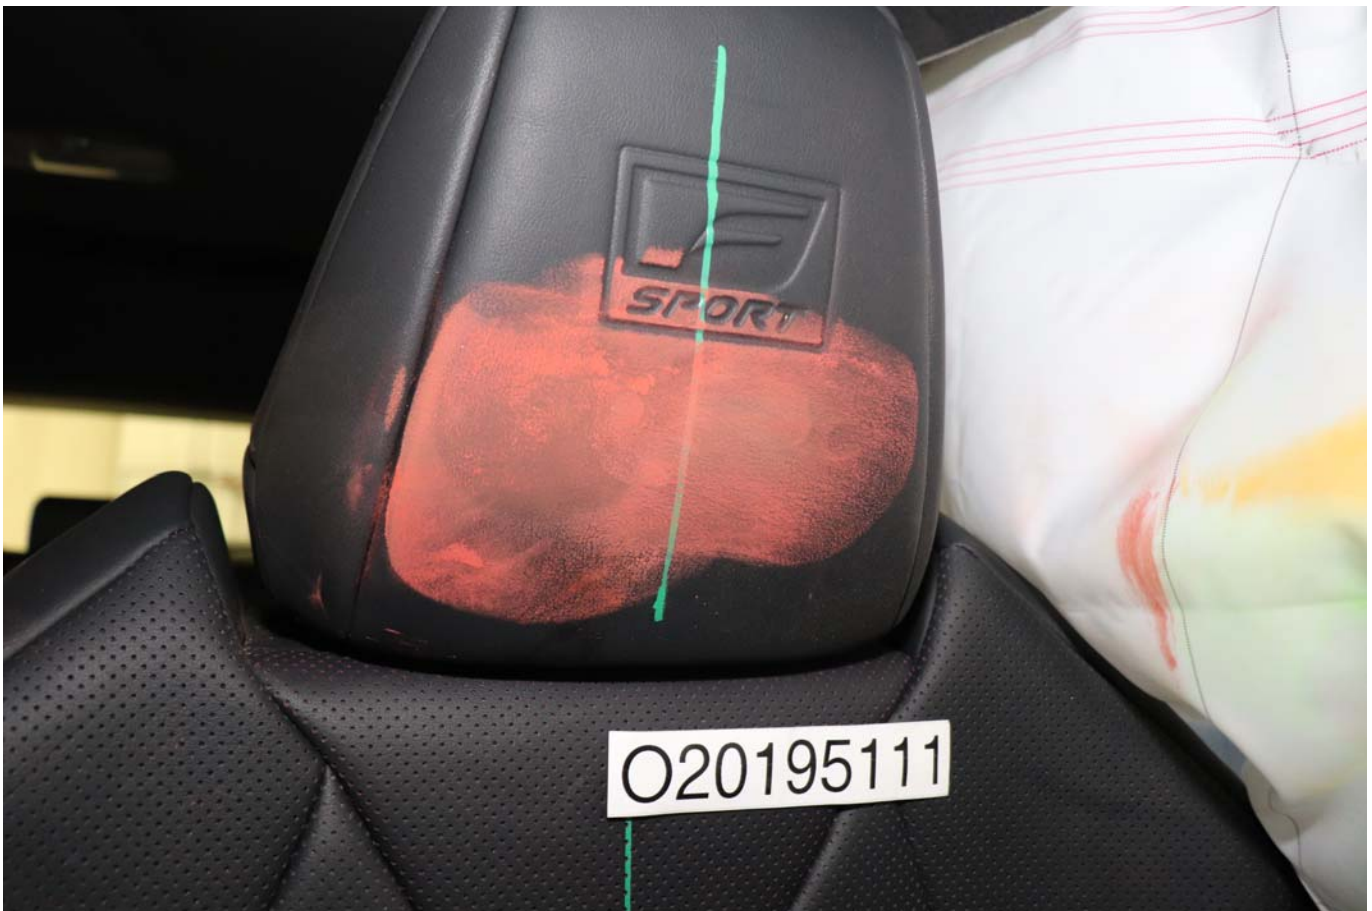
Photo No. 046 - Post-Test Dummy Close-Up Head Contact with Vehicle Interior View

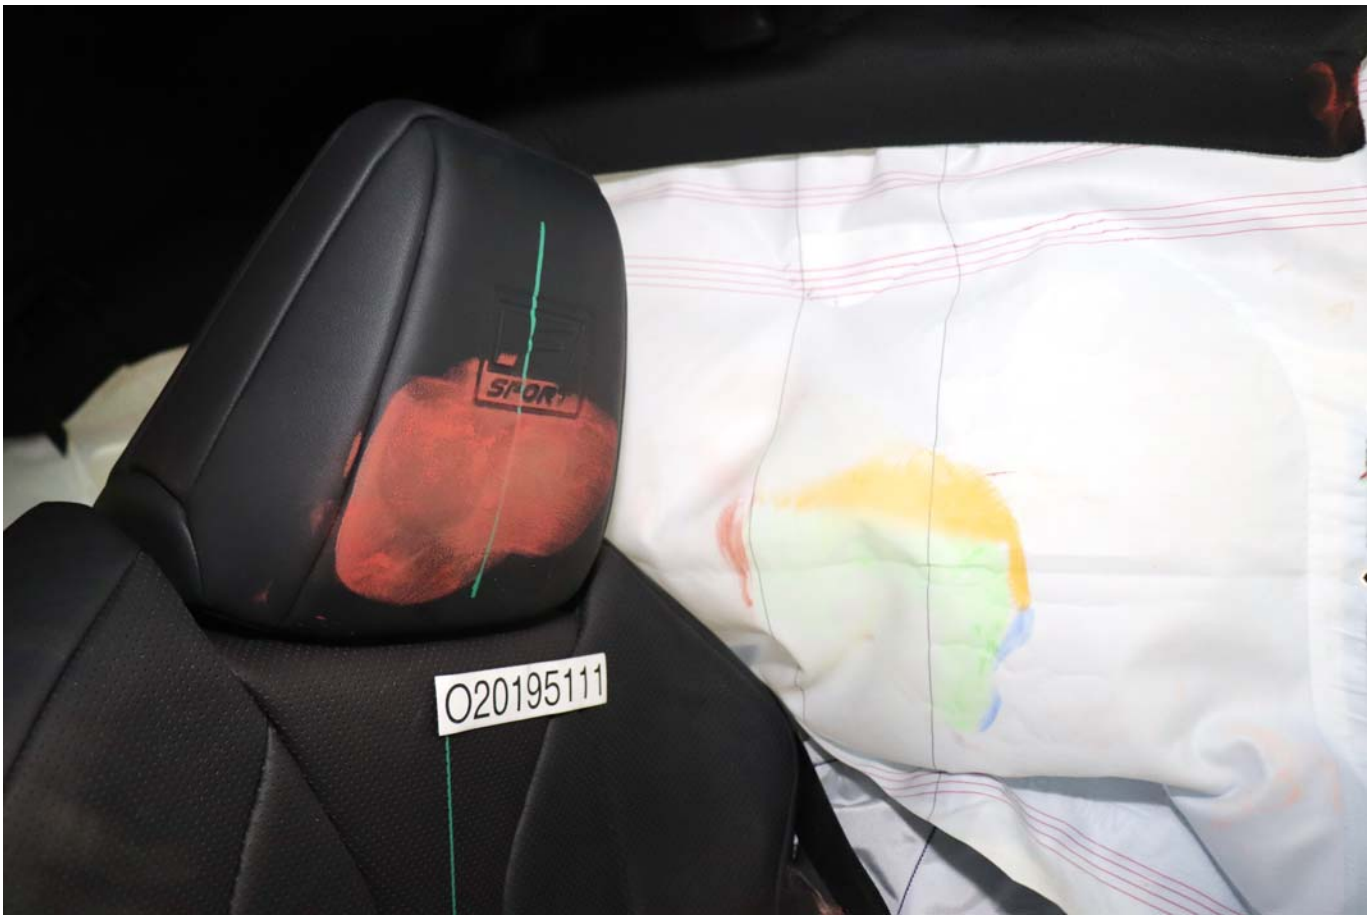
Photo No. 047 - Post-Test Dummy Close-Up Head Contact with Side Air Bag View

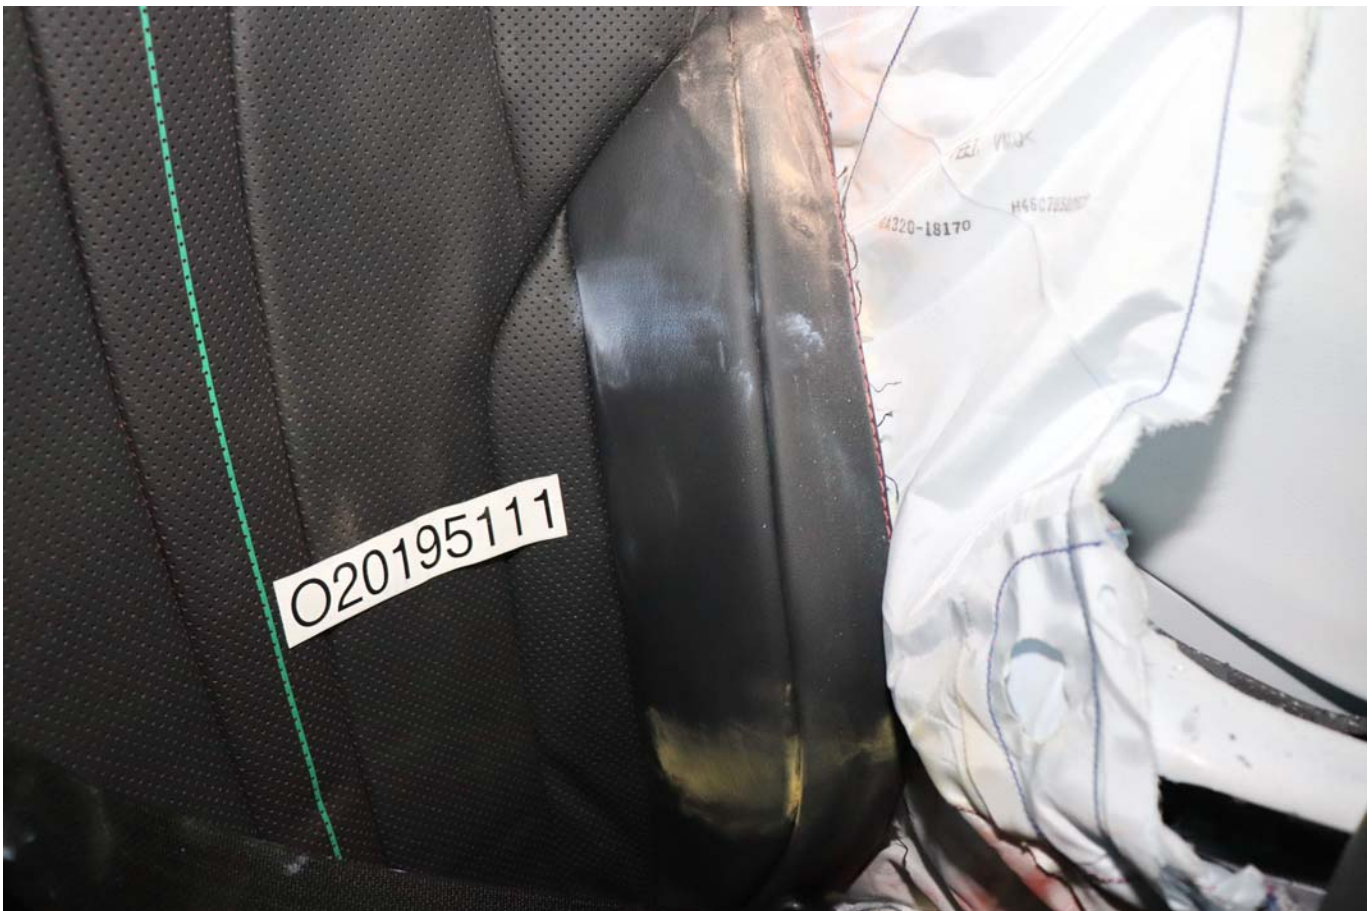
Photo No. 048 - Post-Test Dummy Close-Up Torso Contact with Vehicle Interior View

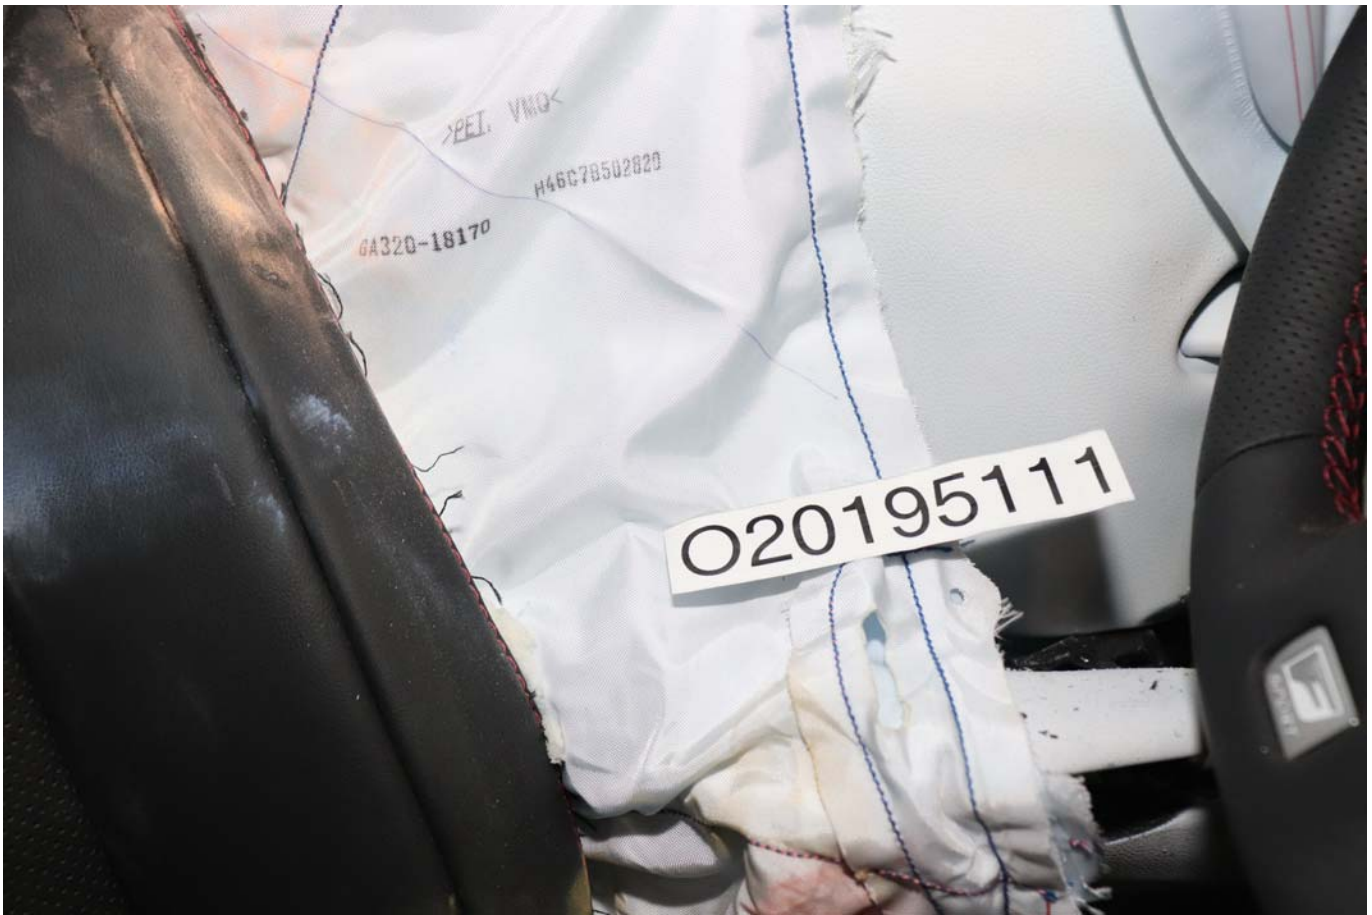
Photo No. 049 - Post-Test Dummy Close-Up Torso Contact with Side Air Bag View

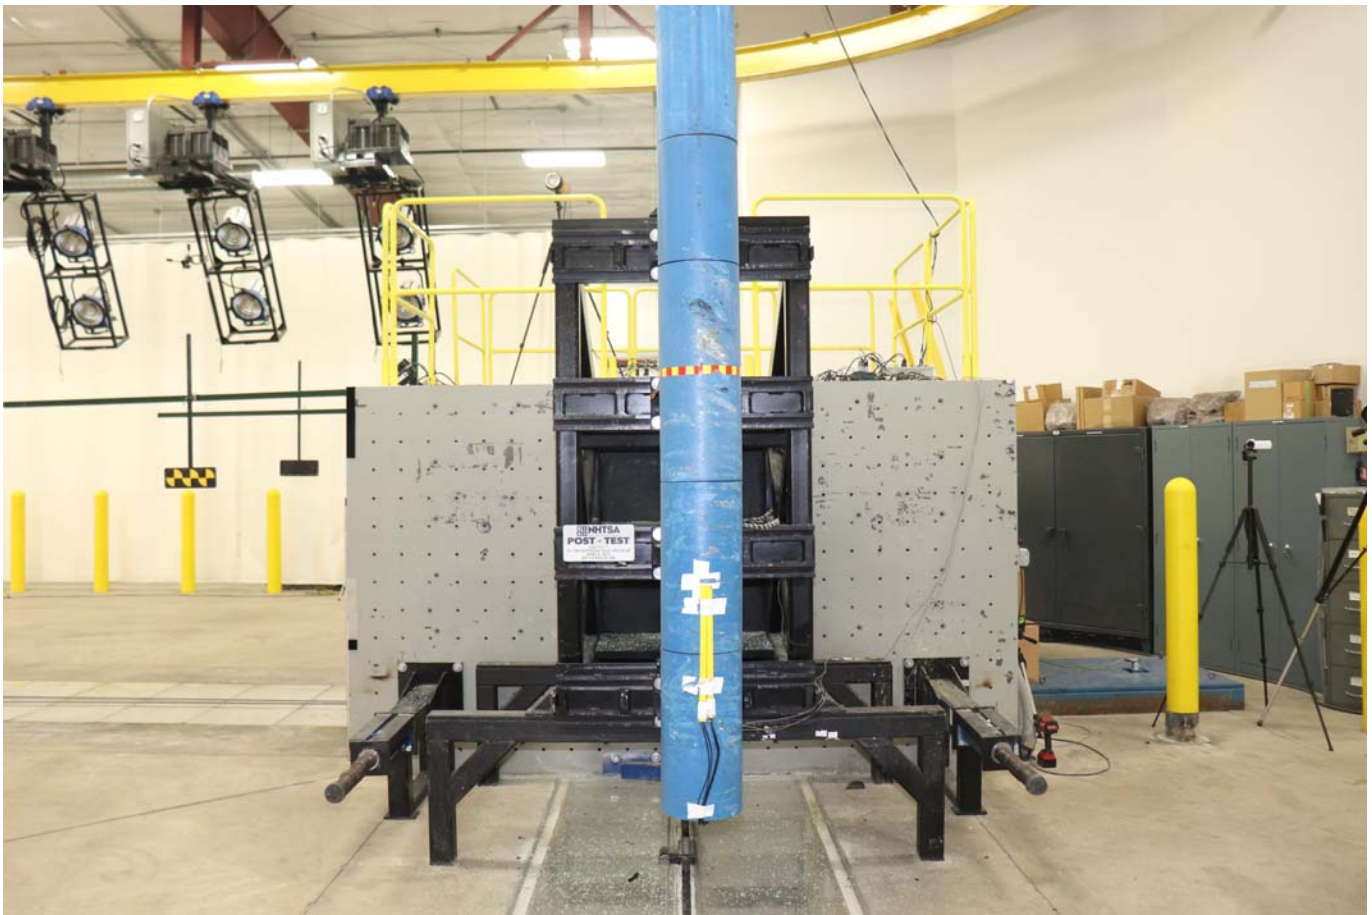
Photo No. 058 - Post-Test Pole Barrier Front View

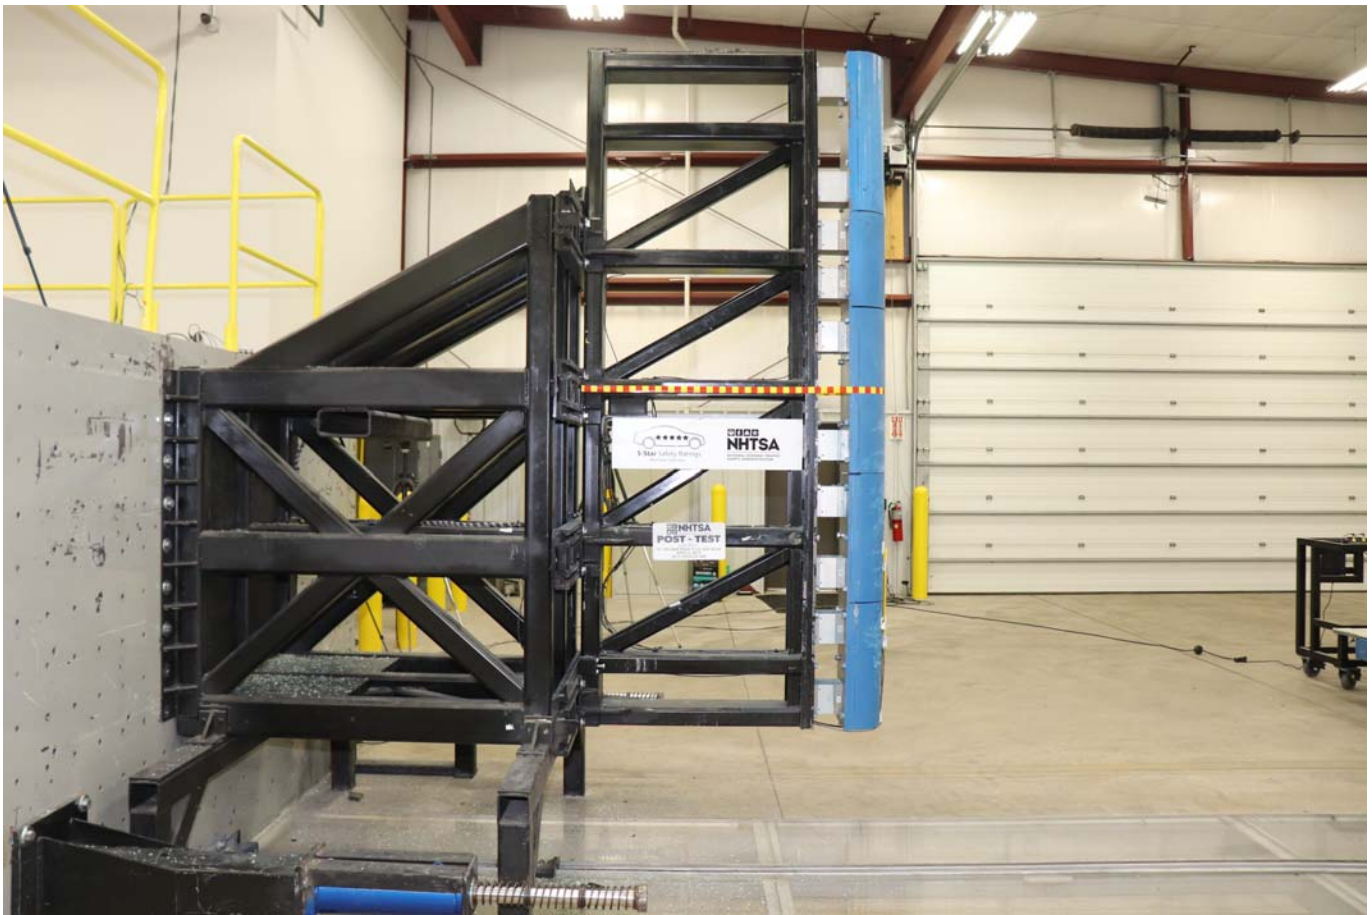
Photo No. 060 - Post-Test Pole Barrier Side View
