REPORT NUMBER: SPNCAP-MGA-2019-040

**NEW CAR ASSESSMENT PROGRAM (NCAP)
Side Impact Pole Test**

**TOYOTA MOTOR CORPORATION
2019 Lexus UX 200 F Sport 5-Door Hatchback
NHTSA No.: O20195111**

**MGA RESEARCH CORPORATION
5000 Warren Road
Burlington, WI 53105**

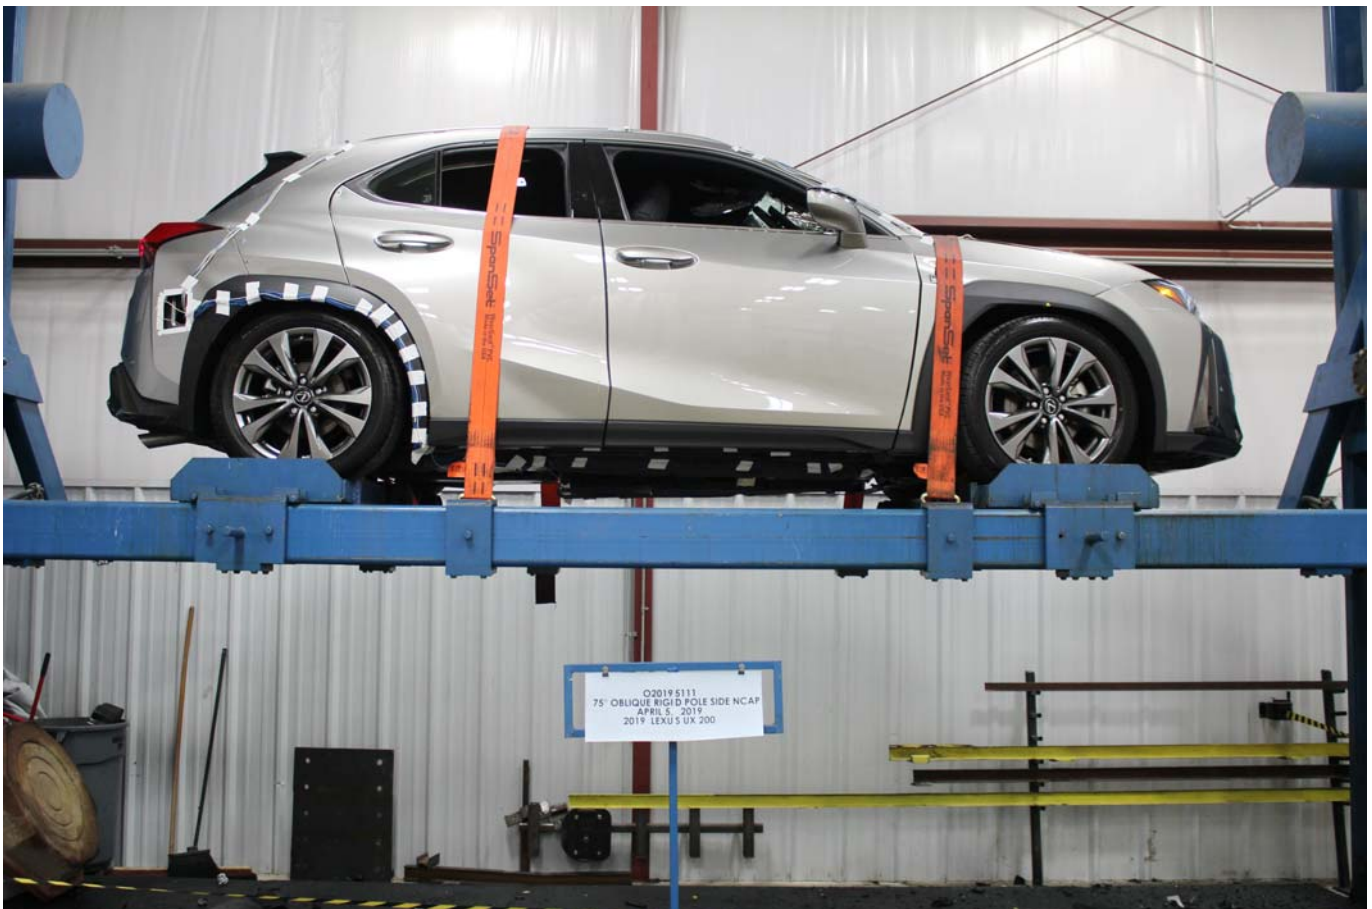
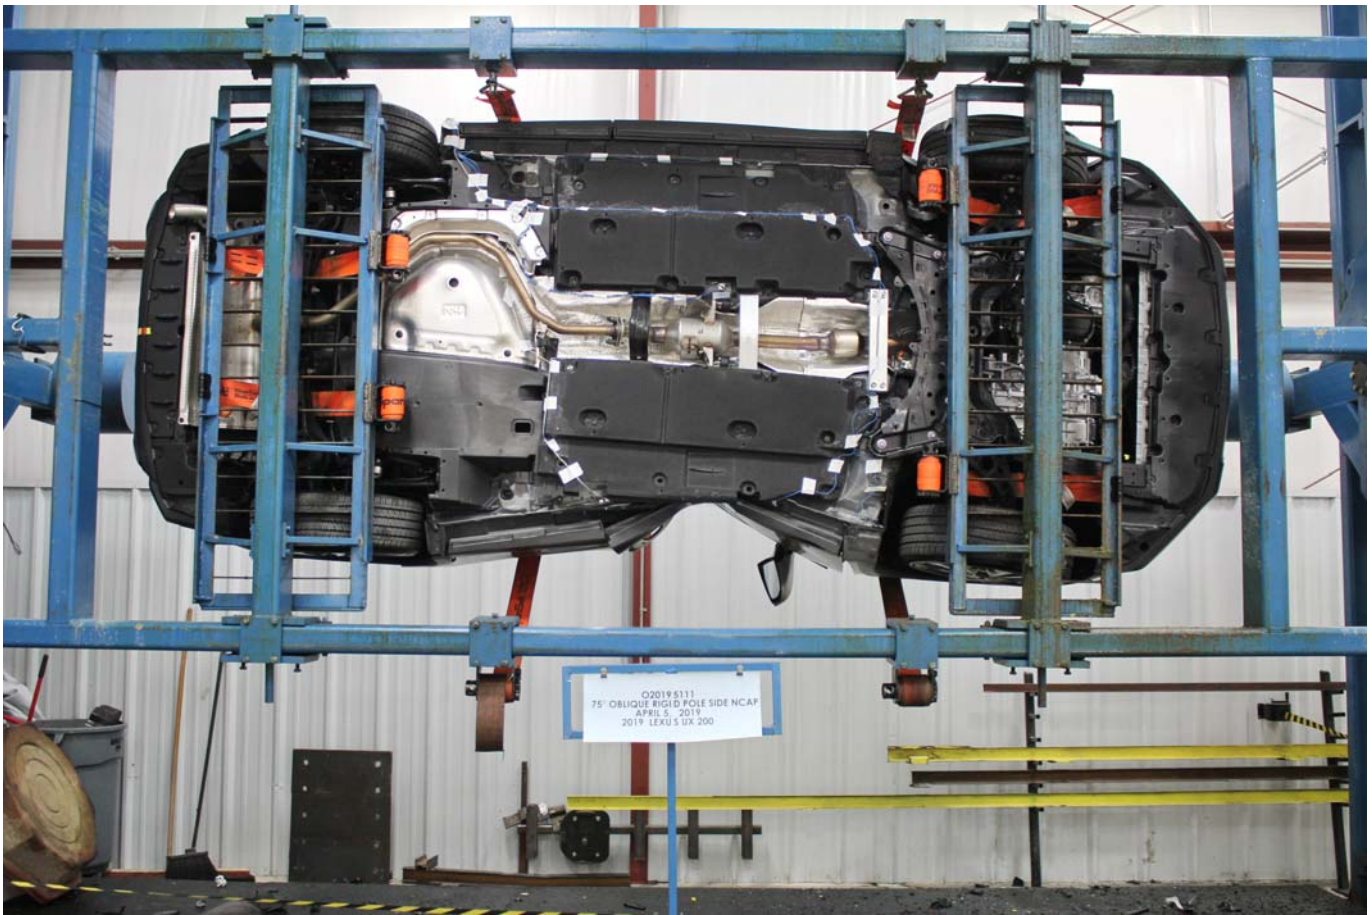
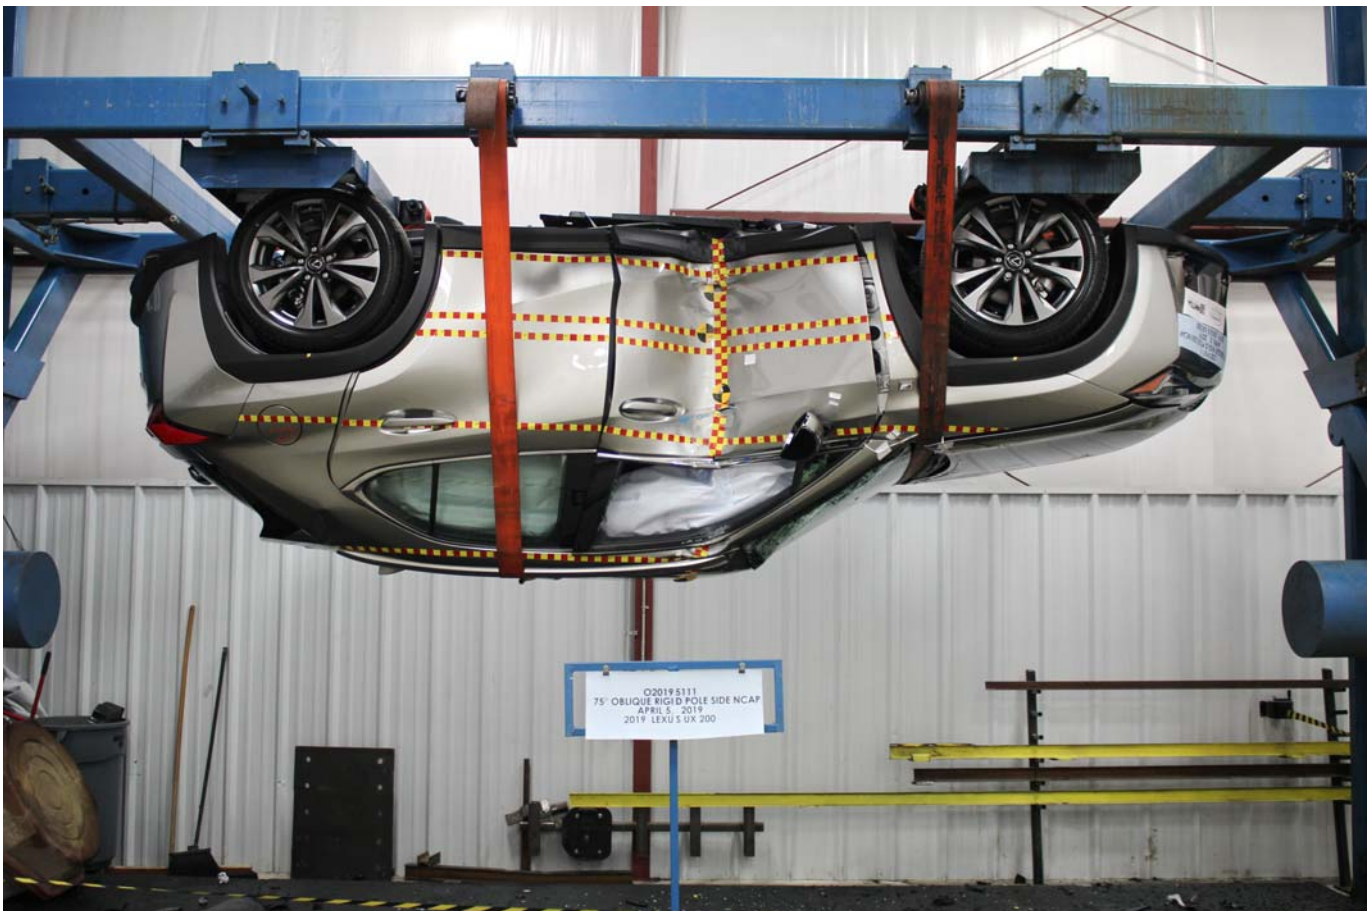
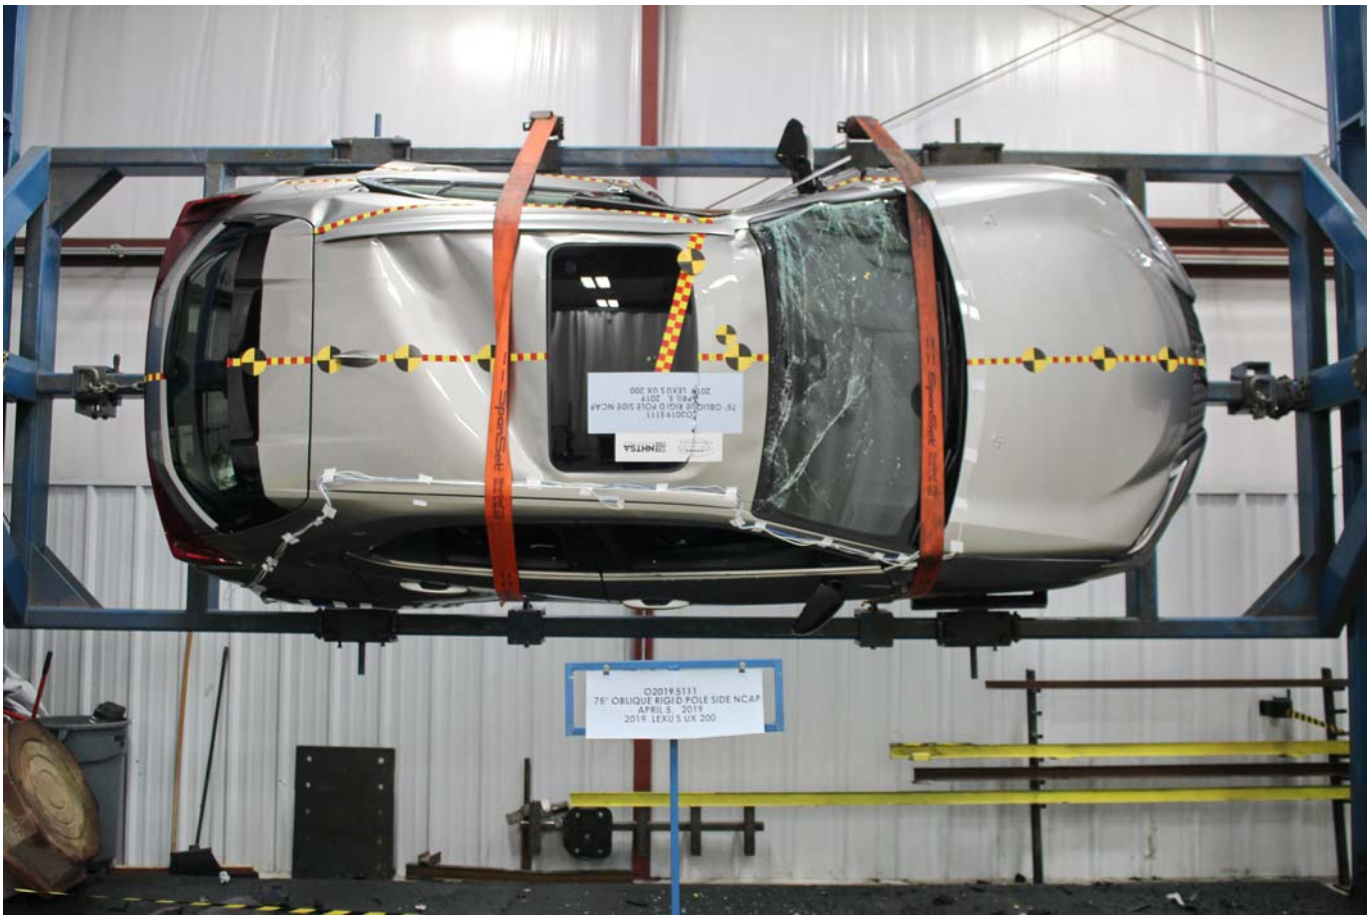
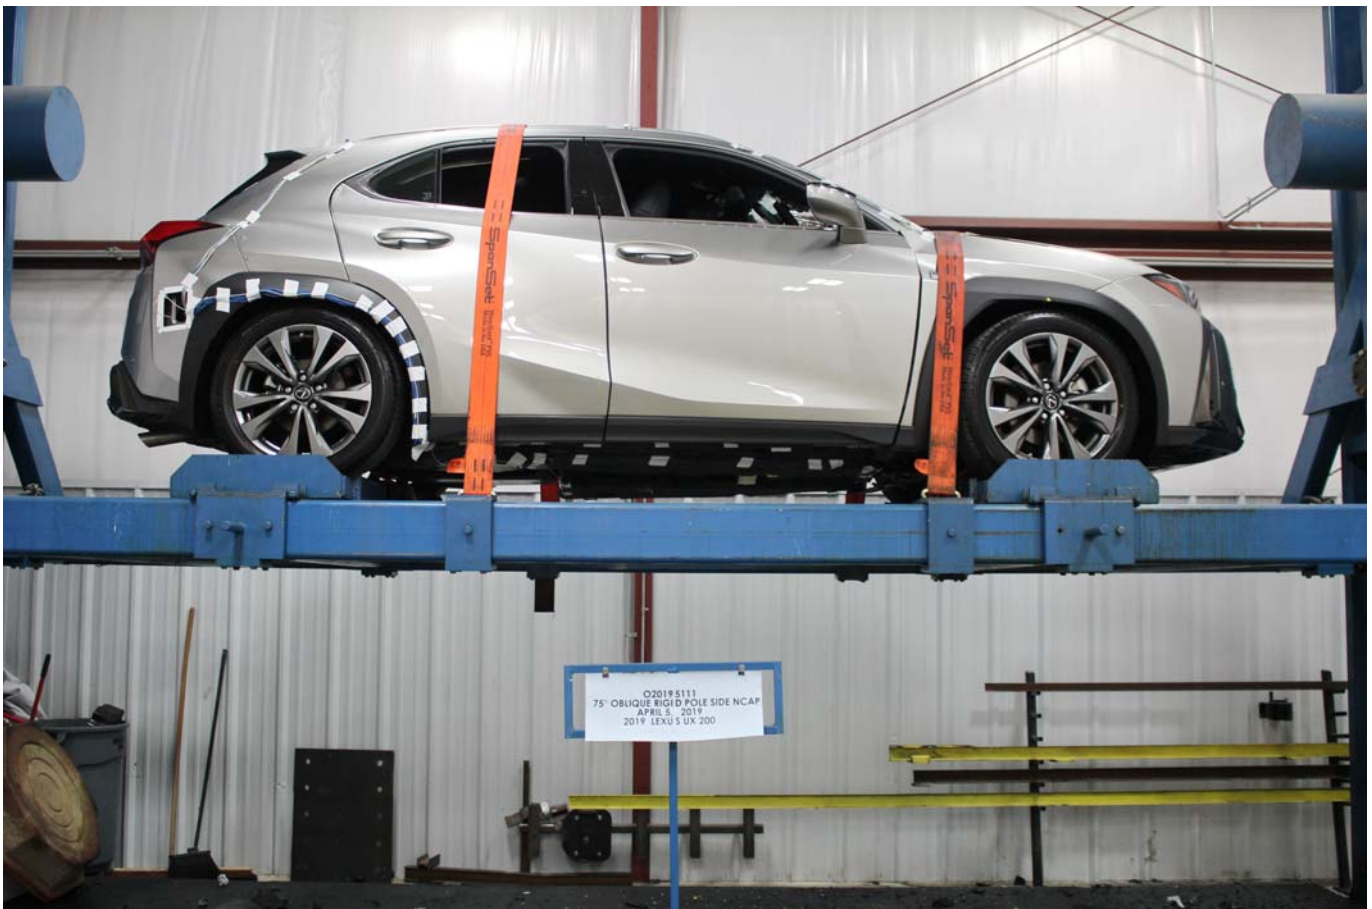
Photo No. 063 - FMVSS Photo No. 301 Static Rollover 0 Degrees

Photo No. 064 - FMVSS Photo No. 301 Static Rollover 90 Degrees

Photo No. 065 - FMVSS Photo No. 301 Static Rollover 180 Degrees

Photo No. 066 - FMVSS Photo No. 301 Static Rollover 270 Degrees

Photo No. 067 - FMVSS Photo No. 301 Static Rollover 360 Degrees

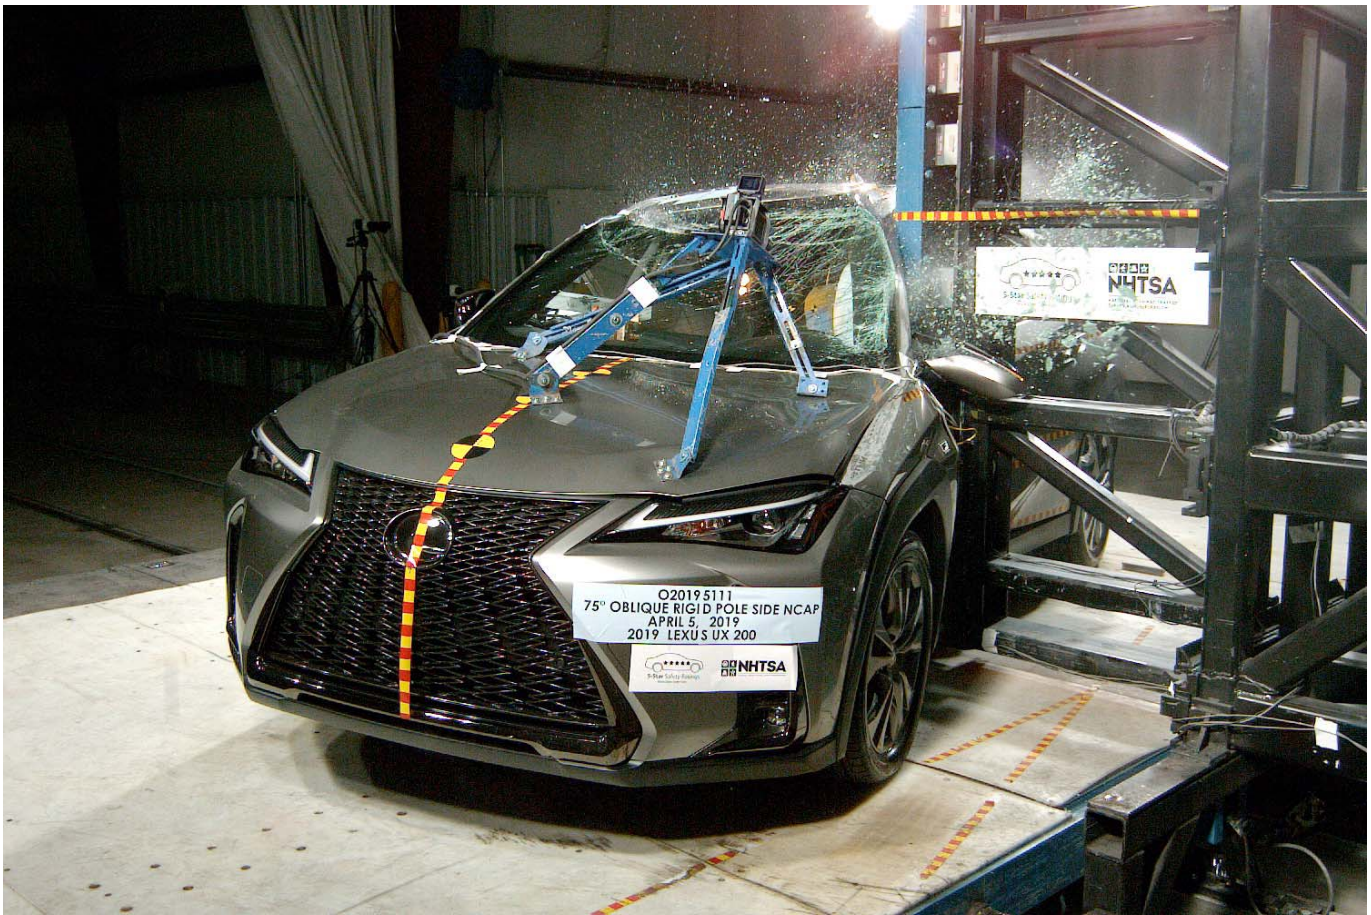
Photo No. 068 - Impact Event

A rigid pole side impact test was conducted on a 2019 Lexus UX 200 F Sport 5-Door Hatchback. The subject vehicle was towed into the rigid pole at an angle of 75° and a velocity of 32.40 km/h. The test was conducted by MGA Research Corporation in Burlington, Wisconsin on April 5, 2019. Pre-test and post-test photographs of the test vehicle and side impact dummy (SID-IIs) are included in Appendix A of this report.
