FINAL REPORT NUMBER: SINCAP-TRC-19-003

NEW CAR ASSESSMENT PROGRAM (NCAP) MOVING DEFORMABLE BARRIER SIDE IMPACT TEST

NISSAN MOTOR CO., LTD. 2019 Infiniti QX50 SUV NHTSA NUMBER: M20195215

PREPARED BY: Transportation Research Center Inc. 10820 State Route 347 P. O. Box B-67 East Liberty, OH 43319

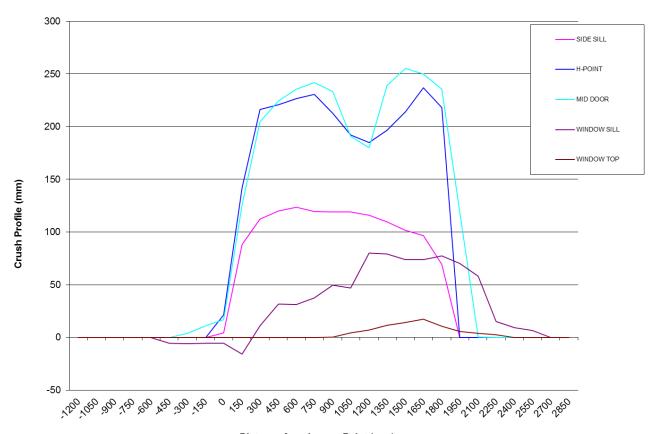
DATA SHEET NO. 11 (CONTINUED) TEST VEHICLE EXTERIOR CRUSH MEASUREMENTS

NOTE: Pre-test measurements are taken when the vehicle is in the "As Tested" weight condition. Vehicle measurements forward of the vertical impact reference line are negative. The crush profile grid is established prior to the test based on an estimated impact point.

Distance from Impact Point (mm)

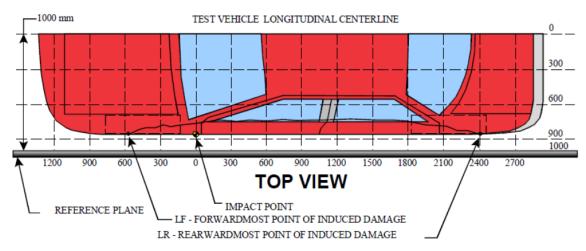
DATA SHEET NO. 13 VEHICLE AND MDB DAMAGE PROFILE DISTANCES

MEASUREMENT CONVENTIONS:

Forward of the impact point (towards front of vehicle) is considered negative (—).

VEHICLE DAMAGE I NOTICE DIGITALIGES					
DPD	Distance From Impact Point (mm)	Level	Post-Test (mm)	Pre-Test (mm)	Crush (mm)
1	2550	4	881	887	6
2	1950	3	833	952	119
3	1350	3	701	940	239
4	900	3	711	945	234
5	300	2	723	939	216
6 ¹	-300	3	947	951	0

MIDE DAMAGE I NOTICE DIGTANGES						
DPD	Distance From Center of MDB	Level	Post-Test (mm)	Pre-Test (mm)	Crush (mm)	
1	800 mm Left of Center	1	266	471	205	
2	500 mm Left of Center	1	277	485	208	
3	200 mm Left of Center	1	274	485	211	
4	200 mm Right of Center	1	270	486	216	
5	500 mm Right of Center	1	268	487	219	
6	800 mm Right of Center	1	231	476	245

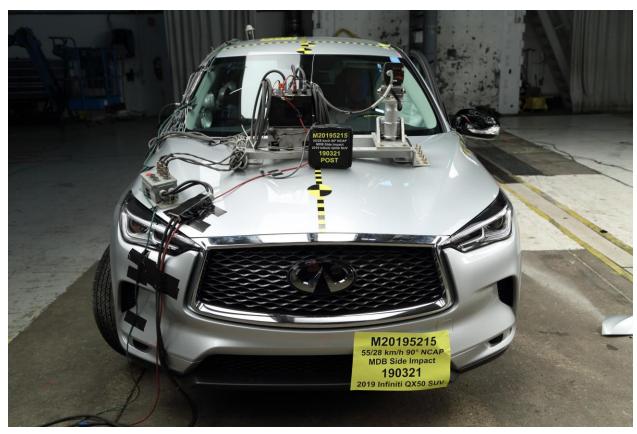
004 Post-Test Frontal View of Test Vehicle

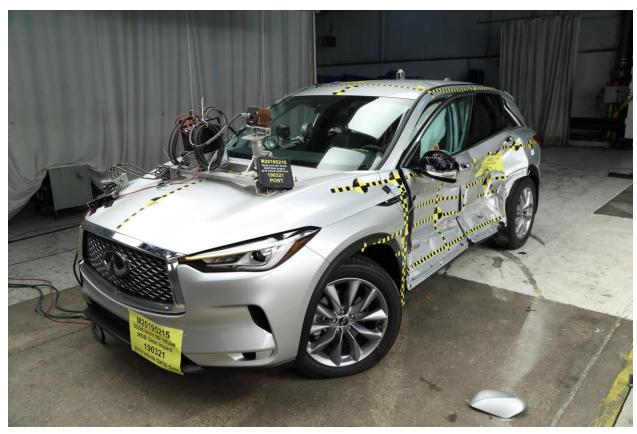
006 Post-Test Left Front 3/4 View of Test Vehicle

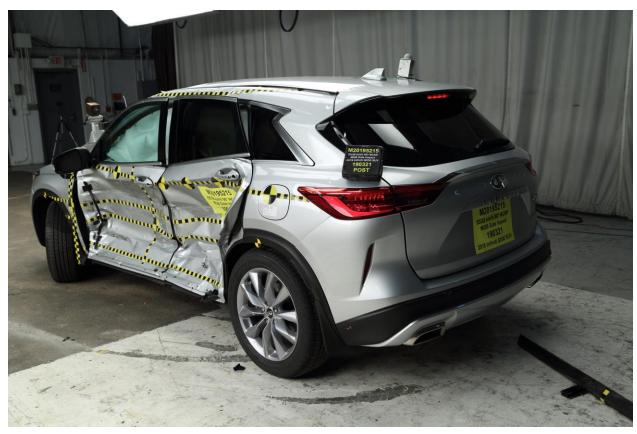
010 Post-Test Left Rear 3/4 View of Test Vehicle

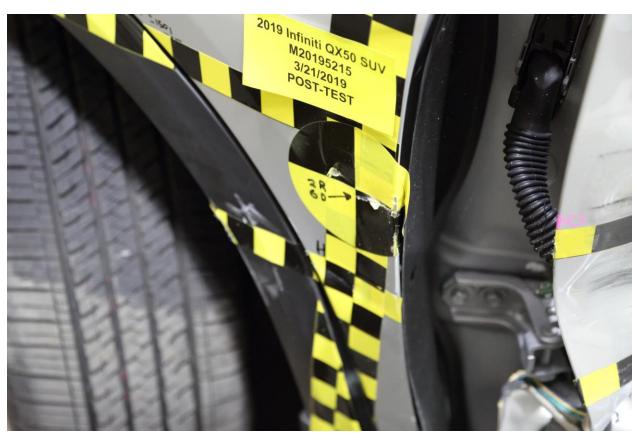
020 Post-Test Close-Up View of Impact Point Target

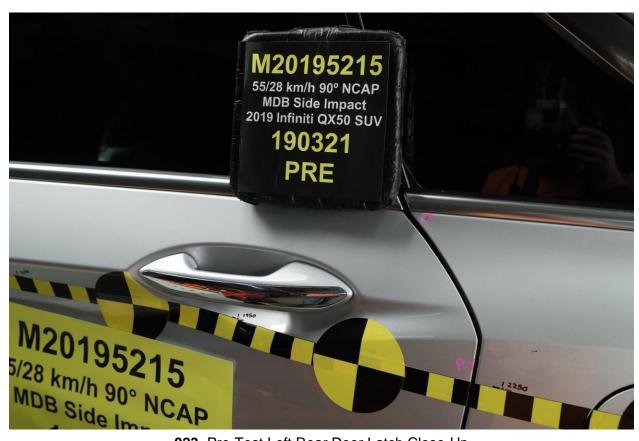
023 Pre-Test Left Rear Door Latch Close-Up

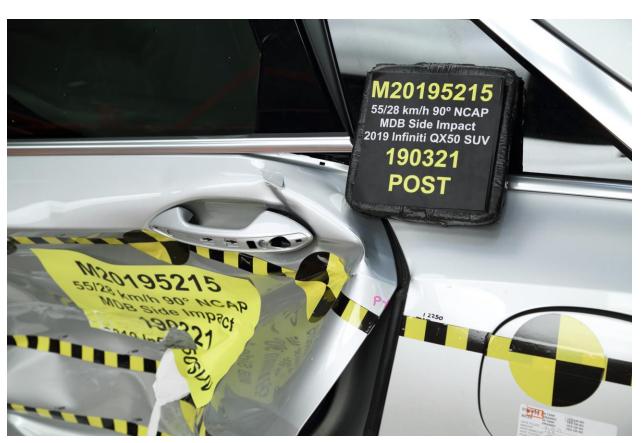
024 Post-Test Left Rear Door Latch Close-Up

The doors on the struck side of the vehicle did not separate from the body at the hinges or latches and the opposite doors did not open during the side impact event.

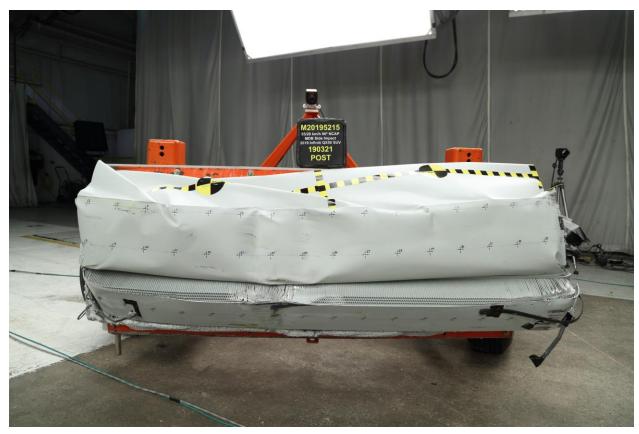
085 Post-Test Front View of MDB Impactor Face

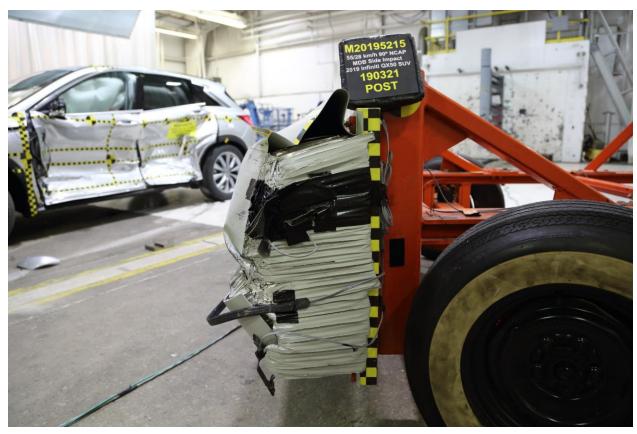
089 Post-Test Left Side View of MDB Impactor Face

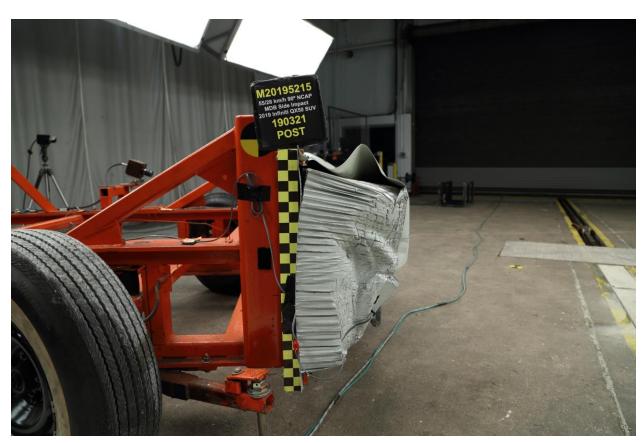
091 Post-Test Right Side View of MDB Impactor Face

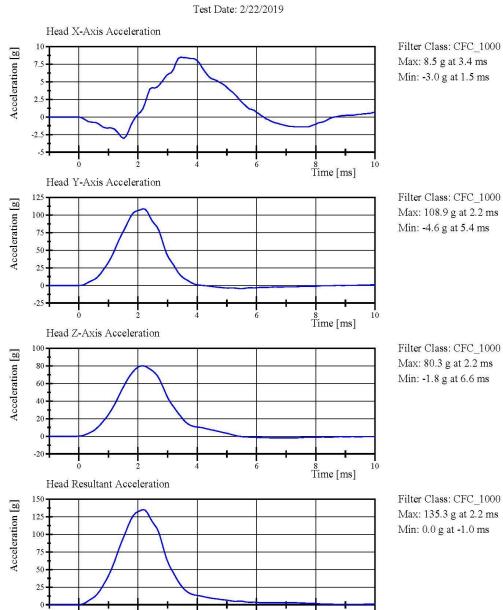
Left Lateral Head Drop
ES-2re Serial No. F030 Certification No. 61-1
Test Date: 2/22/2019

Specification Source: CFR49 Part 572 Subpart U with Polarity in accordance with J211 ${\rm Page}~11~{\rm of}~41$

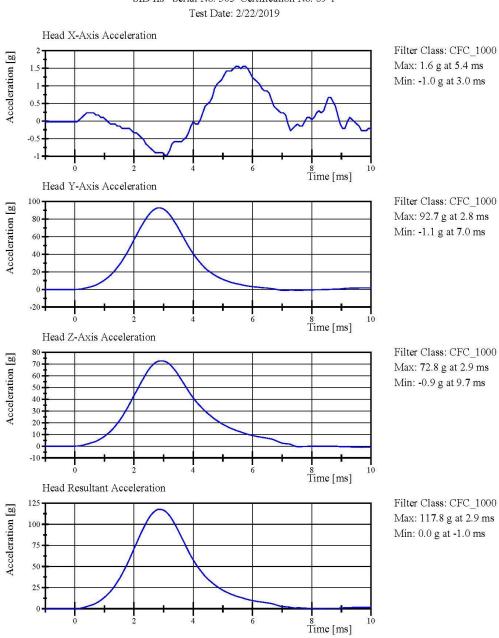
Left Lateral Head Drop
SID IIs Serial No. 305 Certification No. 69-1
Test Date: 2/22/2019

Specification Source: CFR49 Part 572 Subpart V with Polarity in accordance with J211 $$\operatorname{Page}\ 10$ of 31$

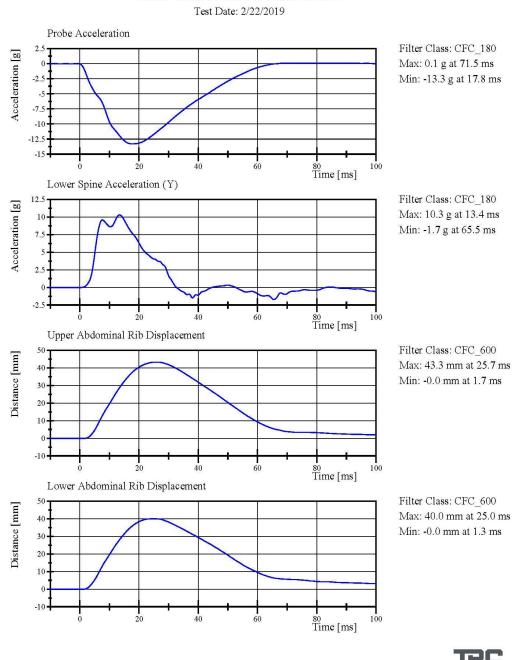
Left Lateral Abdomen SID IIs Serial No. 305 Certification No. 69-1

Specification Source: CFR49 Part 572 Subpart V with Polarity in accordance with J211 Page 24 of 31 02.22.2019 15:27:42 666

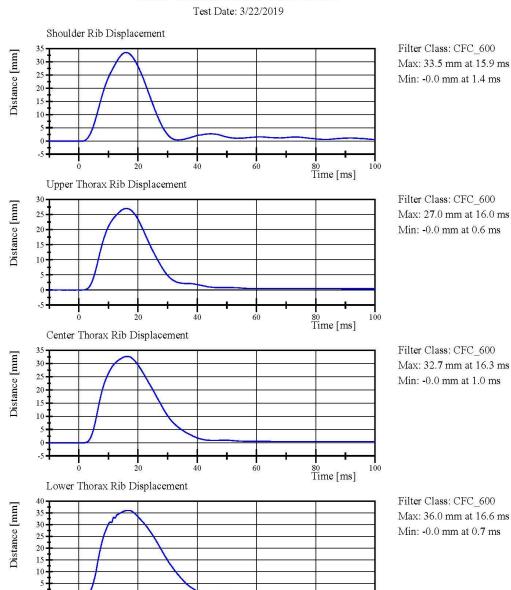
Left Lateral Thorax with Arm
SID IIs Serial No. 305 Certification No. 70-1
Test Date: 3/22/2019

Specification Source: CFR49 Part 572 Subpart V with Polarity in accordance with J211 Page 19 of 31

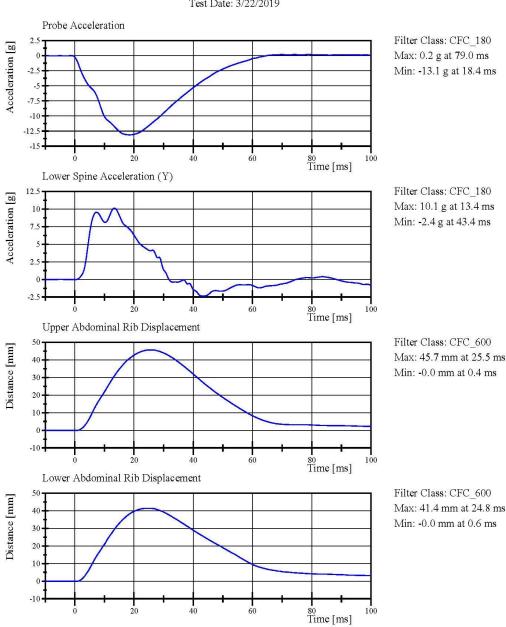
Left Lateral Abdomen
SID IIs Serial No. 305 Certification No. 70-1
Test Date: 3/22/2019

Specification Source: CFR49 Part 572 Subpart V with Polarity in accordance with J211 Page 24 of 31
