Final Report Number: NCAP-TRC-19-005

New Car Assessment Program (NCAP)

Frontal Barrier Impact Test

NISSAN MOTOR CO., LTD. 2019 Infiniti QX50 SUV NHTSA Number: M20195213

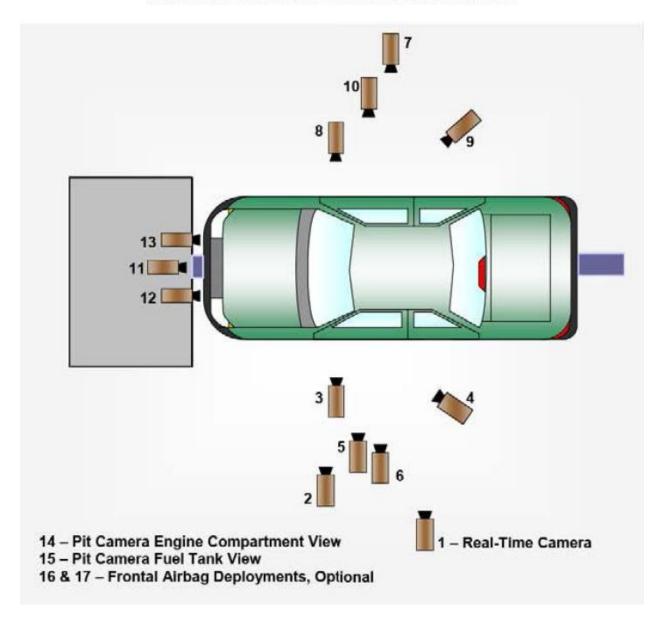
#### CAMERA POSITIONS FOR FRONTAL IMPACTS

One real-time camera and 16 high-speed cameras were used to document the frontal barrier impact event. Camera locations and other pertinent camera information can be found in this report.

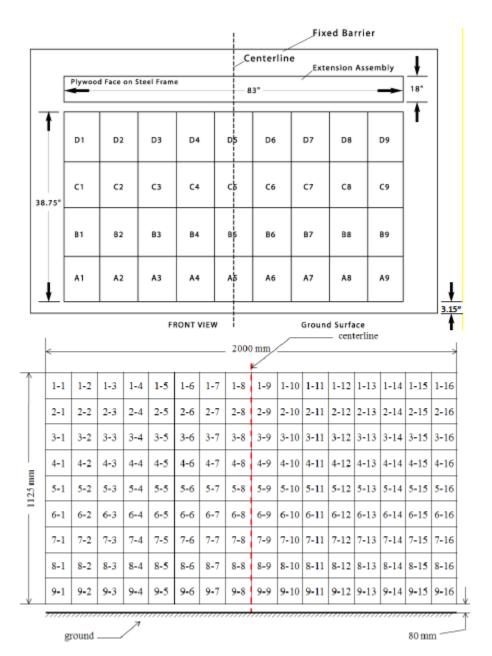
#### DATA SHEET NO. 9 - LOAD CELL LOCATIONS ON FIXED BARRIER

A load cell barrier consisting of 288 load cells was impacted by a 2019 Infiniti QX50 SUV at a velocity of 56.48 km/h. The test was performed at Transportation Research Center, Inc. on March 19, 2019. Pre- and post-test photographs of the vehicle and dummies can be found in Appendix A.

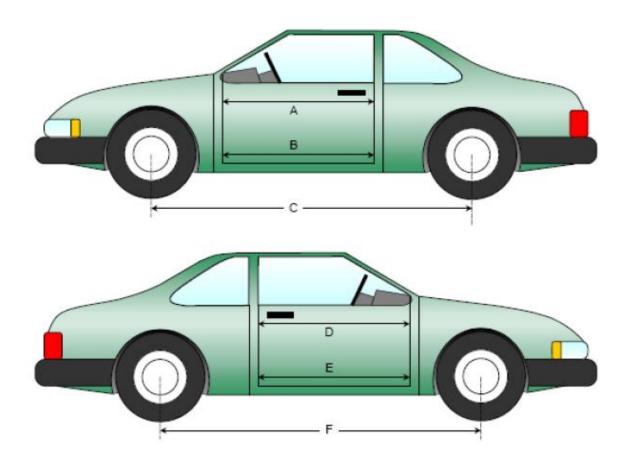
No.	Description	Units	Pre-Test	Post-Test	Difference
С	Left Side Wheelbase	mm	2790	2725	65
F	Right Side Wheelbase	mm	2790	2740	50

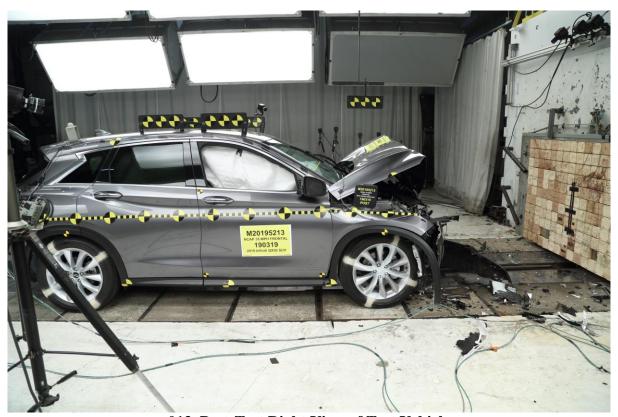
013 Post-Test Right View of Test Vehicle

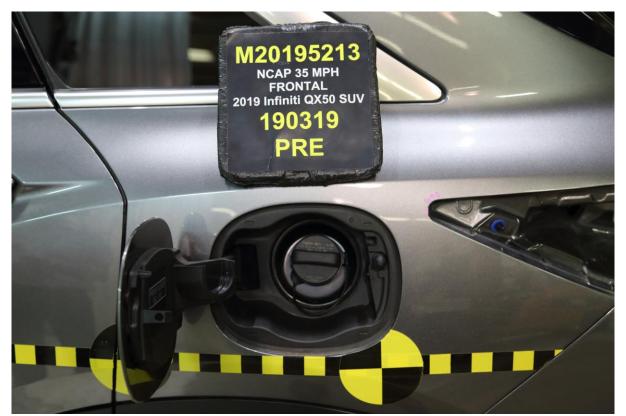
022 Pre-Test Fuel Filler Cap View

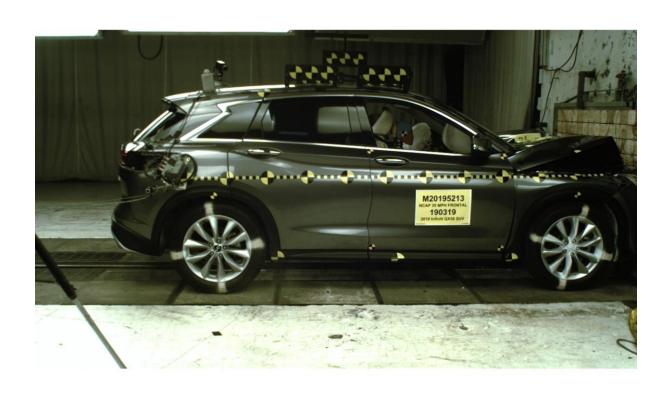
082 2019 Infiniti QX50 SUV Frontal Impact Event

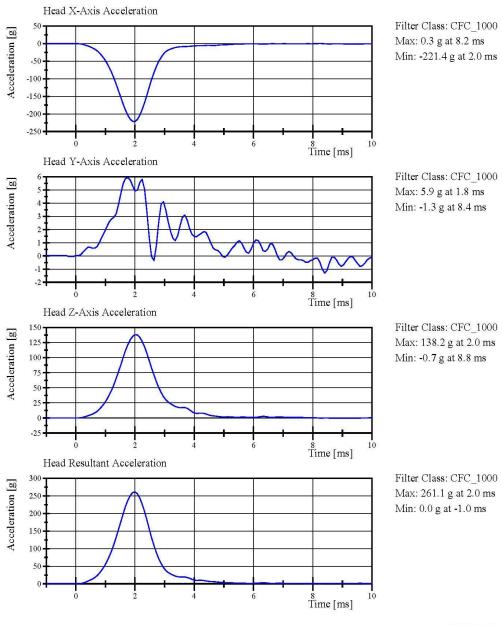
Test Parameter	Specification	<b>Test Results</b>	Pass
Temperature	18.9 <b>-</b> 25.5 ℃	21.7 °C	Yes
Relative Humidity	10 - 70 %	46 %	Yes
Peak Head Resultant Acceleration	225 - 275 g	261.1 g	Yes
Peak Head Lateral Acceleration	(-15) - 15 g	5.9 g	Yes
Is Acceleration Curve Unimodal within 10% of Peak?	Yes	Yes	Yes

Front Head Drop
HIII 50th Serial No. 037 Certification No. 55-1
Test Date: 2/20/2019

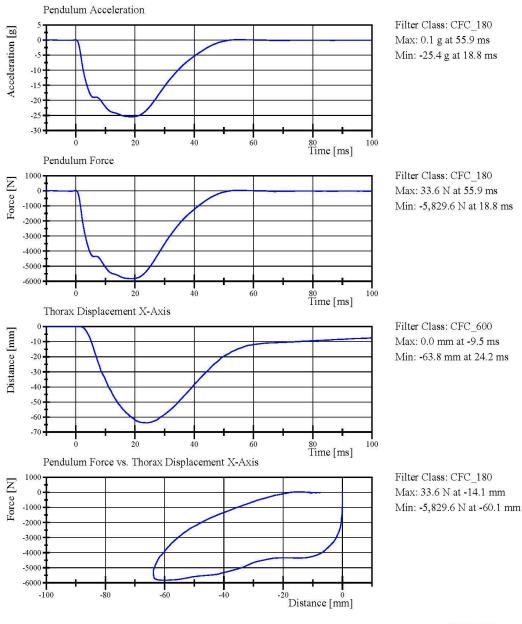
<b>Test Parameter</b>	Specification	<b>Test Results</b>	Pass
Temperature	20.6 <b>-</b> 22.2 ℃	21.3 ℃	Yes
Relative Humidity	10 - 70 %	38 %	Yes
Probe Velocity	6.59 - 6.83 m/s	6.816 m/s	Yes
Probe Force Peak	(-5,160) - (-5,894) N	<b>-5</b> ,829.6 N	Yes
Maximum Chest Compression	(-63.5) - (-72.6) mm	-63.85 mm	Yes
Internal Hysteresis	69 - 85 %	74.9 %	Yes

Front Thorax
HIII 50th Serial No. 037 Certification No. 56-3
Test Date: 2/27/2019

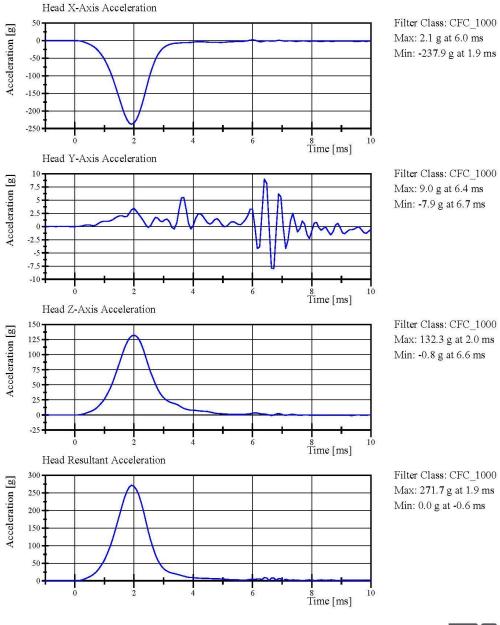
Test Parameter	Specification	<b>Test Results</b>	Pass
Temperature	20.6 <b>-</b> 22.2 ℃	21.4 °C	Yes
Relative Humidity	10 - 70 %	36 %	Yes
Peak Head Resultant Acceleration	225 - 275 g	271.7 g	Yes
Peak Head Lateral Acceleration	(-15) - 15 g	9.0 g	Yes
Is Acceleration Curve Unimodal	Yes	Yes	Yes

Front Head Drop
HIII 50th Serial No. 037 Certification No. 57-1
Test Date: 3/20/2019

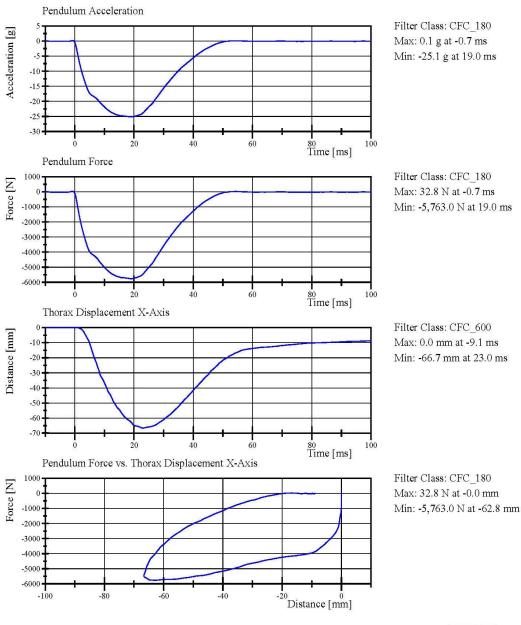
<b>Test Parameter</b>	Specification	<b>Test Results</b>	Pass
Temperature	20.6 <b>-</b> 22.2 ℃	21.5 ℃	Yes
Relative Humidity	10 - 70 %	37 %	Yes
Probe Velocity	6.59 - 6.83 m/s	6.810 m/s	Yes
Probe Force Peak	(-5,160) - (-5,894) N	-5,763.0 N	Yes
Maximum Chest Compression	(-63.5) - (-72.6) mm	-66.68 mm	Yes
Internal Hysteresis	69 - 85 %	74.7 %	Yes

Front Thorax
HIII 50th Serial No. 037 Certification No. 57-1
Test Date: 3/20/2019

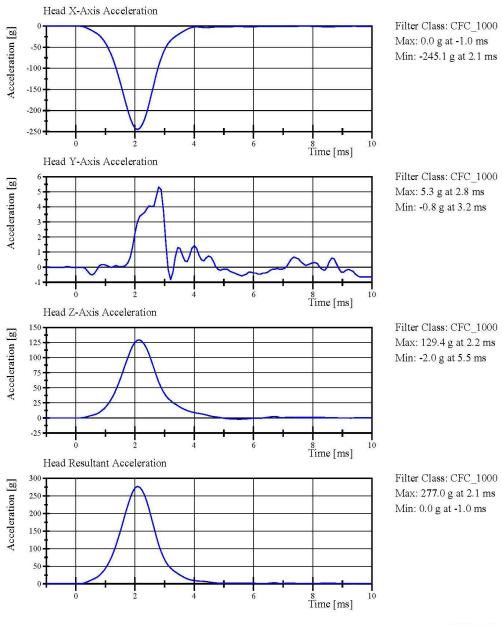
Test Parameter	Specification	<b>Test Results</b>	Pass
Temperature	18.9 <b>-</b> 25.5 ℃	21.4 °C	Yes
Relative Humidity	10 - 70 %	41 %	Yes
Peak Head Resultant Acceleration	250 - 300 g	277.0 g	Yes
Peak Head Lateral Acceleration	(-15) - 15 g	5.3 g	Yes
Is Acceleration Curve Unimodal within 10% of Peak?	Yes	Yes	Yes

Front Head Drop
HIII 5th Serial No. 070 Certification No. 36-1
Test Date: 3/12/2019

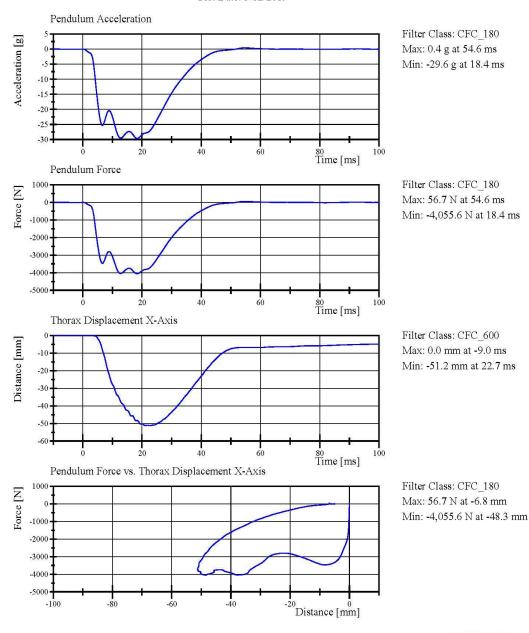
Test Parameter	Specification	<b>Test Results</b>	Pass
Temperature	20.6 <b>-</b> 22.2 ℃	21. <b>7</b> ℃	Yes
Relative Humidity	10 - 70 %	36 %	Yes
Probe Velocity Probe Force Peak Between 50.0 mm	6.59 <b>-</b> 6.83 m/s	6.764 m/s	Yes
and 58.0 mm Chest Deflection	(-3,900) - (-4,400) N	-3,988.2 N	Yes
Probe Force Peak Between 18.0 mm and 50.0 mm Chest Deflection	>= (-4,600) N	-4,055.6 N	Yes
Maximum Chest Compression	(-50) - (-58) mm	-51.2 mm	Yes
Internal Hysteresis	69 - 85 %	73.1 %	Yes

Front Thorax
HIII 5th Serial No. 070 Certification No. 36-1
Test Date: 3/12/2019

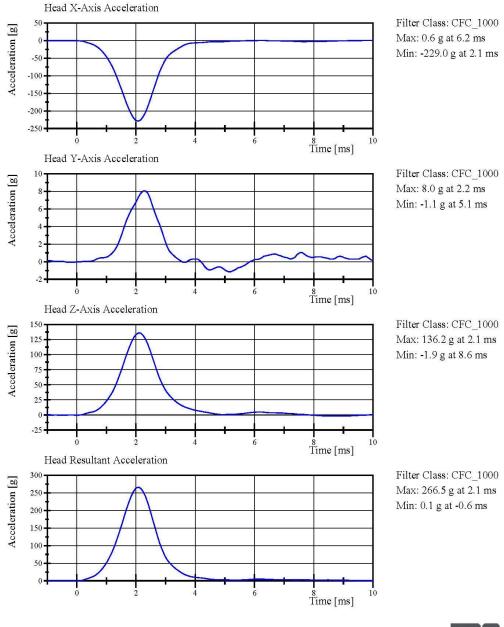
Test Parameter	Specification	<b>Test Results</b>	Pass
Temperature	18.9 <b>-</b> 25.5 ℃	21.5 ℃	Yes
Relative Humidity	10 - 70 %	37 %	Yes
Peak Head Resultant Acceleration	250 - 300 g	266.5 g	Yes
Peak Head Lateral Acceleration	(-15) - 15 g	8.0 g	Yes
Is Acceleration Curve Unimodal	Yes	Yes	Yes

Front Head Drop
HIII 5th Serial No. 070 Certification No. 37-1
Test Date: 3/20/2019

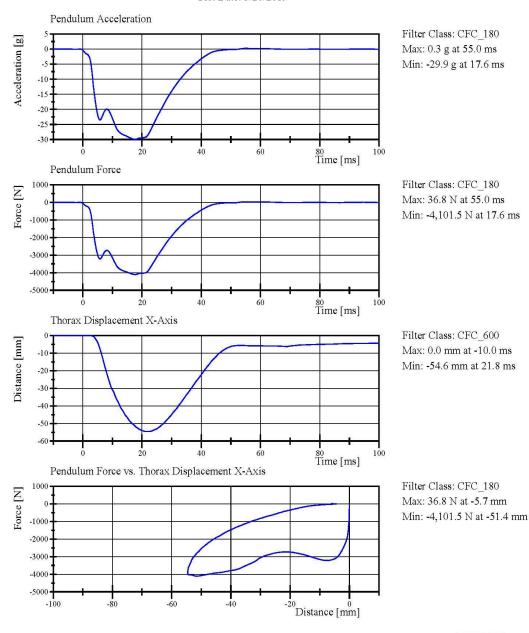
<b>Test Parameter</b>	Specification	<b>Test Results</b>	Pass
Temperature	20.6 <b>-</b> 22.2 ℃	21.6 ℃	Yes
Relative Humidity	10 - 70 %	36 %	Yes
Probe Velocity Probe Force Peak Between 50.0 mm	6.59 <b>-</b> 6.83 m/s	6.763 m/s	Yes
and 58.0 mm Chest Deflection	(-3,900) <b>-</b> (-4,400) N	-4,101.5 N	Yes
Probe Force Peak Between 18.0 mm and 50.0 mm Chest Deflection	>= (-4,600) N	-4,072.6 N	Yes
Maximum Chest Compression	(-50) - (-58) mm	-54.6 mm	Yes
Internal Hysteresis	69 - 85 %	70.7 %	Yes

Front Thorax
HIII 5th Serial No. 070 Certification No. 37-1
Test Date: 3/20/2019
